NRL/MR/6180--06-8934

# Volume Sensor Development Test Series 4 Results — Multi-Component Prototype Evaluation

January 25, 2006

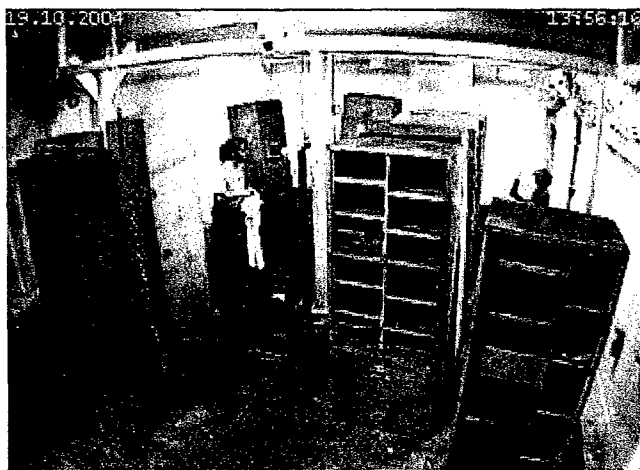
Fig. 6 — Camera view from Volume Sensor prototype location 1

Video cameras are used as part of the Volume Sensor prototype, to monitor and record each test, and to provide a live view of the conditions within the compartment during testing. Figures 6 to 8 show photos of the fields of view for each of the three VS suite standard video cameras. The video images were obtained using standard CCD color cameras, Sony SSC-DC393 with Pentax manual iris 3.5 to 8 mm, variable focus lens.
