# **Tank Sealing with Coating Materials**

**U.S. DEPARTMENT OF TRANSPORTATION**

**Maritime Administration**

**Todd Pacific Shipyards Corporation**

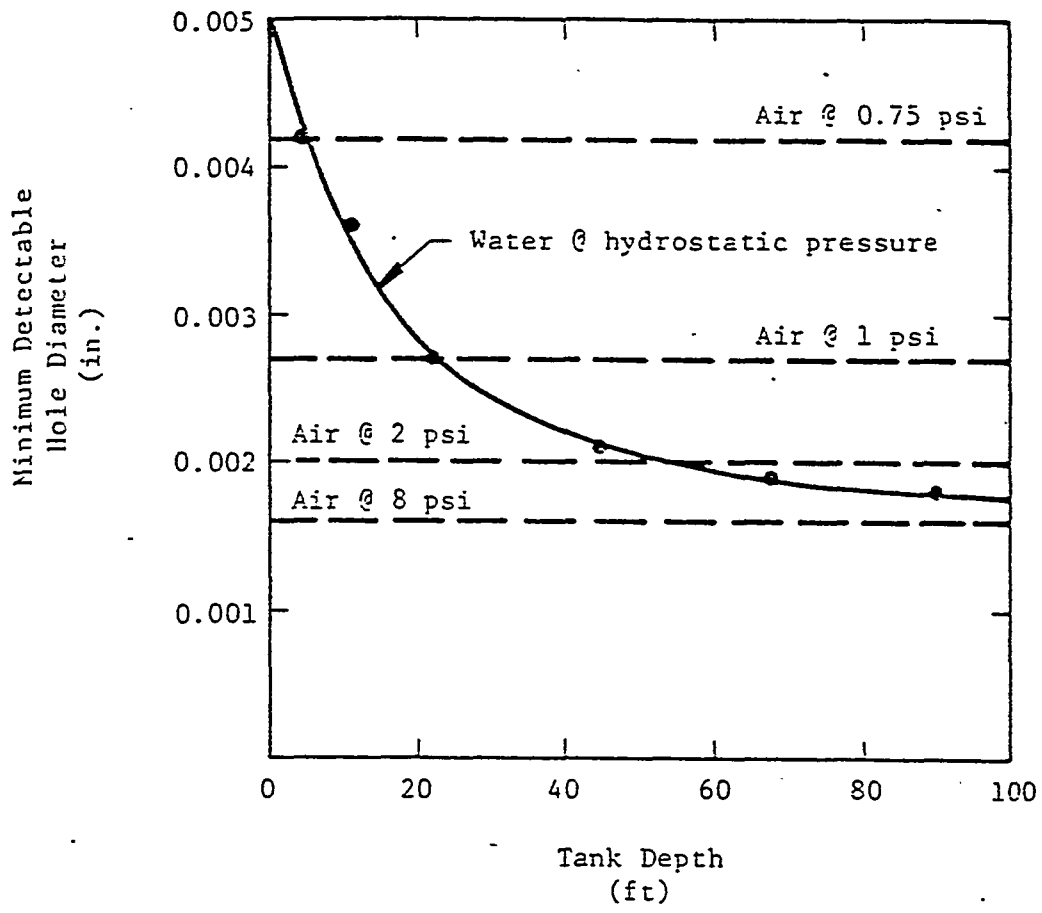
FIGURE 1. MINIMUM DETECTABLE HOLE DIAMETER VS TANK DEPTH

In order to evaluate the accuracy of the various tightness tests, it was necessary to determine the minimum hole or flaw size that could be detected by each method. The information shown on Figure 1 indicates the relative sensitivity of a hydrostatic test and a low pressure air and soap test. In a low pressure air and soap test, air is used to pressurize the tank, thus, forcing air out through any holes in the tank boundary. The exterior of the tank boundary is coated with a soap film, and air leaking across the boundary forms soap bubbles. This provides a clear indication of where small pinhole-type leaks exist in the tank walls. Typically, a shipbuilder performs an air and soap test in order to detect and repair as many leaks as possible before hydrostatically testing for tank tightness.

From Figure 1, one can see that an air and soap test with a pressure differential of 2 psig can detect a hole as small as 2 mils in diameter. The hydrostatic test has a variation in minimum detectable hole size since the differential pressure is a function of the height of the water in the tank. However, for a tank that is 100 feet deep, the minimum detectable hole size (at or near the bottom of the tank) is slightly less than 2 mils in diameter. Near the tank top, the minimum detectable hole size is between 3 and 5 mils in diameter. Comparing the two methods, there is little difference in the accuracy of (1) a 2 psig air and soap test and (2) a hydro test. In addition, the air-test would be more likely to uncover leaks over the entire surface area of any size tank than would a hydro test since the detectable hole size of the hydro test is a function of the water level in the tank.
