NRL/MR/6180--07-9025

Future Naval Concepts — Crew Reductions through Improved Damage Control Communications (FNC-CRIDCC)

Triad Test 2 Report (18-22 Sep 2006)

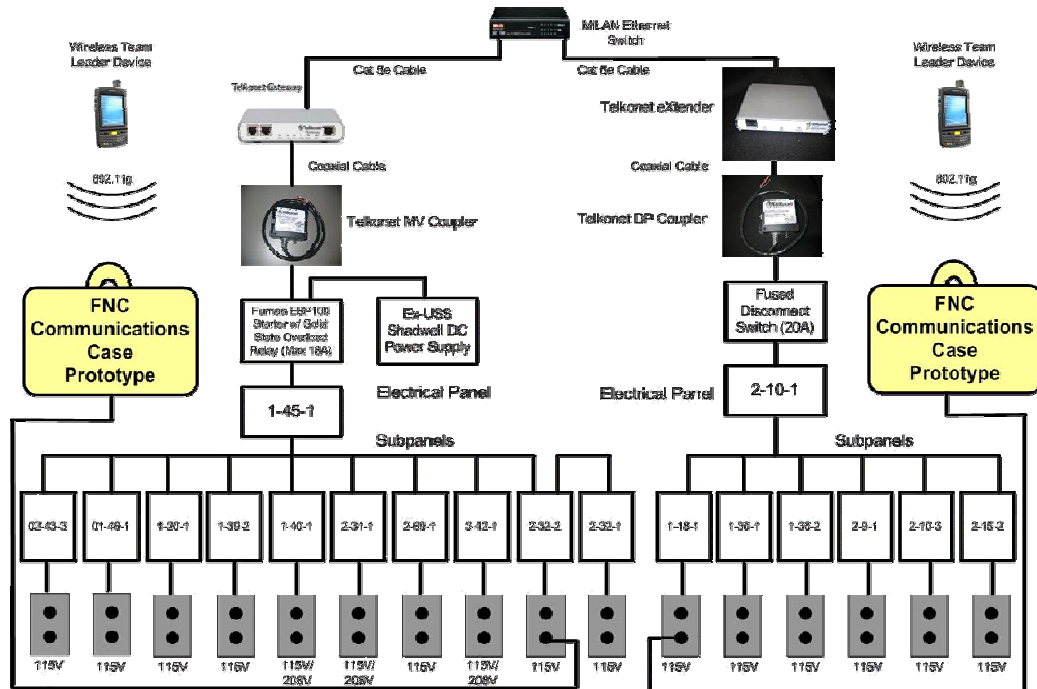
Figure 1 – Voice Calls on the PLC Standalone Network

This test verified SIP voice communications between a receptacle on the Telkonet eXtender[®] path and a receptacle on the Telkonet Gateway[®] path of the PLC network without any connection with the ex-USS *Shadwell* Gigabit Ethernet System. (Figure 1)

**Ex-USS Shadwell
CommCase-to-CommCase
PLC Configuration**

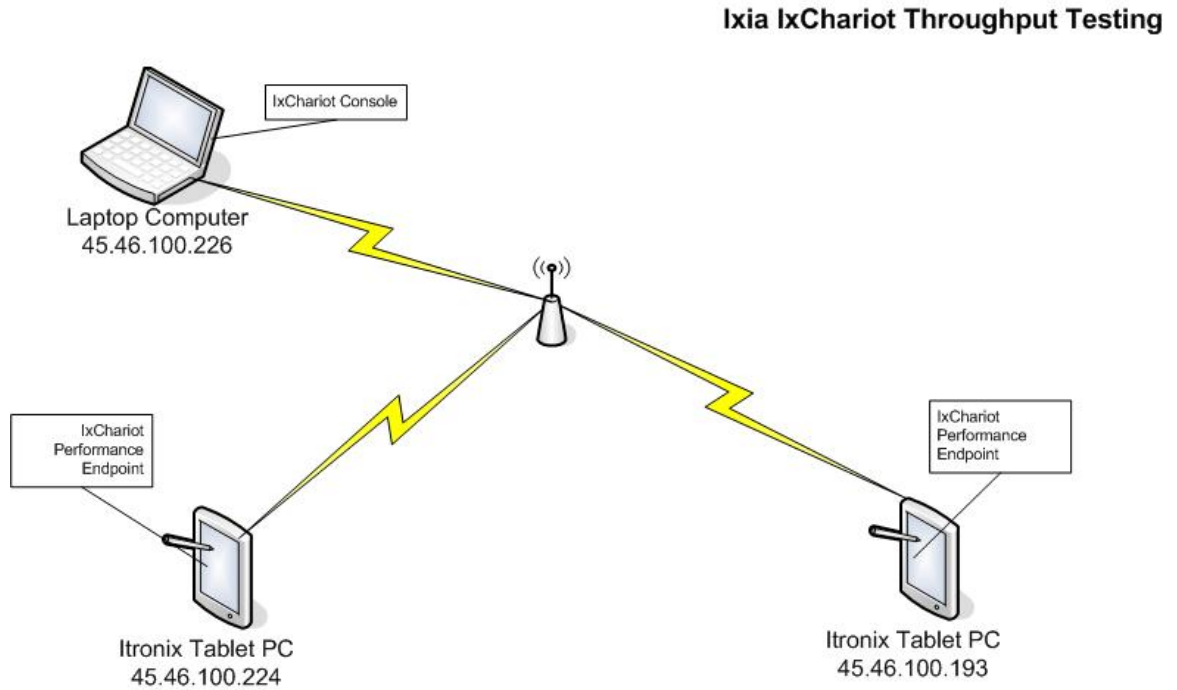
Figure 9 – Fire Event 2 Throughput Testing Topology

A problem was identified with the Fire Event 1 WLAN throughput test and the configuration was changed for Fire Event 2. During this Fire Event one of the performance endpoints was positioned in the passageway outside compartment 1-26-1. This endpoint was using the 45.46.100.193 IP address. The other endpoint was positioned in compartment 2-23-3, using the 45.46.100.224 IP address. Figure 9 is a conceptual representation of the configuration.

During this Fire Event, the performance endpoint located at 2-23-3 (45.46.100.224) failed before the test started. Operators were unable to bring it online. No data was collected from that location. Data were collected from the performance endpoint located in the passageway outside compartment 1-26-1 (45.46.100.193) during this test.

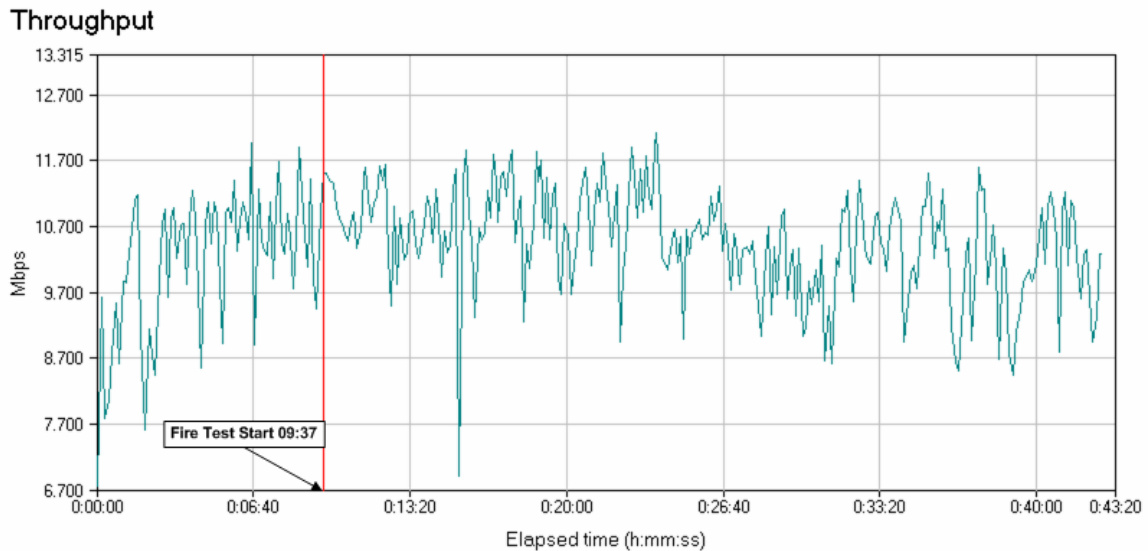
Figure 10 – Fire Event 2 Throughput Graph

The graph in Figure 10 illustrates the throughput data collected from the start of the baseline testing to the end of the Fire Event.

Fire Event testing results show that overall throughput decreased slightly during the fire. It is unknown if the cause of this was the fire itself or if it was because of the use of various other networked devices during this time period such as IP cameras, Air Magnet tablet PCs, PDAs, Vocera Badges, Laptop Computers, and smoke modeling sensors.

Group/Pair	Average (Mbps)	Minimum (Mbps)	Maximum (Mbps)	Throughput 95% Confidence Interval	Time Measured (seconds)	Relative Precision
All Pairs	10.369	6.758	12.116			
45.46.100.193	10.369	6.758	12.116	0.103	2,569.132	.995
Totals:	10.369	6.758	12.116

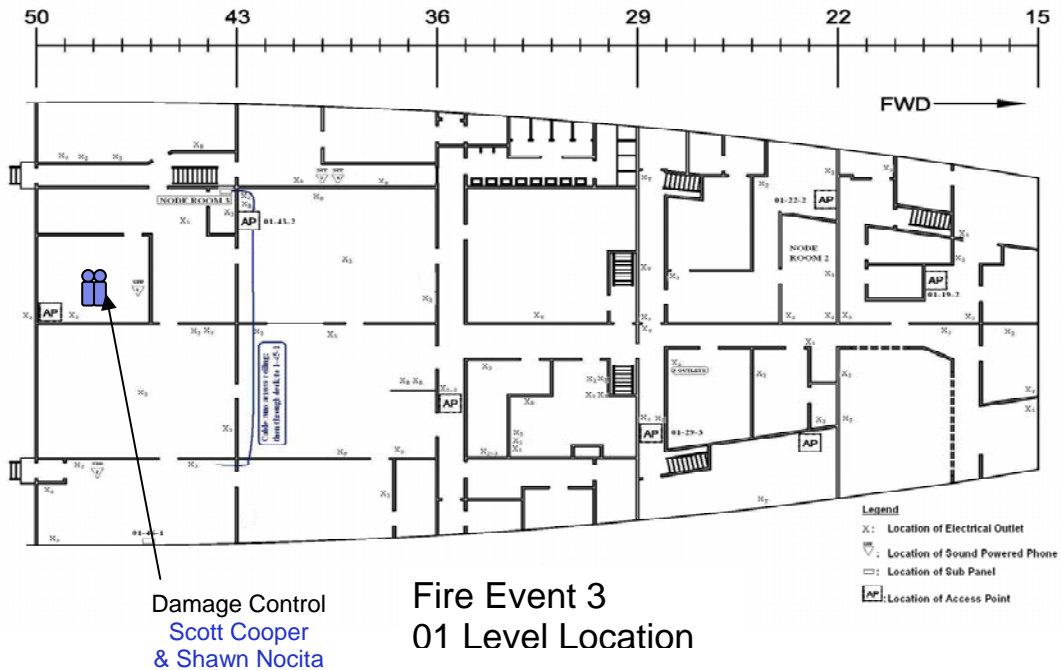
Figure 11 – DC Central Team on the 01 level during Fire Event 3

Damage Control
Scott Cooper
& Shawn Nocita

**Fire Event 3
01 Level Location**

Figures 11, 12, and 13 illustrate locations of teams and fire for Fire Event 1. The data collection teams used Vocera[®] communications badges for voice communications and Symbol[®] MC70 PDAs with iMov Messenger client for text messaging/chat to conduct “back channel” communications.

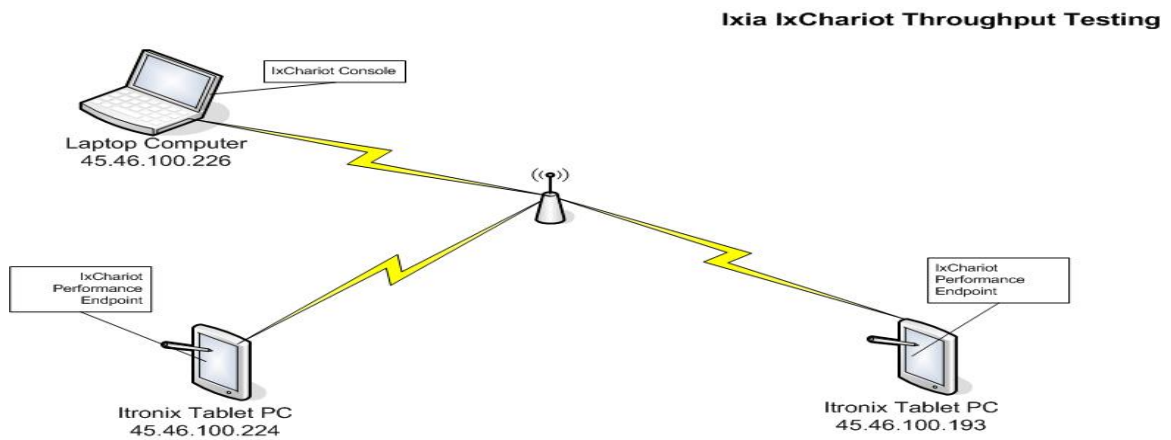
Figure 14 – Fire Event 3 Throughput Testing Topology

Operators changed the performance endpoint configuration during Fire Event 3. They moved one performance endpoint from the passageway outside EDG 1-26-1 to the 02 Level in the passageway near 2-26-1 on the port side of the ship. This endpoint was using the 45.46.100.193 IP address. They moved the other performance endpoint from 2-23-3 to the passageway outside EDG 1-26-1. This endpoint was using the 45.46.100.224 IP address. Figure 14 shows a conceptual depiction of the arrangement.

During this Fire Event, the performance endpoint located in the passageway outside EDG 1-26-1 (45.46.100.224) failed to send data to the IxChariot Console at the end of the testing period. Engineers only collected data from the performance endpoint located in the passageway near 2-26-1 on the port side (45.46.100.193) during this test. There was connectivity between the performance endpoint 45.46.100.224 and the IxChariot console during the entire test, the device itself did not fail.

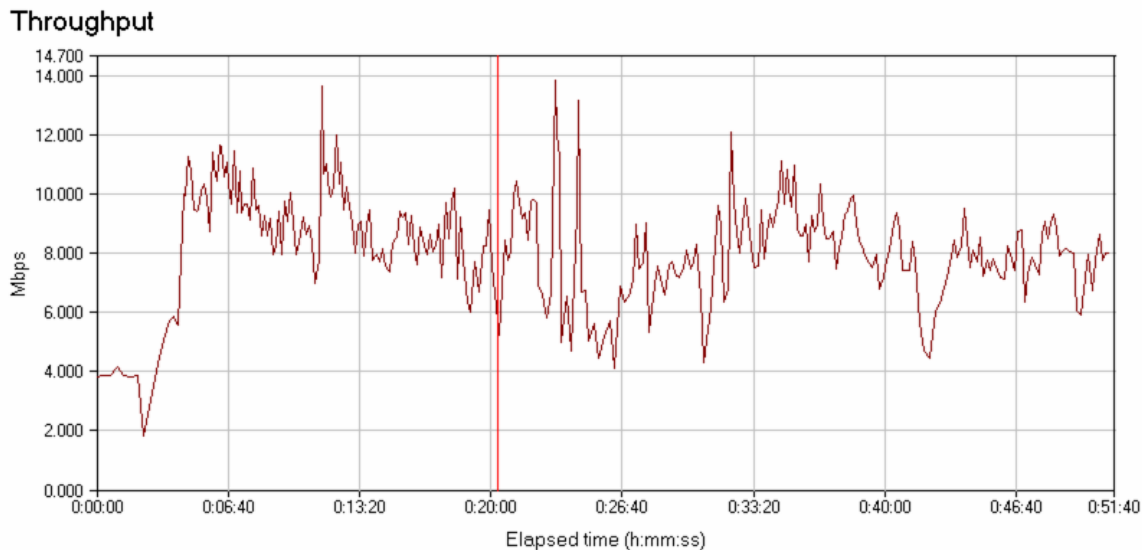
Figure 15 – Fire Event 3 Throughput Graph

Figure 15 illustrates throughput data collected from the start of the baseline testing to the end of the Fire Event.

Group/Pair	Average (Mbps)	Minimum (Mbps)	Maximum (Mbps)	Throughput 95% Confidence Interval	Time Measured (seconds)	Relative Precision
All Pairs	7.785	1.844	13.850			
45.46.100.193	7.785	1.844	13.850	0.286	3,082.675	3.673
45.46.100.224	n/a	n/a	n/a	n/a	n/a	n/a
Totals:	7.785	1.844	13.850
