US Army Corps  
of Engineers®  
Engineer Research and  
Development Center

## Investigation of Mechanical Processes for Removing Lead-Based Paint (LBP) from Wood Siding

September 2006

Final report

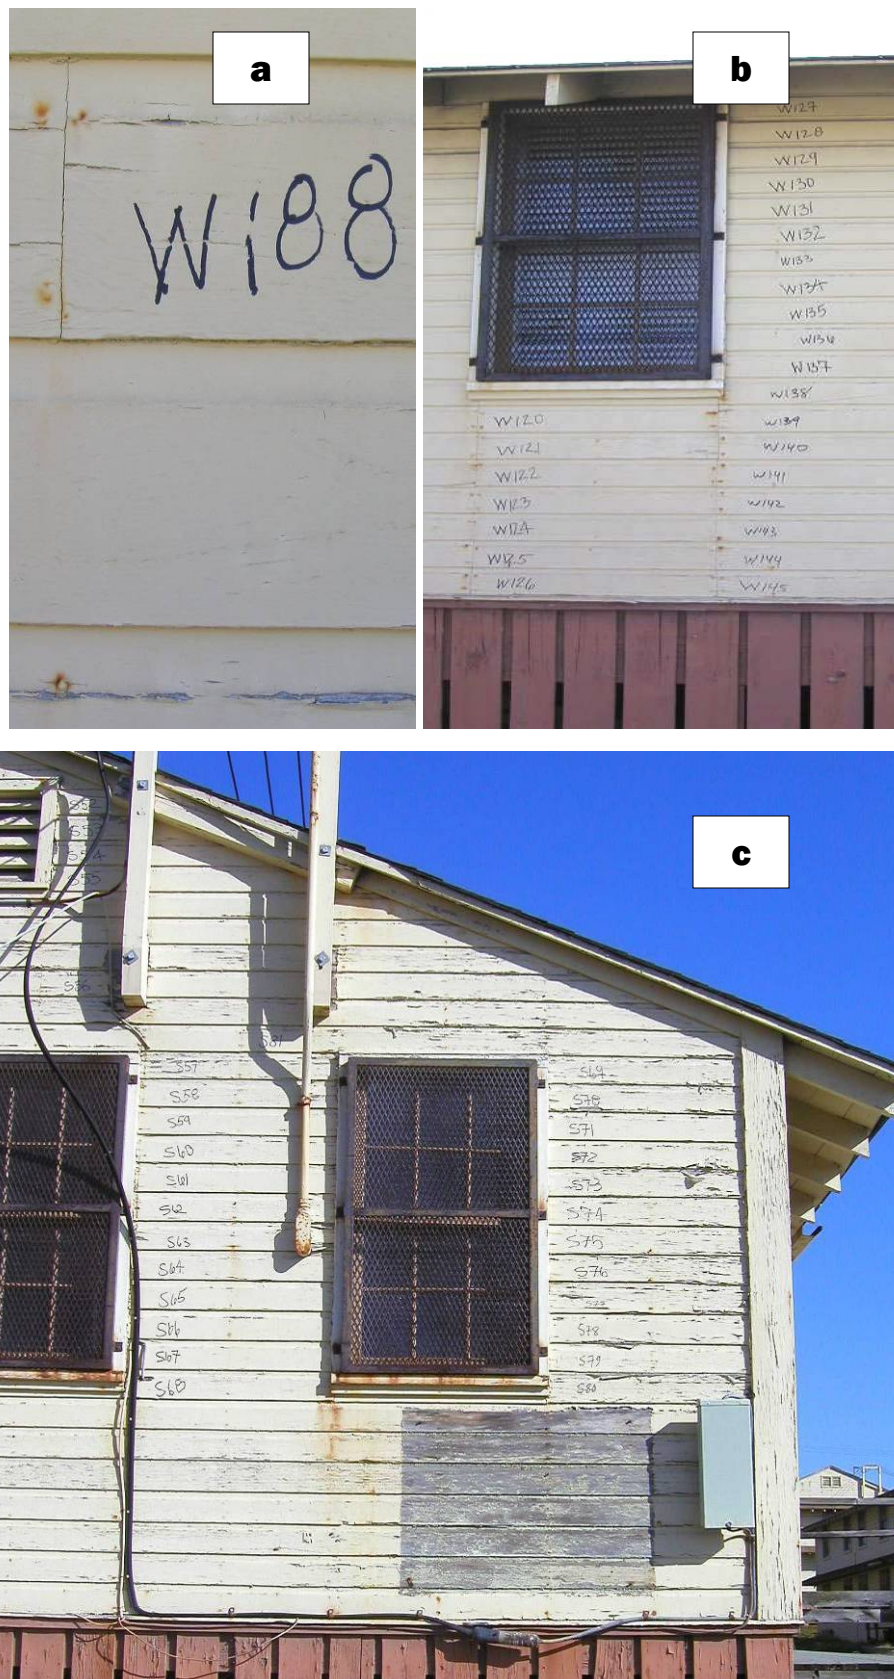
An onsite appraisal of the barracks siding materials at Fort Ord was completed in April 2002. The siding was visually inspected and photographed to document building exterior conditions. During the visit, each piece of siding on each building was given an identification (ID) number. The ID number included a letter prefix indicating wall orientation – north (N), east (E), south (S) or west (W) – and a number giving vertical location Figure 2 (a, b, and c). Building T2824 was marked with a red permanent marker and Building T2825 was marked with black.

In Figure 2a, note double nail pattern at left, indicated by rust spots. Also, note the difference in siding condition in Figures 2b (west wall) and 2c (south wall), which is apparently a result of differences in weathering and exposure.

Figure 2. Typical ID numbering of individual siding pieces at Fort Ord.

In spite of a difference in siding width, both the Fort Campbell and Fort Ord siding were nailed to the building framing using a double nail pattern spaced 24 in. on-center, as shown in Figure 2. Because the Fort Campbell buildings had wood siding overlaid with vinyl siding, additional nail holes were evident in every piece. Nail holes in salvaged siding are a significant factor that can reduce its value or limit its usefulness in certain ready-to-finish millwork products.

The siding salvaged from Fort Ord (Figure 6) was generally in much better condition than the Fort Campbell siding. In general, the same defects as described for Fort Campbell were found in the Fort Ord siding, but with much less frequency. The paint loss and wood weathering of the Fort Ord siding was more location-specific; the most severe degree of weathering and checking were found on pieces from the south sides of the building, where solar exposure was highest. Figure 2c shows a typical southern exposure and Figure 2b shows a typical western exposure.

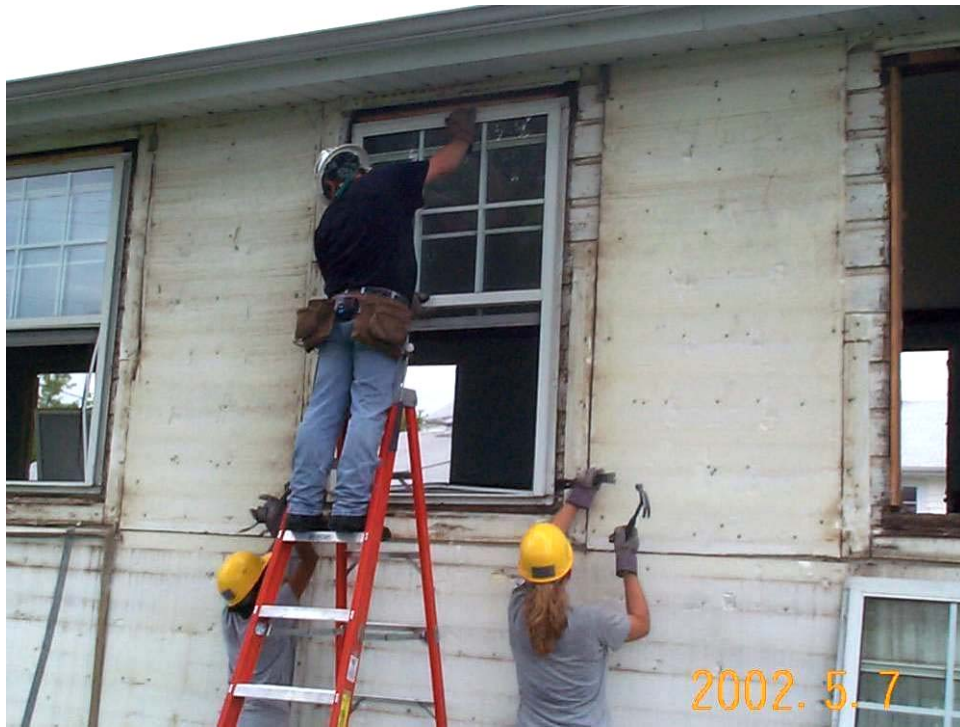
The scheduled deconstruction of five buildings at Fort Campbell (Figure 3) provided another source of wood siding for evaluation. The siding from those buildings was separated from the other salvaged materials because of its LBP content and the poor condition of the paint film. The siding was disposed of as debris except for boards from one two-story barracks building. Those boards were removed, bundled, banded, and shipped to FPL. In order to assess the condition of the siding boards relative to their position on the building, a coding scheme was adopted similar to that used at Fort Ord, with N, E, S, and W indicating compass orientation and a number indicating vertical and horizontal location of each piece. ERDC-CERL personnel coded each siding piece, and the boards were removed by Austin Habitat for Humanity, Austin, TX, the deconstruction contractors for this project.

Figure 3. Deconstruction at Fort Campbell.

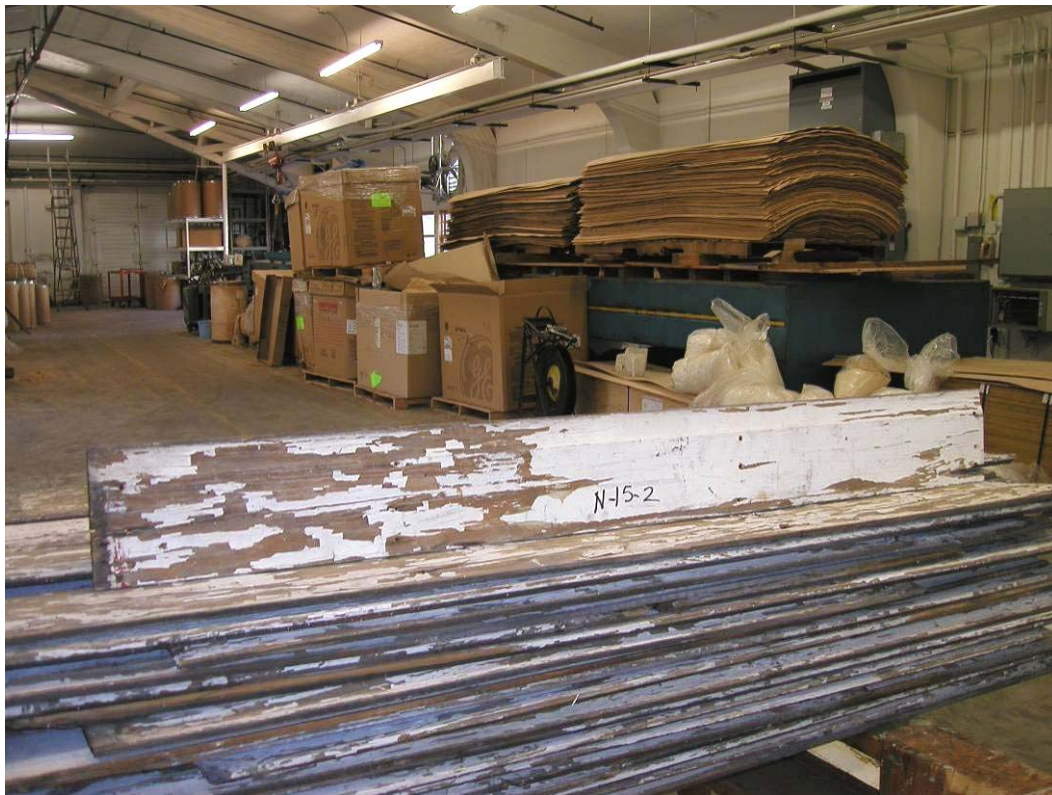
A visual assessment of the siding specimens from Fort Campbell indicated that it had been painted several times, but the paint surface was in poor condition. Surface quality varied considerably, and paint film separation and flaking were evident in most pieces (Figure 5). This paint failure was problematic because many siding pieces lost the hand-marked ID numbers during handling and transportation. This problem limited the ability to accurately account for and track all the siding back to its original building position.

Figure 5. Salvaged siding from Fort Campbell.

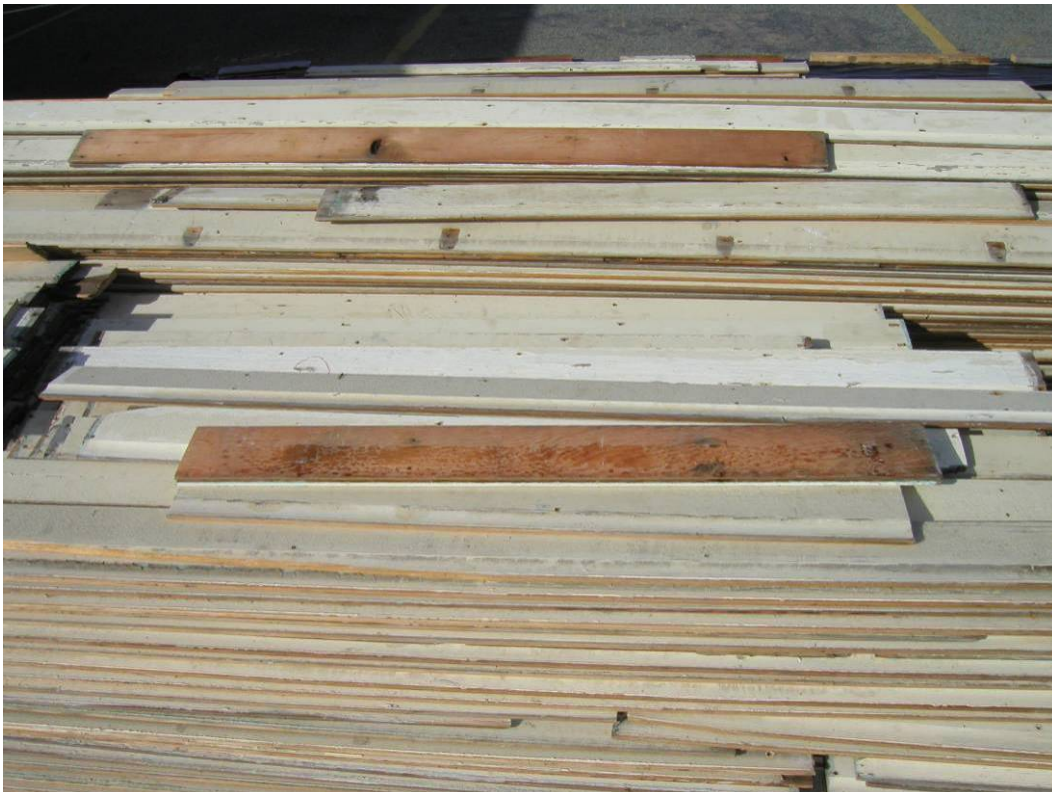
Figure 6. Douglas fir siding salvaged from Fort Ord.

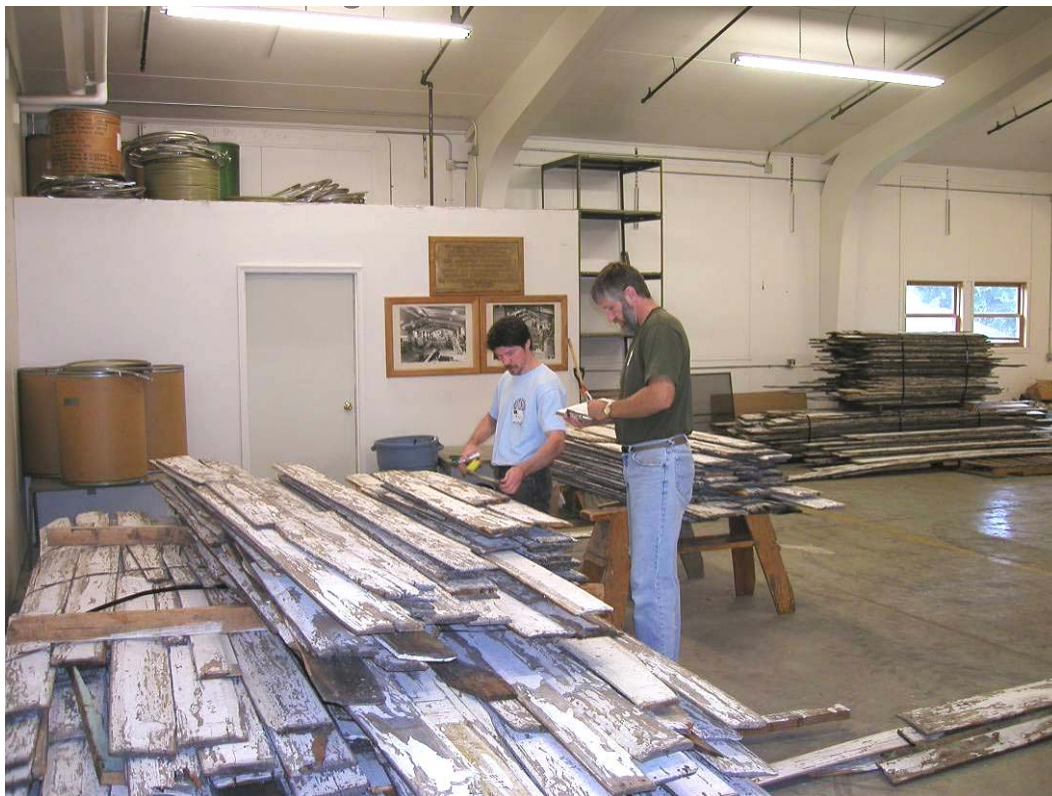
Separation by profile classification was based mainly on recoverable length. Because wood flooring grades allow pieces as short as 16 in., pieces up to 7 ft in length were classified as tongue and groove (T&G) flooring. Wood paneling is typically sold in lengths greater than 8 ft, often to 10 ft, to accommodate vertical placement on interior walls. Therefore, siding pieces from 8 – 10 ft were separated for remanufacture into V-groove paneling. Lengths more than 10 ft were segregated as bevel siding for remanufacture, because longer siding is preferred in the home building market and commands the highest price. Figure 7 shows the first inspection in progress.

Figure 7. Quantitative inspection of Fort Campbell siding.

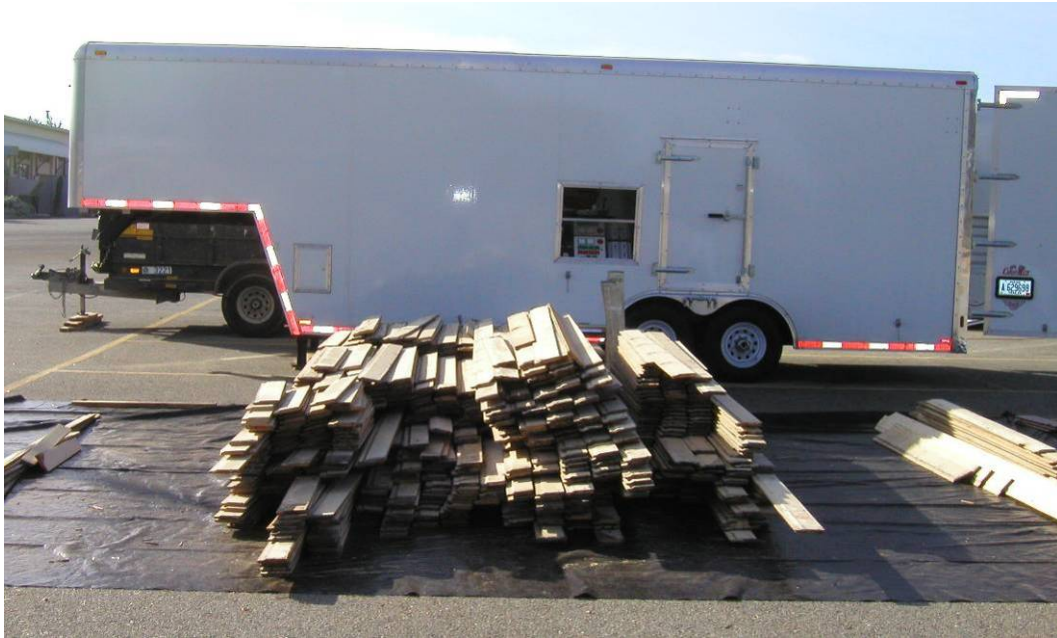
FORA donated 1,226 pieces of siding (7,830 lf) from previous deconstruction projects for use in the demonstration by Auburn Machinery, Inc. (later renamed Auburn Enterprises, Inc., Auburn, ME). The siding had been stored for many years under cover and was left over from a previous deconstruction project. A visual inspection of the wood indicated no discernable difference between this siding and the siding shipped to FPL. For this reason, all conclusions on the quality of the siding evaluated at FPL can be assumed applicable for the siding remilled by Auburn. The siding made available to Auburn at Fort Ord is shown in Figure 8.

Figure 8. Fort Ord siding provided for remanufacture by Auburn.

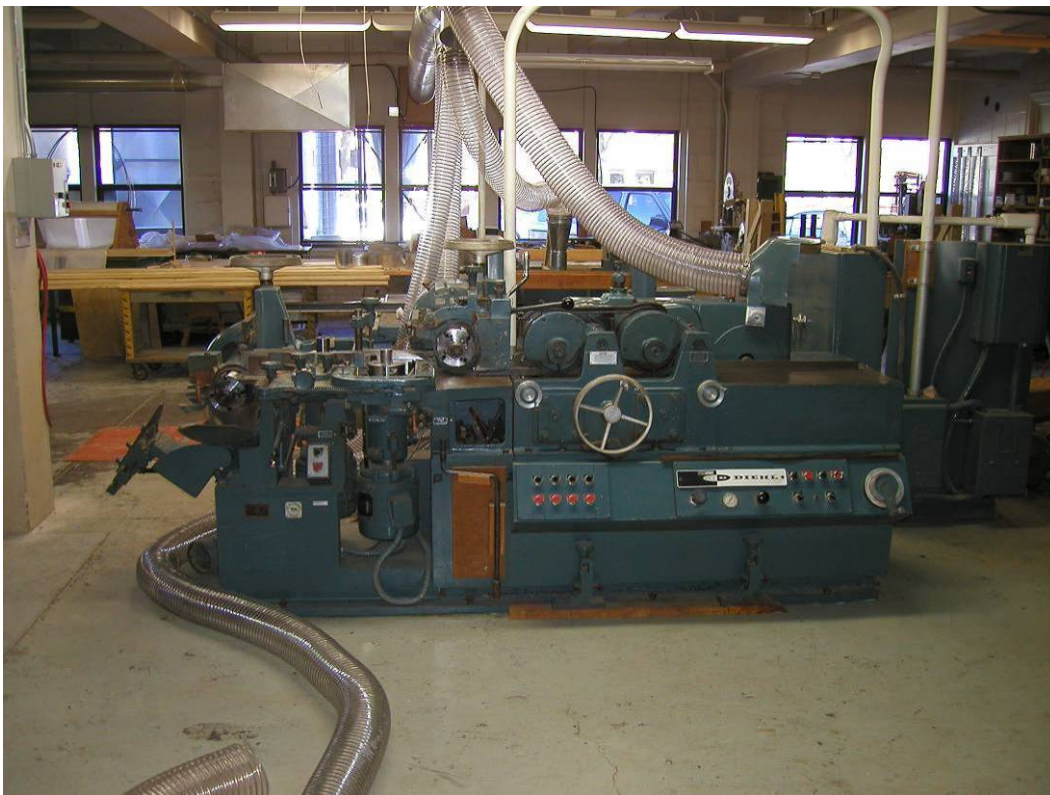
A Diehl molder (Model D-6) located at FPL was used in the laboratory portion of this study (Figure 12). The machine, manufactured in 1966, is fully functional and typical of molder/planer equipment used widely by mill-work producers. It is versatile enough to convert feedstock into many different types of surfaced four side (S4S) wood products in a single pass. In addition, these machines are readily found on the used machine market. The unit is equipped with four cutting heads — two for side cutting, and two for surface cutting.

Figure 12. FPL's Diehl S4S molder.

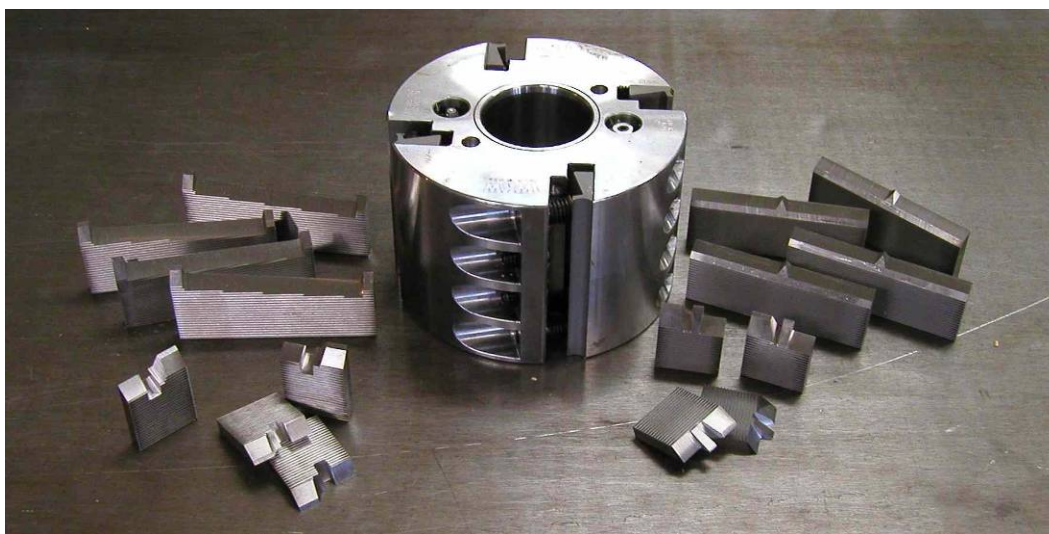
Inspection of the molder indicated that the cutter heads and arbor assemblies needed to be replaced. The existing rotor-style cutter heads with hub lockdowns for constant axial setup were replaced with precision chamber pressure sleeve cylinder cutter heads. This substitution was made to as-

sure accuracy, uniformity, and concentricity for quality processing performance. These replacement parts are shown in Figure 13.

New Hydroloc™ cylinder 150 mm diameter, 150 mm height body (2-1/8 in. bore) surface cutter heads and 150 mm diameter, 60 mm body height (1-13/16 in. bore) side cutter heads were purchased from Hermance Machinery, Inc., in Williamsport, PA. All four cylinder heads were ordered with a 12-degree cutting angle. This cutting angle is optimal for Douglas fir, but less efficient for other pine species, which machine better at different cutting angles.

Figure 13. High-speed steel profile knives and Hydroloc™ cutter head.

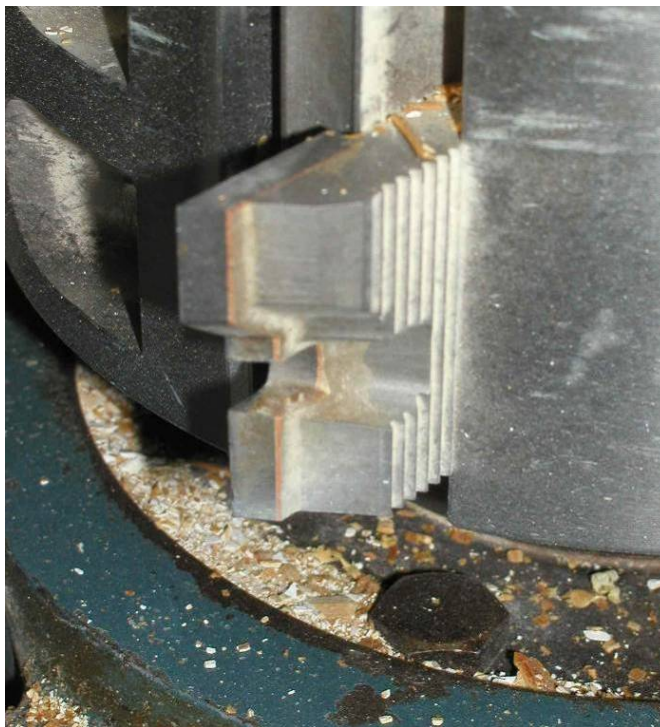
Most of the Fort Ord siding was milled using the ordinary steel blades; the remainder of the Fort Ord siding and all of the Fort Campbell siding was milled using carbide steel blades. The Fort Ord Douglas fir siding was processed using flat and profile M-2 grade, high-speed steel (HSS) knives manufactured by Wisconsin Knife Works, Beloit, WI. Four knives were used in each cutter head. These 35-degree bevel knives with 16/60 corrugated back blades were matched to the replacement cutter heads. The corrugations on the backs of the knives simplified installation, removal, and mechanical locking of the knife in the cutter head; they are shown in Figure 14.

The excessive wear of HSS knives witnessed in early machining trials suggested that carbide knives could be a logical alternative. In addition to the abrasive nature of the paint, the Southern Pine siding from Fort Campbell

had a larger number of knots, which also tends to rapidly dull knives, also shown in Figure 14.

Figure 14. Carbide knife used to machine southern pine, showing corrugation on back.

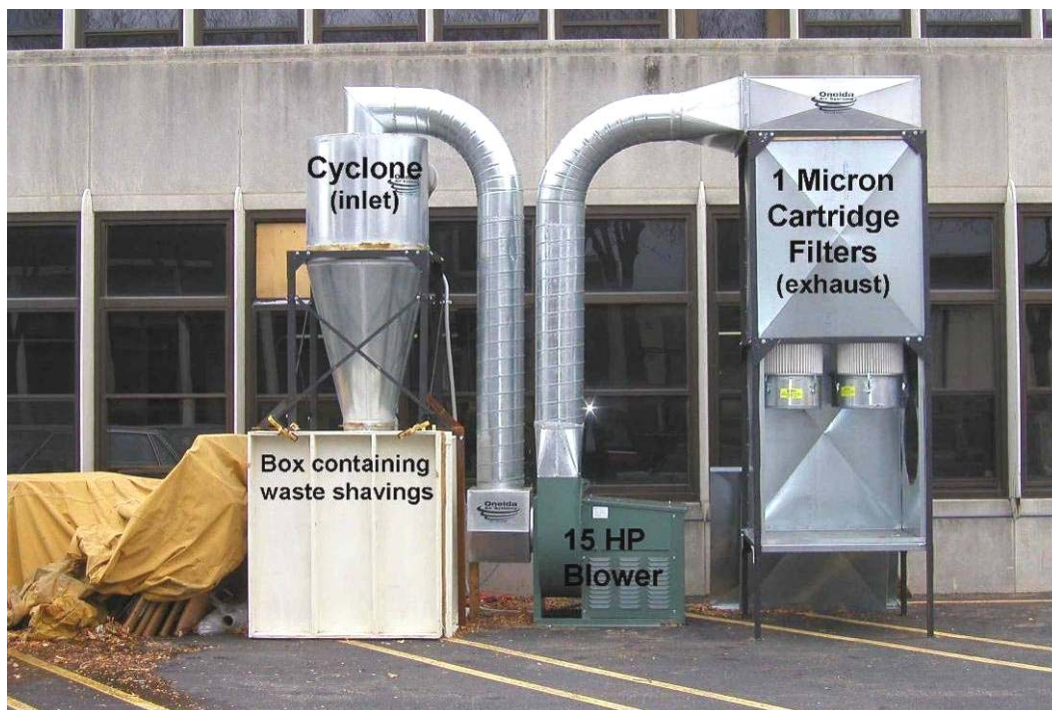
As shown in Figure 15, the new dust collection system was installed outside the FPL mill shop in order to help reduce potential LBP exposure hazards.

Figure 15. Oneida dust collection system as installed outdoors at FPL.

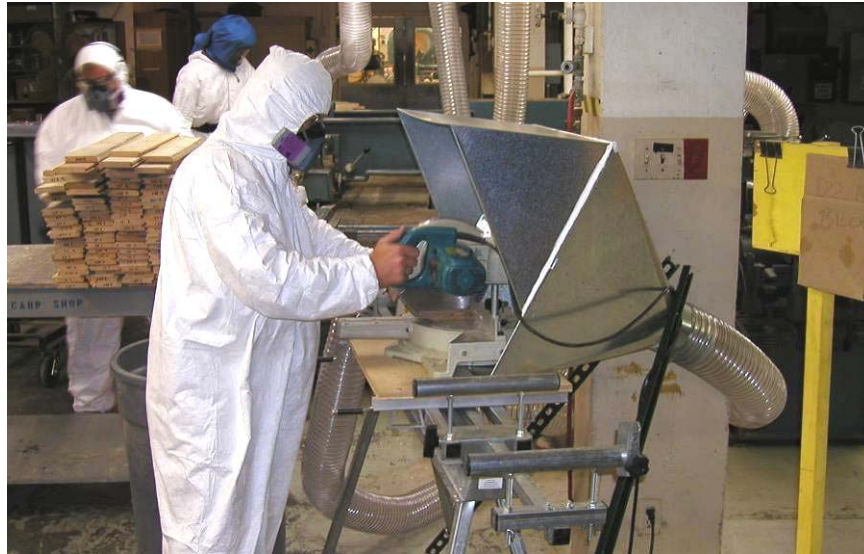
Before processing, each piece of siding was square end-trimmed. This step minimized material feeding problems in the four-head molder, removed wood that was unusable because of end-grain splitting or residual fasteners remaining after deconstruction, and ensured that only usable wood would be machined into finished millwork. End-cuts and crosscutting were performed on the 10 in. Makita compound sliding power miter box shown in Figure 16.

Figure 16. End-trimming with sliding compound miter saw.

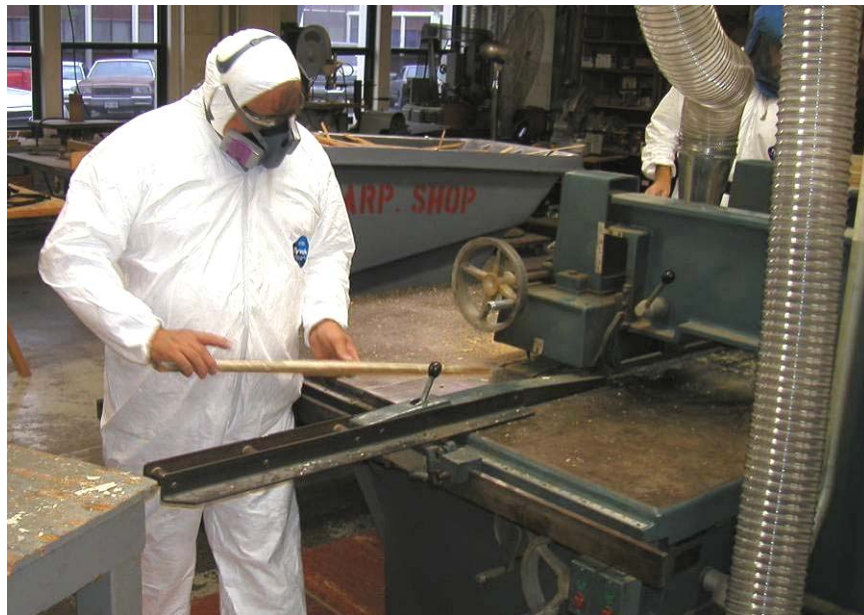
Directly after end-trimming, all siding pieces were ripped to a consistent width that was appropriate for the profile to be manufactured. The inline rip saw used in this step is shown in Figure 17.

Figure 17. Ripping of siding to width.

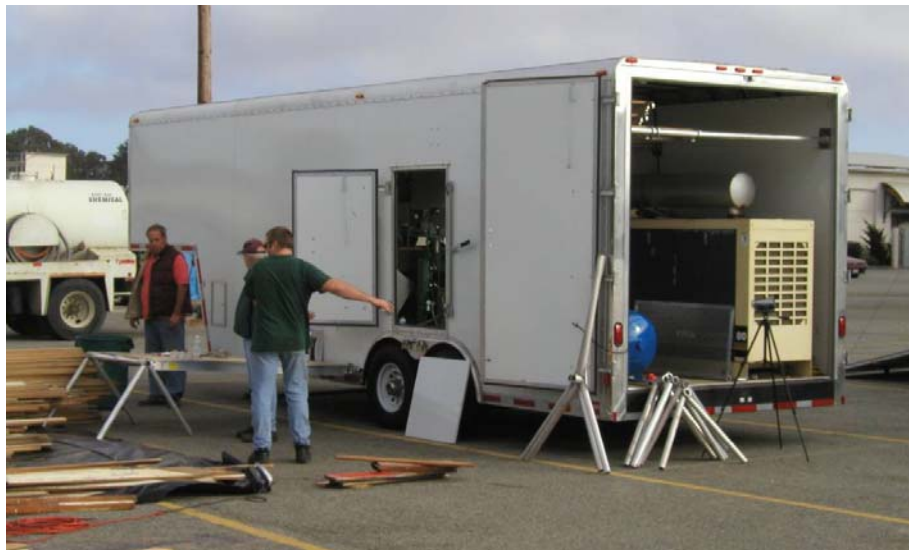
The Yield Pro machine evaluated in this study consisted of two planing heads (one top and one side head) and a side-ripping blade. (The side-ripping blade can be replaced with a hogging blade to grind up the removed material rather than leaving it in the form of a strip.) The machine is enclosed in a self-contained trailer that includes an electrical generator, an air compressor, a dust collection and storage system, and a fire suppression system (Figure 19).

Figure 19. Auburn's Yield Pro mobile unit at Fort Ord.

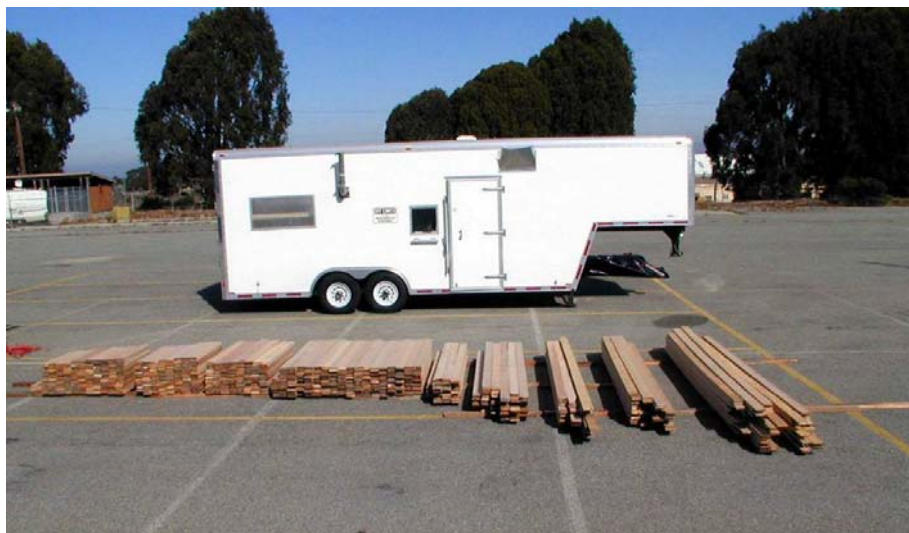
Using cutting tools designed to process wood with embedded nails and surface coatings, this system can resize and profile salvaged wood into uniformly-dimensioned stock. Figure 20 shows the 5/8 in. x 4 in. rectangular blanks produced from salvaged wood using the Auburn system.

Figure 20. Salvaged Fort Ord wood siding remilled into 5/8 x 4 in. boards for molding into value-added wood products.

As indicated in Figure 20 and Figure 25, Auburn mobile unit operations were conducted in a very large parking lot at Fort Ord. This location provided good conditions for isolating mobile unit operations from nearby activities and the general public.

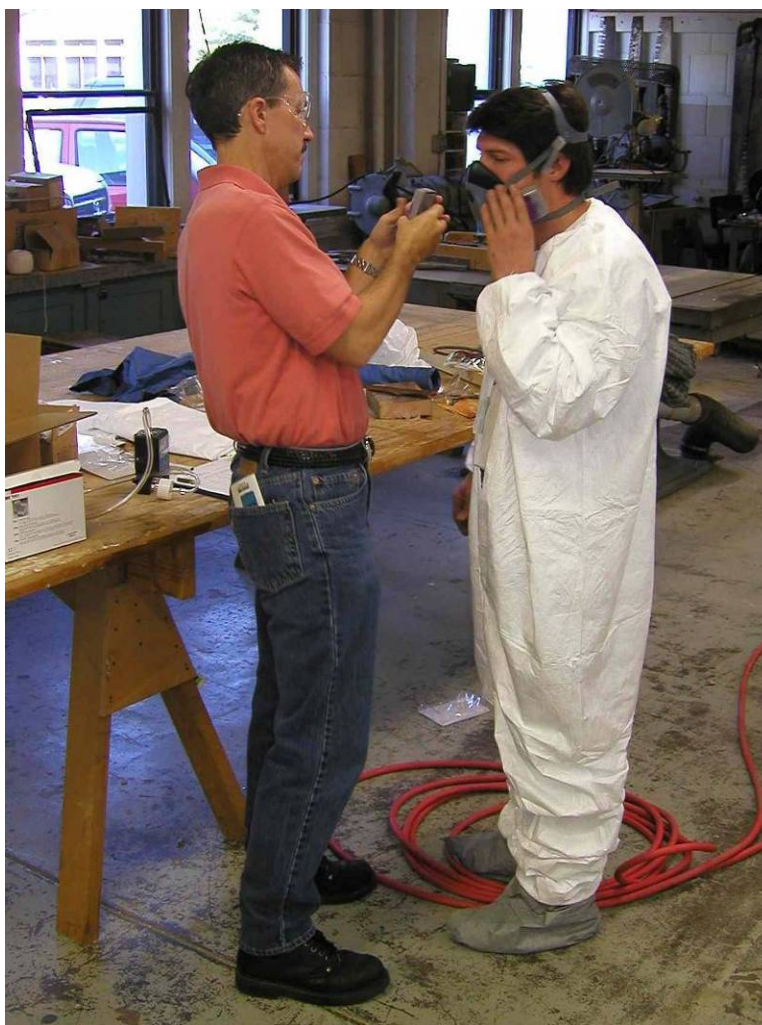
were tested for a baseline blood lead level by a local hospital before machining began. All participants were fitted by a local safety equipment company with the type of HEPA dust mask recommended by OSHA safety regulations for protection from lead-contaminated dust, and they were instructed in proper use of the mask. Disposable Tyvek protective suits (Figure 21) also were provided for each worker to minimize the transfer of lead-contaminated dust to the employees' clothing, homes, or other parts of the shop. These suits were disposed of after each use.

Figure 21. Fitting of safety equipment by FPL safety officer.

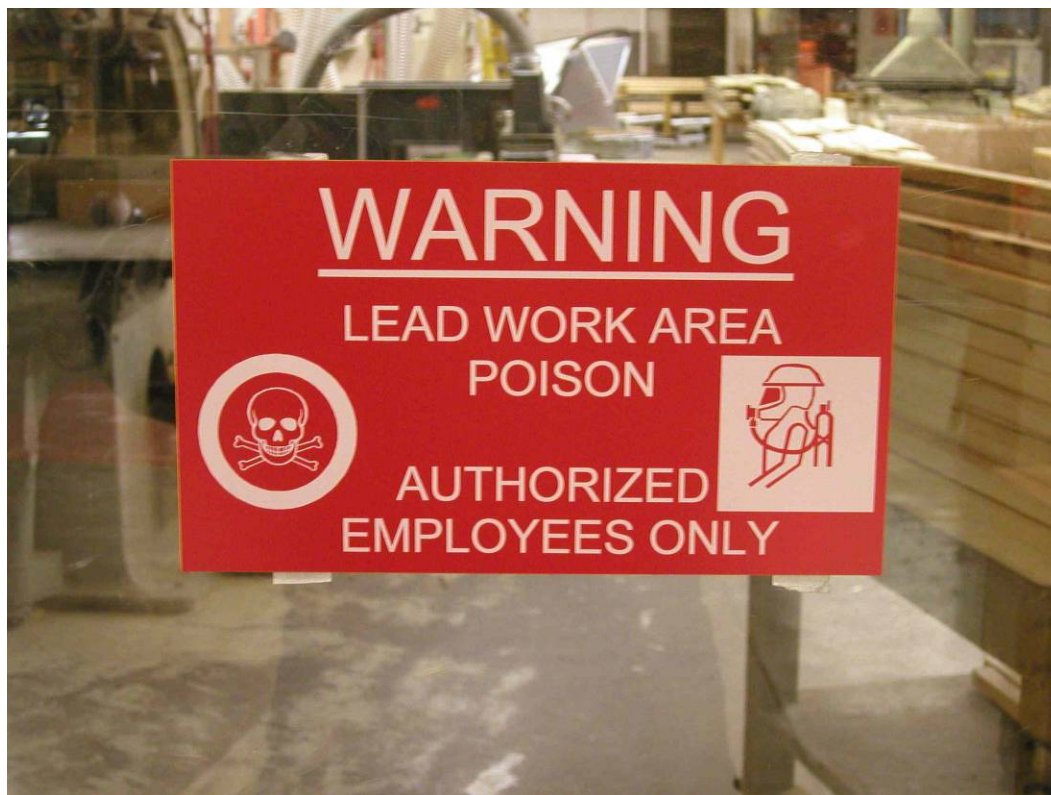
nouncements to staff about ongoing operations were made through the local daily bulletin. Work areas directly involved with milling operations were cordoned, either using signage or visible barriers like those shown in Figure 22.

Figure 22. Signage warning staff of lead hazard in the work area.

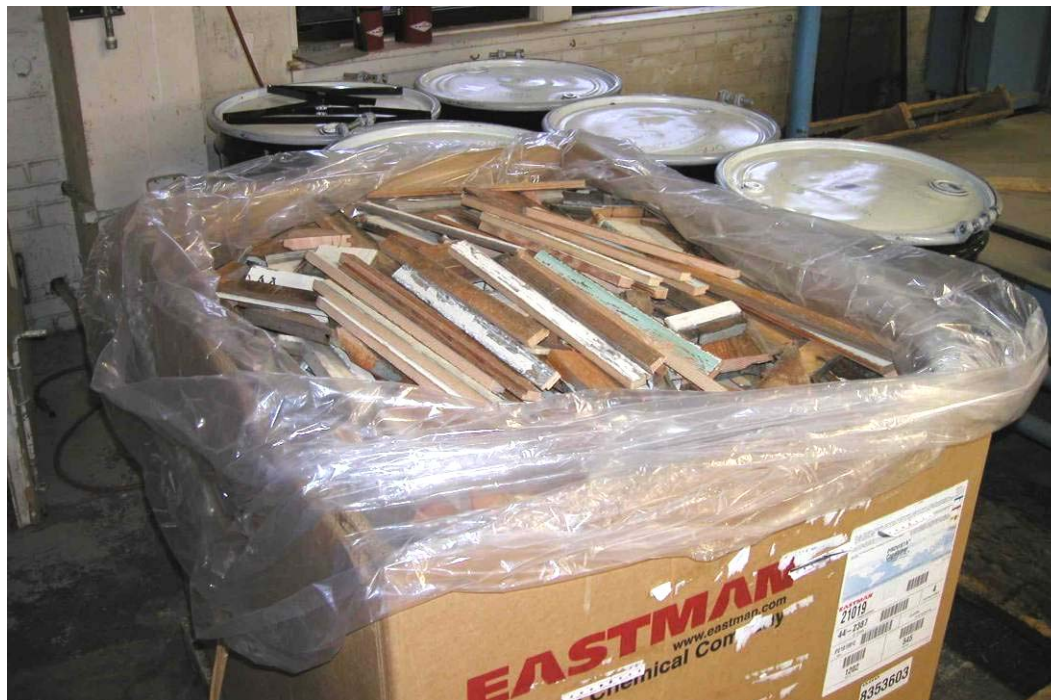
ERDC-CERL requested that all wood waste materials generated by the re-milling work be placed in containers to be shipped to other locations for further waste treatability studies. All cutoff scraps, edge trim pieces, and shavings from the molding operations were placed in either 55 gal\* steel drums or standard Gaylord-type corrugated shipping boxes with plastic liners, as shown in Figure 24.

Figure 24. Containers used for storage and shipping of lead-contaminated wood waste.

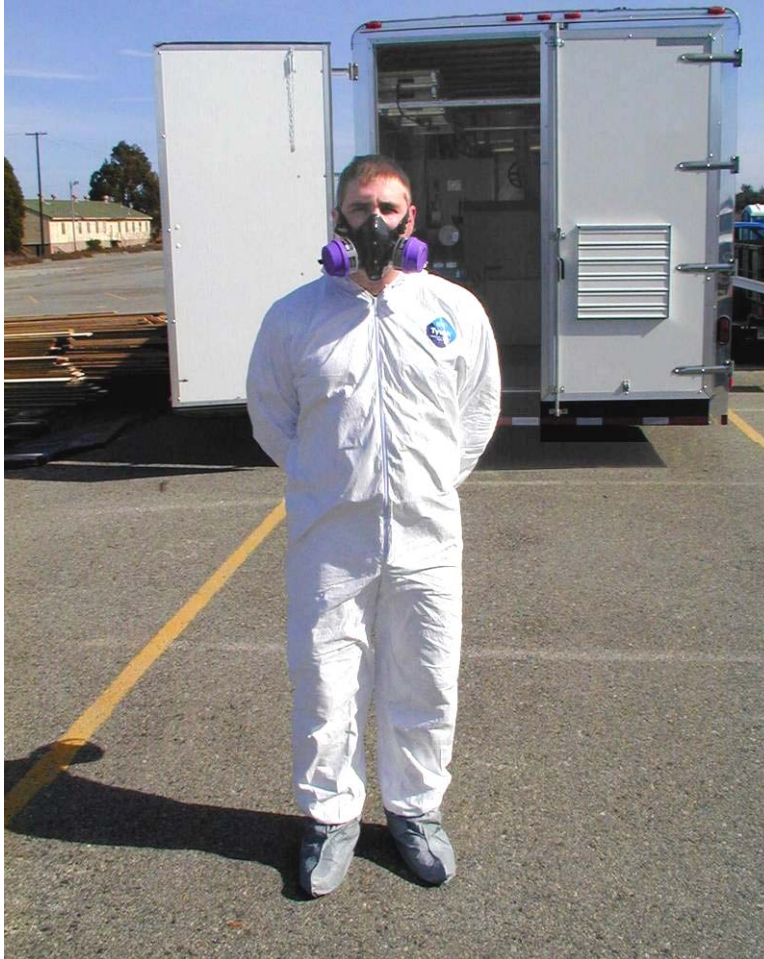
Figure 25. Personal safety equipment used in the Yield Pro demonstration.

Auburn and Wood Waste Diversion personnel used safety equipment similar to that used at FPL (i.e., HEPA face masks and Tyvek suits). Unlike the indoor operations at FPL, the Auburn mobile unit was operated outdoors, and it was determined that only personnel in the immediate vicinity of the work would need the personal safety equipment shown in Figure 25.

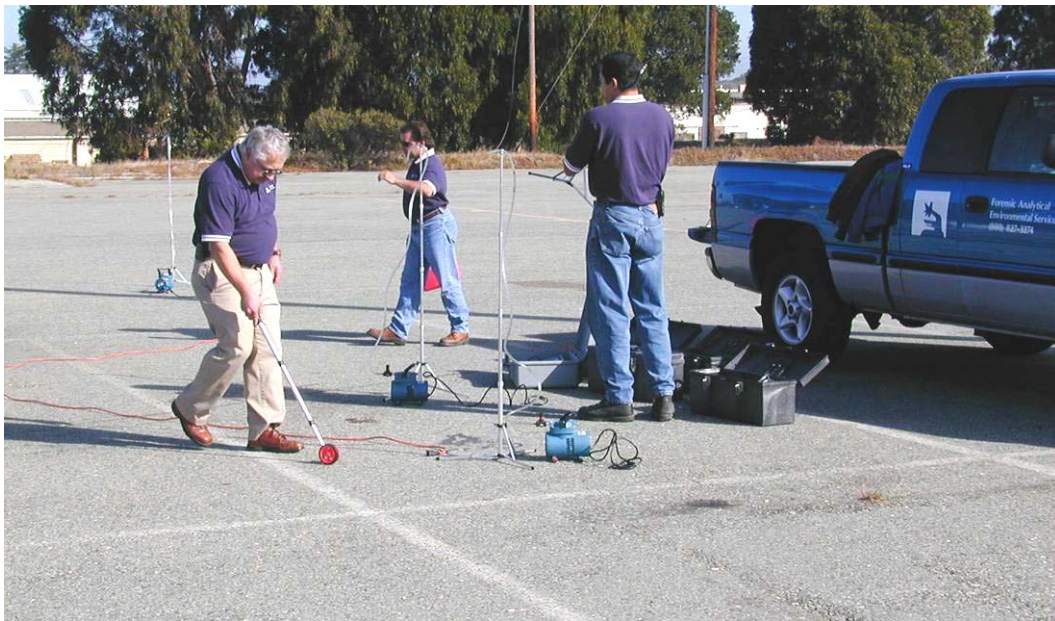
Figure 26. Setting up for air monitoring at Fort Ord demonstration.

During demonstration of the mobile unit on October 31, 2002, air quality was measured both inside and outside the unit. Forensic Analytical, a California-based environmental consulting firm, was contracted to perform the air sampling. As shown in Figure 26, measurement stations were established around the perimeter of the mobile unit at distances up to 65 ft.

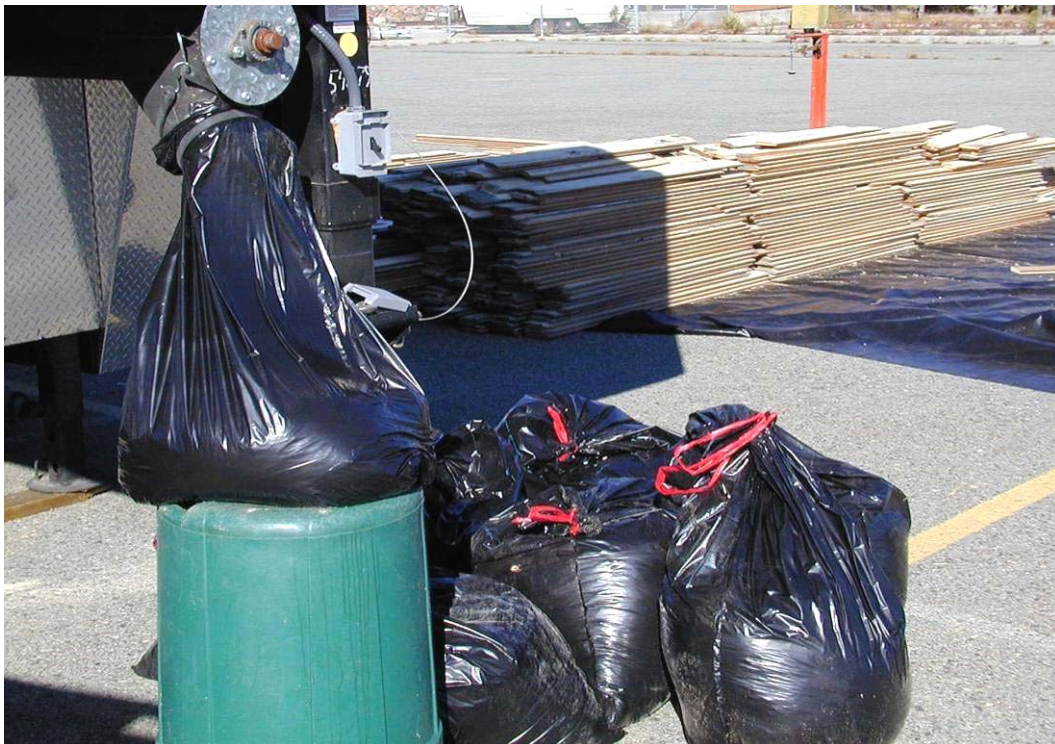
Figure 27. Waste collection from mobile processing unit.

The waste materials generated by mobile unit operations were sequestered from the dust collection area into plastic bags using an auguring system (Figure 27). These materials were disposed of by Wood Waste Diversion.

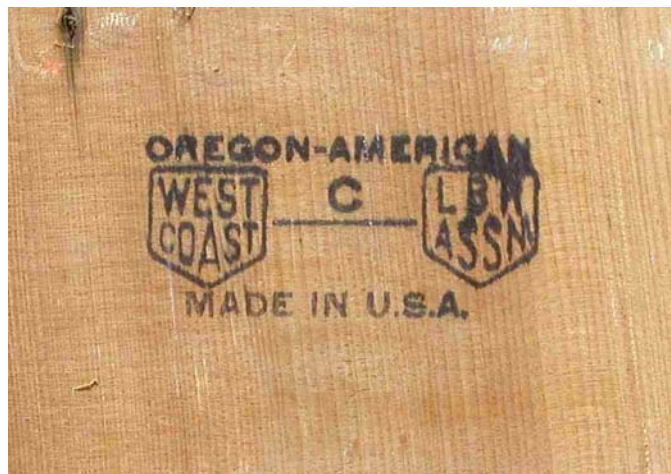
(C = visual grade, Oregon-American = Mill ID)

Figure 28. West Coast Lumber Association grade stamp on sample of salvaged Fort Ord siding.

A visual assessment of all pieces indicated that the siding recovered from Fort Ord was manufactured of very high quality Douglas fir. This determination was confirmed by the discovery of old grade stamps on the siding, as shown in Figure 28. This stamp shows that the siding as installed was grade C or better which, at the time, represented the highest grade of Douglas fir siding available. The condition of the siding as recovered was generally very good, with good paint adhesion and relatively little wood damage or degradation.

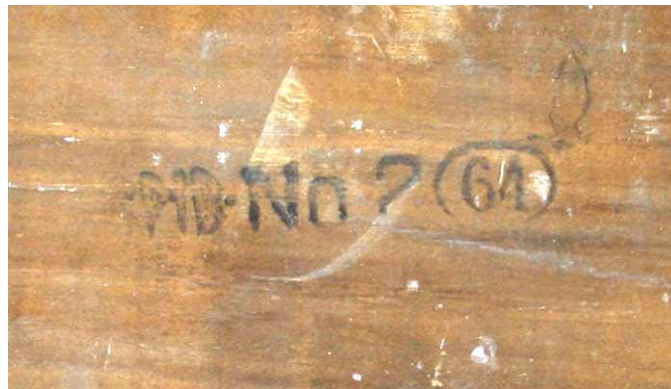
(SPIB = Southern Pine Inspection Bureau, No. 2 = visual grade, 64 = mill number.)

**Figure 29. Southern Pine Inspection Bureau grade stamp on sample of salvaged Fort Campbell siding..**

Visual inspection of all the pieces indicated that the Fort Campbell siding was manufactured from Southern Pine and contained many larger knots. The siding was generally in poor condition, with considerable flaking paint, warping and cracking, and a significant amount of deconstruction damage. More importantly, the grade stamps found on the siding indicated that the original wood was only of moderate quality —No. 2 lumber board stock , which allows much larger knots than siding grades. It is likely that, because these barracks were classified as temporary structures with an assumed service life of 3 years, No. 2 stock was considered adequate for the application. The stamp is shown in Figure 29.

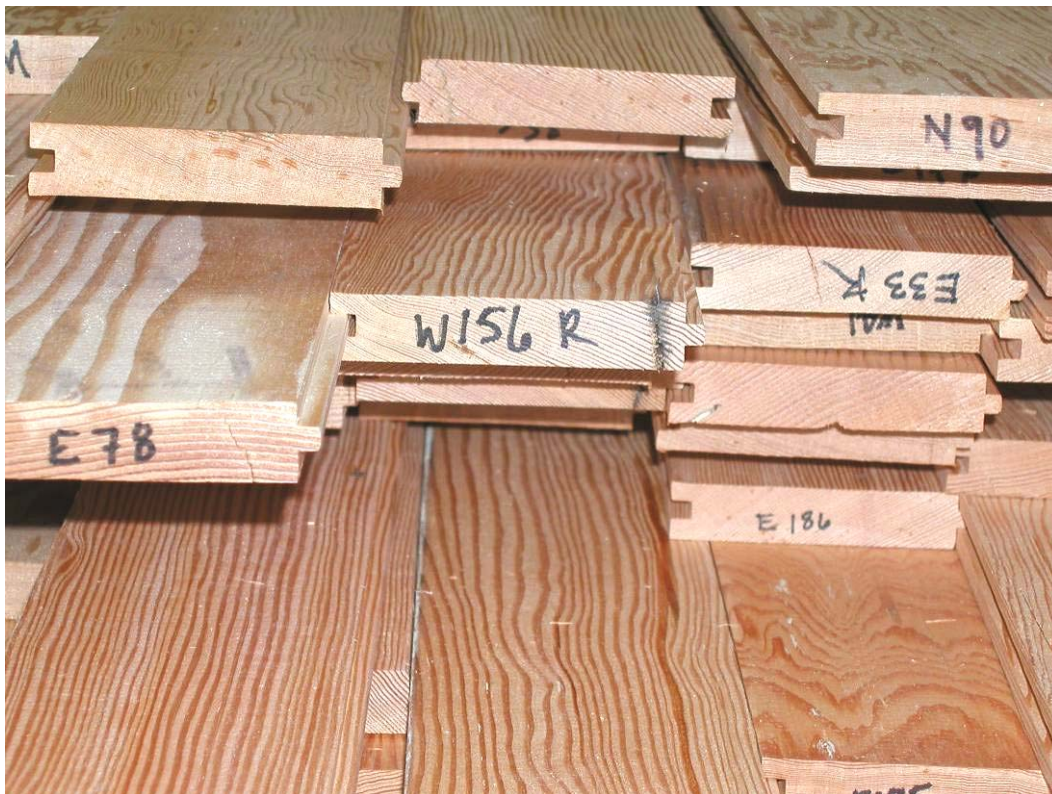
Figure 30. T&G flooring produced from Fort Ord siding.

Figure 30 – Figure 32 show examples of the T&G flooring, V-groove paneling, and bevel siding, respectively, remanufactured from the Fort Ord siding.

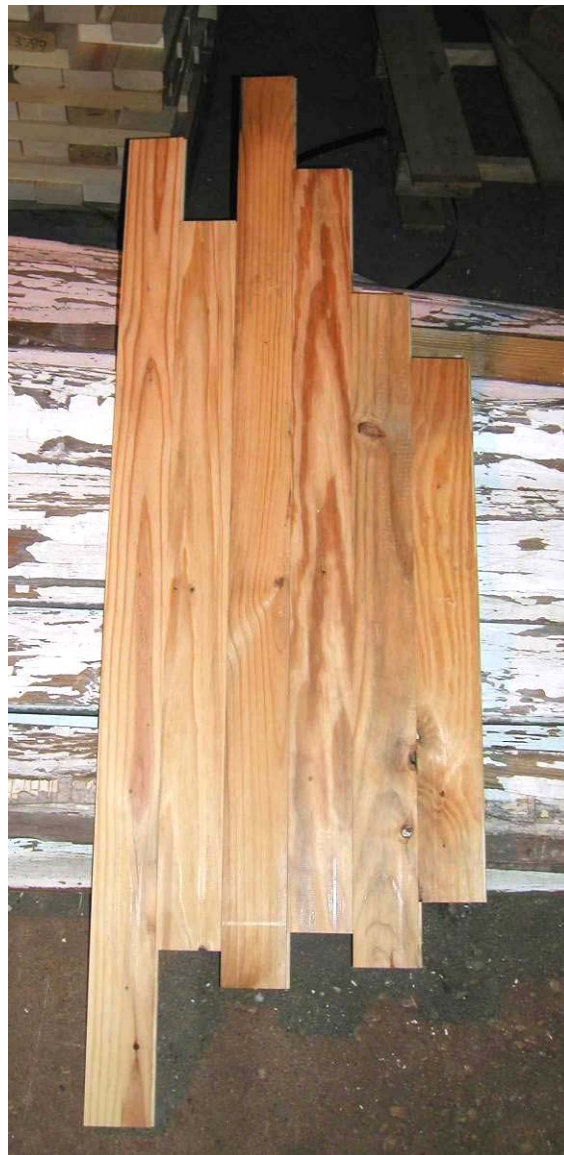
Figure 33 shows T&G flooring produced from the Fort Campbell siding. Although there were many knots in the product because of the original grade of wood used, it appeared to be attractive and marketable.

Figure 33. T&G flooring produced from Fort Campbell siding.

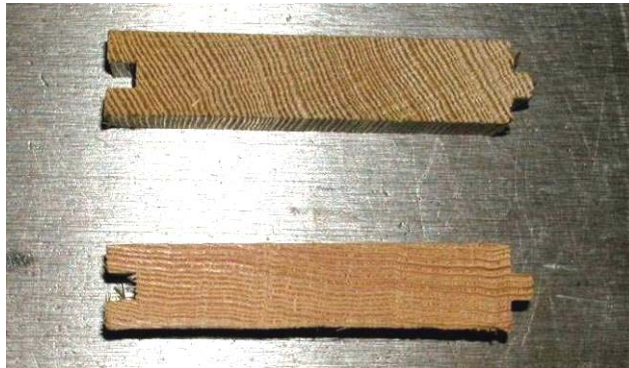
Figure 34. Samples of vertical grain (top) and flat grain (bottom).

As discussed in Chapter 2, the remanufactured products were visually inspected after processing to determine the losses due to defects not detected in the feedstock or otherwise not allowed by the applicable grading standard. For the Fort Ord materials this inspection also included examination of a large percentage of the milled pieces to determine grain orientation (i.e., either vertical or flat). Grain is an important characteristic for pricing wood because vertical grain commands a much higher price in some niche markets than flat grain due to its warp resistance, superior paint adhesion, and evenness of grain appearance. Figure 34 shows the difference between these two grain orientations. Table 7 indicates the distribution of vertical versus flat grain from the Fort Ord siding. Because the

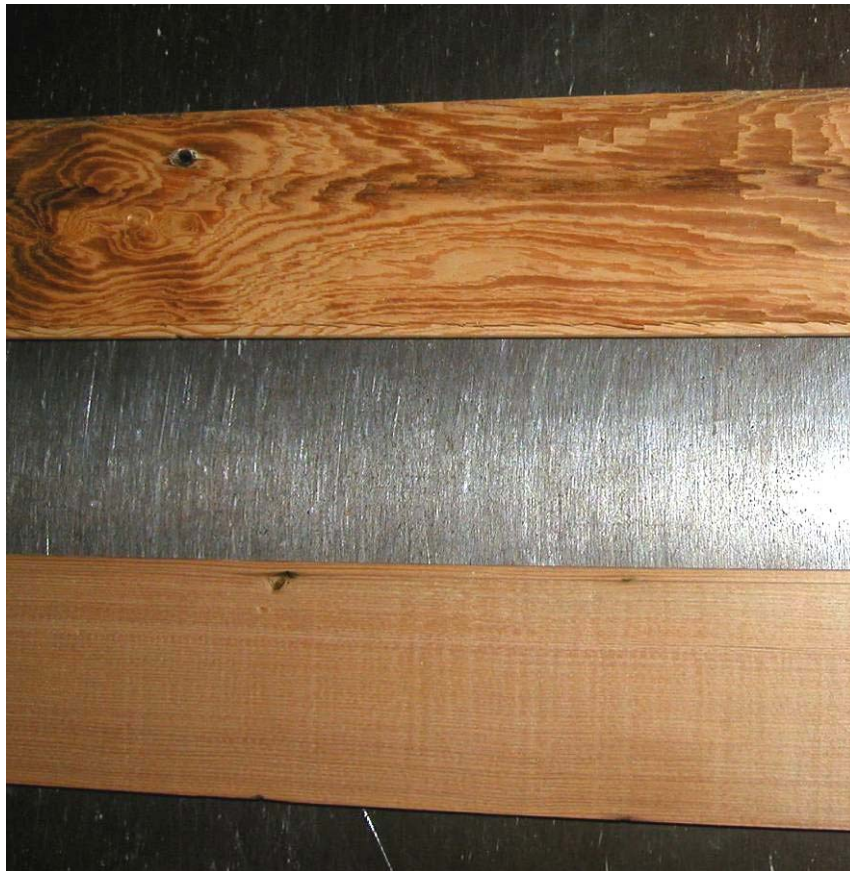
Figure 36. Degradation of wood surface quality (top) due to dulling of HSS knives.

As shown in Figure 35, the machining of the LBP siding was very abrasive to HSS knives; the knife was razor sharp when installed but dulled dramatically after machining less than 1,000 lf of siding. This dulling in turn degraded the surface quality of the machined wood, as shown in Figure 36.
