US Army Corps  
of Engineers®  
Engineer Research and  
Development Center

## Investigation of Mechanical Processes for Removing Lead-Based Paint (LBP) from Wood Siding

September 2006

Final report

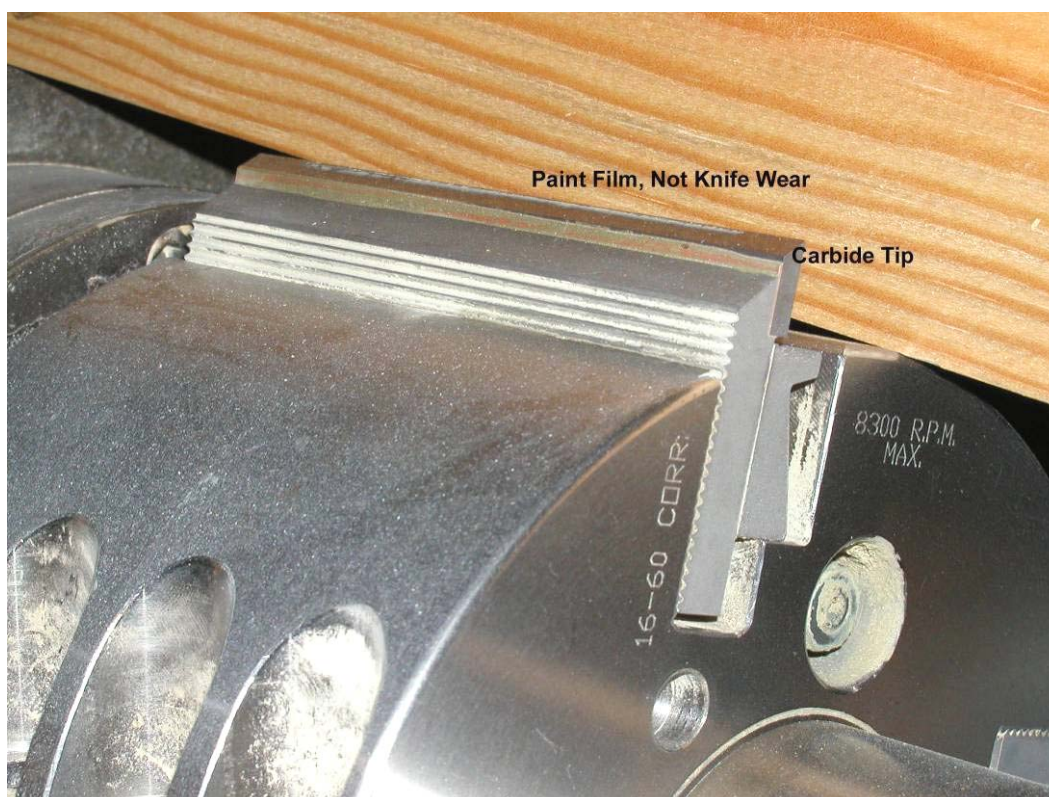
Figure 37. Carbide knife after machining, showing sharp edge with traces of paint residue.

Carbide knives were investigated in machining the Fort Campbell siding. As shown in Table 10, 882 lf of siding were machined with HSS knives before serious dulling of the knives occurred. Using carbide tipped knives, 3,277 lf of siding were machined with no noticeable knife wear or surface quality degradation, as illustrated in Figure 37. This is nearly four times the amount of siding produced with the HSS knives. The test had to be discontinued at 3,277 lf, since no more siding was available to be machined. It was felt that significantly more footage of siding could be produced with these carbide knives before re-sharpening.

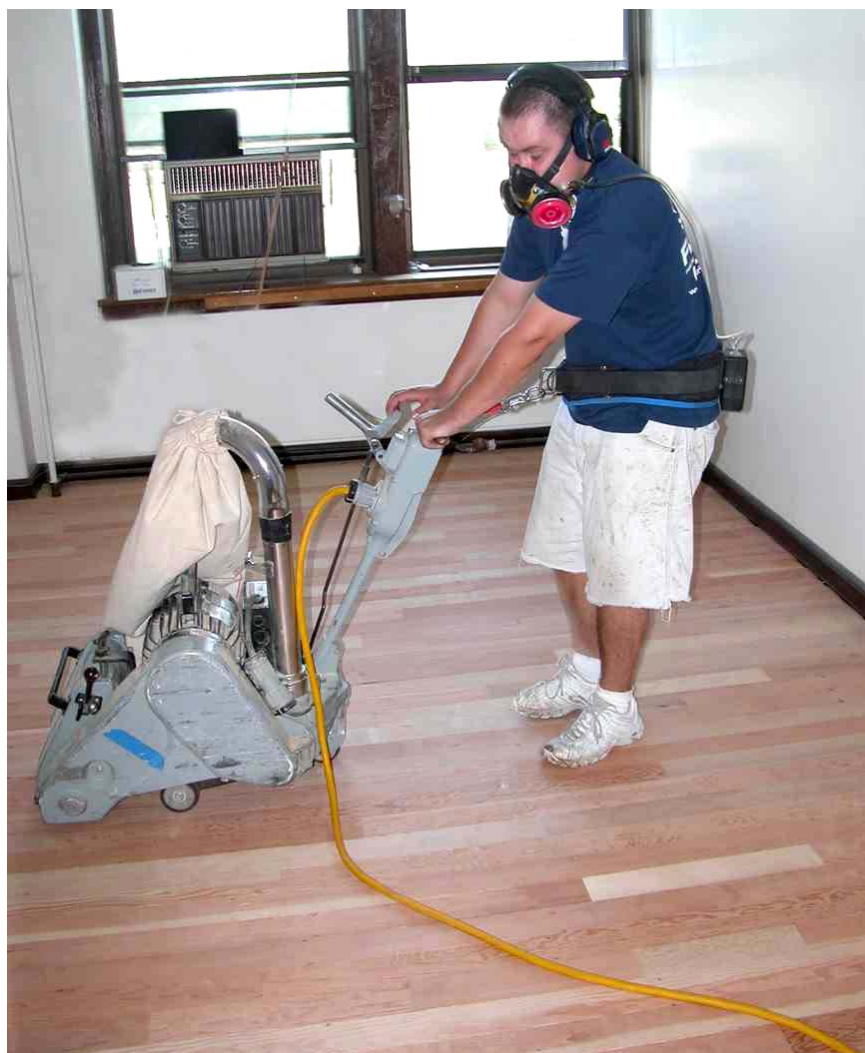
Figure 38. Sanding process for remanufactured flooring, showing air monitoring pump fitted at operator's waist.

A portion of the produced T&G flooring was installed in two rooms at the FPL for display purposes. Although the lead penetration tests indicated that only a trace amount of lead was likely to be present in the remanufactured flooring (because more than 0.06 in. was removed from the painted surface), the air was monitored during the floor sanding process to ensure that the workers were not exposed to an unsafe level of lead-containing dust. A personal air monitoring pump was fitted to the floor sander operator (Figure 38). No lead was detected in the air sample, indicating that the remanufactured flooring product was free of any significant lead content. A swab test for lead, after the floor was finished with polyurethane, produced negative results. Figure 39 shows the floor after finishing.

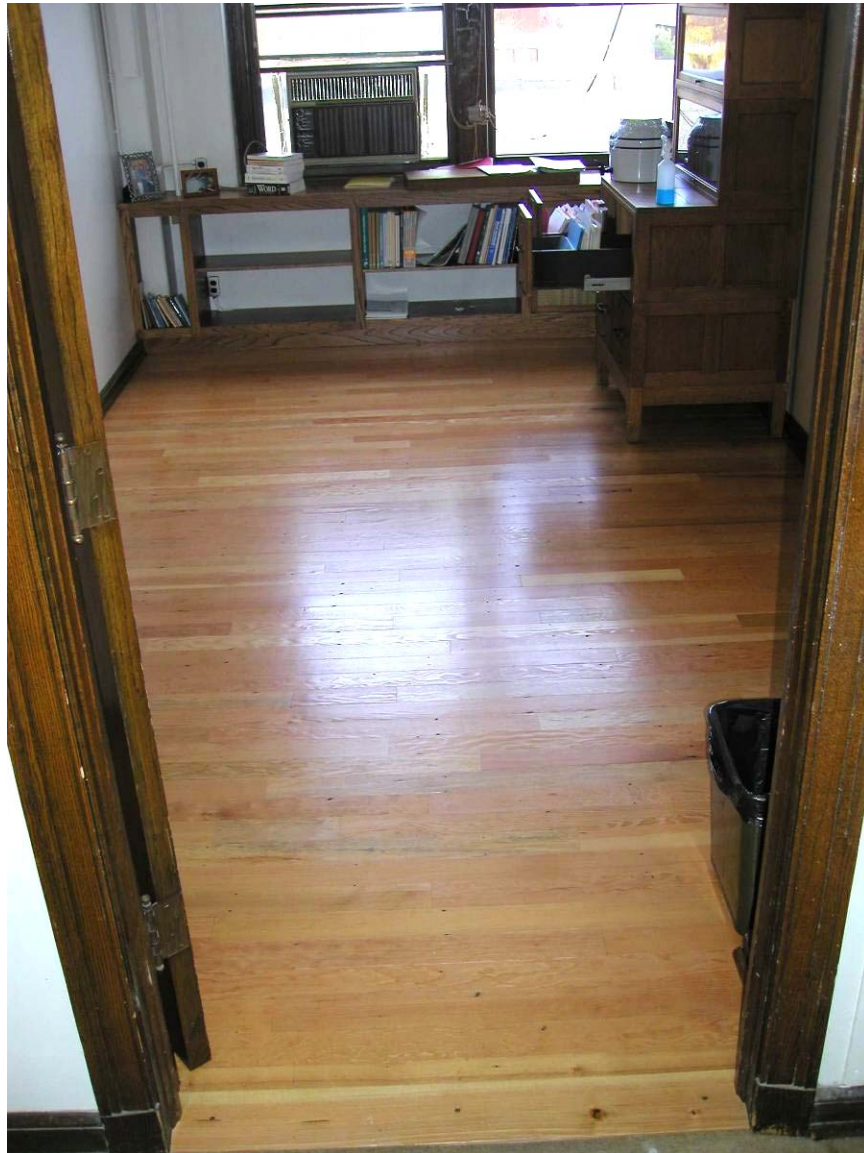
Figure 39. Installed floor after finishing.
