# **Self-Healing Composite Armor**

## **FINAL REPORT**

Contract No. W911NF-06-2-0003

# SELF-HEALING COMPOSITES FOR MITIGATION OF IMPACT DAMAGE IN U.S. ARMY APPLICATIONS

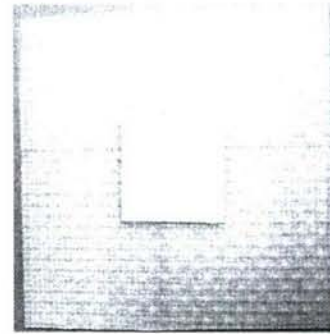
Figure 2: Composite panel with 48x48 mm ceramic bonded at center of strike face.

Two groups of panels were tested ballistically (Table 1). Panels in Group A were simple woven glass-epoxy laminates. Group B consisted of the same woven glass-epoxy laminates, but with small alumina tiles adhesively bonded at the center of their strike faces. The composite panels were approximately 150 × 150 × 3 mm thick, composed of 4 plies of the same S2 glass fabric used in low-velocity impact panels and Epon 828 and DETA (4:1 ratio) epoxy resin. For the Group B specimens, a scrim fabric was used at the ceramic/composite bond line to ensure complete wet-out of the bonded ceramic face. The ceramic tiles for these specimens were CoorsTek AD94 alumina, 48 × 48 × 2 mm thick. The composites were fabricated using a hand lay-up process followed by curing in a hot press. For the Group B specimens, lay-up was done directly on top of the ceramic tiles, integrally bonding them during resin wet-out and cure. The curing conditions for all panels were 93 kPa pressure, with a 24 hour room temperature cure followed by 24 hours at 35°C. The panels interrogated ballistically had no self-healing properties, and were intended as surrogates for future self-healing panels.

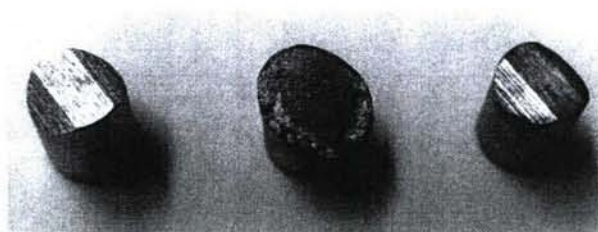
Figure 12: 5.59 mm steel FSPs before impact (left), after impacting a ceramic-faced composite (center), and after impacting a composite without a ceramic strike face (right).

Figure 12 shows FSPs before impact, and after impact of unfaced (Group A) and ceramic-faced (Group B) composites. The FSPs that impacted ceramic-faced targets are very deformed, clearly undergoing severe plastic deformation while in contact with the ceramic tile. In contrast, the FSPs that impacted unfaced composite panels show very little or no projectile damage or deformation.
