**EFFECTS OF TEMPERATURE AND STEAM ENVIRONMENT ON FATIGUE
BEHAVIOR OF THREE SIC/SIC CERAMIC MATRIX COMPOSITES**

THESIS

Vipul Sharma, 2nd Lieutenant, USAF

AIR FORCE INSTITUTE OF TECHNOLOGY

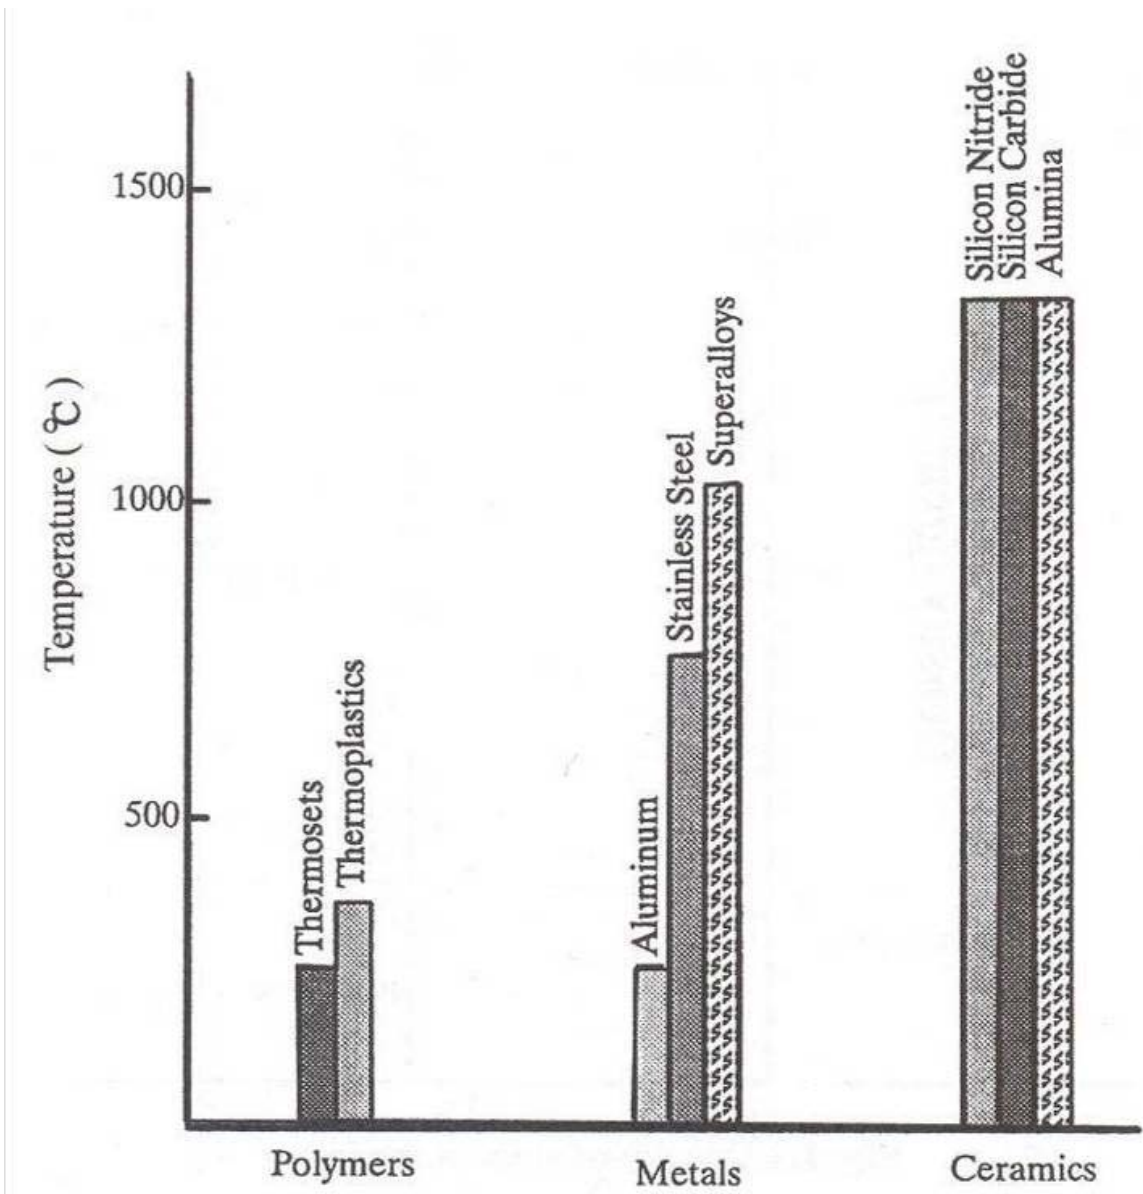
CMC matrices are usually capable of withstanding high temperatures and are composed of one or more metals combined with a nonmetal such as oxygen, carbon, nitrogen, or boron. Figure 1 shows maximum service temperatures for different materials.

Figure 1. Maximum Material Service Temperatures [5:5]

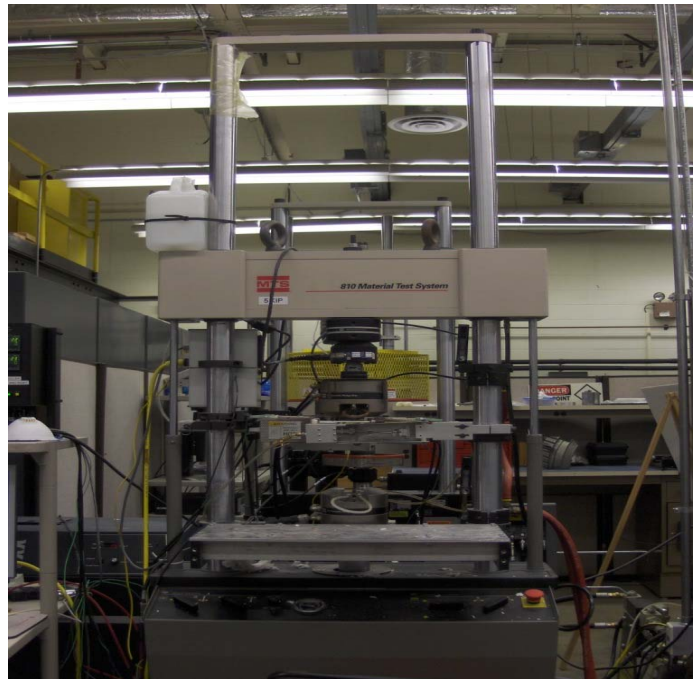
Figure 8. MTS System Corporation model 810 5 kip servo-hydraulic machine.

Next the specimen was placed in the grips. A grip pressure of 8 MPa was used for all tests conducted on the 5-kip MTS testing machine. A grip pressure of 3 MPa was used for all tests conducted on the 22-kip MTS testing machine. The top grip was closed while in displacement control and the load cell auto-zeroed. Control mode was switched to force and the bottom grip was closed. For tests conducted in steam, the susceptor was closed around the specimen and the oven was pulled forward into position making sure that the steam tube was inserted into the opening in the back of the susceptor. The extensometer was mounted on the specimen. Then the oven sides were completely closed around the specimen and clearances for the extensometer rods were checked. The water chiller was turned on and the cooling water temperature set to 15°C. The water lines for each grip were opened fully and the air cooling line for the extensometer was opened to 30 psi.

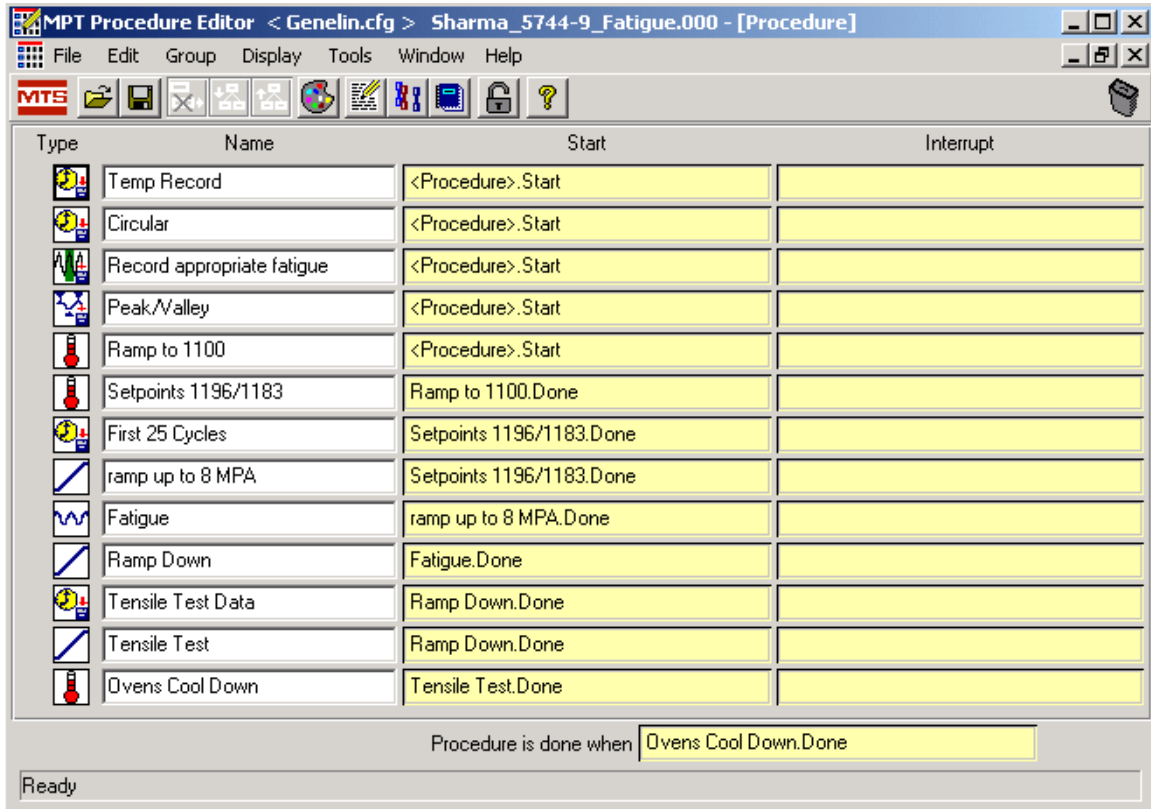
Next the MPT software was opened and the test procedure was written. A sample test procedure can be seen in Figure 10. Lastly, the test procedure was started and heating of the specimen began. For testing in steam, the steam generator was turned on right after the test started. In all tests, the furnace temperature was ramped to 1100°C in 25 min. Then, the furnace temperature was ramped more slowly (25 min) to 1300 °C. Once the test temperature was reached the specimen was allowed to thermally stabilize for 25 min prior to applying the mechanical loading.

Figure 10. Sample MPT test procedure.

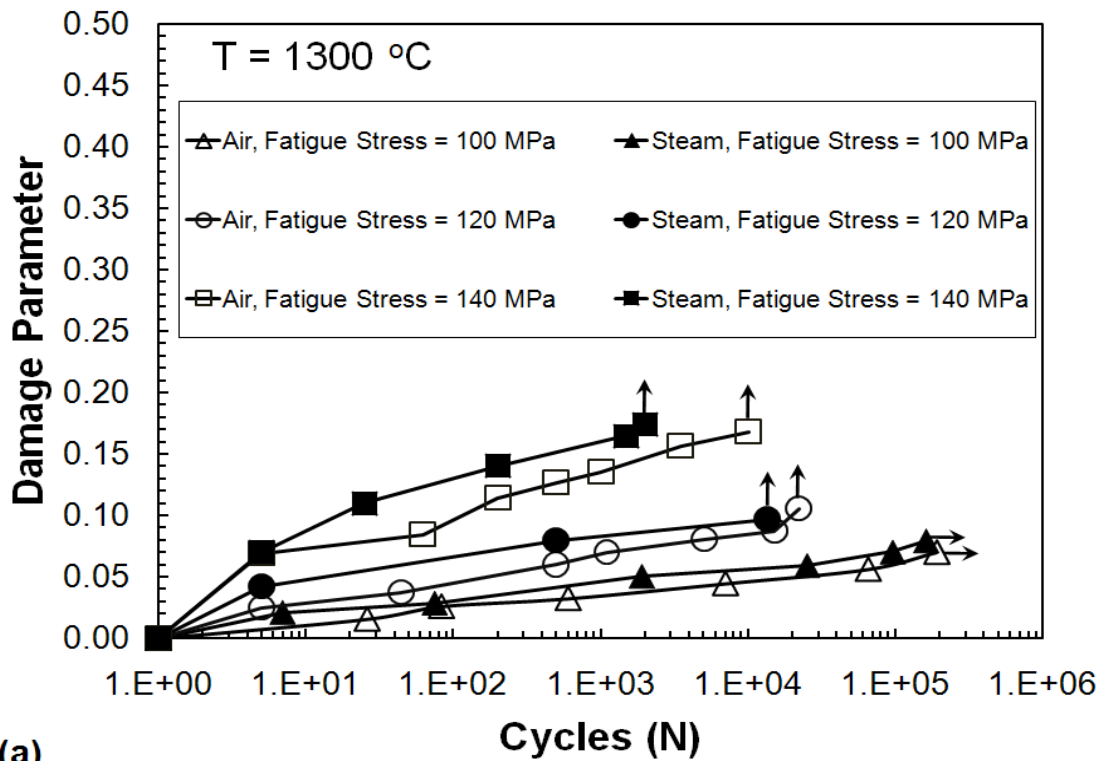
Damage parameter as a function of fatigue cycles in air and in steam is presented in Figures 13a and 13b for composites C1 and C2, respectively.

Figure 13. Damage parameter vs. cycle numbers at 1300 °C in air and in steam for: (a) composite C1 and (b) composite C2.

It is seen that the damage parameter increases with higher fatigue stress. Both composites C1 and C2 demonstrate that they experience more permanent damage as the maximum fatigue stress increases. Moreover, composites C1 and C2 also show that tests conducted in steam are more damaging than tests conducted in air.

Composite C2 achieved run-out in both air and steam for fatigue tests conducted with maximum fatigue stress $\sigma = 140$ MPa and demonstrated a 4.5% reduction in elastic modulus in both air and steam. For tests conducted with a maximum fatigue stress $\sigma = 140$ MPa composite C2 demonstrated a 23.9% reduction in elastic modulus in air and 23.8% reduction in elastic modulus in steam

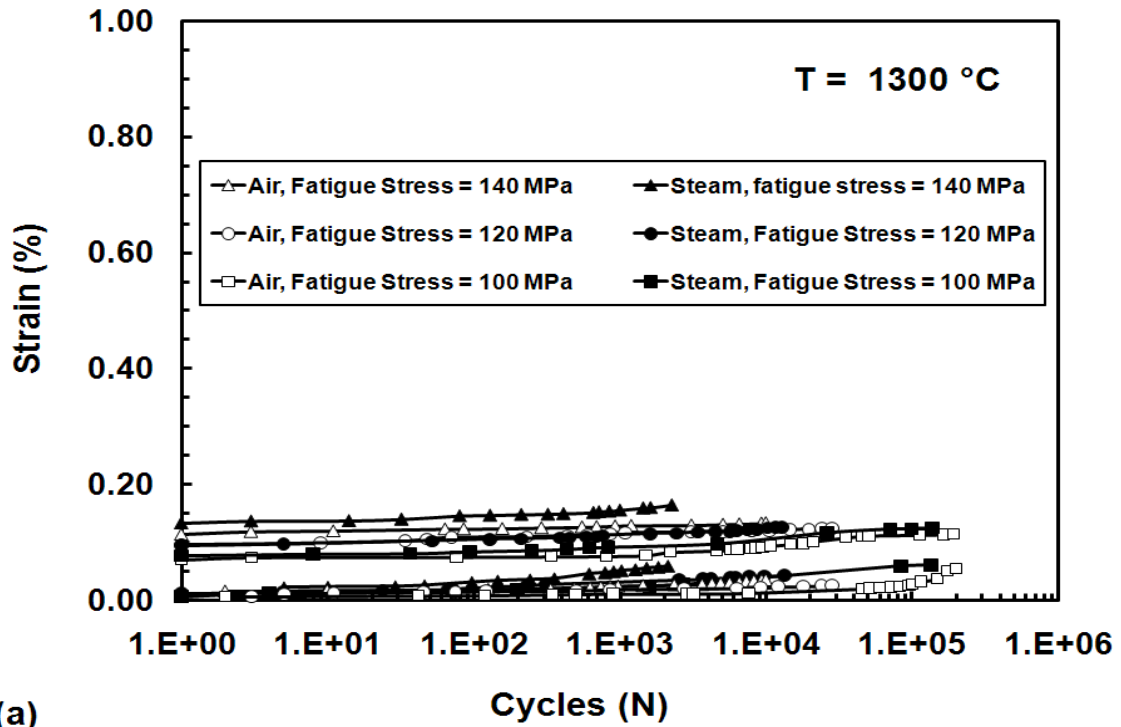
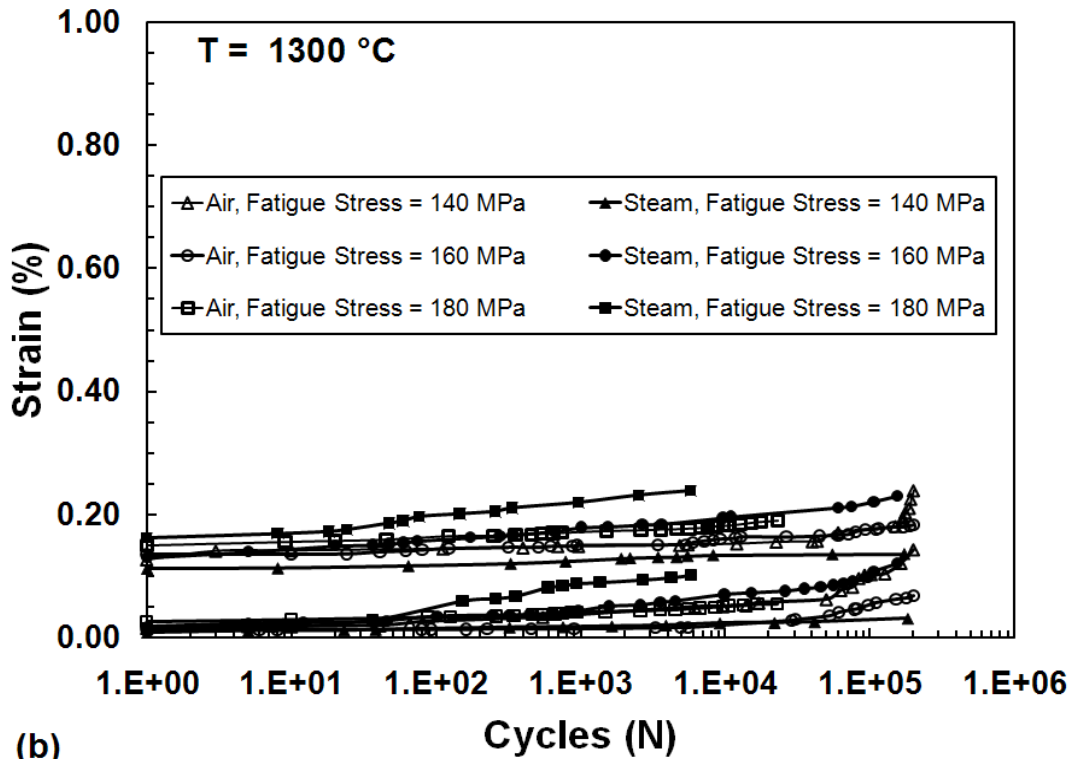
Maximum and minimum cyclic strains as functions of cycle number for fatigue tests conducted at 1300°C in laboratory air and steam are presented in Figs. 14(a) and 14(b) for composites C1 and C2, respectively.

Figure 14. Maximum and minimum strains as functions of cycle number at 1300°C in air and in steam for: (a) composite C1 and (b) composite C2.

Results shown for composite C2 in Figure 9(b) reveal that ratcheting takes place in fatigue tests conducted in steam with the maximum stress levels of 160 and 180 MPa. Earlier onset of ratcheting (after approximately 100 cycles) is observed in the 180 MPa test than in the 160 MPa test, where the ratcheting commences after about 10000 cycles. Surprisingly, ratcheting is also observed in the 140 MPa test conducted in air. In this case the increase in the accumulated strain is seen after about 100000 cycles. However, it should be noted that the maximum strains accumulated in fatigue tests by composite C2 are limited to 0.24%, which is also the failure strain obtained in tension test. The strong interface bond, typical in SiC/SiC ceramic composites is likely responsible for minimal amounts of ratcheting observed for composites C1 and C2.

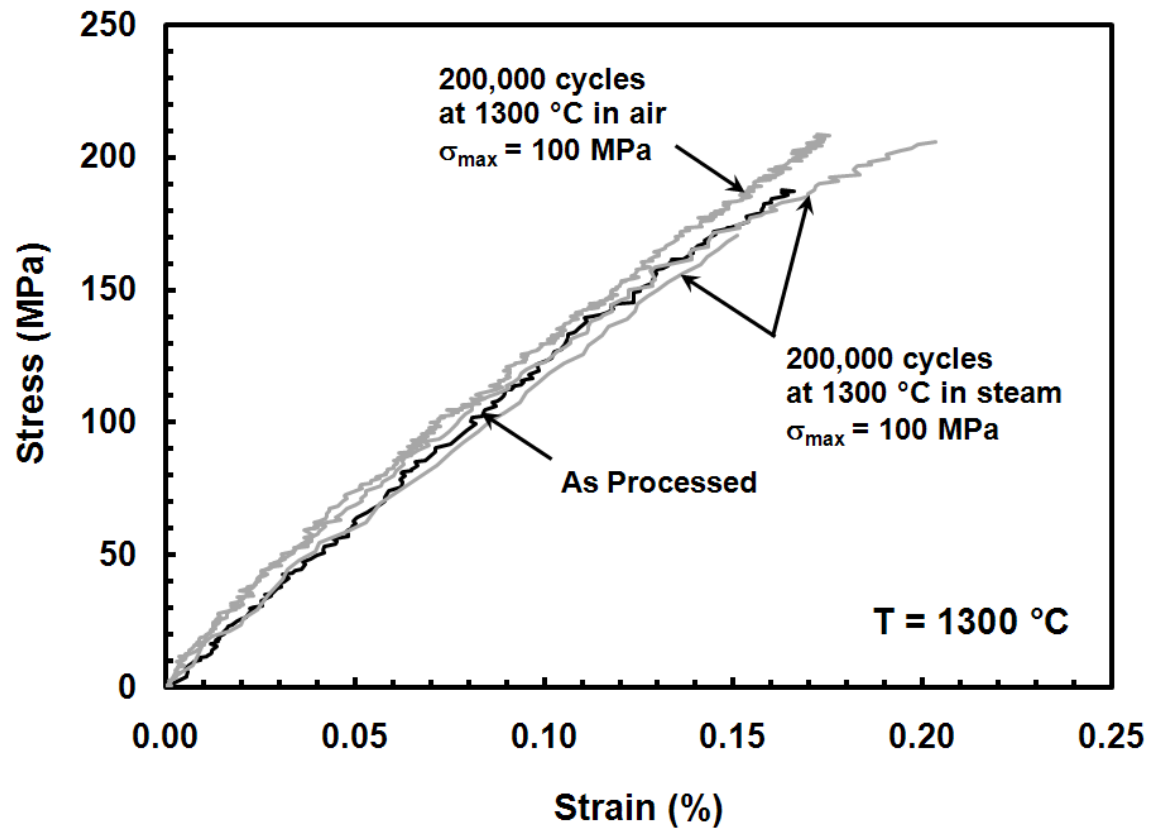
Tensile stress-strain curves obtained for the composite C1 specimens subjected to prior fatigue at 1300 °C in air and in steam are presented in Figure 15 together with the tensile stress-strain curve for the as-processed material. Effects of prior fatigue in air and in steam on tensile stress-strain behavior of composite C2 are typified in Figure 16 where the tensile stress-strain curve for the as-processed material is presented for comparison.

Figure 15. Effects of prior fatigue at 1300 °C in air and in steam on tensile stress-strain behavior of composite C1.

It is seen that on the average composite C1 exhibited no loss of tensile strength due to prior fatigue in air or in steam. However, stiffness loss of up to 11% was observed. Full retention of tensile strength suggests that no fatigue damage occurred to the fibers. The reduction in stiffness is most likely due to additional matrix cracking. Effects of prior fatigue in air on tensile properties of composite C2 were similar. On the average composite C2 retained 100 % of its tensile strength after 200,000 fatigue cycles at 1300 °C in air. Stiffness loss was near 10% for specimens pre-fatigued with the maximum stress level of 140 MPa and 13% for specimens pre-fatigued with the maximum stress of

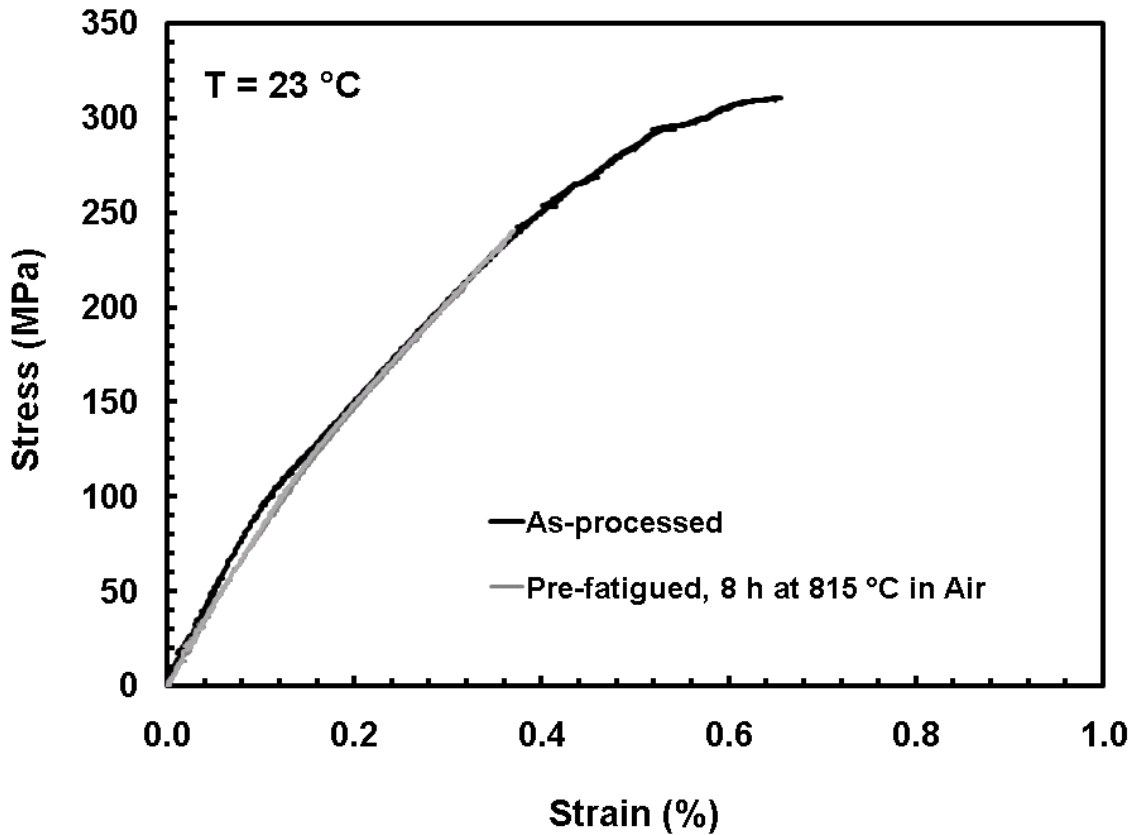
Figure 20. Tensile stress-strain curves obtained at 23 °C for pre-fatigued C3 specimens aged for 8 h at 815 °C in air and for the as-processed composite C3.

The stress-strain curves for the pre-fatigued C3 specimens aged for 8 h at 815 °C in air are presented in Figure 20 together with the stress-strain curve for the specimen aged in air (but not subjected to fatigue before aging) and the stress-strain curve for the as-processed C3 composite. It is seen that prior aging in air has qualitatively similar effects on the pre-fatigued and on the as-processed specimens. Prior fatigue at 23 °C followed by aging at 815 °C in air caused a ~28% reduction in the tensile strength of the composite C3, but had virtually no effect on the elastic modulus or on the overall stress-strain behavior until failure. The stress-strain curves obtained for the aged material are essentially the same as the stress-strain curve for the as-processed material until the failure stress of the aged material is reached.

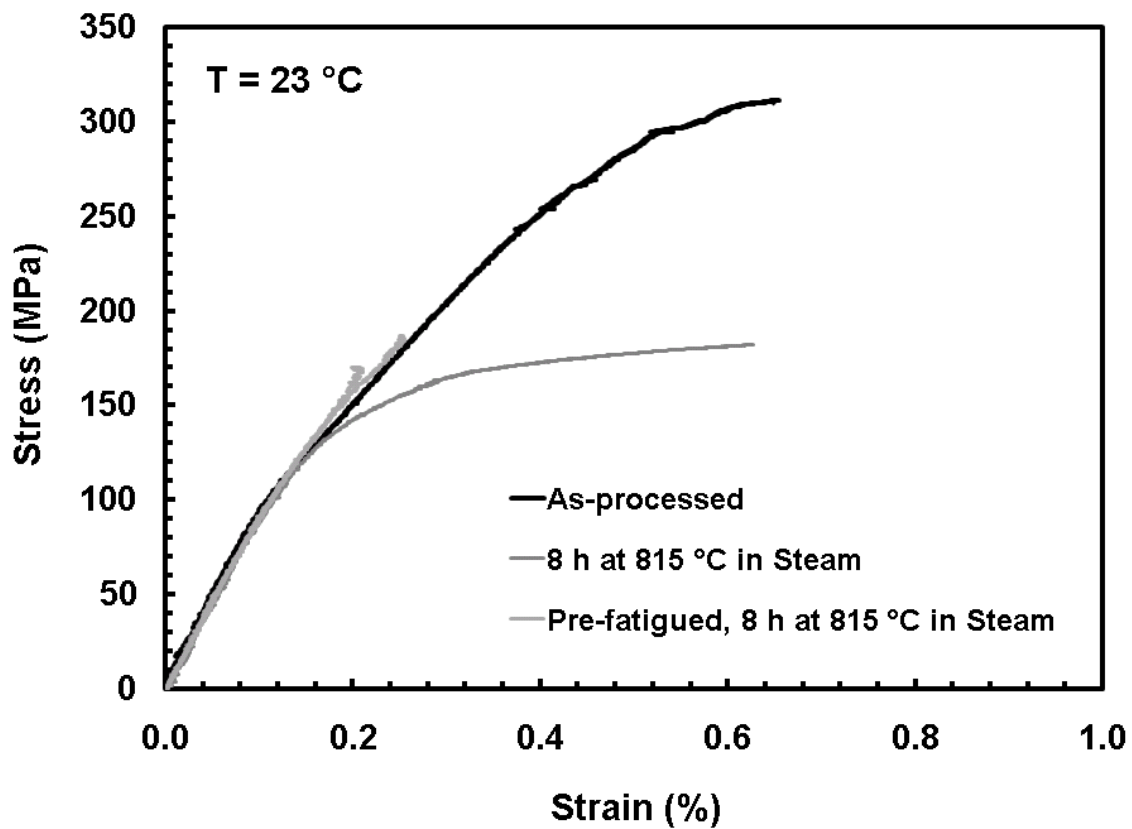
Figure 21. Tensile stress-strain curves obtained at 23 °C for pre-fatigued C3 specimens aged for 8 h at 815 °C in steam, for as-processed C3 specimens aged for 8 h at 815 °C in steam, and for the as-processed composite C3.

The stress-strain curves for the pre-fatigued C3 specimens aged for 8 h at 815 °C in steam are presented in Figure 21 together with the stress-strain curve for the specimens aged in steam (but not subjected to fatigue before aging) and the stress-strain curve obtained for the as-processed C3 composite. It is seen that prior fatigue followed by aging in steam caused a ~43% reduction in the tensile strength, which was close to the 42% reduction in strength due to prior aging in steam alone. The elastic modulus remained largely unaffected by the combination of prior fatigue and aging in steam. However, the stress-strain behavior of the specimens subjected to prior fatigue followed by aging in steam was noticeably different from that exhibited by the specimens

subjected to prior aging alone. Pre-fatigued specimens produced the stress-strain curves that were nearly linear for stresses < 100 MPa. At the stress of about 100 MPa a slight nonlinearity develops, then the stress-strain curve continues in a nearly linear fashion (albeit with a lower slope) to failure. Strains to failure produced by the pre-fatigued specimens were about one third of the failure strain produced by the specimen subjected to prior aging alone.

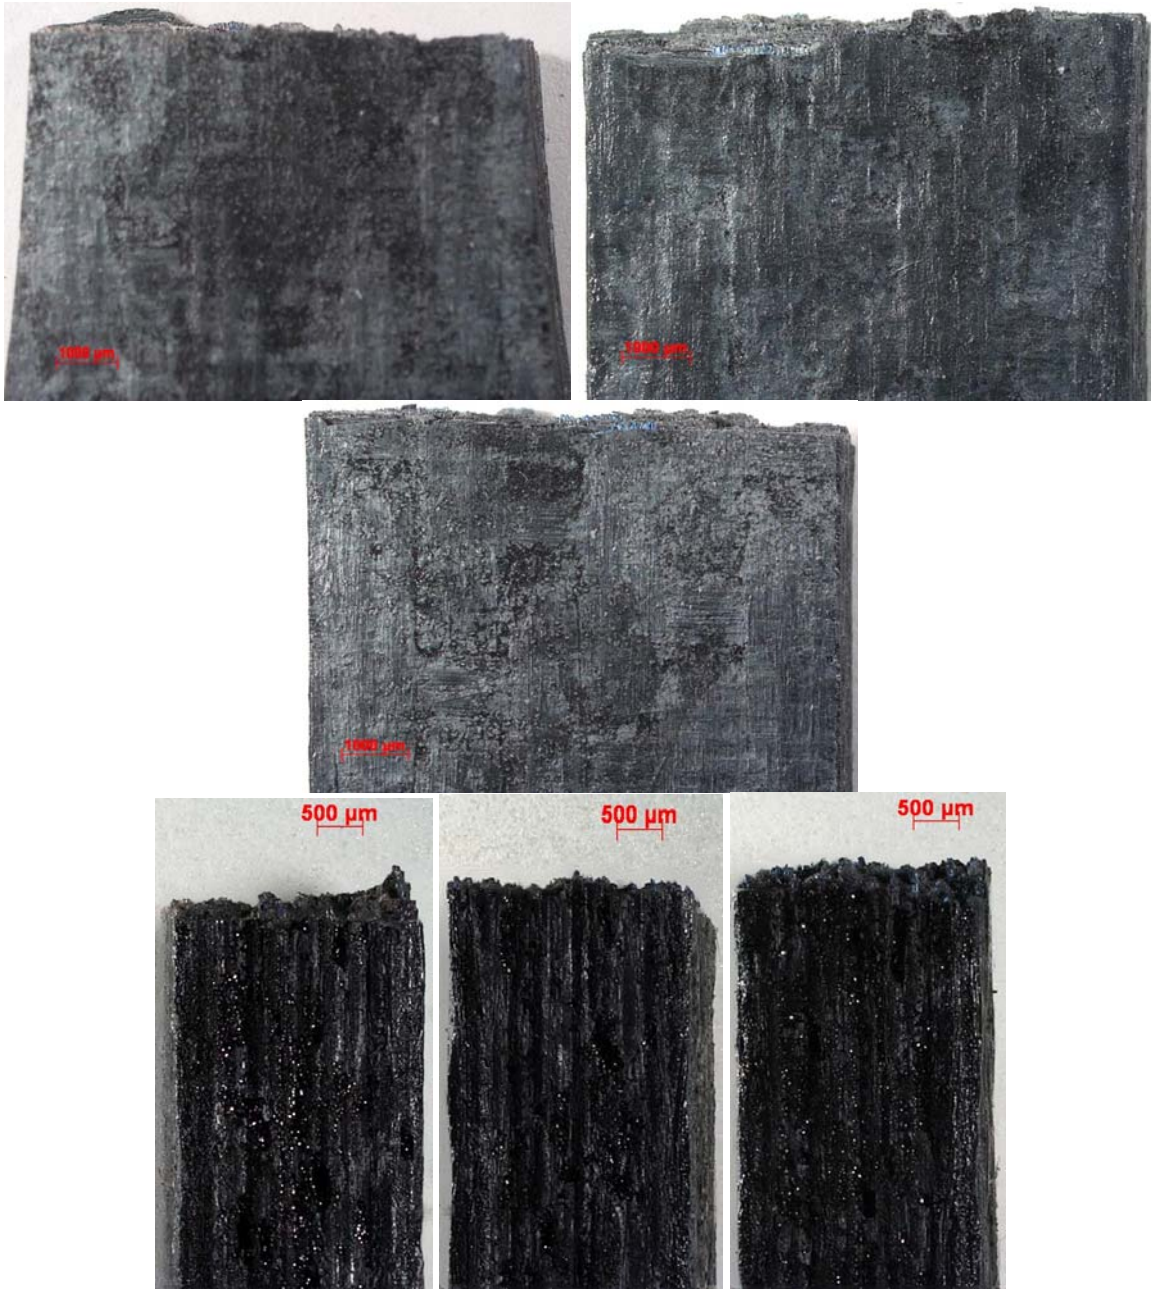
Figure 69. Fracture surface optical micrographs of composite C1 specimen fatigued in air at 1300 °C with maximum fatigue stress $\sigma_{\max} = 100$ MPa

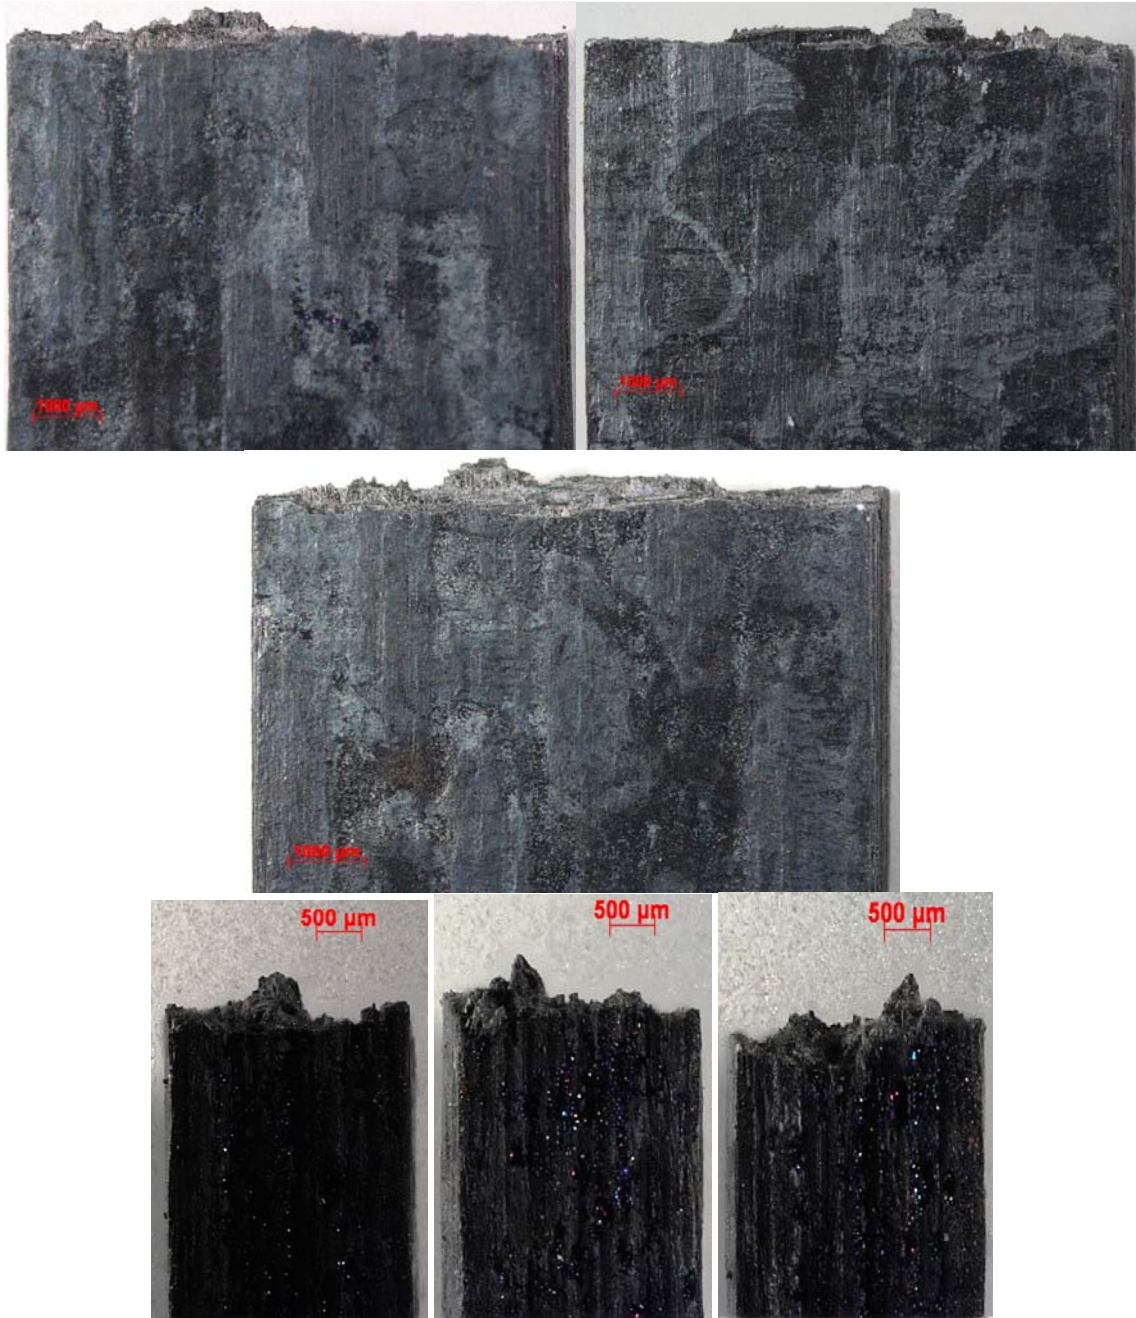
Figure 70. Fracture surface optical micrographs of composite C1 specimen fatigued in air at 1300 °C with maximum fatigue stress $\sigma_{\max} = 120$ MPa

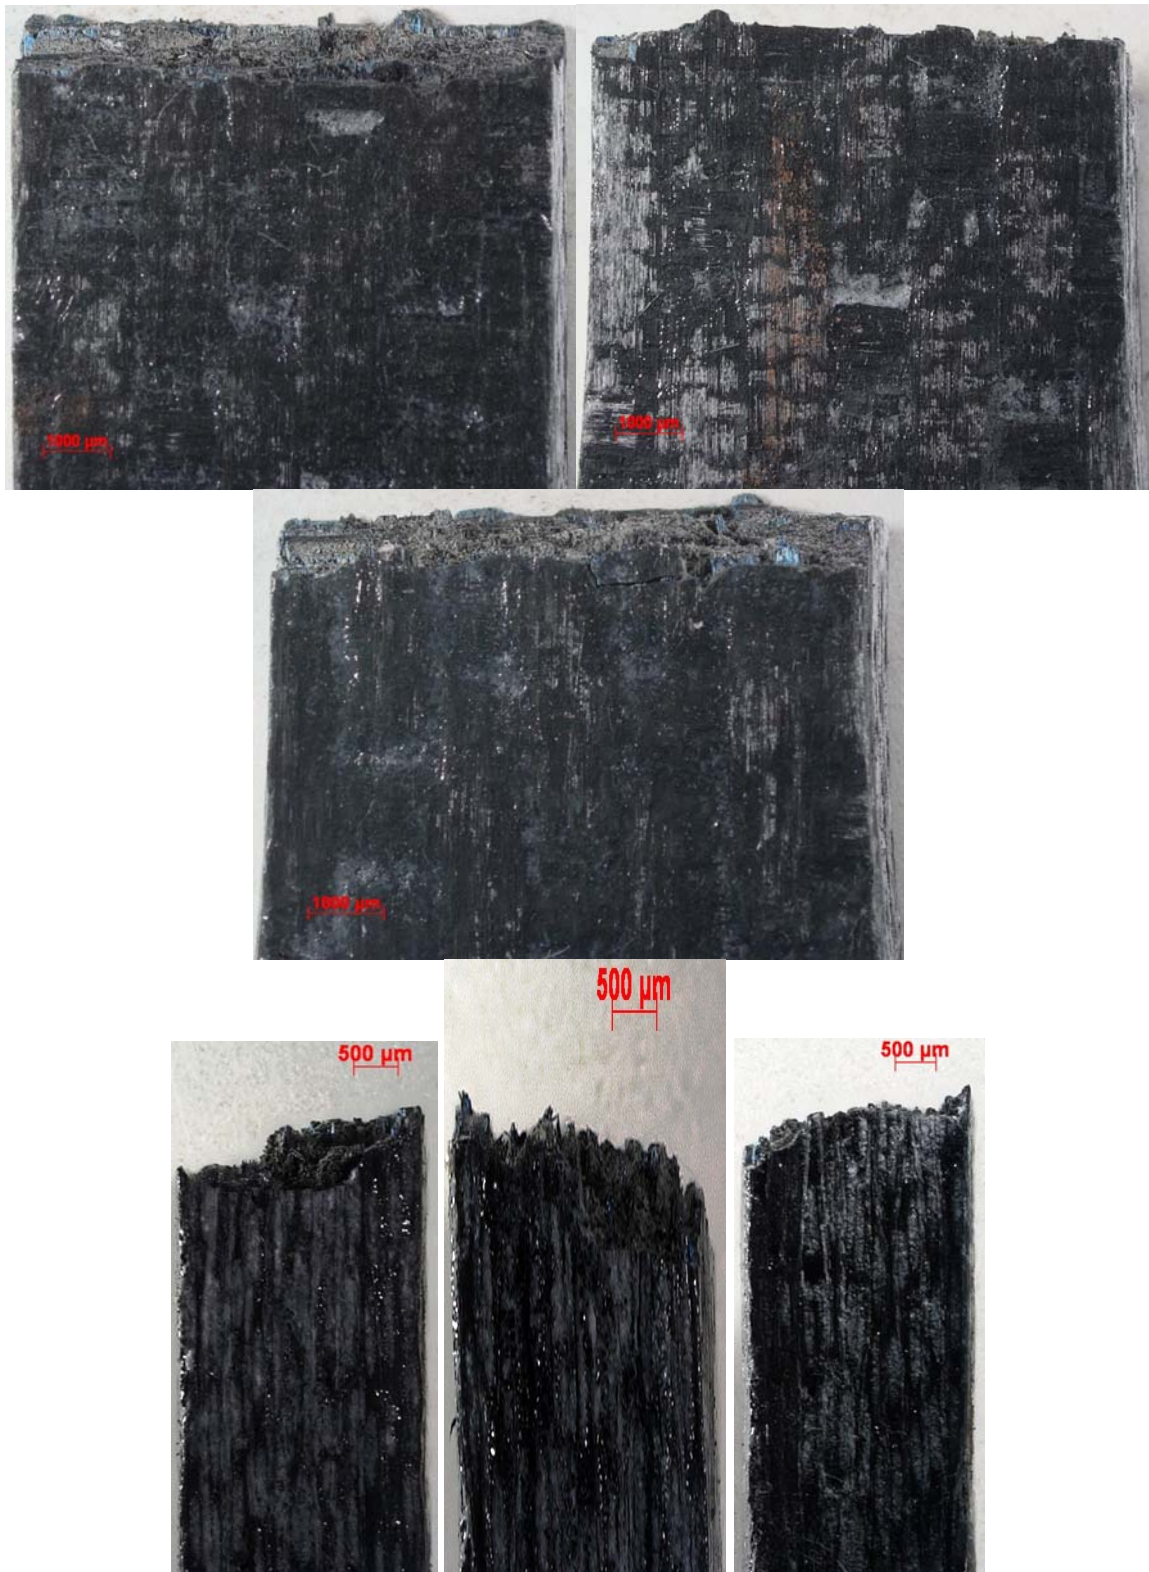
Figure 72. Fracture surface optical micrographs of composite C1 specimen fatigued in steam at 1300 °C with maximum fatigue stress $\sigma_{\max} = 100$ MPa

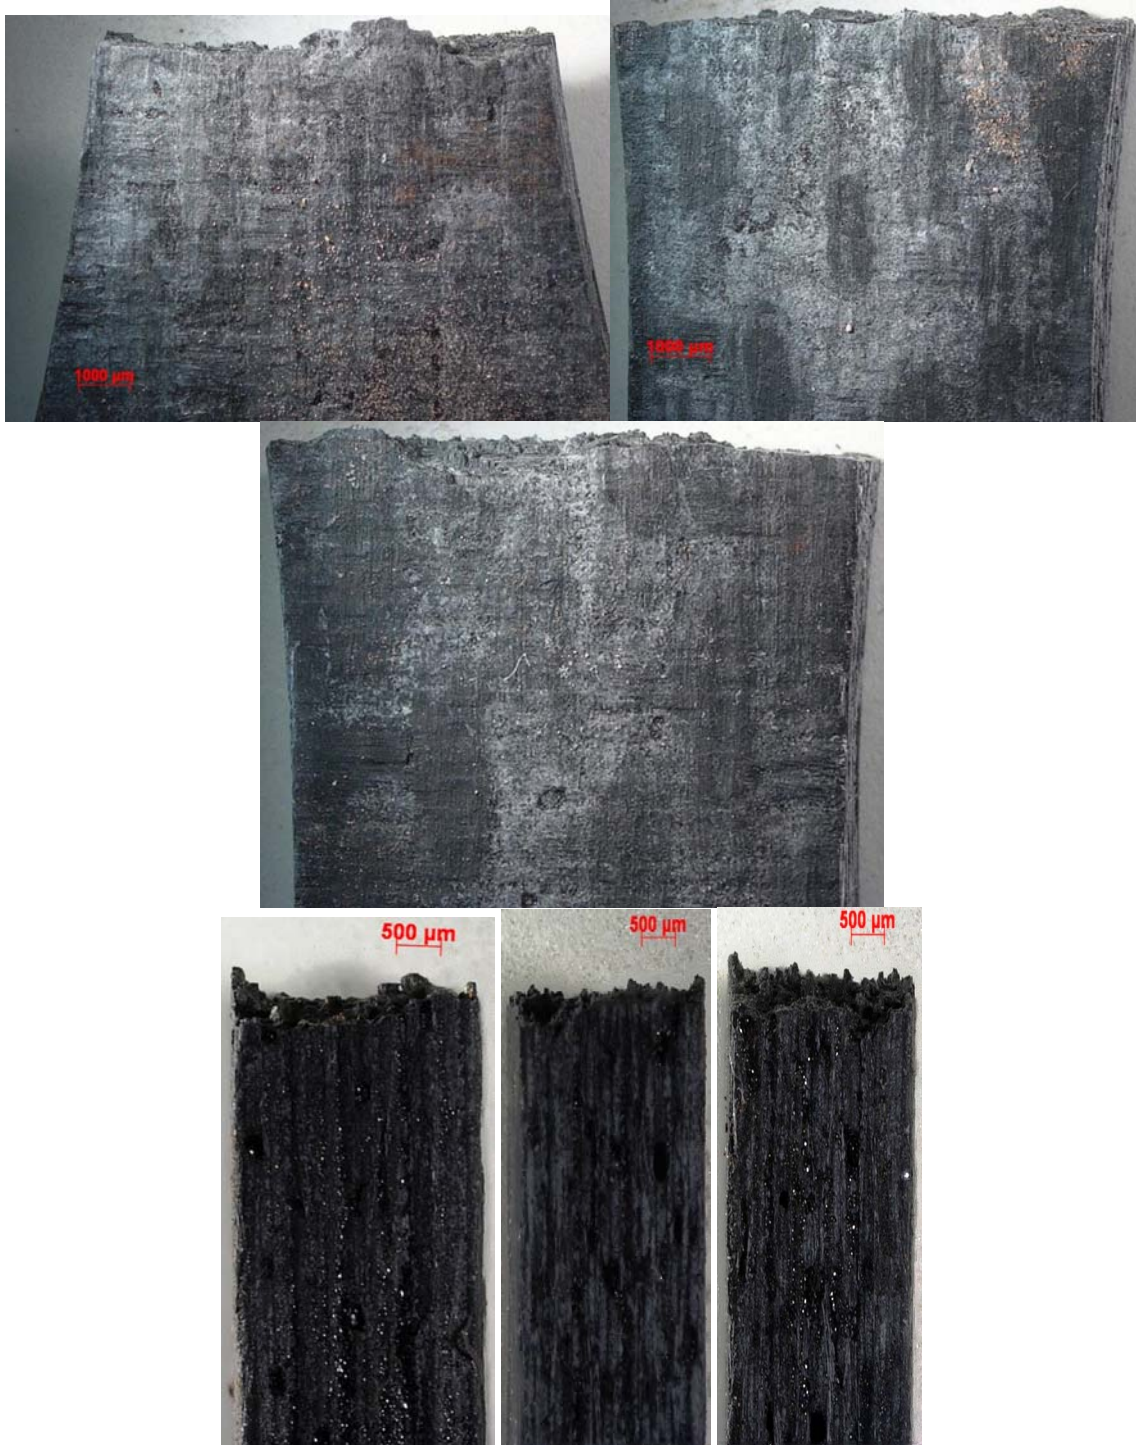
Figure 73. Fracture surface optical micrographs of composite C1 specimen fatigued in steam at 1300 °C with maximum fatigue stress $\sigma_{\max} = 120$ MPa

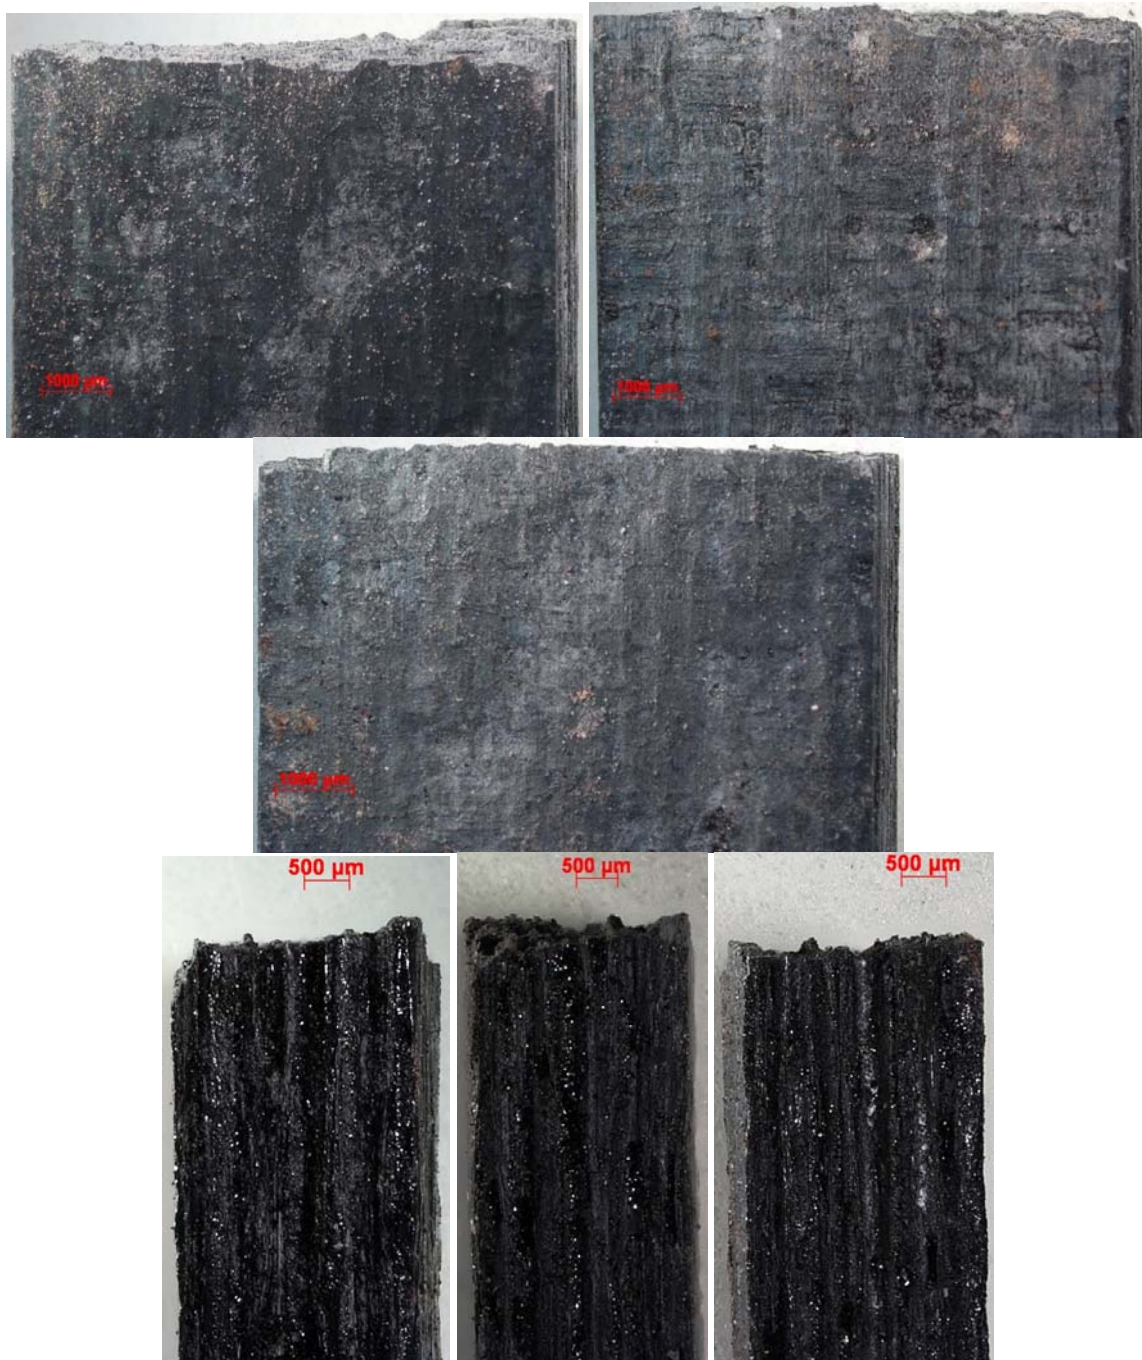
Figure 74. Fracture surface optical micrographs of composite C1 specimen fatigued in steam at 1300 °C with maximum fatigue stress $\sigma_{\max} = 140$ MPa

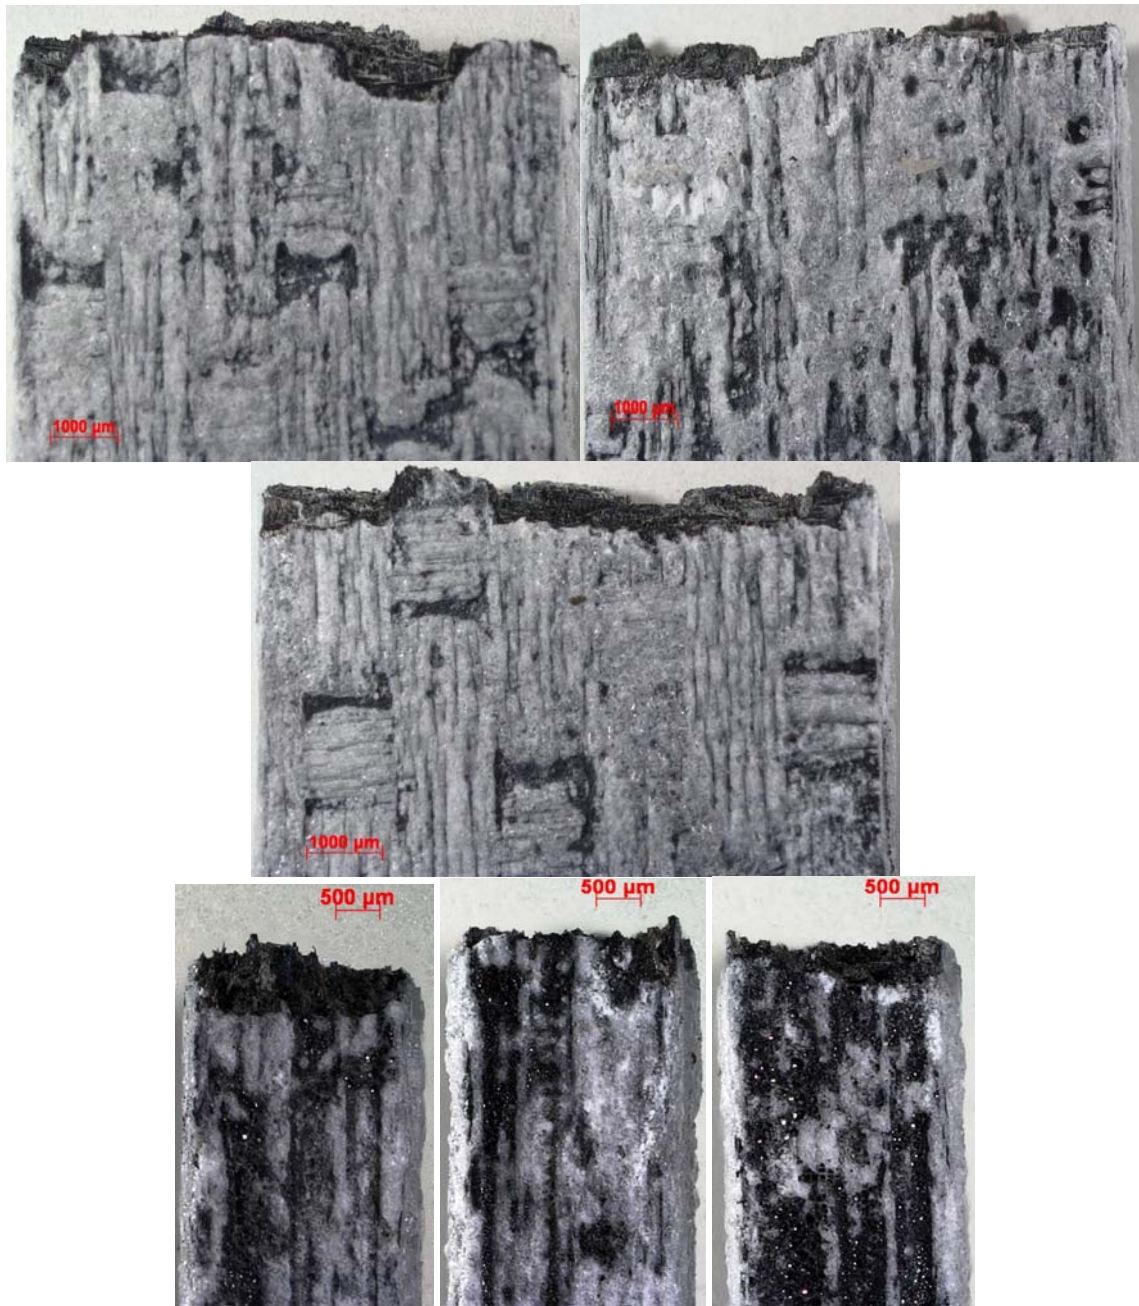
Figure 79. Fracture surface optical micrographs of composite C2 specimen fatigued in steam at 1300 °C with maximum fatigue stress $\sigma_{\max} = 140$ MPa

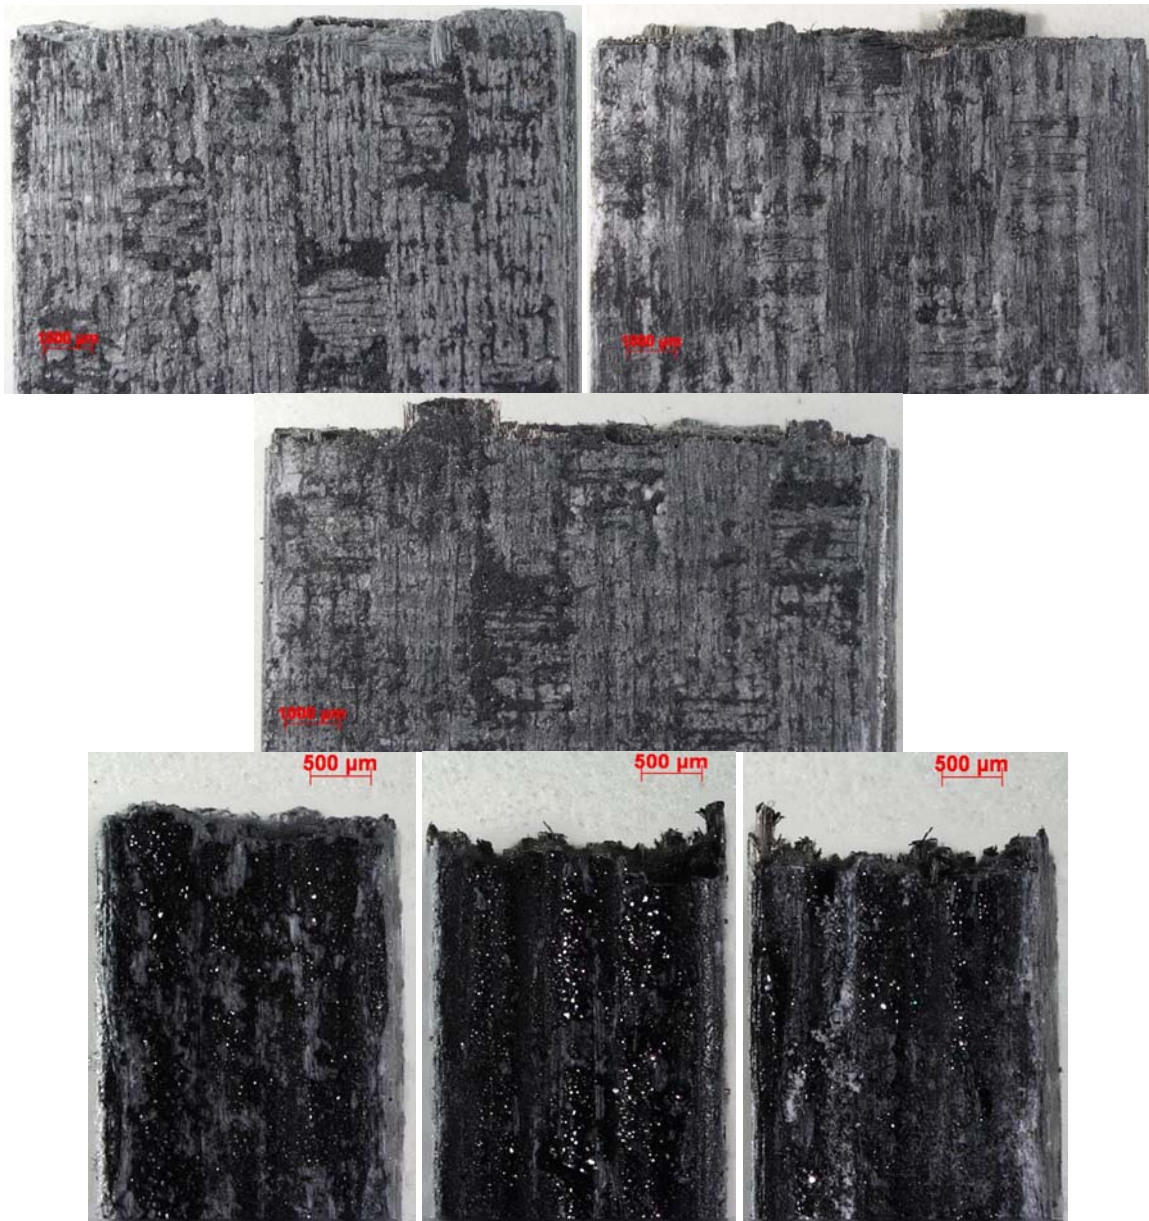
Figure 81. Fracture surface optical micrographs of composite C2 specimen fatigued in steam at 1300 °C with maximum fatigue stress $\sigma_{\max} = 180$ MPa

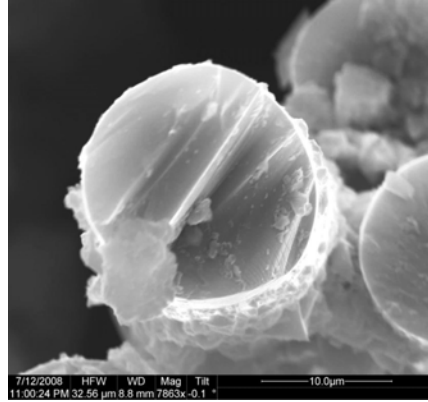
Figure 164. Fracture surface SEM micrograph of composite C3 specimen aged in steam for 8 hours at 815 °C and subjected to a monotonic tension test to failure.
