**FATIGUE BEHAVIOR OF AN ADVANCED SIC/SIC COMPOSITE WITH AN OXIDATION INHIBITED  
MATRIX AT 1200°C IN AIR AND IN STEAM**

THESIS

Delapasse Jacob, Captain, USAF  
AFIT/GAE/ENY/10-M07

**AIR FORCE INSTITUTE OF TECHNOLOGY**

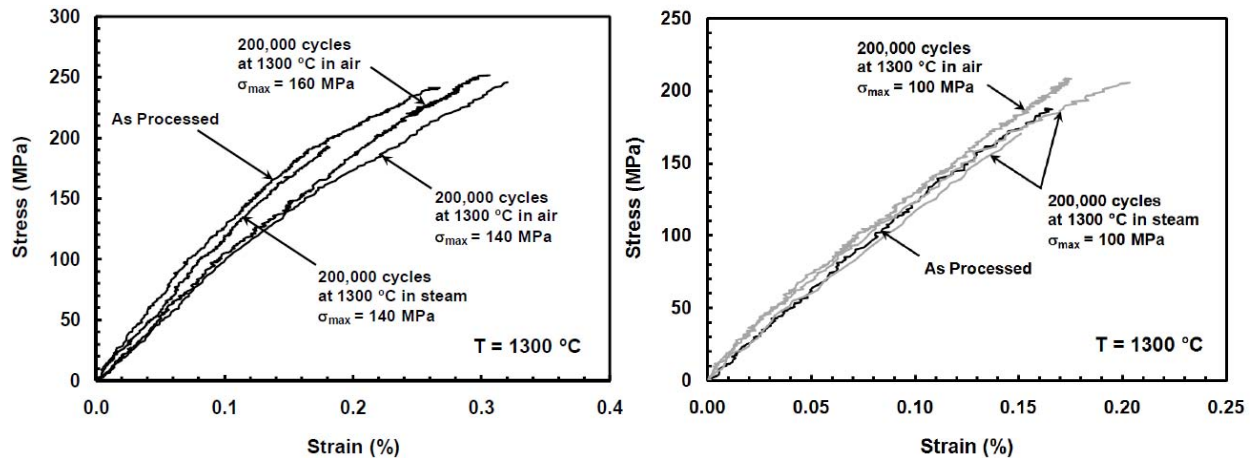
**Figure 3: The effects of prior fatigue at 1300°C in air and steam for C1 (right) and C2 (left) [27]**

Prior research has seen the presence of steam cause a noticeable degradation in fatigue performance in SiC/SiC CMCs at elevated temperatures. In Sharma's research, two types of SiC/SiC CMCs were tested in laboratory air and steam at 1300°C [27]. Both materials were classified as SiC-SiNC CMCs. The two composites were processed by using polymer infiltration and pyrolysis (PIP). The first composite (C1) tested was a 5HSW fiber fabric reinforced with Sylramic fibers and coated with a proprietary dual-layer interface. The composite was infiltrated with a mixture of polymer, filler particles, and solvent. During pyrolysis under nitrogen at high temperatures, the polymer was pyrolyzed to an amorphous SiNC ceramic matrix. The second composite (C2) varied from the first in that it consisted of a Sylramic-iBN fiber, but contained the same proprietary dual-layer interface in a modified PIP SiNC matrix. Tensile test and tension-tension fatigue test at 1.0 Hz ranging from 100 to 180 MPa at 1300°C were accomplished by Sharma. He noticed that fatigue limit based on a run-out condition of  $2 \times 10^5$  cycles in both air and steam for C1 was 100 MPa (53% UTS at 1300°C). The fatigue limit for C2 was 160 MPa (66% UTS) in air and 140 MPa (58% UTS) in steam. As the maximum stress for fatigue test was increased, the specimens tested in steam had shorter lifetimes than in air. Both specimens maintained 100% tensile strength in air, while only maintaining 90% of their tensile strength in steam for specimens achieving run-out. The data for this analysis can be seen in Figure 3.

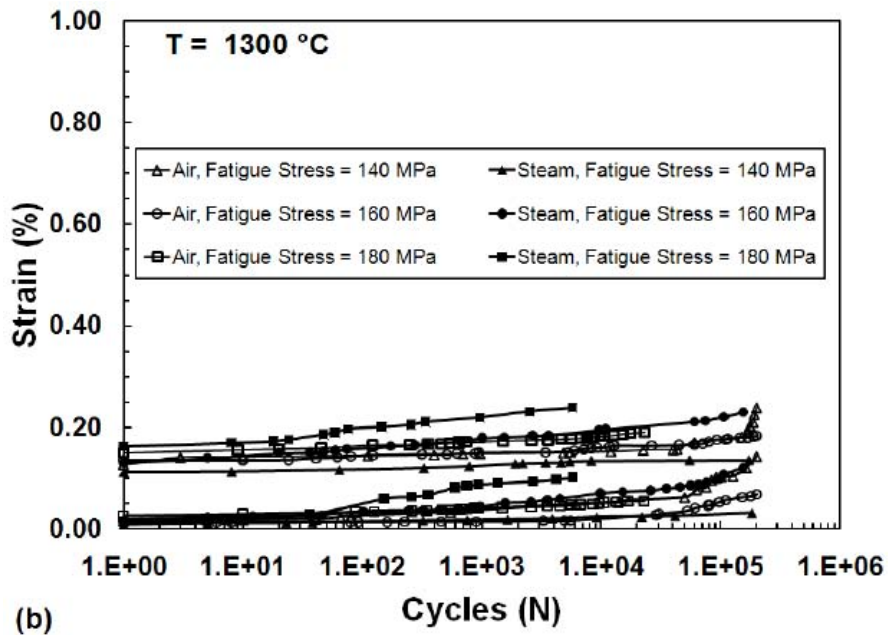
Figure 5: Maximum and minimum strains versus number of cycles in air and steam at 1300°C for composite C2 [27].

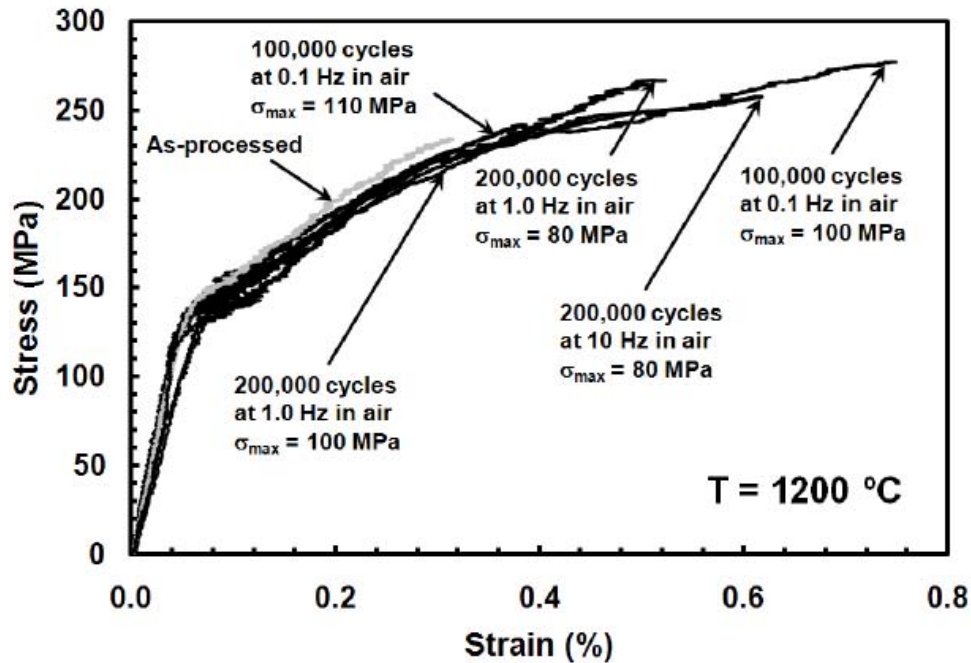
**Figure 6: Stress-strain response of Hi-Nicalon/BN/SiC specimens fatigue in air at 1200°C then subjected to a monotonic tensile test to failure in laboratory air at 1200°C at displacement rate of 0.05 mm/s [8].**

Research on SiC/SiC CMCs was also accomplished by Christensen [8]. The composite tested by Christensen consisted of a SiC matrix reinforced with a Boron Nitride (BN) coated Hi-Nicalon fibers woven into an eight-harness-satin weave. This SiC matrix was densified using the chemical vapor infiltration process. Tensile test and tension-tension fatigue test were conducted at 1200°C. The fatigue tests were conducted in laboratory air and steam at 1200°C at frequencies of 0.1 Hz, 1.0 Hz, and 10 Hz with a max stress ranging from 80-120 MPa in air and 60-110 MPa in steam. The fatigue limit was 100 MPa (46% UTS) and 80 MPa (37% UTS) in air and steam respectively. With run-out defined at  $2 \times 10^5$  cycles for 1.0 Hz and 10 Hz test and  $10^5$ , all specimens in air retained 100% of their tensile strength and only one specimen in steam showed minor strength degradation as seen in Figure 6. In Figure 6, there is a noticeable bend in the stress versus strain curve. The bend is where matrix cracking occurs and the majority of the load is transferred to the fibers. In Sharma's work, C1 and C2 had a less noticeable bilinear effect due to the weakness of the PIP matrix. In materials tested by Sharma and Christensen, the bend indicates vulnerability of the internal composite to the outside environment due to matrix cracking. It is at this point where the presence of steam has degraded the performance of CMCs as seen in both Christensen and Sharma's work.

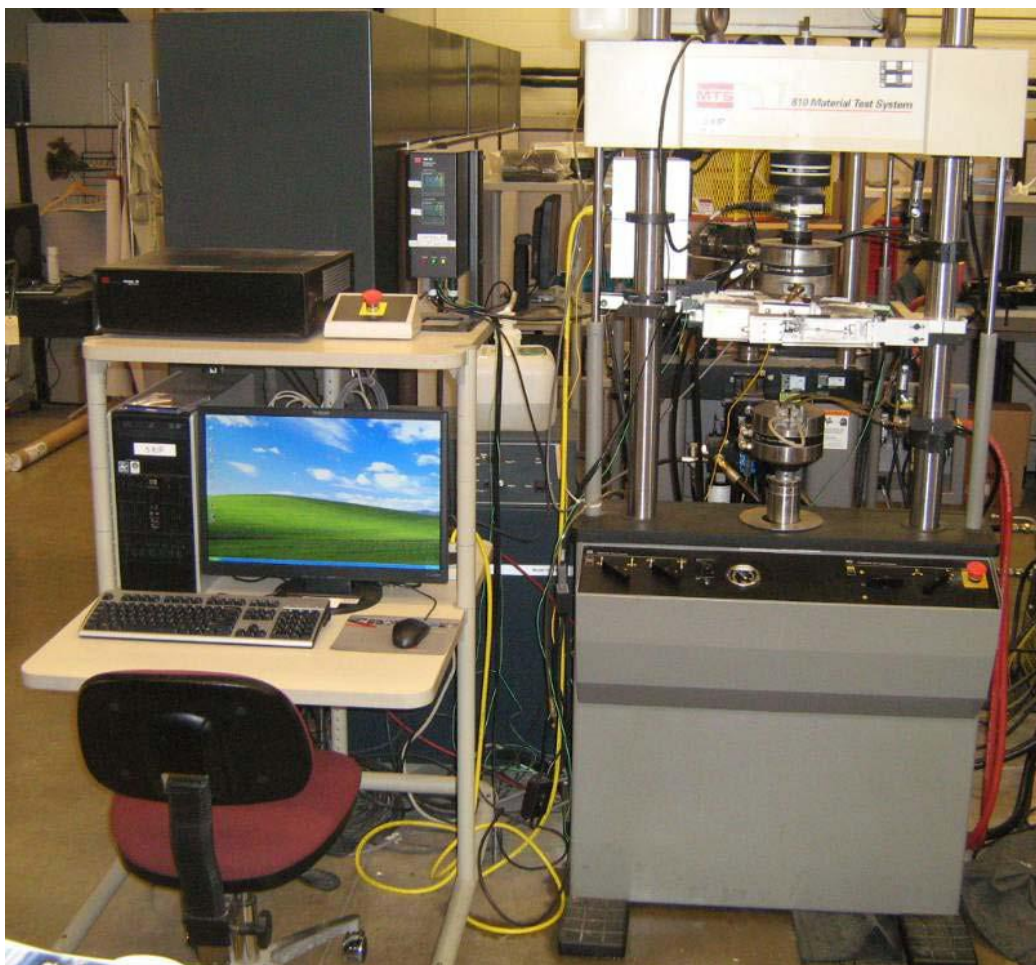
Figure 13: MTS 5 Kip machine.

A servo-hydraulic controlled MTS mechanical testing machine (5 kip machine) equipped with hydraulic water-cooled collet grips, a compact two-zone resistance-heater furnace, and two temperature controllers was used in all tests (Figure 13).

The maximum force available on this unit is 5 kip (approximately 25 kN). Before any tests were run, the 5 kip machines hydraulic system had to be warmed up, which was accomplished by inputting a .25in magnitude sin waveform input as the displacement command for 20 minutes.

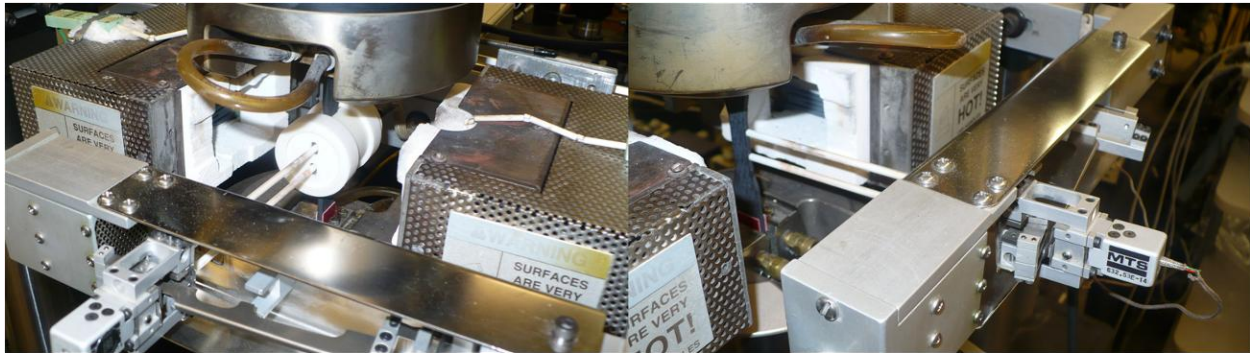
**Figure 15: Test specimen mounted for steam (left) and air (right) with extensometer attached**

After the specimens were mounted, a high temperature extensometer, MTS Model 632.53 E-14, was placed on the specimen as seen in Figure 15 to measure strain throughout the test.

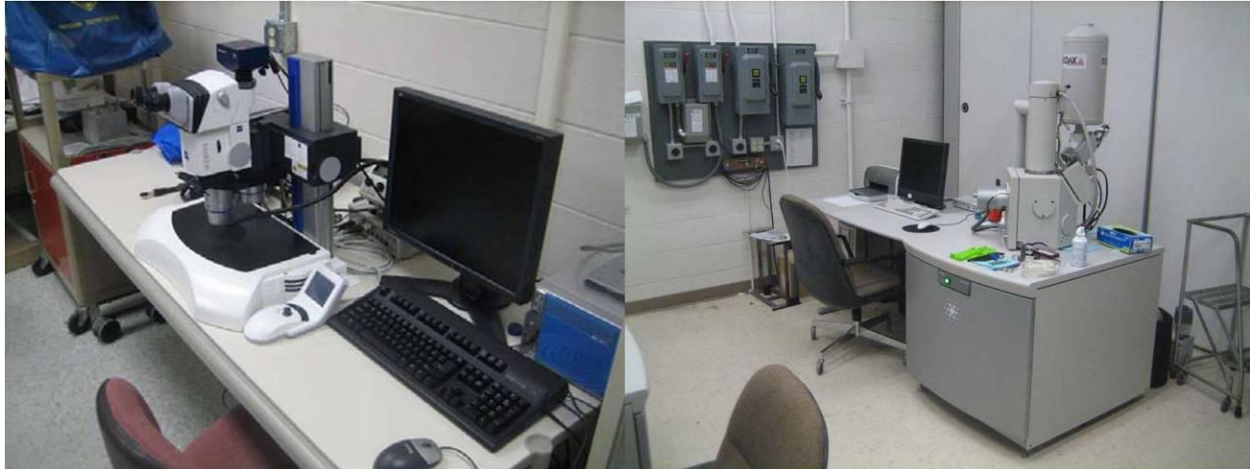
**Figure 17: Zeiss Stemi SV II optical microscope (left) and Quanta 200 scanning electron microscope (right).**

Once fractured, the test specimens were investigated by means of a Zeiss Stemi SV II optical microscope equipped with a Zeiss AxioCam HRc digital camera and the Quanta 200 scanning electron microscope (SEM) (Figure 17).

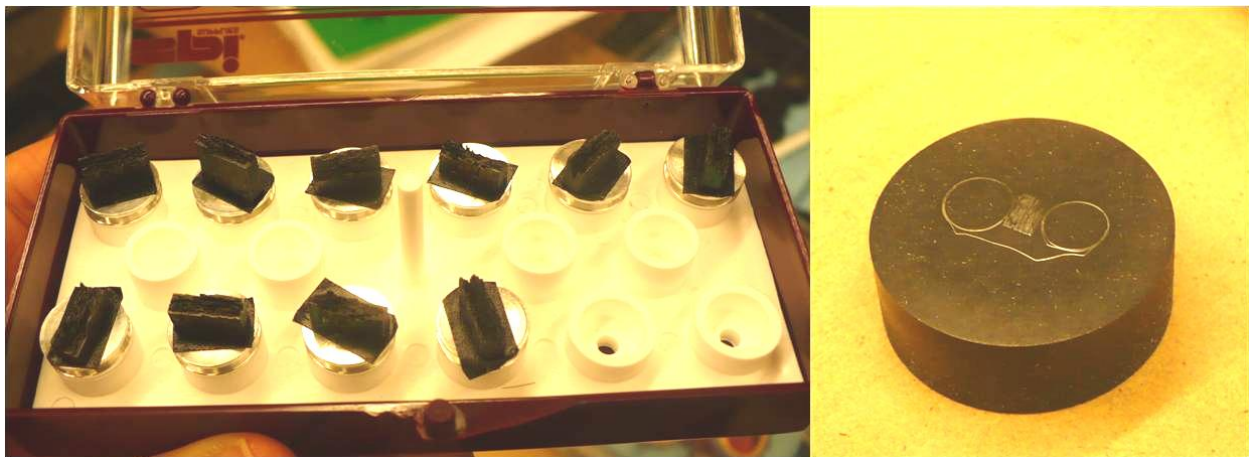
**Figure 19: Hi-Nicalon/PyC/SiC specimens prepared for SEM observation.**

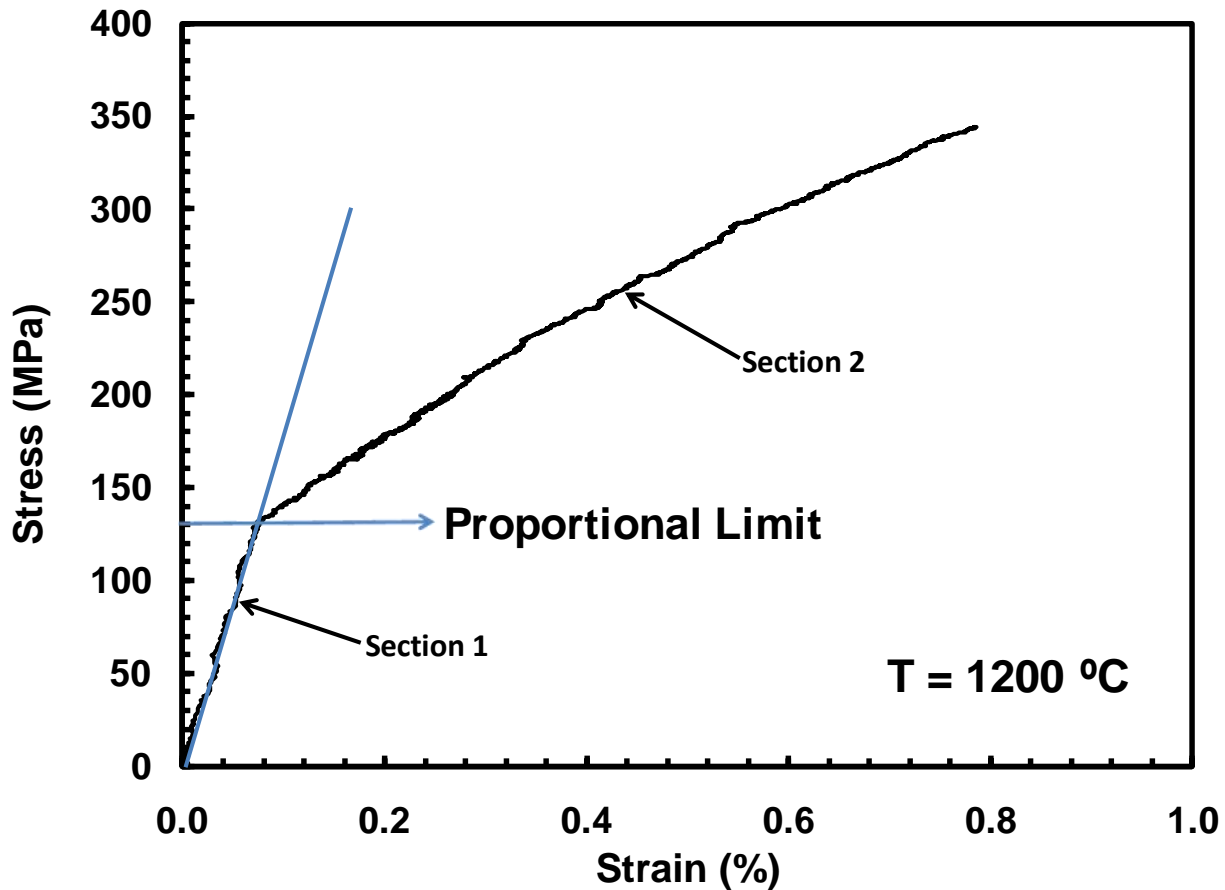
Figure 24: Tensile stress-strain curve obtained for the Hi-Nicalon/PyC/HyprSiC composite at 1200°C showing the proportional limit. The bilinear nature of the stress-strain curve is evident.

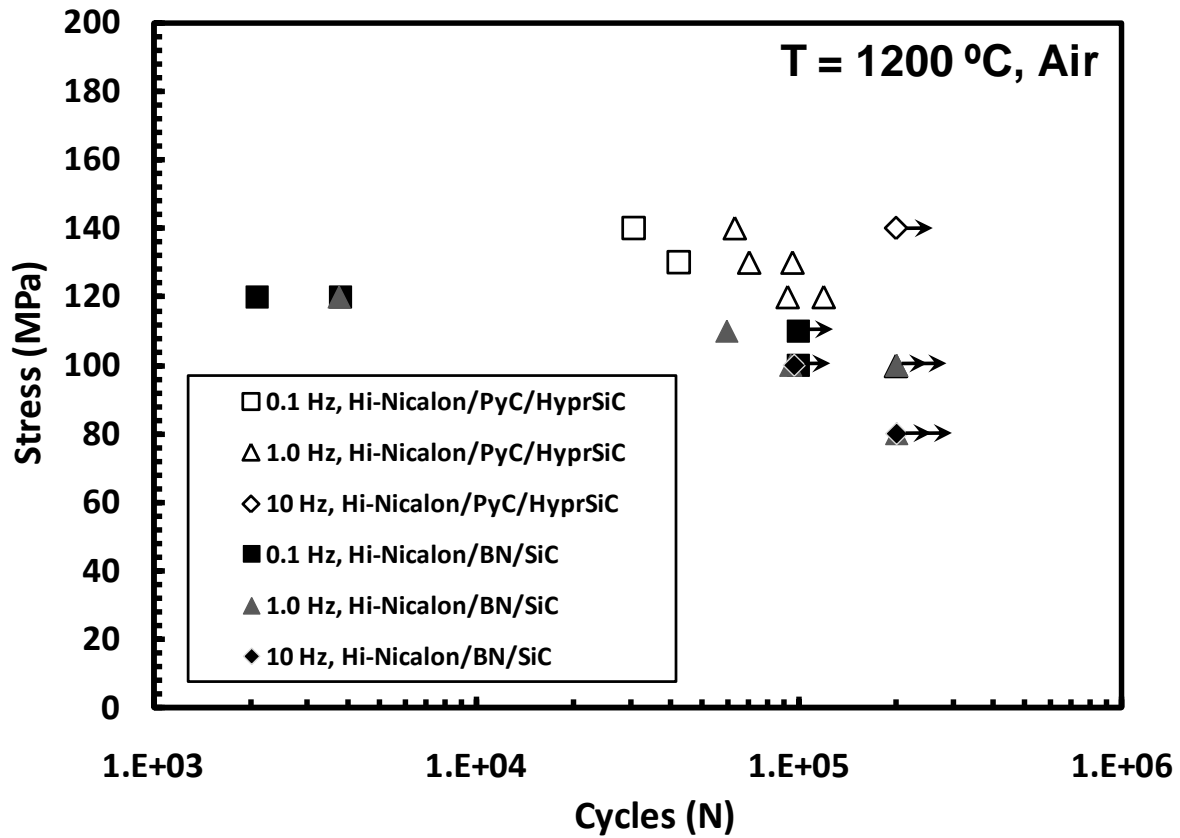
**Figure 28: Fatigue S-N diagram for the Hi-Nicalon/PyC/HyprSiC and Hi-Nicalon/BN/SiC CMCs at 1200°C in laboratory air. Data for Hi-Nicalon/BN/SiC from Christensen [8].**

The fatigue results obtained for the Hi-Nicalon/PyC/HyprSiC composite in this study are compared with the results obtained for the baseline material [8] in Figure 28. Results in Figure 28 reveal that the Hi-Nicalon/PyC/HyprSiC composite exhibits an overall better fatigue performance than the baseline material. This is particularly apparent at the low frequency of 0.1 Hz. At the maximum stress of 120 MPa, the baseline material failed after 3,780 cycles while the Hi-Nicalon/PyC/HyprSiC composite survived over 40,000 cycles. It is noteworthy that the baseline material exhibits an opposite trend as regards the dependence of the cyclic life on the loading frequency. Results reported by Christensen [8] reveal that the cyclic life of the baseline material degrades with increasing frequency.

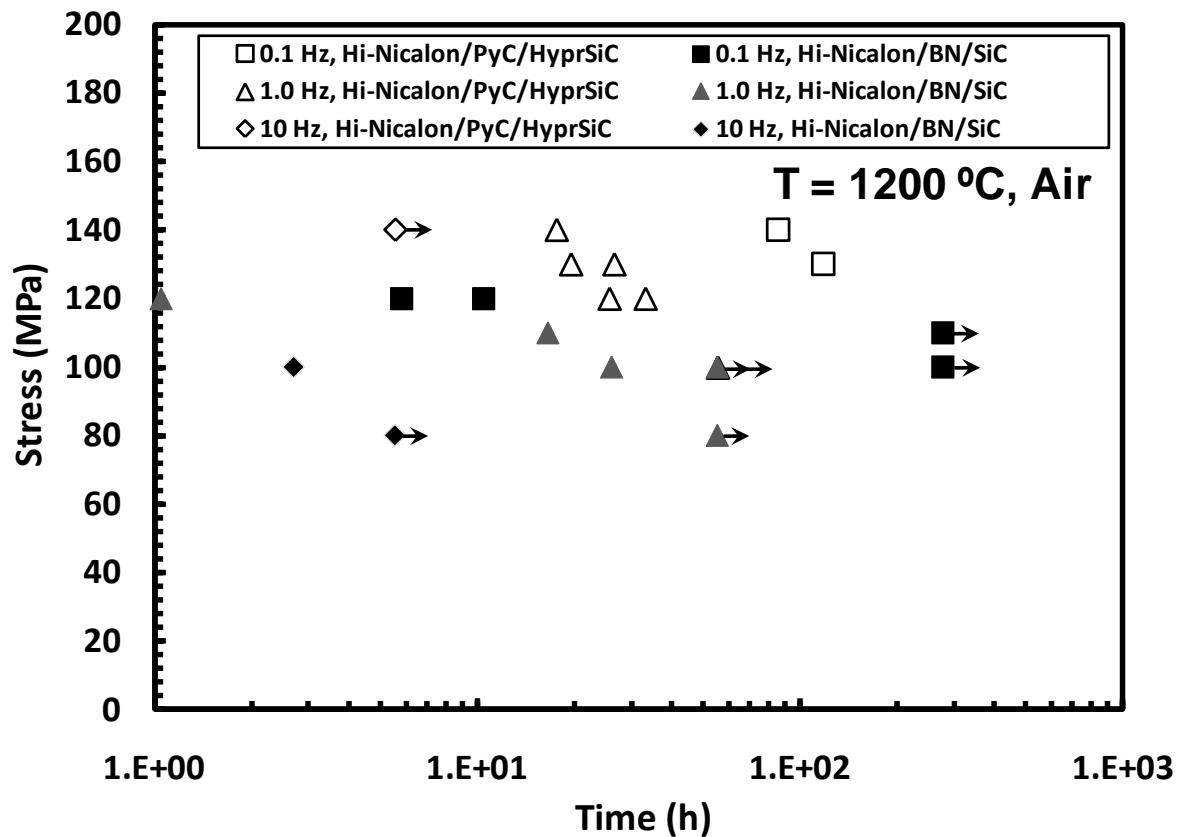
**Figure 29: Fatigue stress vs. time to failure for Hi-Nicalon/PyC/HyprSiC and Hi-Nicalon/BN/SiC CMCs at 1200°C in laboratory air. Data for Hi-Nicalon/BN/SiC from Christensen [8].**

The fatigue versus time to failure for the Hi-Nicalon/PyC/HyprSiC composite in this study is compared with the results obtained for the baseline material [8] in Figure 29. Both materials had longer lifetimes with specimens tested at lower frequencies for a given maximum stress.

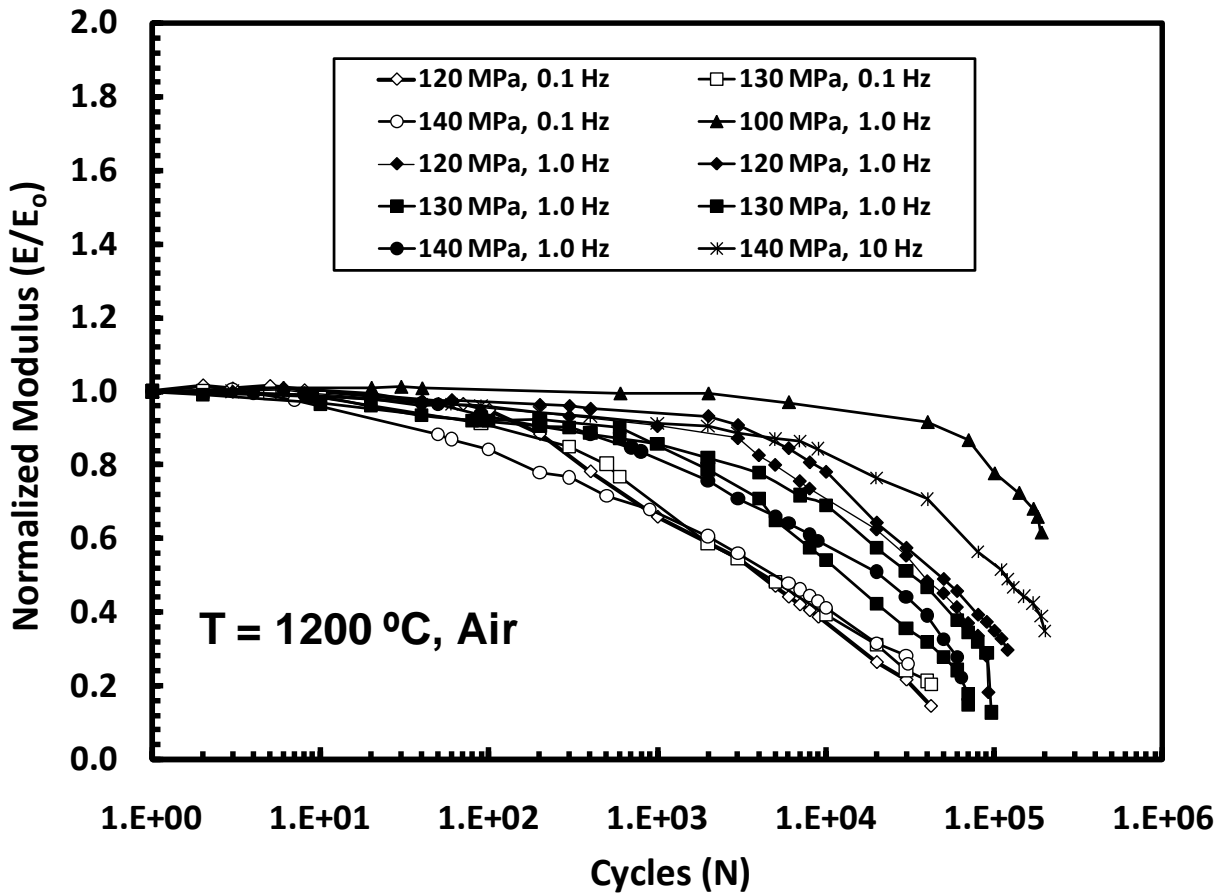
Figure 30: Normalized modulus vs. fatigue cycles for the Hi-Nicalon/PyC/HyprSiC ceramic composite at  $1200^\circ\text{C}$  in laboratory.

Of importance in cyclic fatigue is the reduction in stiffness (hysteresis modulus determined from the maximum and minimum stress-strain data points during a load cycle), which reflects the damage development during fatigue cycling. Modulus evolution with fatigue cycles is shown in Figure 30, where normalized modulus (i.e. modulus normalized by the modulus obtained in the first cycle) is plotted vs. fatigue cycles. A decrease in normalized modulus with cycling was observed for all specimens tested at 1200°C in air, including the specimens that achieved fatigue run-out. The modulus loss was affected by the fatigue stress

level as well as by the loading frequency. Results in Figure 30 show that modulus decreased at a faster rate in test conducted with higher maximum stress and in tests conducted at lower frequency. In some cases reductions in hysteresis modulus reached 90%.

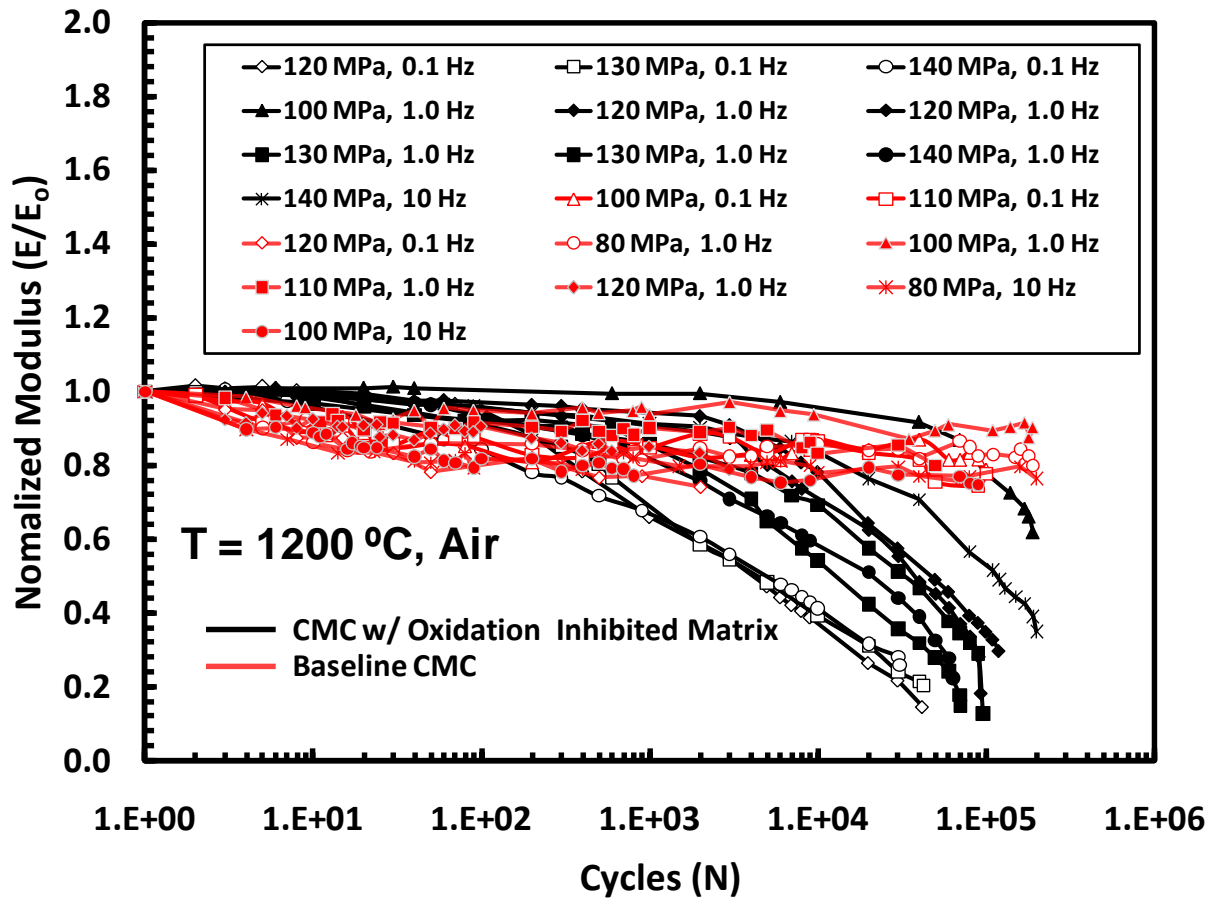
Figure 31: Normalized modulus vs. fatigue cycles for the Hi-Nicalon/PyC/HyprSiC and Hi-Nicalon/BN/SiC ceramic composites at 1200°C in laboratory air. Data for Hi-Nicalon/BN/SiC from Christensen [8].

Modulus evolution with fatigue cycles recorded for the Hi-Nicalon/PyC/HyprSiC composite is compared with the results obtained for the Hi-Nicalon/BN/SiC CMC by Christensen [8] in Figure 31. Note that a larger decrease in hysteresis modulus with fatigue cycles is seen

for the Hi-Nicalon/PyC/HyprSiC composite than for the baseline material. This observation can be made for all fatigue stress levels and for all fatigue frequencies. While in the 120 MPa test at 0.1 Hz the Hi-Nicalon/BN/SiC composite exhibited a modulus loss of 26%, the Hi-Nicalon/PyC/HyprSiC material showed a modulus decrease of 86%. Likewise, in the 120 MPa test at 1.0 Hz the modulus loss was 20% for the baseline material and 82% for the composite with the oxidation inhibited matrix.

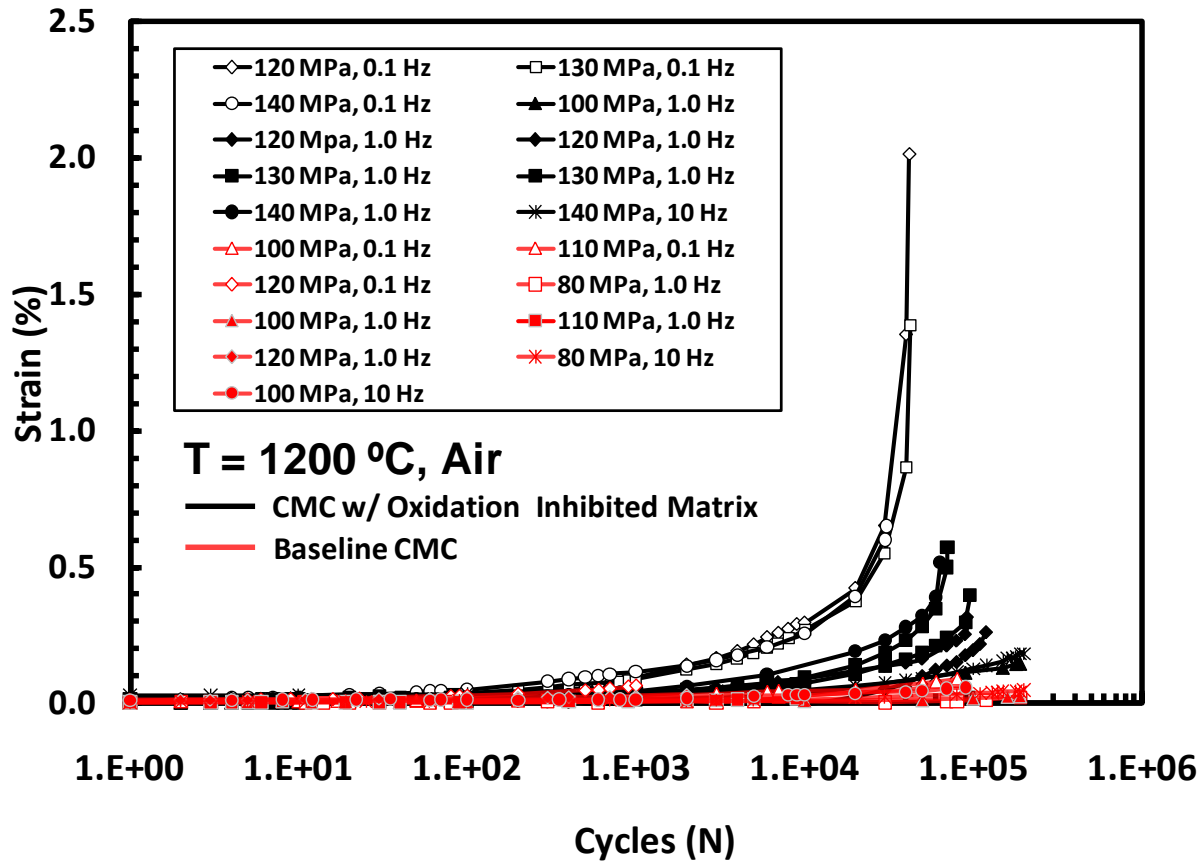
Figure 33: Accumulated strain vs. fatigue cycles for the Hi-Nicalon/PyC/HyprSiC and Hi-Nicalon/BN/SiC ceramic composites at 1200°C in laboratory air. Data for Hi-Nicalon/BN/SiC from Christensen [8].

Strain accumulation with fatigue cycles recorded for the Hi-Nicalon/PyC/HyprSiC composite is compared with the results obtained for the Hi-Nicalon/BN/SiC CMC by Christensen [8] in Figure 33. Clearly much larger strains are accumulated by the Hi-Nicalon/ PyC/HyprSiC CMC than by the baseline material. Strains accumulated by the Hi-Nicalon/ PyC/HyprSiC composite range from 0.14% (100 MPa test at 1.0 Hz) to 2.01% (120 MPa test at 0.1 Hz). Conversely, all strains accumulated by the baseline material at 1200°C in air are below 0.1%. Furthermore, while loading frequency had a significant effect on the rate of strain accumulation in the case of the Hi-Nicalon/PyC/HyprSiC composite, it had little influence on the rate of strain accumulation or on the accumulated strains in the case of the Hi-Nicalon/BN/SiC CMC.

A possible reason for the larger strain accumulation by the CMC with the oxidation inhibited matrix may be dependent on the type of loading conditions applied. In specimens tested at 140 MPa, the bulk of the load is carried by the fibers due to matrix cracking. In this case creep would be dominated by the fibers and the increase strain during fatigue is due to the improved fiber coatings (PyC and B<sub>4</sub>C). At lower maximum stresses, the matrix is not fully cracked and still supports a load. Here the strain accumulation is due to the both the fibers and the matrix. The additions to the SiC matrix may contribute to increased strain when compared to an ordinary SiC matrix. Because of this, a creep study of the oxidation inhibited matrix should be considered. On the other hand, the baseline CMC has a single fiber coating of boron nitride which breaks down when exposed to oxidative environments when matrix cracking occurs. At this point the BN coating no longer provides a weak fiber/matrix interface to deflect matrix cracking resulting in lower strain accumulations.

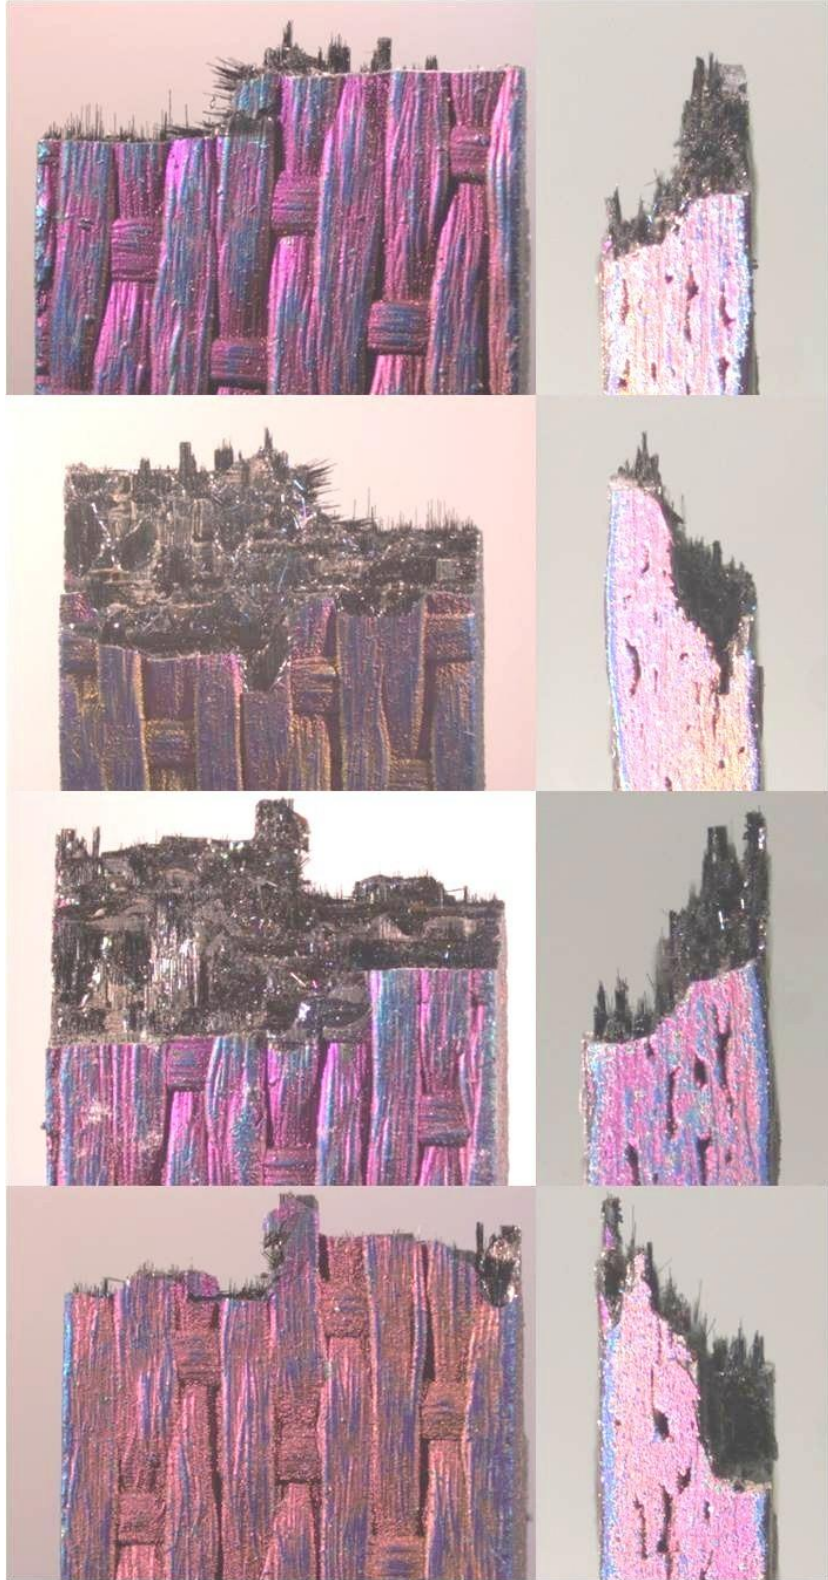
Figure 107: Optical micrographs of fracture surface of specimen P5-7 tested in fatigue at 1.0 Hz in air at 1200°C.  $\sigma_{\max} = 130$  MPa,  $N_f = 70,309$ ,  $t_f = 19.5$  h.
