# MILITARY GEOLOGY OF SAIPAN, MARIANA ISLANDS

VOLUME I

INTRODUCTION AND ENGINEERING ASPECTS

PREPARED UNDER THE DIRECTION OF THE  
CHIEF OF ENGINEERS, U.S. ARMY  
BY THE  
INTELLIGENCE DIVISION, OFFICE OF THE ENGINEER  
HEADQUARTERS UNITED STATES ARMY FORCES FAR EAST  
AND EIGHTH UNITED STATES ARMY  
WITH PERSONNEL OF  
THE UNITED STATES GEOLOGICAL SURVEY

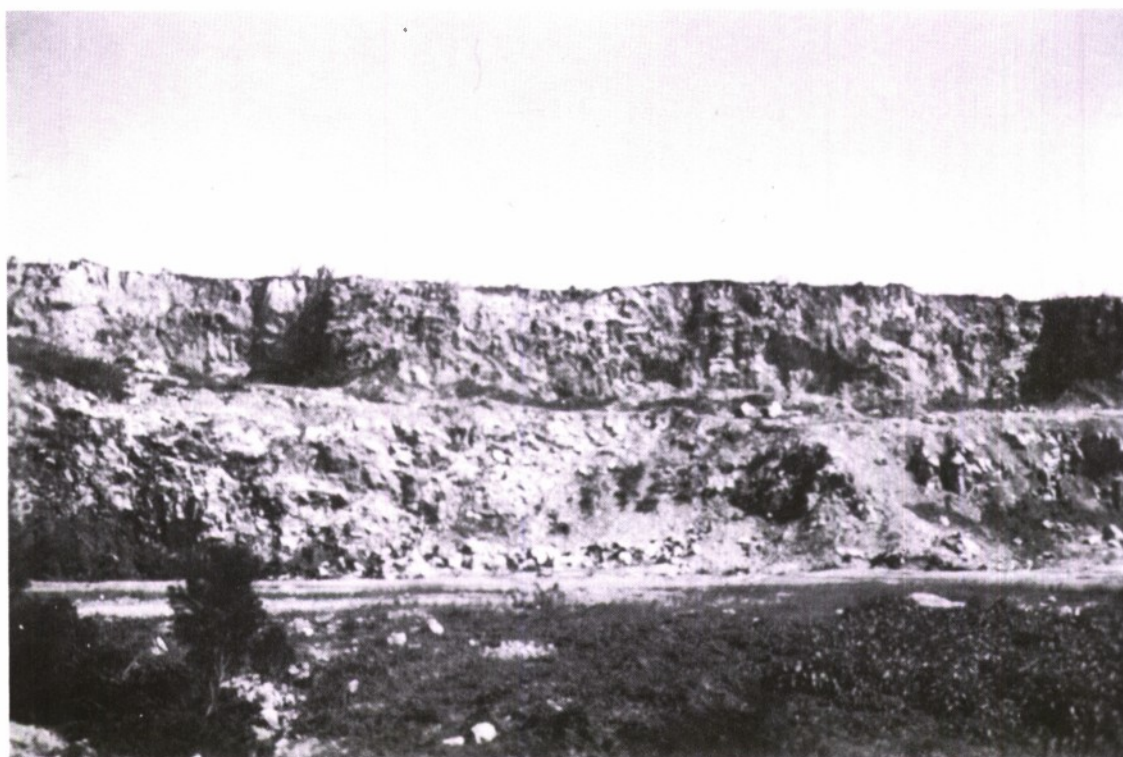
A. Unit No. 1 Very compact limestone. Quarry S-25 at Laderan Dago, south-central Saipan. Sample site No. 2.

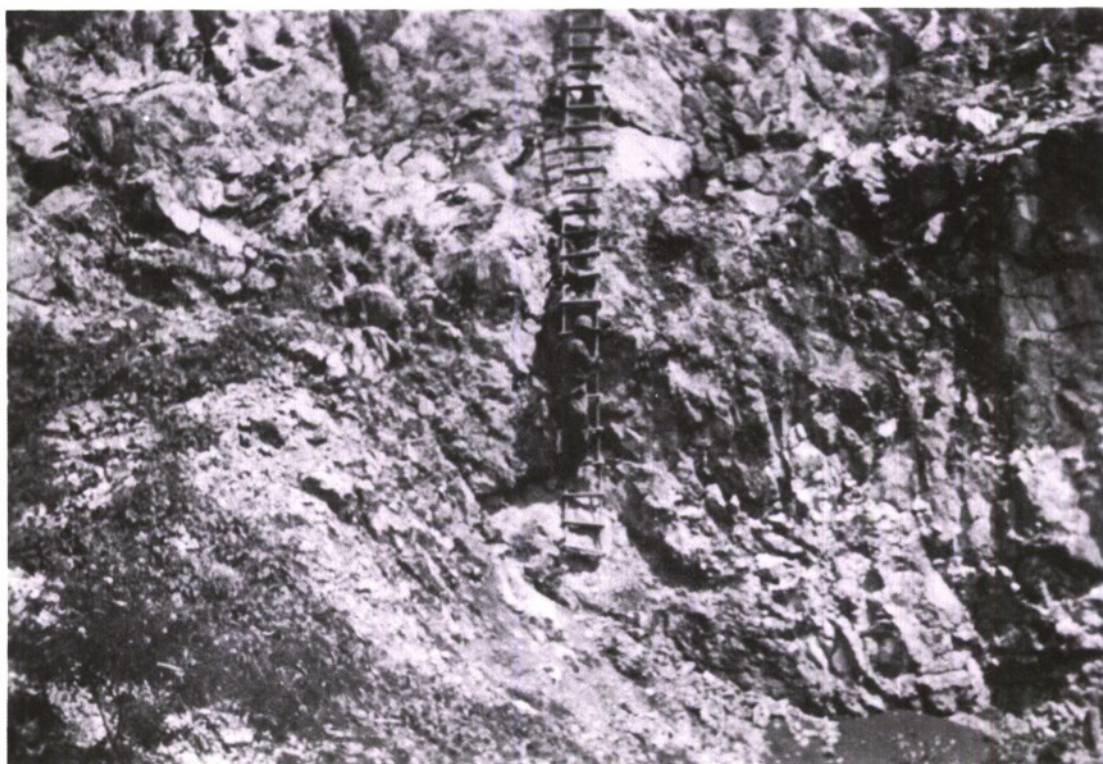
B. Unit No. 1 Very compact limestone. Quarry S-25 at Laderan Dago, south-central Saipan. Sample site No. 2.

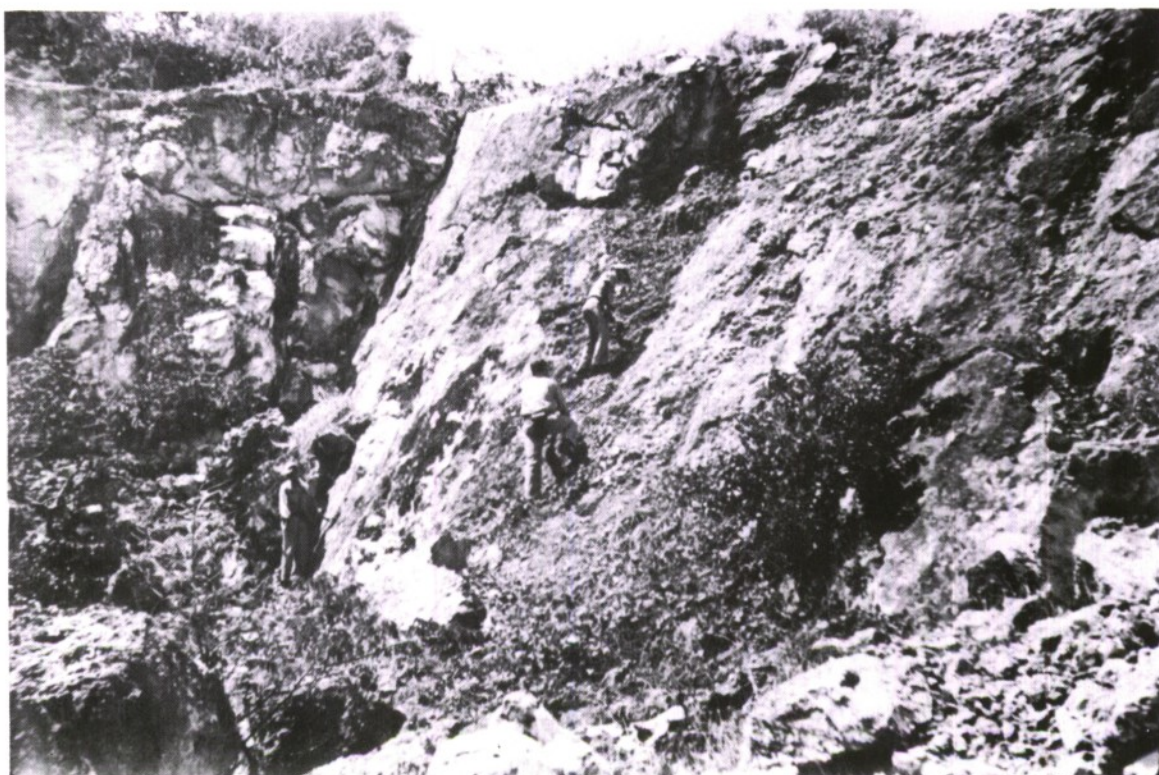
A. Unit No. 1 Very compact limestone. Quarry S-2 at south side of Laderan Laguna, northeast Saipan.

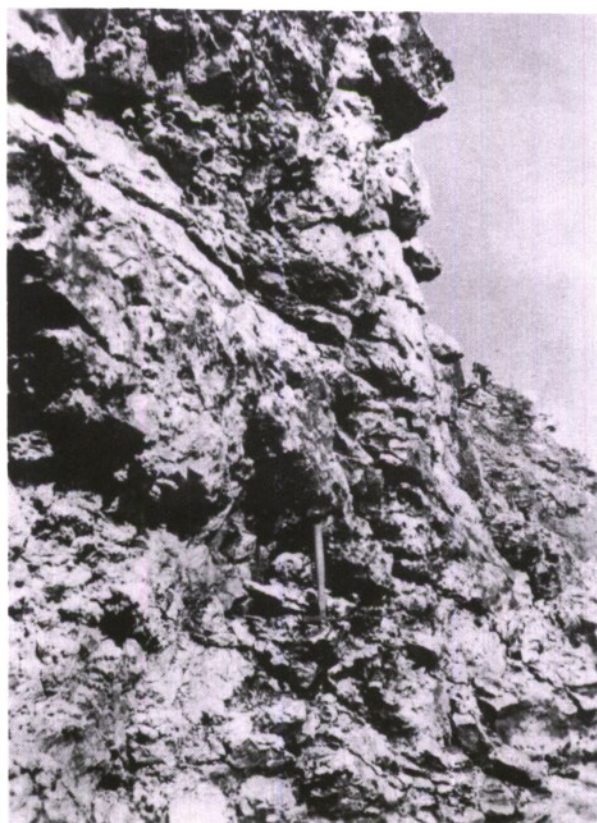
B. Unit No. 2 Firm, porous limestone. Quarry at Laderan Dandan, southeast Saipan.

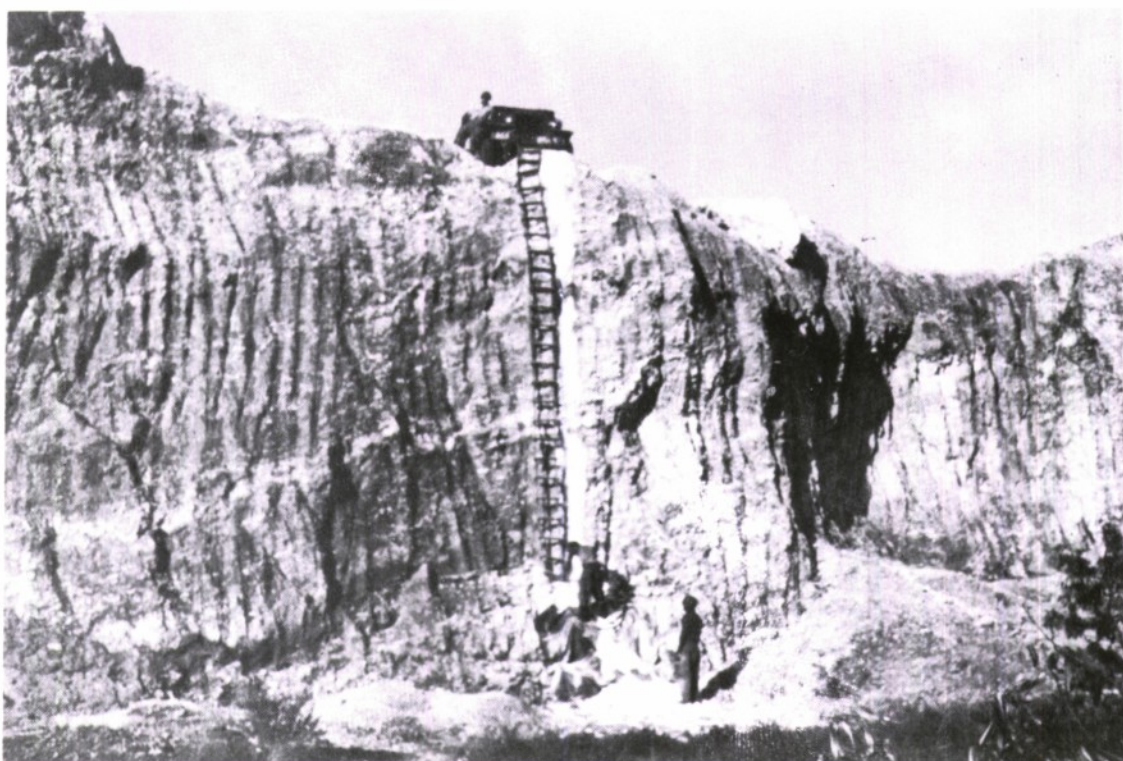
A. Unit No. 3 Coralline rubble. Quarry in southern part of district of As Matuis, northern Saipan. Sample site No. 2.

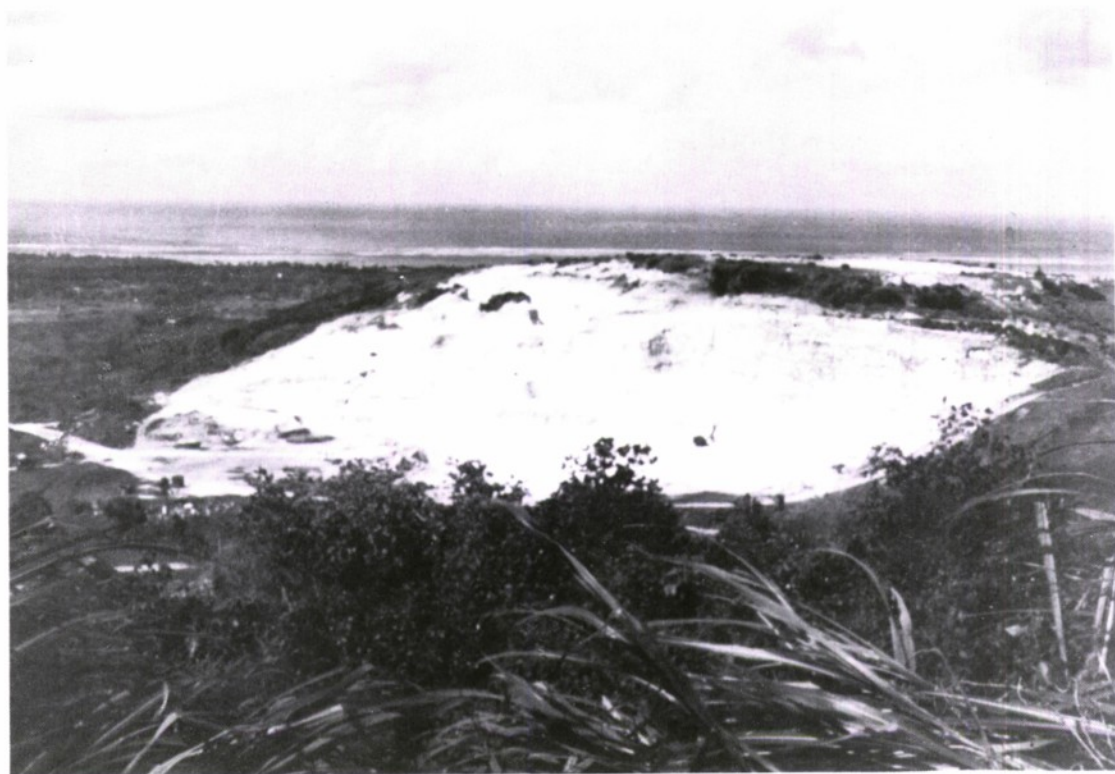
A. Unit No. 3 Coralline rubble. Distant view of Quarry S-16 at Laderan Dandan, south-central Saipan. Sample site No. 1.

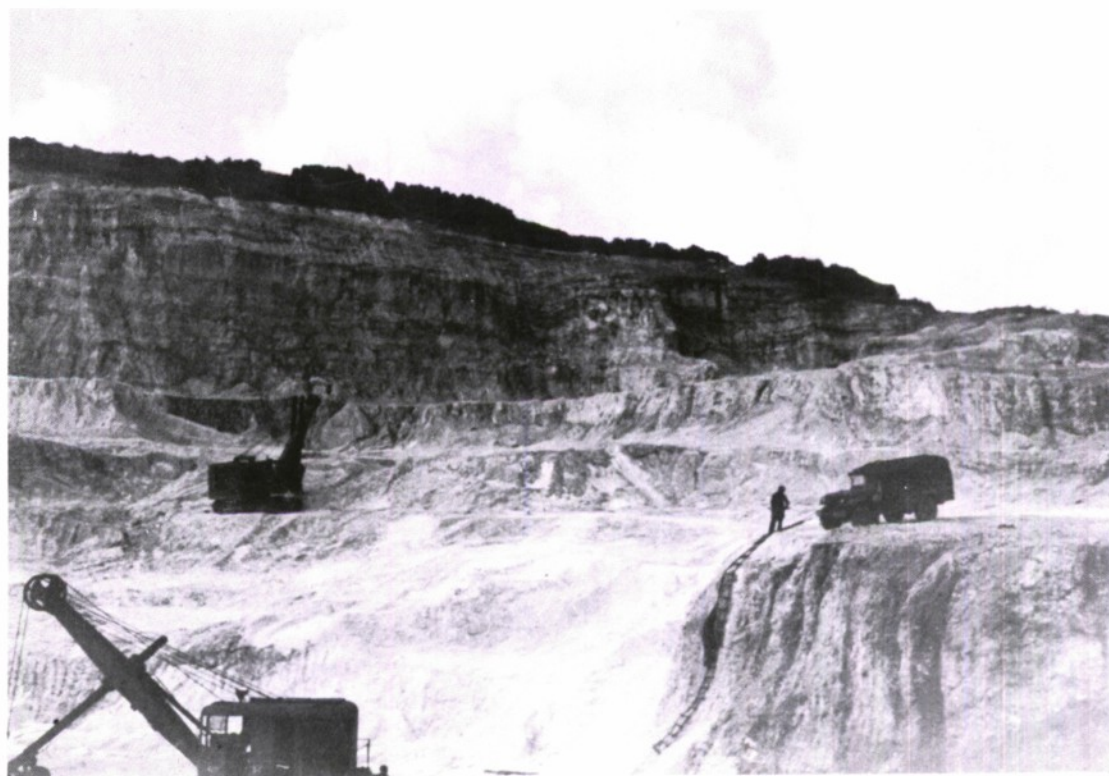
B. Unit No. 3 Coralline rubble. Close-up view of quarry S-16 at Laderan Dandan, south-central Saipan. Sample site No. 1.

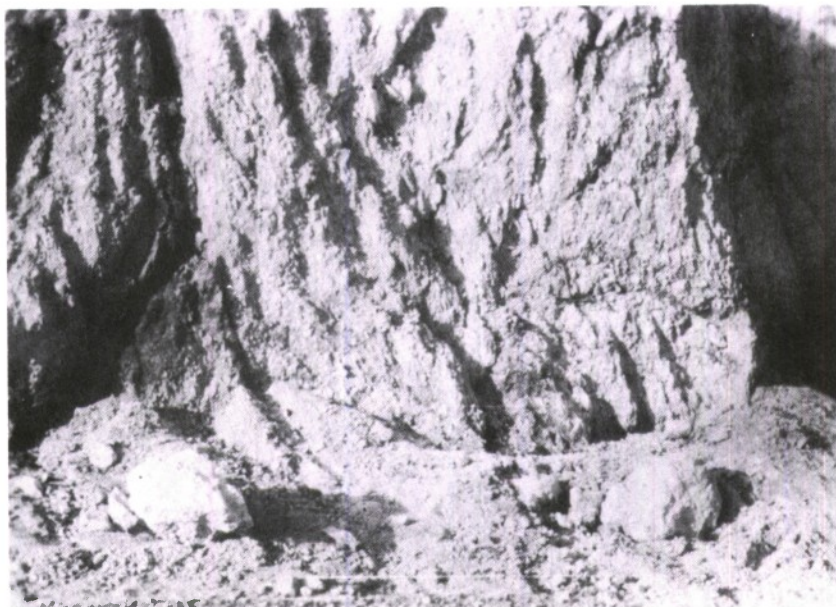
A. Unit No. 3 Coralline rubble. Quarry S-16 at Laderan Dandan, south-central Saipan. Sample site No. 1.

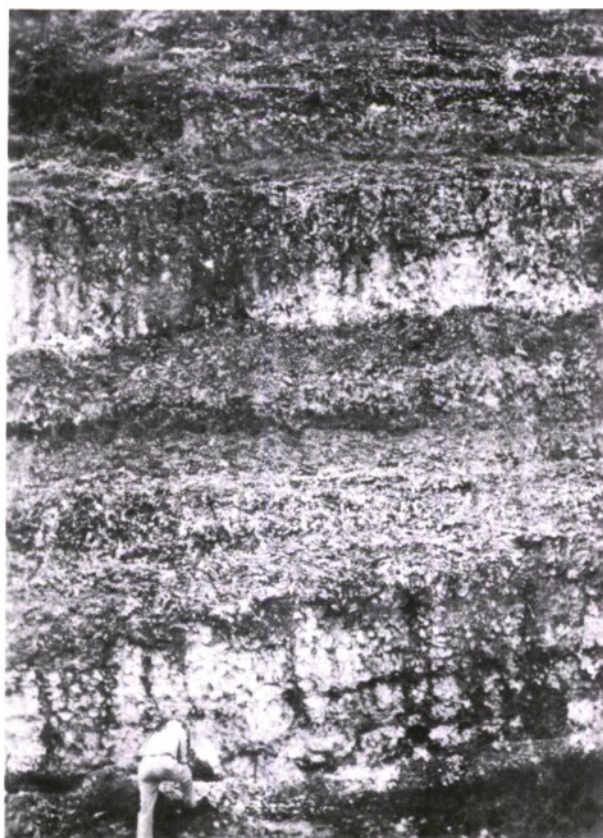
B. Unit No. 3 Coralline rubble. Quarry at base of Laderan I Agag, east-central Saipan.

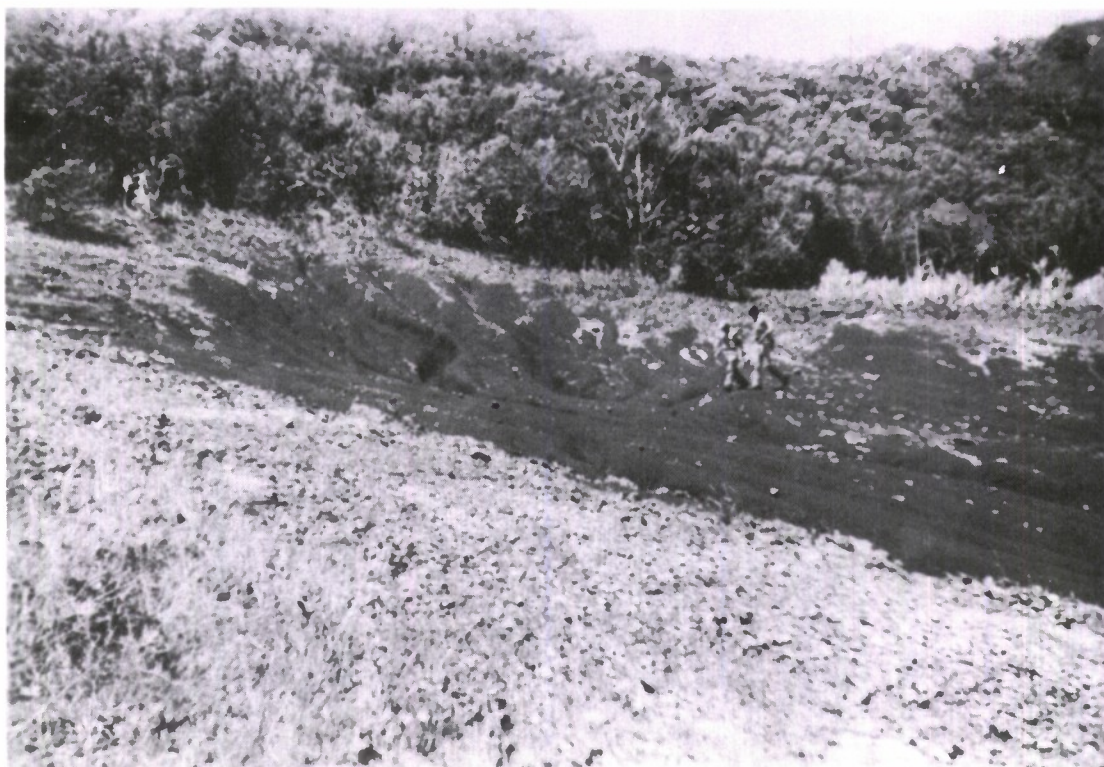
A. Unit No. 5 Red clay overlying limestone. At base of Laderan Kalaberan Katan, north Saipan.

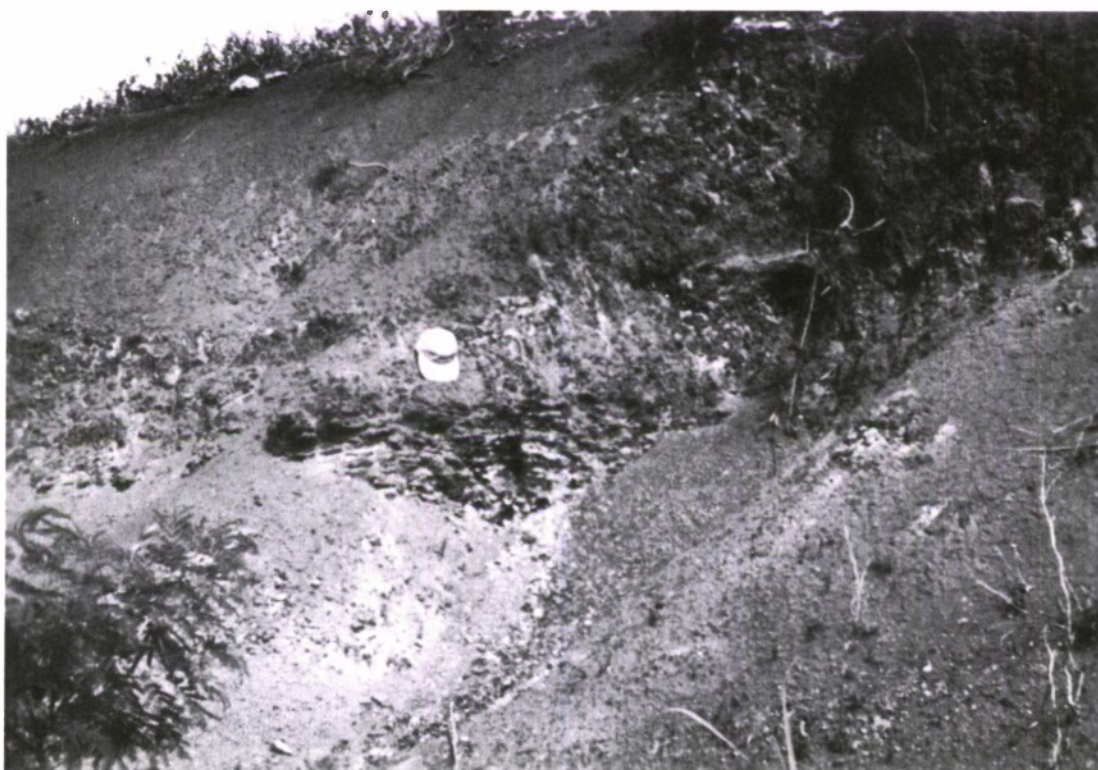
B. Unit No. 6 Brown clay. Cut along west side of Cross-Island Highway, district of Papago, east-central Saipan.

General description: This is a brown to yellowish clay, commonly containing pea-sized concretions of manganiferous and ferruginous composition, some sand, and limestone fragments. Valley deposits of the clay are gravelly. The clay is weakly to highly plastic; commonly loose when dry, but very sticky when wet. Thickness averages perhaps 5 feet or more and may reach as much as 25 feet locally. Underlying beds are not ordinarily exposed, but in most places they are limestone. A typical exposure is shown in plate 11B.

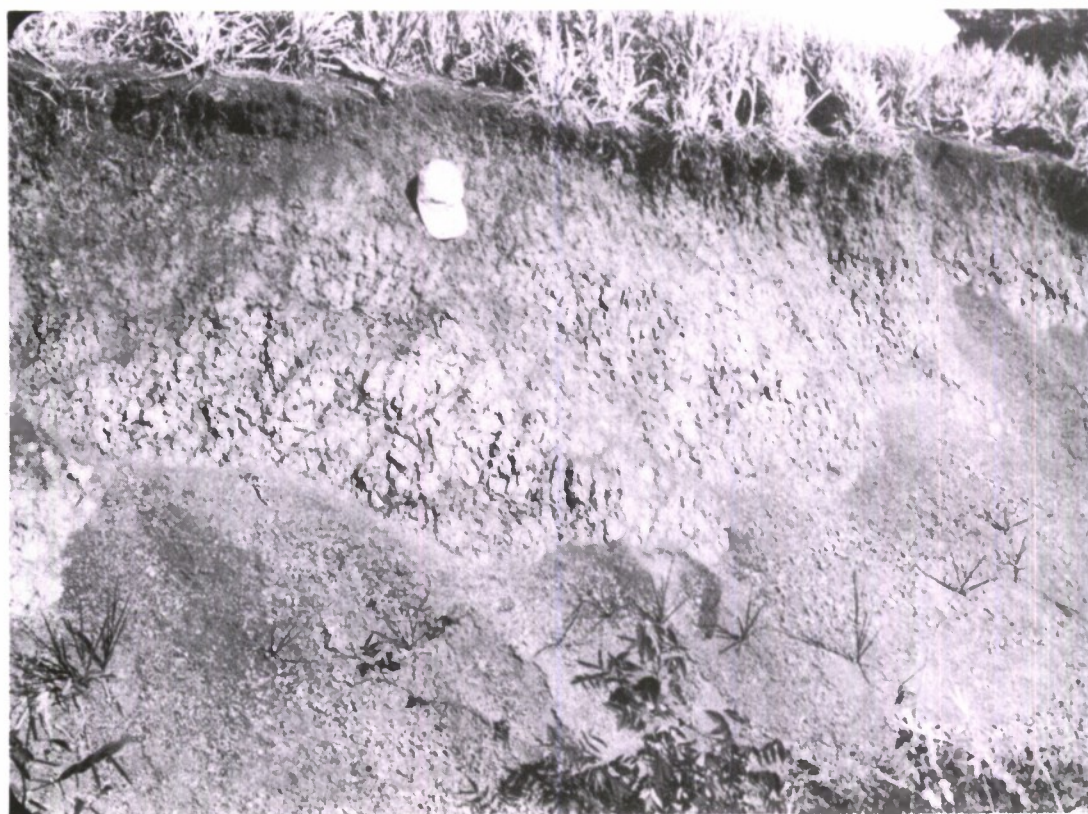
B. Unit No. 7 Mottled clay. About 100 feet northeast of As Perdido Road, district of Fina-sisu, southwest Saipan.

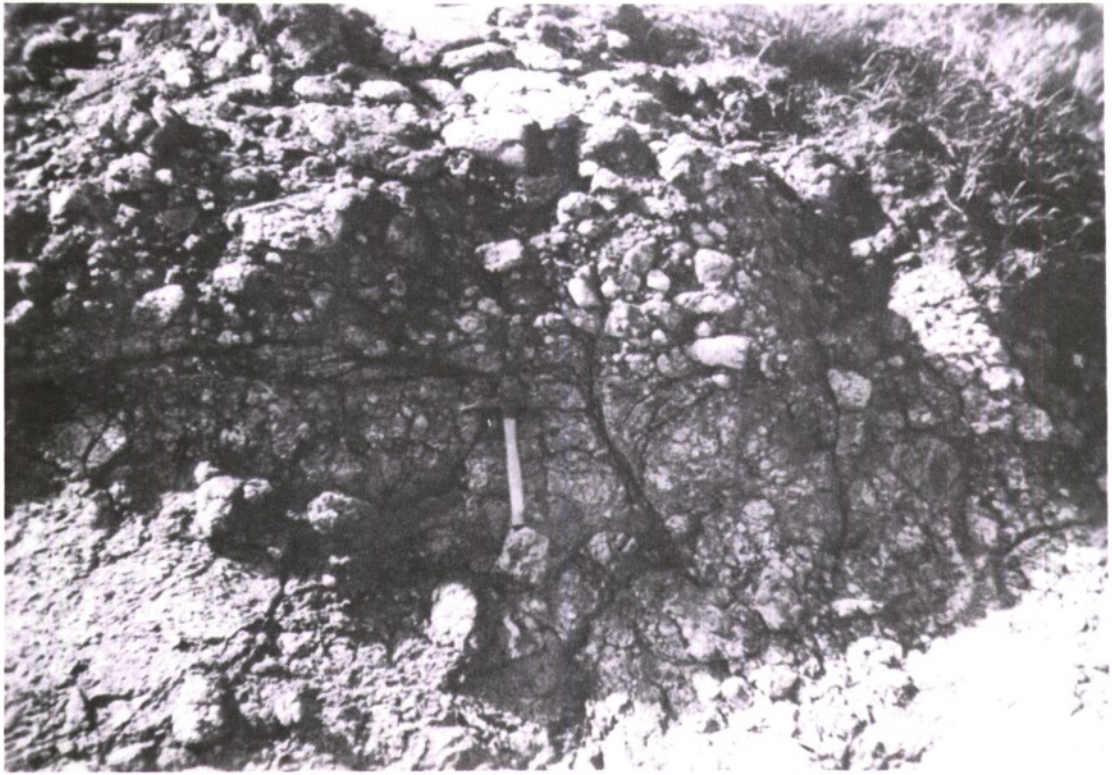
A. Unit No. 8 Weathered andesitic conglomerate and breccia.  
District of Talofofu, northeast Saipan.

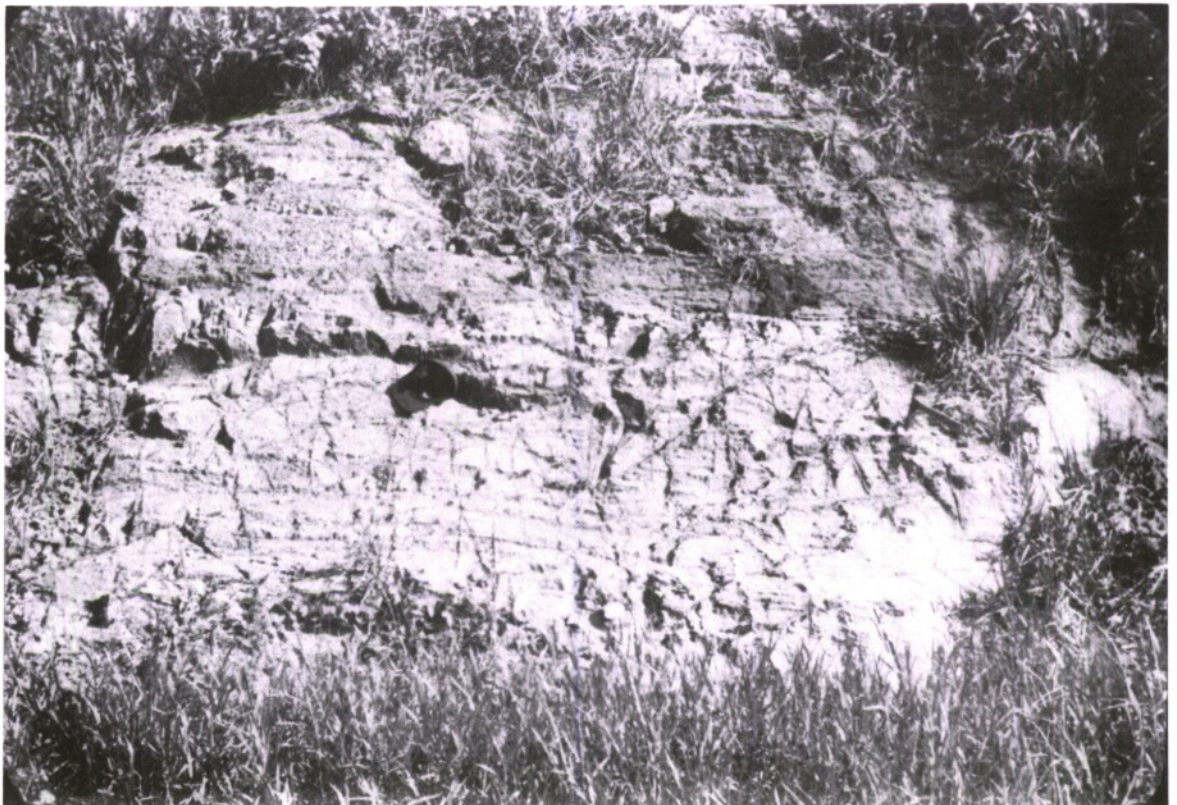
B. Unit No. 8 Weathered andesitic conglomerate and breccia. Cut  
along west side of Cross-Island Highway, district of Papago, east-  
central Saipan.

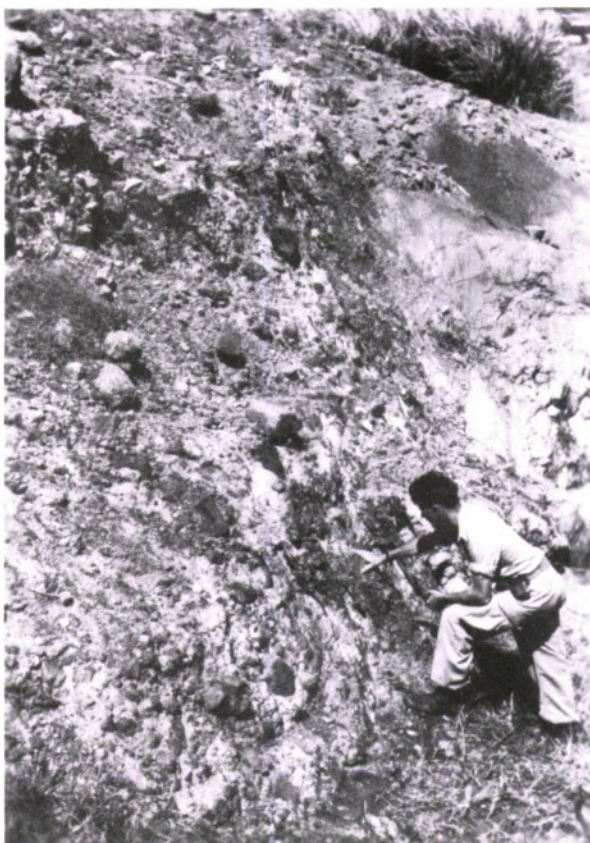
A. Unit No. 9 Partly weathered andesitic conglomerate and sandstone. Road cut at Laderan Hagman, eastern Hagman Peninsula, east-central Saipan. Sample site No. 1

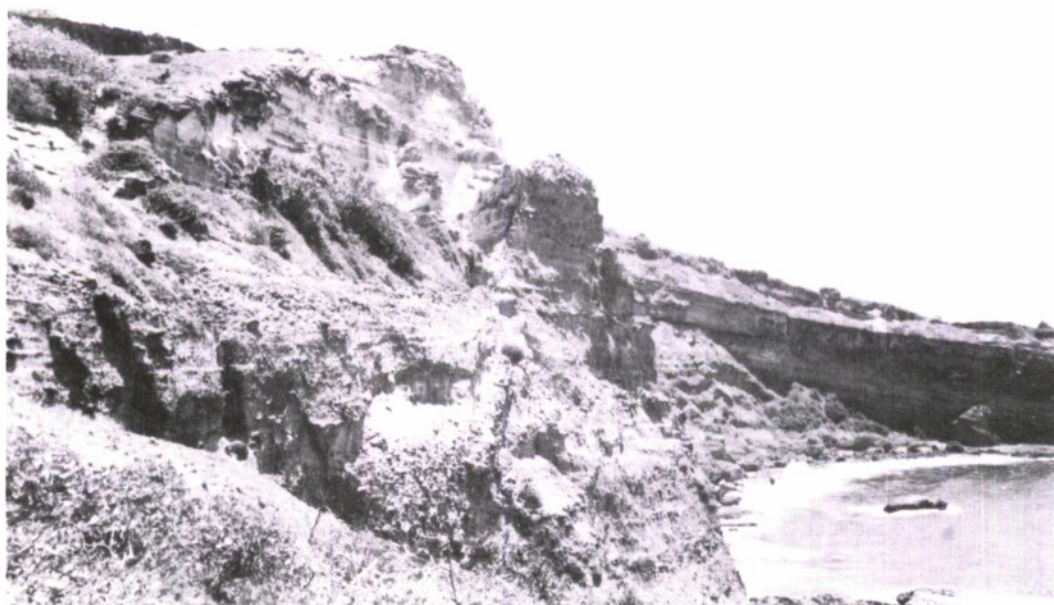
B. Unit No. 9 Partly weathered andesitic conglomerate and sandstone. Bluffs above Unai Hagman, eastern Hagman Peninsula, east-central Saipan.

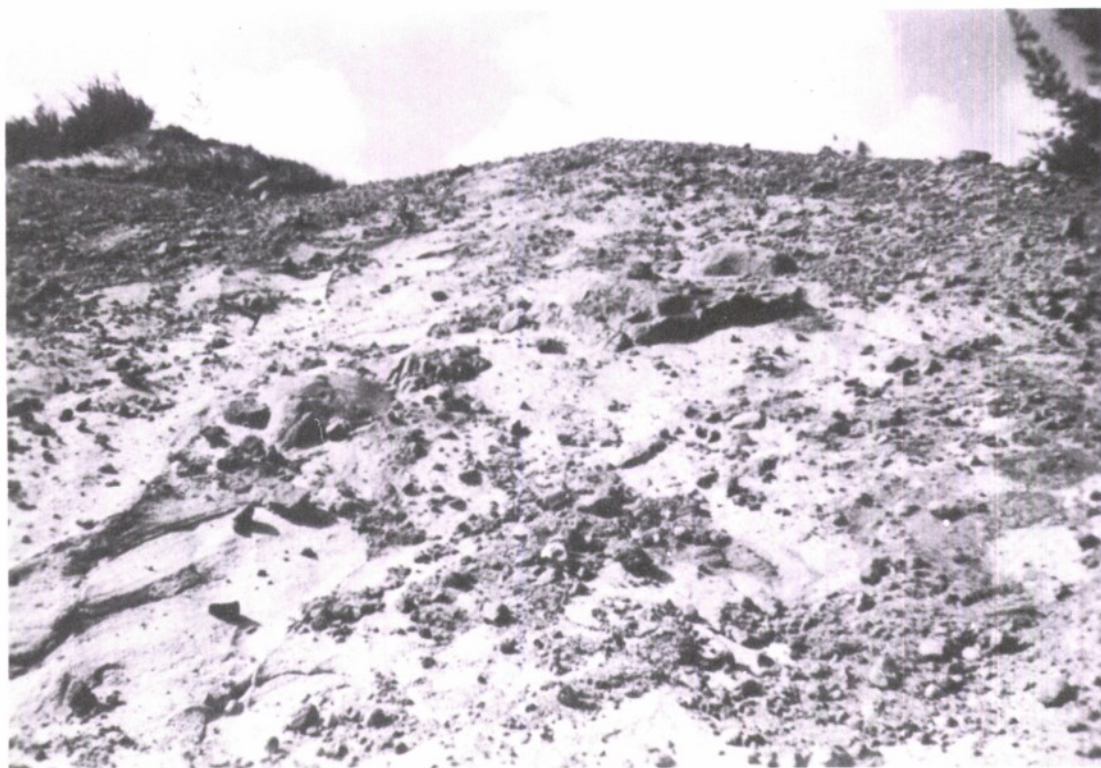
A. Unit No. 9 Partly weathered andesitic conglomerate and sandstone. East slope of Laderan Hagman, eastern Hagman Peninsula, east-central Saipan.

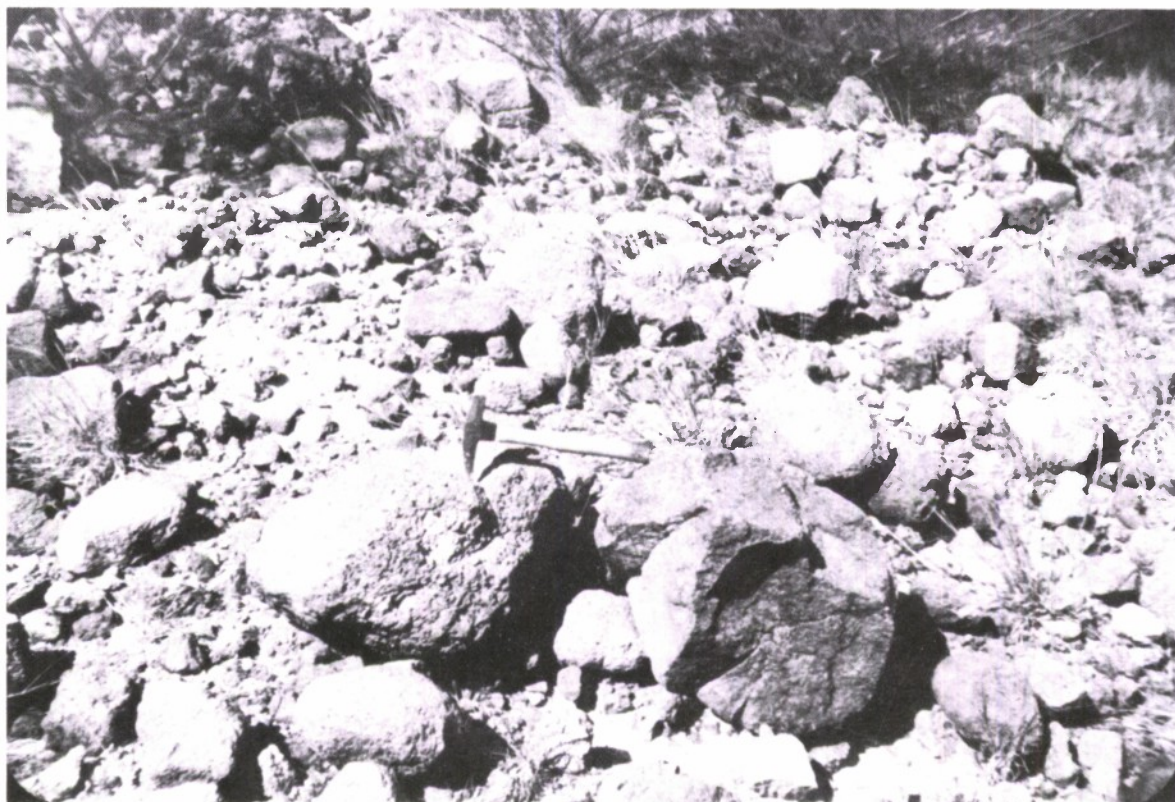
B. Unit No. 9 Partly weathered andesitic conglomerate and sandstone. Fresh andesite boulders and cobbles on surface. East slope of Laderan Hagman, eastern Hagman Peninsula, east-central Saipan.

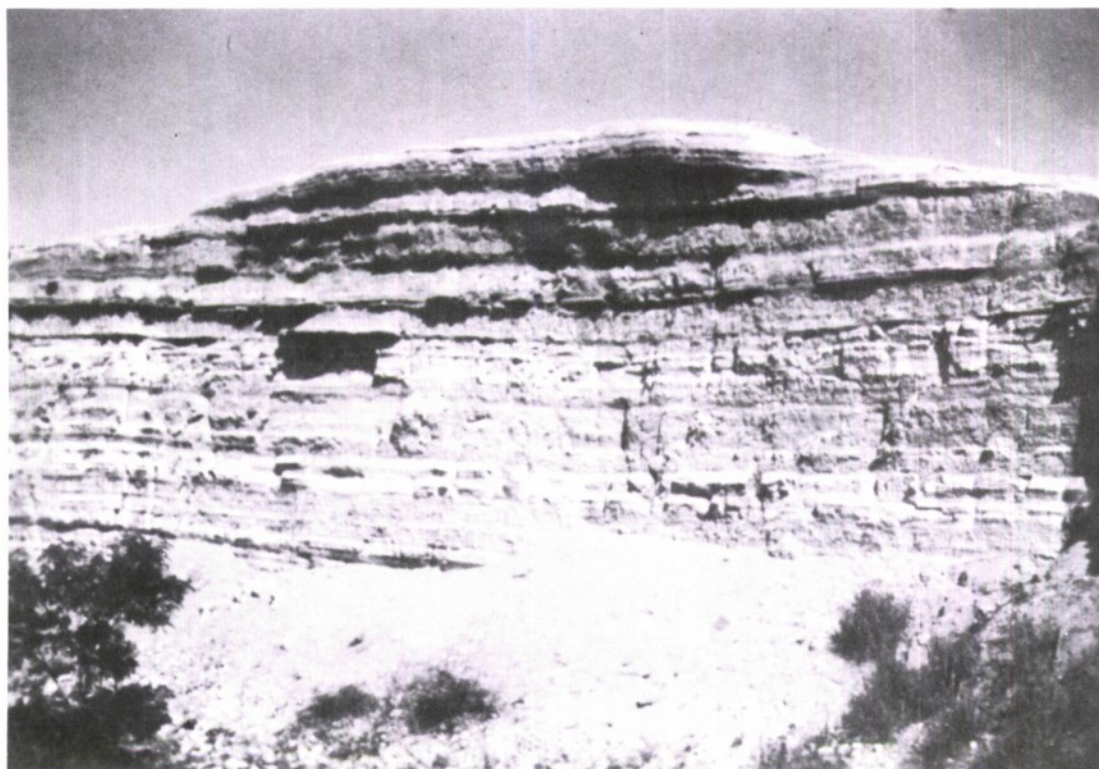
A. Unit No. 10 Clayey volcanic sediments. Quarry at Laderan Dago, about 800 feet east of Isley Entrance Road, south-central Saipan. Sample site No. 2.

General description: Stratified layers of silt, silty clay, sandy clay, marl, and weakly-cemented, calcareous, tuffaceous sandstone; silt and clay layers predominate. Maximum thickness of this unit is approximately 200 feet. Individual beds range from a few inches to several feet in thickness and are various shades of brown, green, gray, and red; they are inclined generally eastward at moderate angles, and in some areas are gently folded, deeply incised, and eroded. Some beds are partly bentonitic, and swell when wet. Textural and compositional differences between beds, undulations caused by folding, and erosion account for exposure of dissimilar layers at different locations within the unit. Typical exposures are shown in plates 16A and 16B.

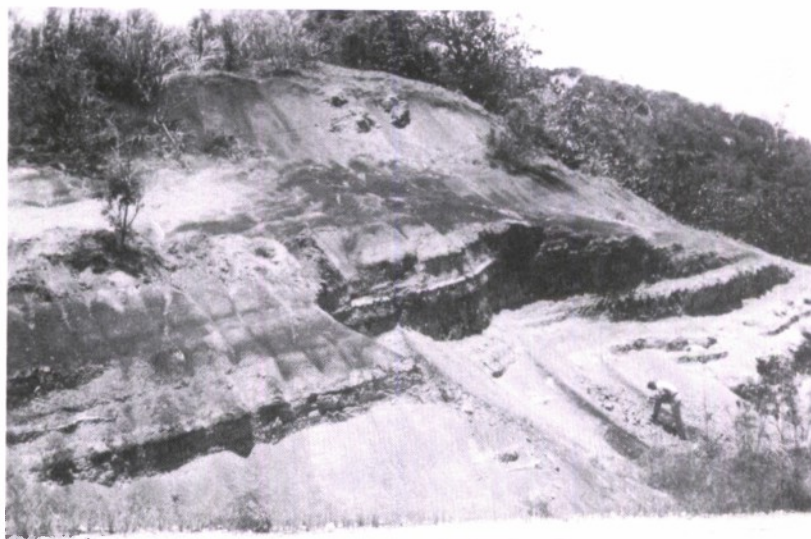
B. Unit No. 10 Clayey volcanic sediments. Cut along East Coast Highway, district of I Hasngot, northeast Saipan.

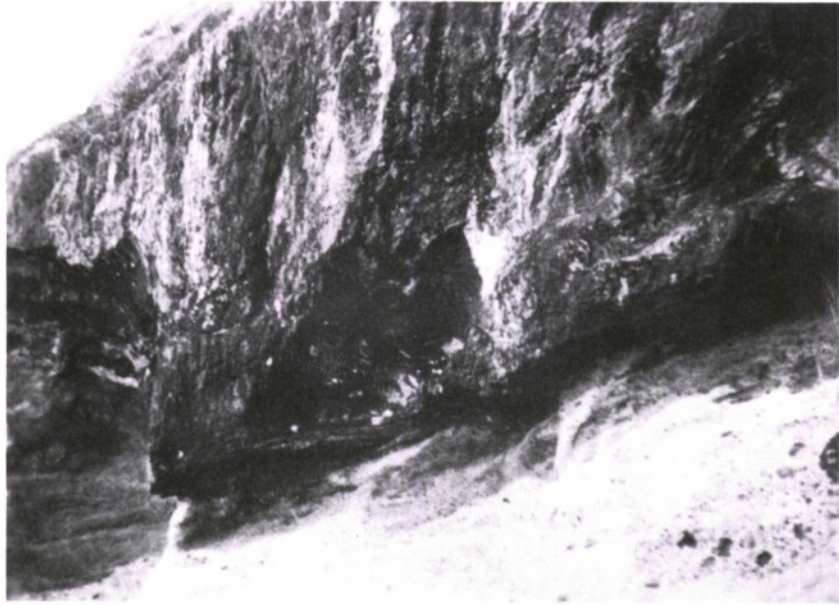
A. Unit No. 11 Compact dacite in upper part. Unai Fanunchuluyan, northeast Saipan.

General description: Fairly hard, massive, compact, glassy, porphyritic dacite rock; closely jointed and fractured. Contains extremely hard, but brittle, siliceous zones. Commonly intercalated with and overlain by unit 12. Typical exposures are shown in plates 17A, 17B, and 18A.

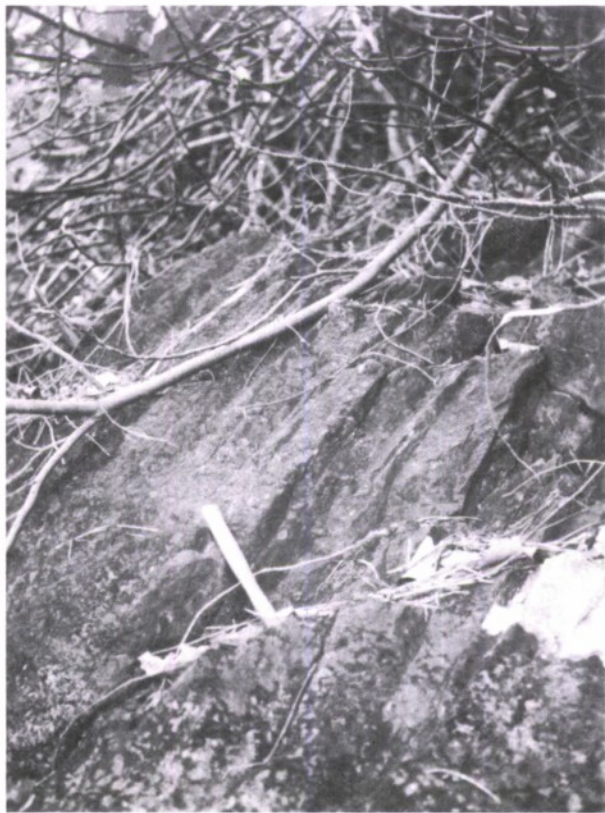
B. Unit No. 11 Compact dacite. In valley on southwestern flank of Ogso Achugau, northeast-central Saipan.

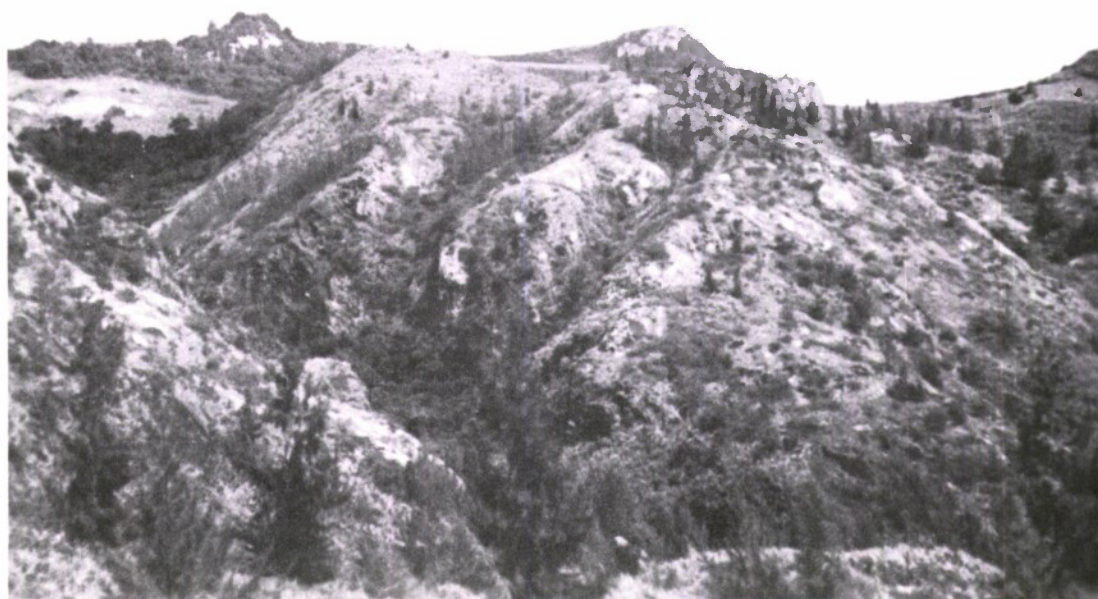
A. Units No. 11 and 12 Compact dacite, and friable dacitic breccia and tuff. Achugau district, northeast-central Saipan.

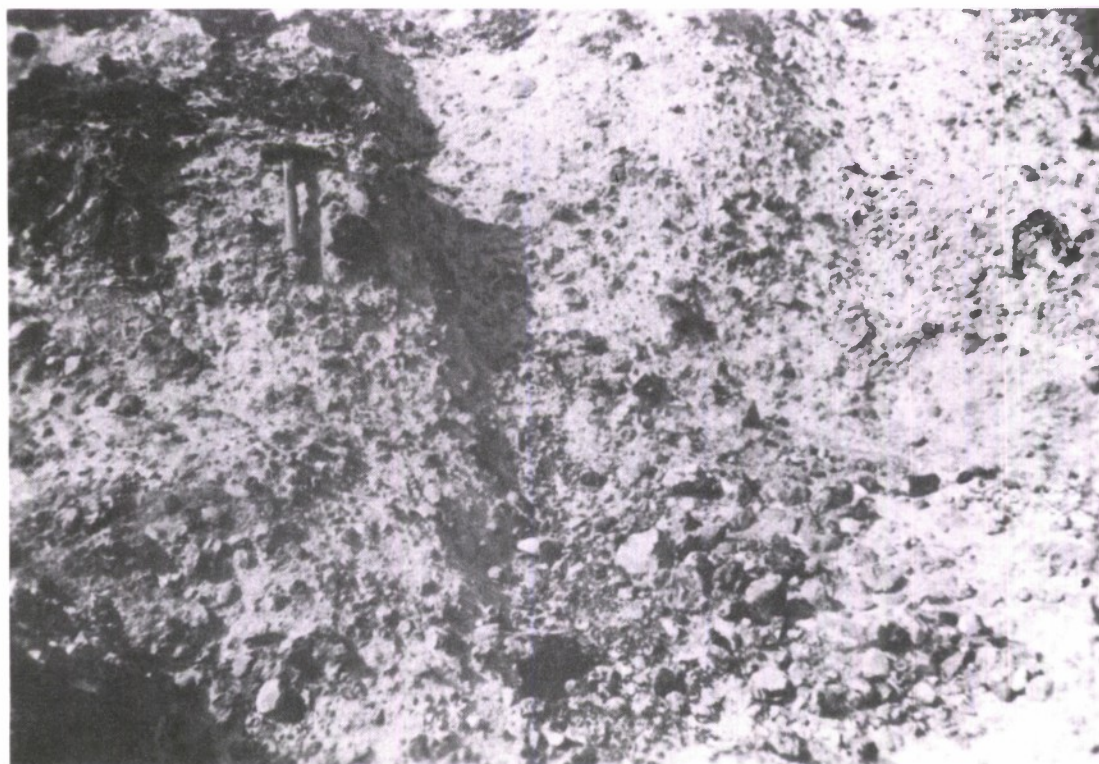
B. Unit No. 12 Friable dacitic breccia. Southeast slope of Ogso Achugau, northeast-central Saipan.

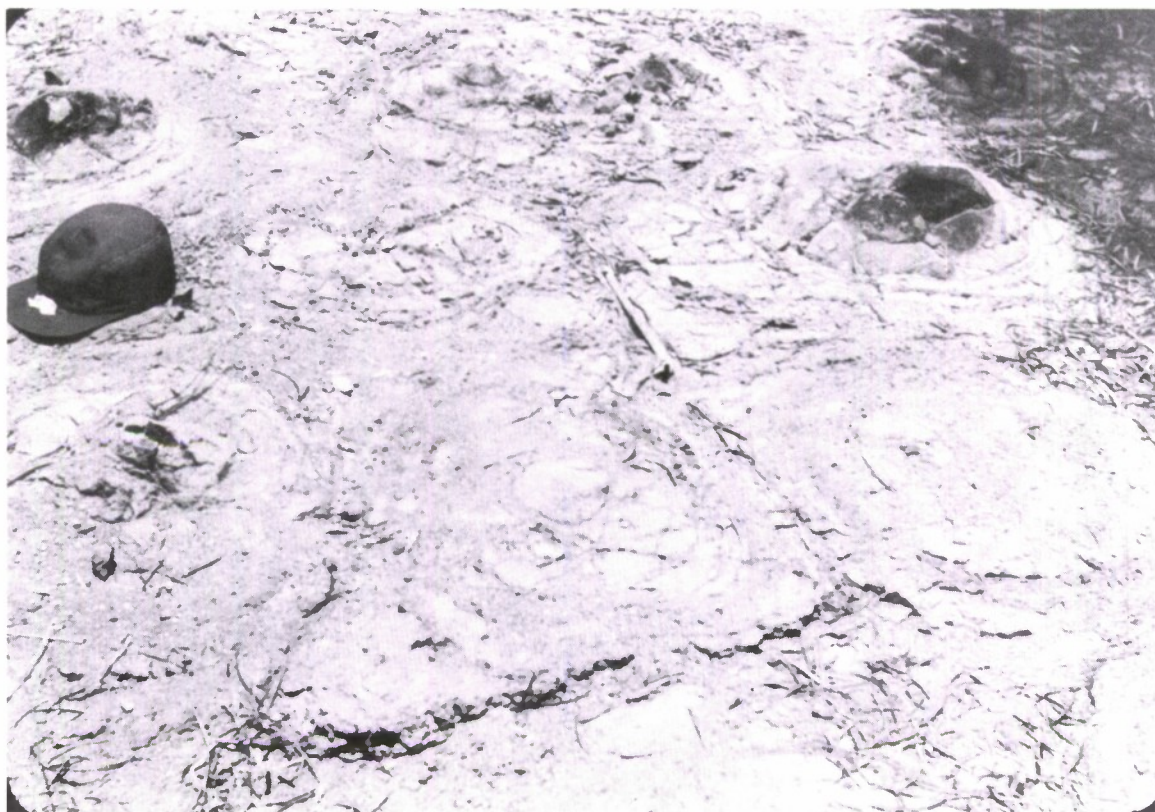
Unit No. 13 Compact andesite. About 1000 feet northeast of As Perdido Road, district of Fina-sisu, southwest Saipan.

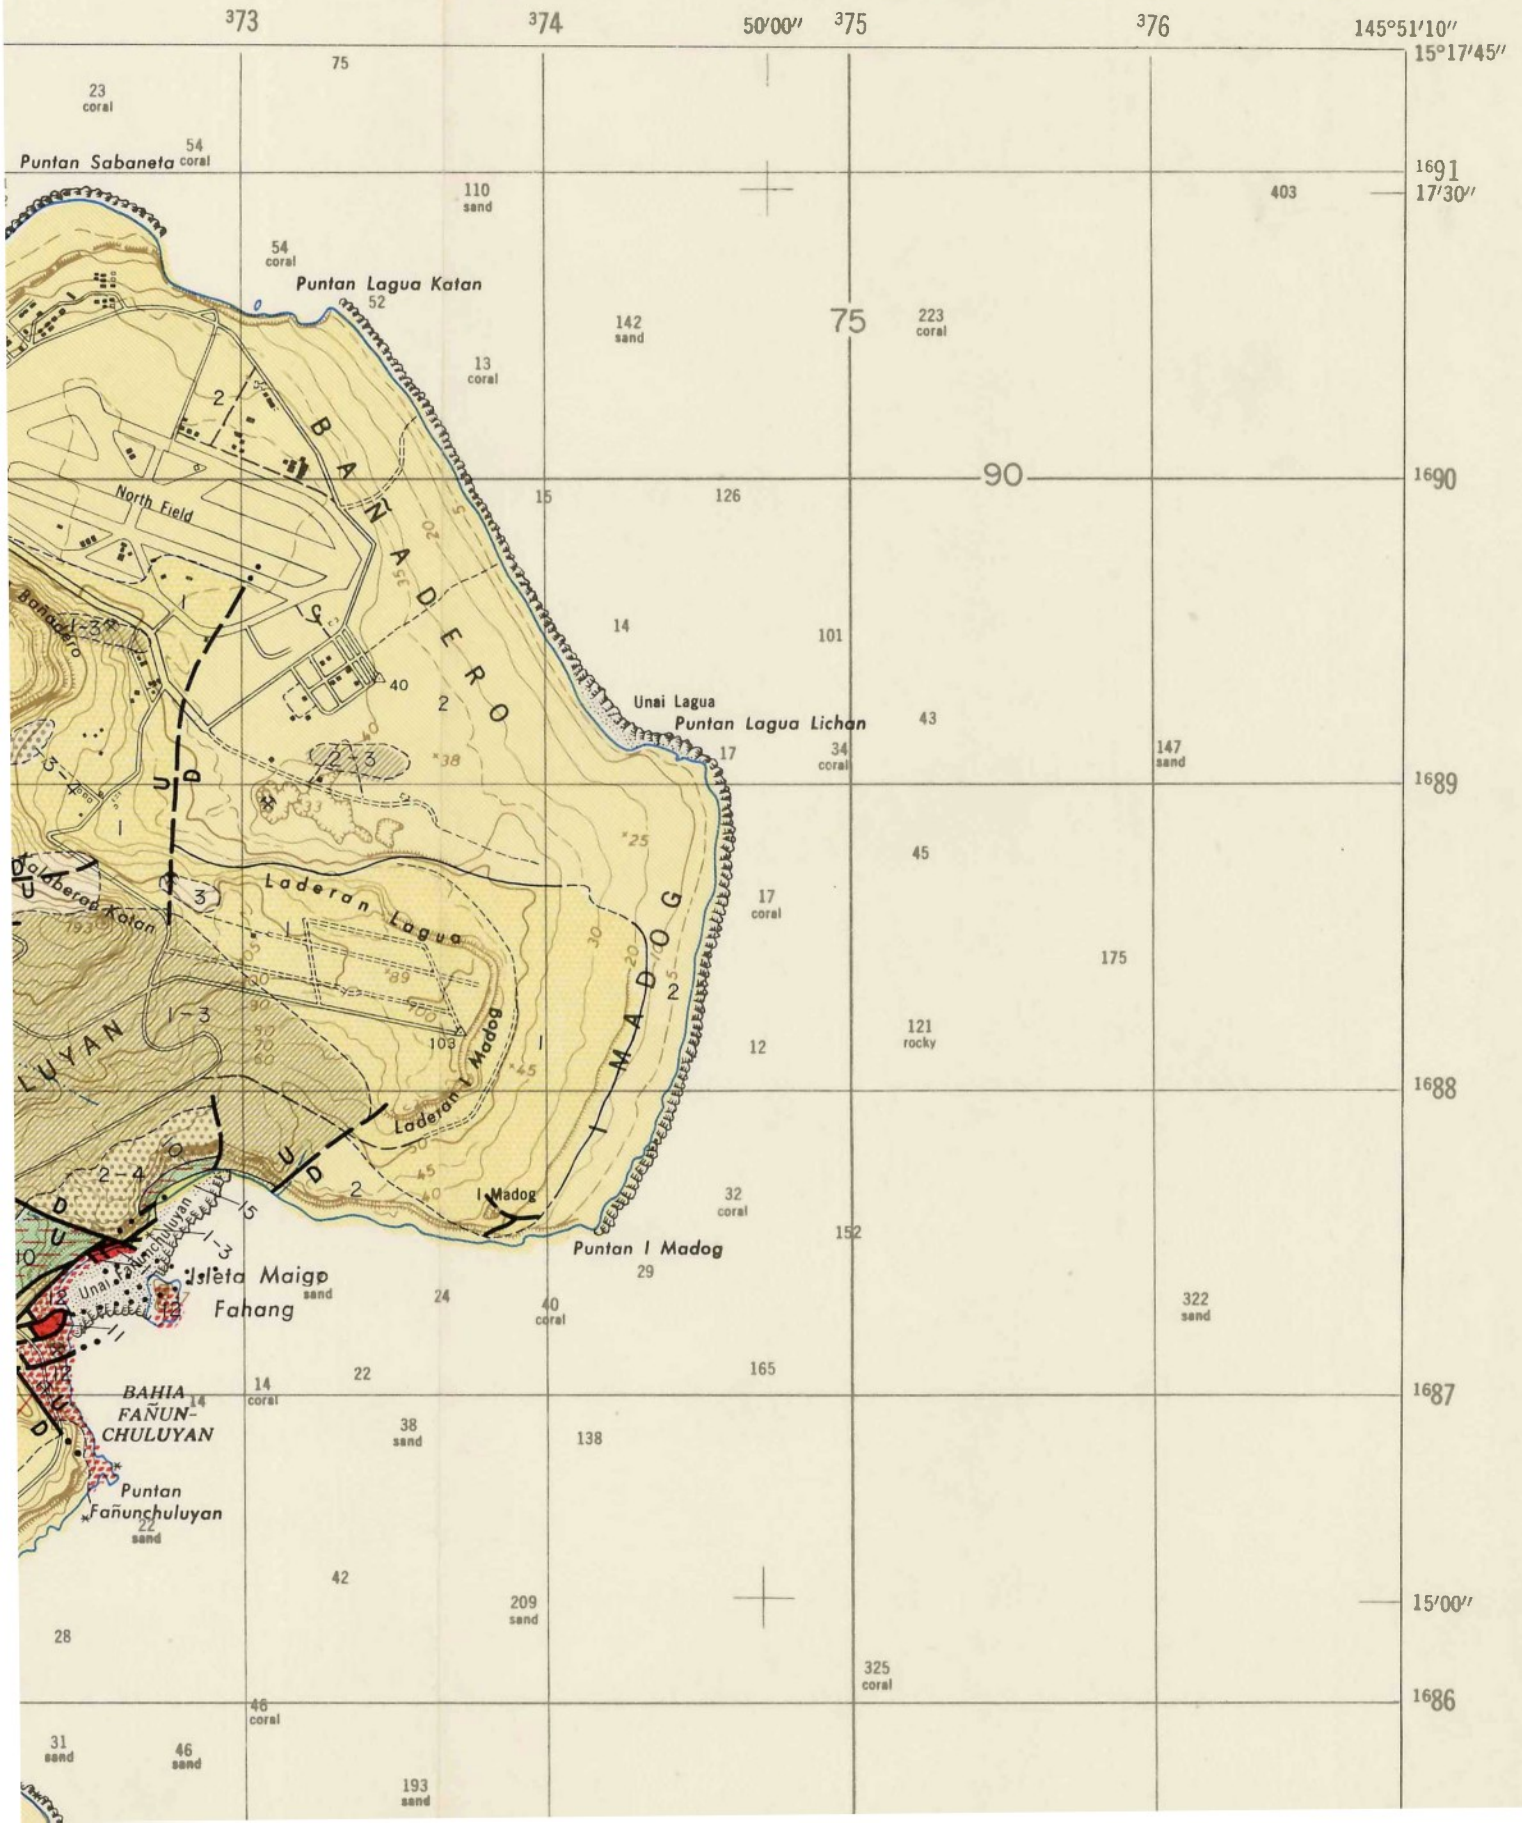
SAIPAN, MARIANA ISLANDS, VOL. I, PL. 4

Loose, rubbly, clastic limestone containing porticles up to several inches in diameter in a sandy matrix. Overburden clay usually thin. Easily excavated by power equipment or hand tools. Bearing capacity excellent for structures. Excellent construction material.

Loose, rubbly, clastic limestone containing clay-coated porticles up to several inches in diameter in a matrix of sandy clay; content ranges up to 50 percent. Overburden clay usually less than 7 feet thick. Easily excavated by hand tools or power equipment. Bearing capacity is inadequate for all structures. Good to poor construction material depending on clay content.

Plastic clay containing some sand. Easily excavated by hand tools or power equipment; wet clay is strongly adhesive to equipment. Unsatisfactory and unstable foundation for heavy structures. Generally an unsatisfactory construction material.

Weakly to strongly plastic clay. Easily excavated by hand tools or power equipment. Bearing capacity unsatisfactory and unstable foundation for heavy structures. Generally unsatisfactory construction material.
