**AFRL-RX-WP-TR-2010-4200**

**NONDESTRUCTIVE EVALUATION (NDE)  
EXPLORATORY DEVELOPMENT FOR AIR FORCE  
SYSTEMS**

**Delivery Order 0006: Paint Stripping Effects on Fluorescent Penetrant  
Inspection**

**DECEMBER 2009  
Final Report**

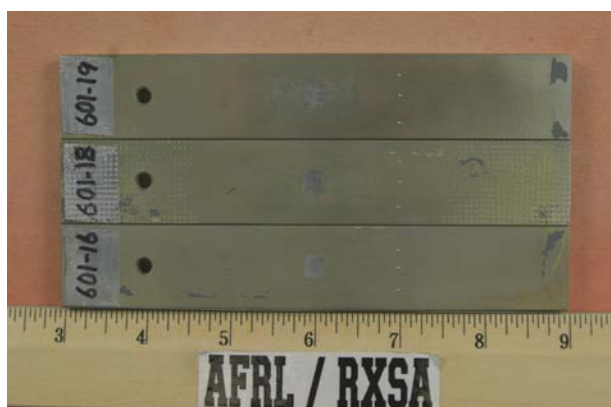
On specimens stripped with chemical stripper there was no evidence of anything on the surface that would affect the formation of FPI crack indications (Figure 12 and Figure 13). Unlike the PMB and plasma processes the chemical stripper was applied to the entire area of all specimens. Only random spots of paint remained. In a typical USAF maintenance arena such residual spots of paint would be removed with some type of PMB, which could add to the problem of degraded FPI indications.

**Figure 13. 2024-T3 Specimens Processed with Chemical Stripper**

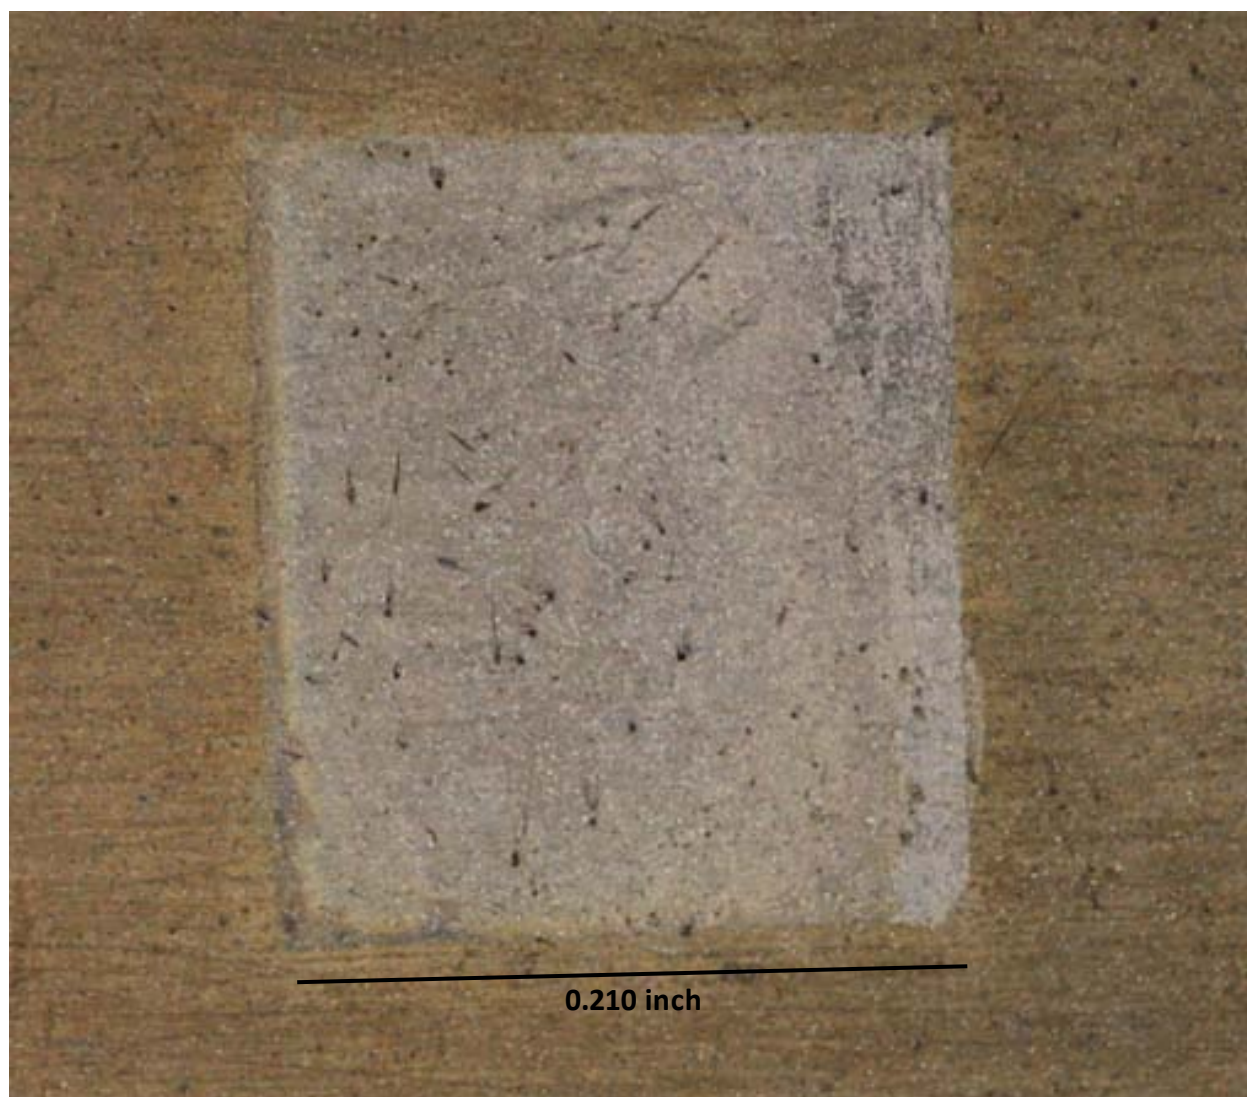
**Figure 16. Close-up Picture of the Center of 2024-T3 Specimen 601-14**

To the unaided eye nothing unusual was noted on the specimens stripped with plasma (Figure 14 and Figure 15) except for some transverse bands toward each end of 2024-T3 specimen 601-14, pictured at the top of Figure 15. The company (AP Solutions) that had removed paint with atmospheric plasma had used these areas (away from the center cracked area) to empirically develop the stripping parameters for these specimens. Consequentially, over-aggressive paint removal occurred in these areas before the parameters were optimized. When a hand-held 10X magnifier was used to examine these bands more closely, numerous tiny dark and bright spots were observed over the entire stripped surface. Similar features were also observed on the surfaces of the other six specimens. A close-up photograph of the center of specimen 601-14 (Figure 16) shows these features, which became the targets of subsequent microscopic examination as discussed Section 10.6.4.

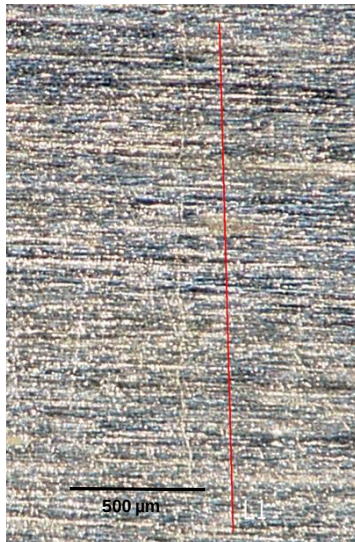
Microscopic examination of 7075-T6 specimen 609-05 revealed a long (0.074 inch) and tight crack (Figure 18a), but one that produced a good pre-paint FPI indication (Figure A-2b). The post-strip image in Figure 18b provides a good view of different surface features: 1) media impingement on the specimen surface with little metal upset (small dark spots), 2) metal upset (brighter irregular marks) occasionally bridging the crack and 3) embedded media (large sharp-cornered irregular dark areas). The more highly magnified post-strip image in Figure 18c shows small amounts of media embedded in the crack and metal smear closing part of the crack opening. The post-strip FPI indication (Figure A-2b) was barely visible.

(a) Pre-Paint Optical Image

(b) Post-Strip SEM Image

(c) High Magnification Image

**Figure 18. Post-Strip Image of Crack in 7075-T6 Specimen 609-05**

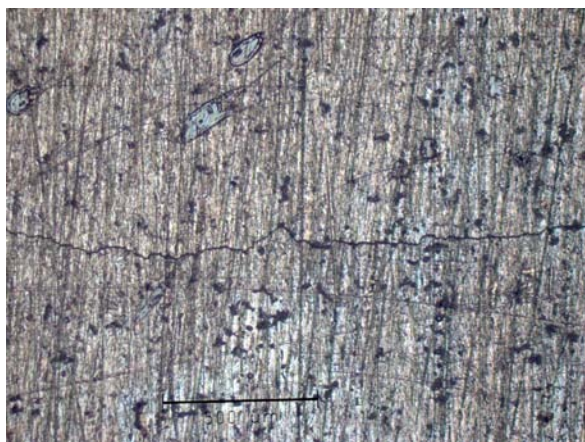
Figure 26a shows three directional copper splatters in the upper left corner. An enlarged view of the largest is shown in Figure 26b.

(a) Angled Copper Splatter

(b) Close-up of Large Splatter in (a)

**Figure 26. Angled Copper Splatter on Specimen 601-08**
