ANALYSIS OF POSSIBLE EXPLOSION AT KSC DUE TO  
SPONTANEOUS IGNITION OF HYPERGOLIC PROPELLANTS

Frank B. Tatom  
Engineering Analysis Inc.  
Huntsville, Alabama

Stephen D. Brown  
NASA  
KSC, Florida

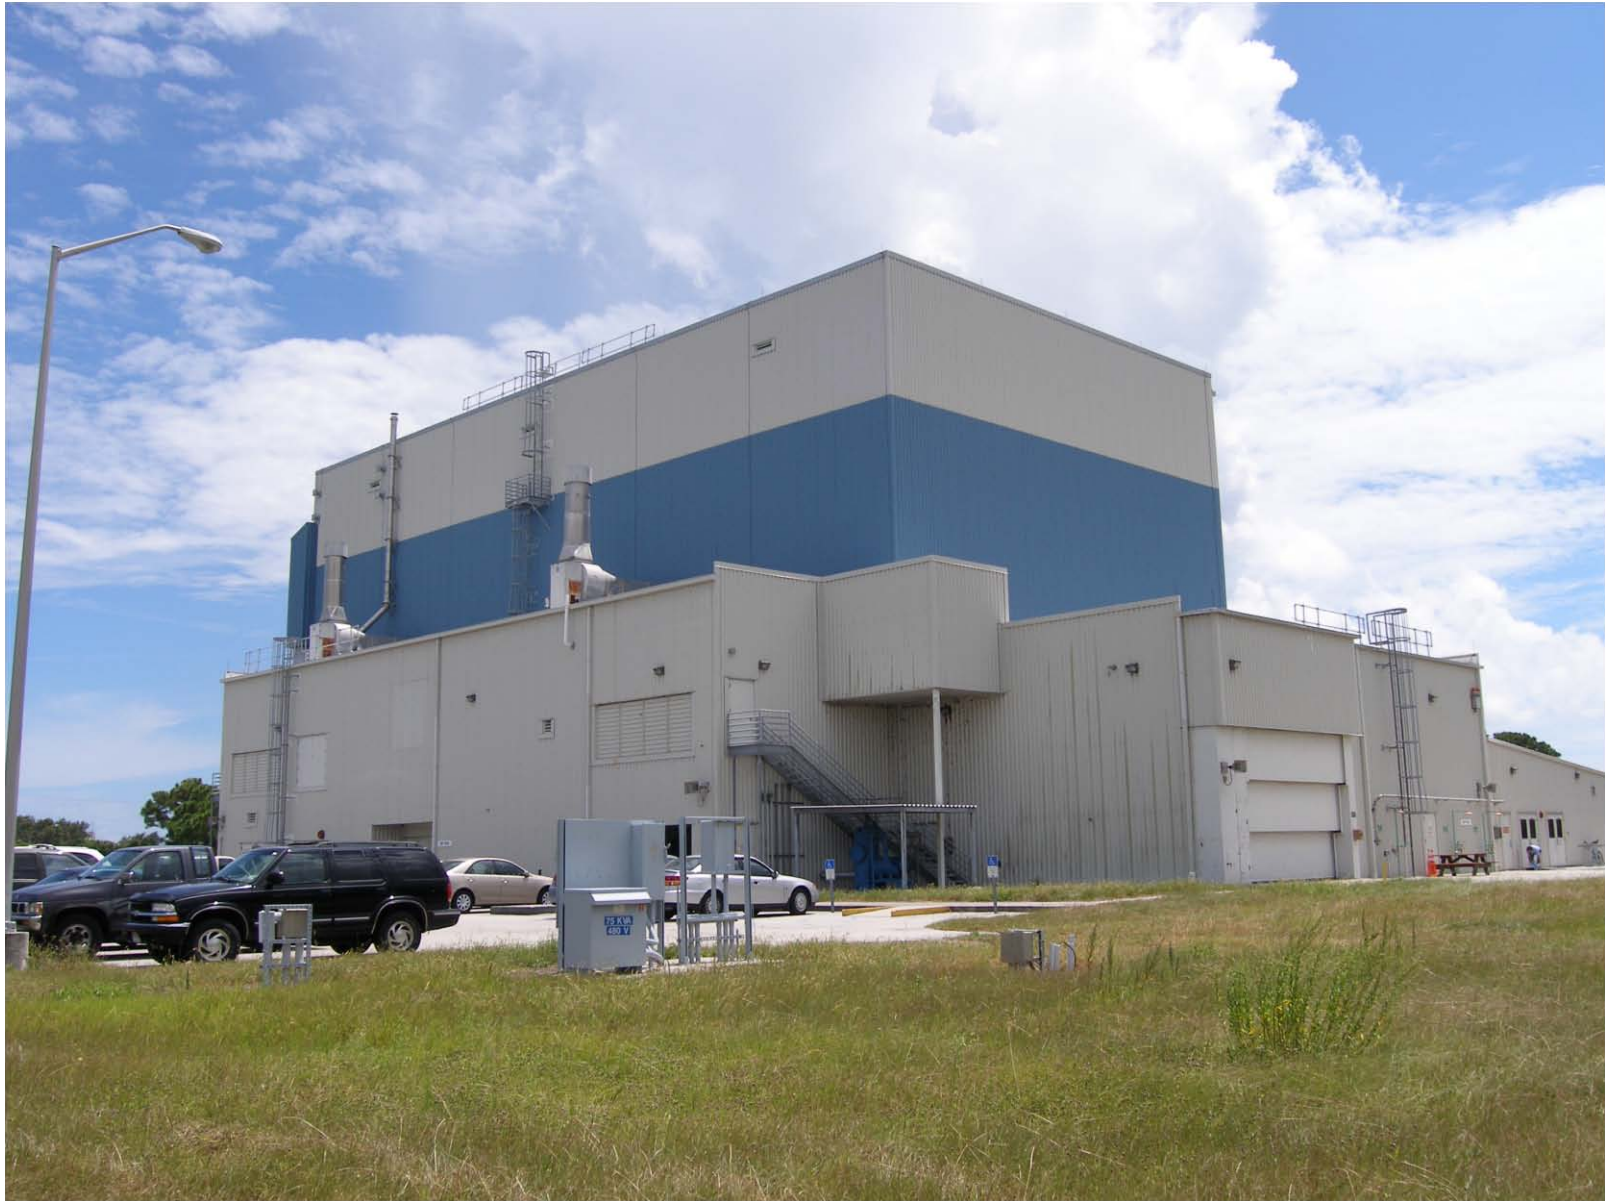
Figure 1. Multi-Payload Processing Facility (MPPF)

Subsequent discussion deals with the MPPF analysis. The MPPF complex, constructed by NASA in 1994, is located just off E Avenue south of the Operations and Checkout (O&C) building in the Kennedy Space Center industrial area. The MPPF includes a high bay and a low bay. The MPPF high bay is 40.2 m (132 ft) long x 18.9 m (60 ft) wide with a ceiling height of 18.9 m (62 ft). The low bay is a 10.4 m (34 ft) long x 10.4 m (34 ft) wide processing area and has a ceiling height of 6.1 m (20 ft). The MPPF is currently used to process non-hazardous payloads. Figure 1 provides a view of the MPPF from the northwest. An interior view of the facility is shown in Figure 2.

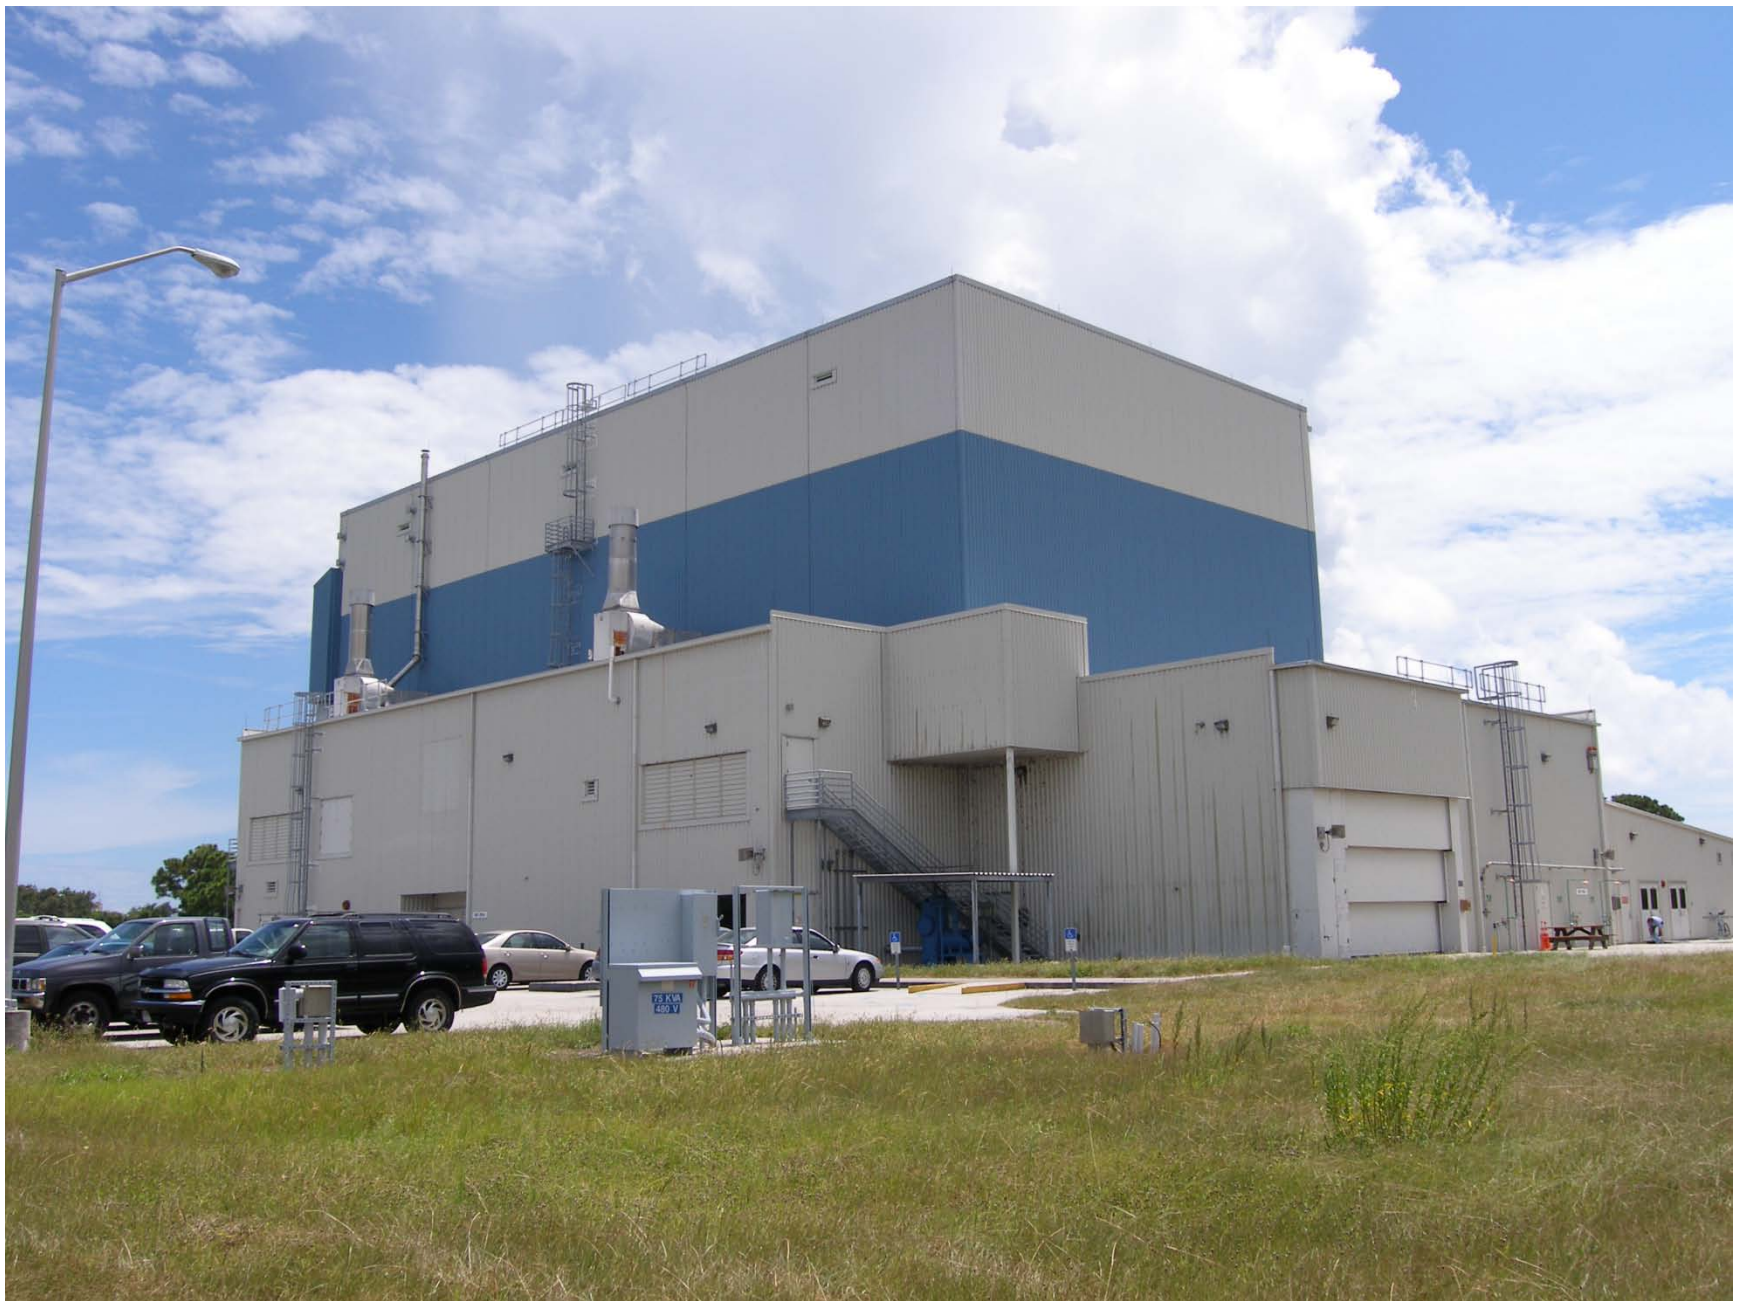
**FIGURE 1. MULTI-PAYLOAD PROCESSING FACILITY (MPPF)**
