# NAVAL POSTGRADUATE SCHOOL

## THESIS

**DYNAMIC FAILURE OF SANDWICH BEAMS WITH FLUID-  
STRUCTURE INTERACTION UNDER IMPACT LOADING**

December 2010

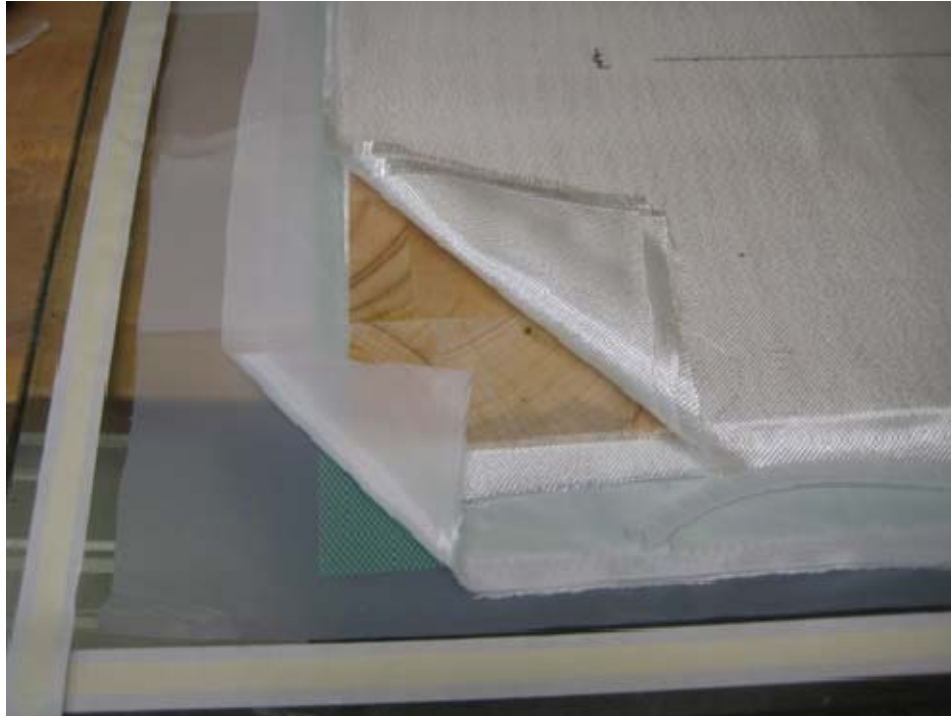
Step 4: Layup material in the following order from bottom to top: distribution medium (required on mold side since skin thickness limits resin flow), peel ply, 3 sheets of E-glass, fibers aligned, balsa core, 3 sheets of E-glass, peel ply, distribution medium, peel ply (to protect the vacuum film from the cut edges of the distribution medium.) Figure 2 shows the beginning of this layup sequence.

Figure 2. Dry layup, bottom to top: Teflon, distribution medium, peel ply, E-glass, Balsa Core, E-glass. Not yet added: peel ply, distribution medium, vacuum film.
