RTO AGARDograph

AG-AVT-140

Corrosion Fatigue and Environmentally Assisted Cracking in Aging Military Vehicles

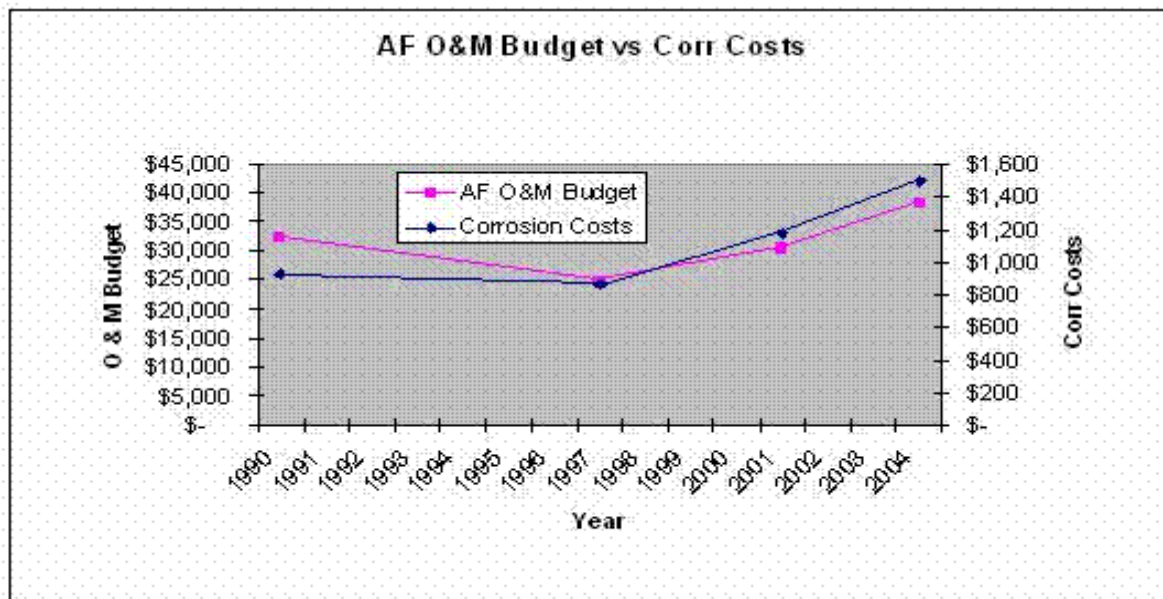
Figure 3-1: Role of Direct Corrosion Maintenance in the AF O&M Budget (in Millions).

Figure 3-1, Role of Direct Corrosion Maintenance in AF O&M Budget, graphically illustrates the impact of corrosion maintenance on the budget. It shows quite clearly that the reduction in corrosion maintenance expenditures in the 1990 – 1997 period of shrinking defence budgets was slower than the drop in the overall budget, and once the budgets started to recover, the corrosion maintenance costs grew quickly and have remained a cost driver within the O&M Budget.

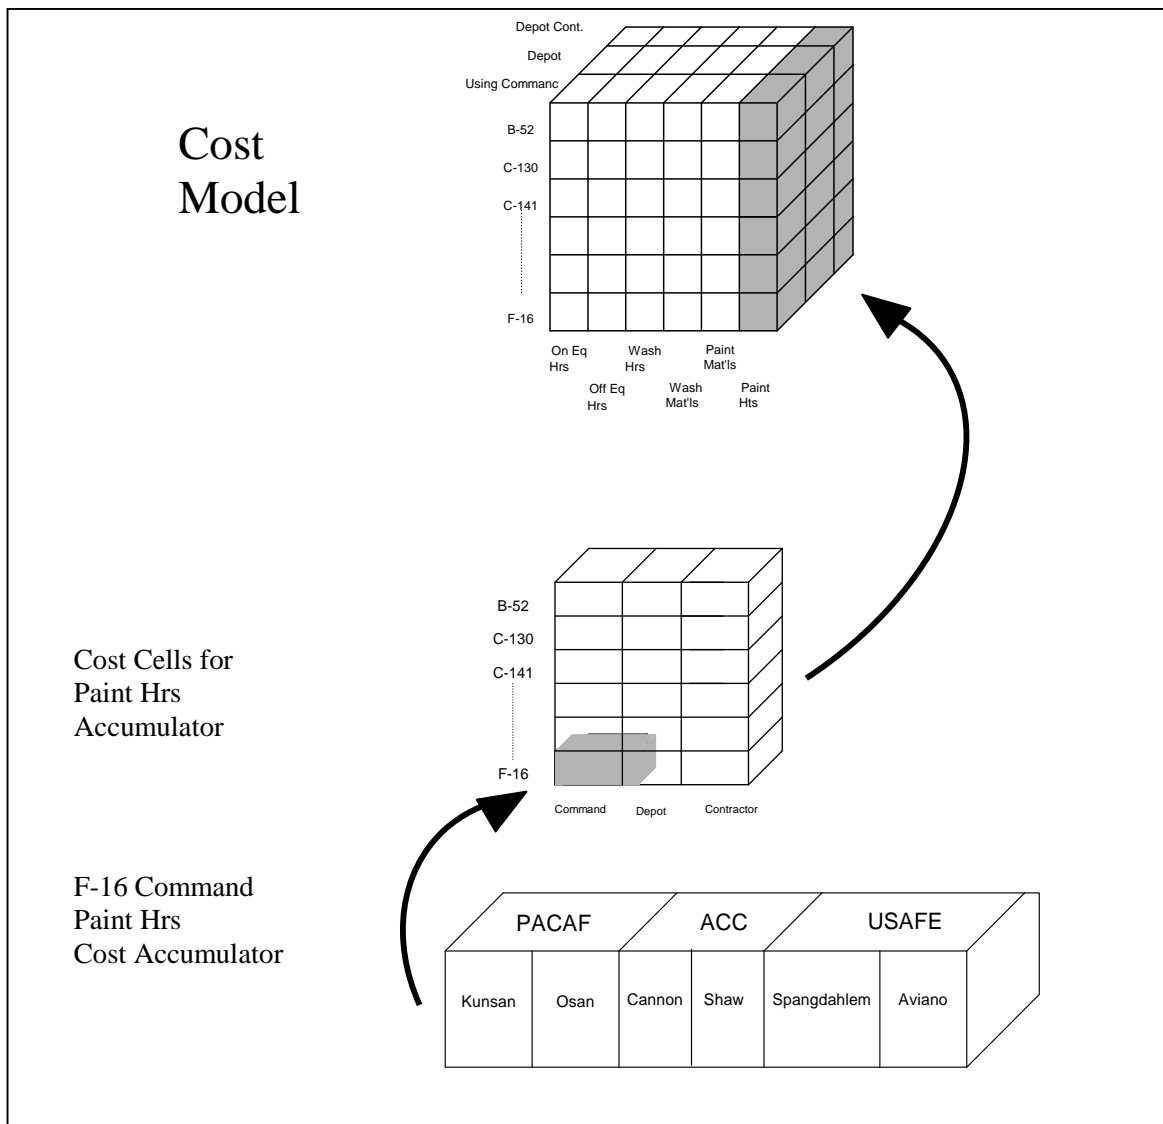
Figure 3-3: Methodology Illustration.

Figure 3-3 (below) illustrates the methodologies that were used to fill the individual cells of the cost model matrix. Starting at the bottom of the figure, the man-hours consumed in painting F-16 aircraft in each of the commands that operate F-16s are collected from each base. The man-hour total for each base is multiplied by the appropriate dollars per man-hour figure, obtained from AFI 65-503, U.S. Air Force Cost and Planning Factors, and placed in the cell for that base. We used the summary cost for all grades from Table A33-1 for extracting the labor hour costs from AFI 65-503. When all bases have been analyzed for all operating commands, the figure will be entered in the F-16 “command” cell of the slice in the matrix labeled “paint hours”. When the costs of painting for F-16s at depot and contractor repair facilities are calculated, they will also be added to the appropriate cells. After all paint hours accumulators are entered, the total labor cost associated with painting F-16s can be obtained from summing the three location axis cells for F-16 paint hours.

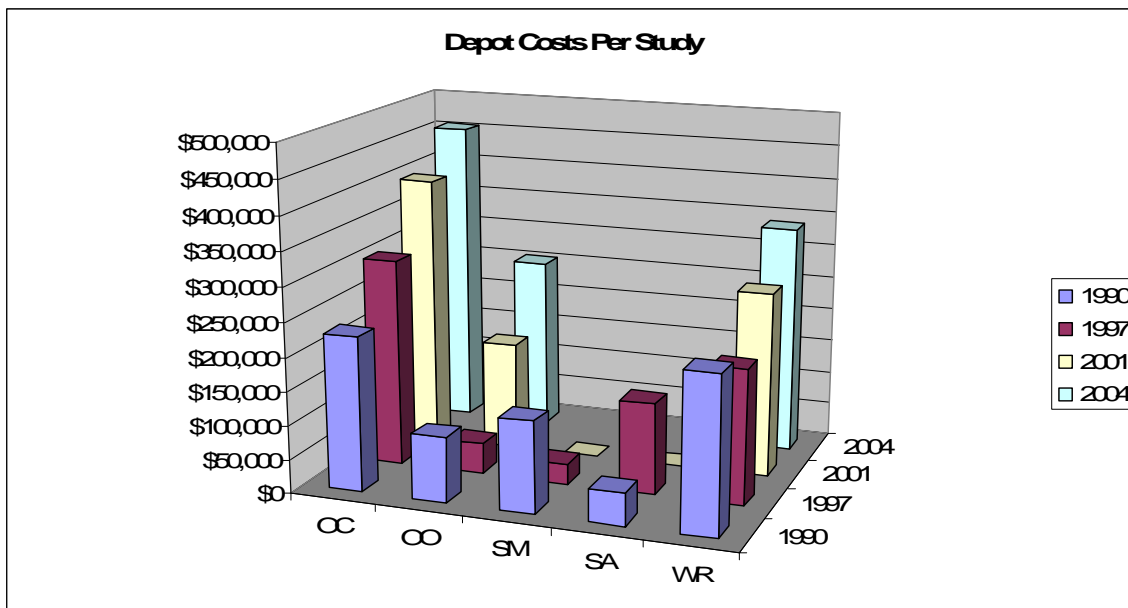
Figure 3-6: Depot Costs in '04 Dollars (in Thousands).

The figure below (Figure 3-6) makes very plain in a graphical format the changes, not only in overall cost, but also in the structure of the depot maintenance. The Air Force has gone from five depots to only three, but the corrosion work requirements remain, and despite dropping from five ALCs to three, the overall costs have increased.

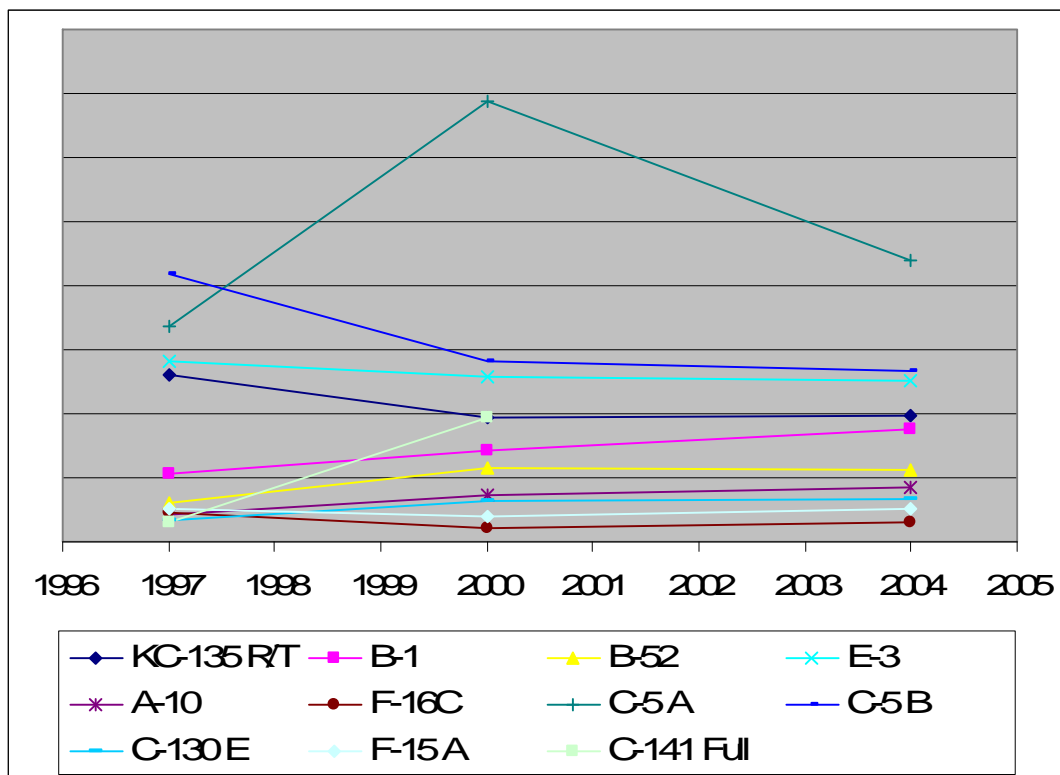
Figure 3-7: Paint Man-Hours.

Two maintenance elements were examined, addressing the main cost drivers in every corrosion cost study – depot level paint and repair. The following figures, Figure 3-7 and Figure 3-8, present the work load associated with painting and repairing aircraft at the depots for the years 1997, 2001, and 2004.

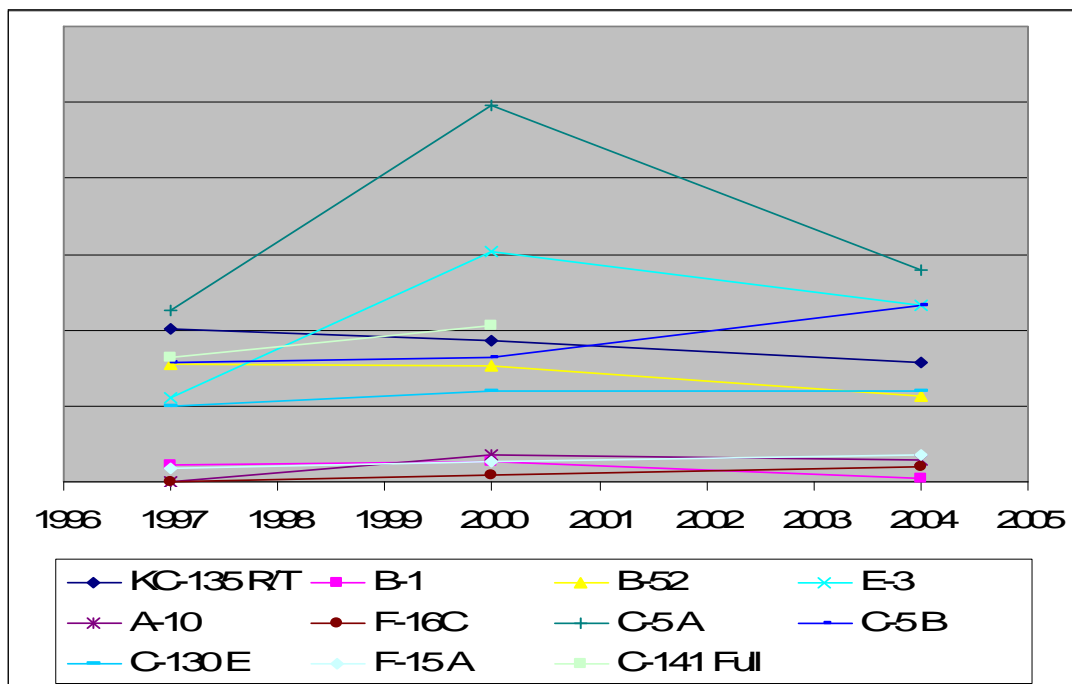
Figure 3-8: Repair Labor.

Again, Figure 3-8 appears to present a picture of fairly consistent corrosion repair labor requirements. Figure 3-9 below presents the reported/calculated corrosion percentage of depot effort over time, again suggesting a picture of steady corrosion work requirements, rather than a continuously growing proportion of the overall depot maintenance requirement.

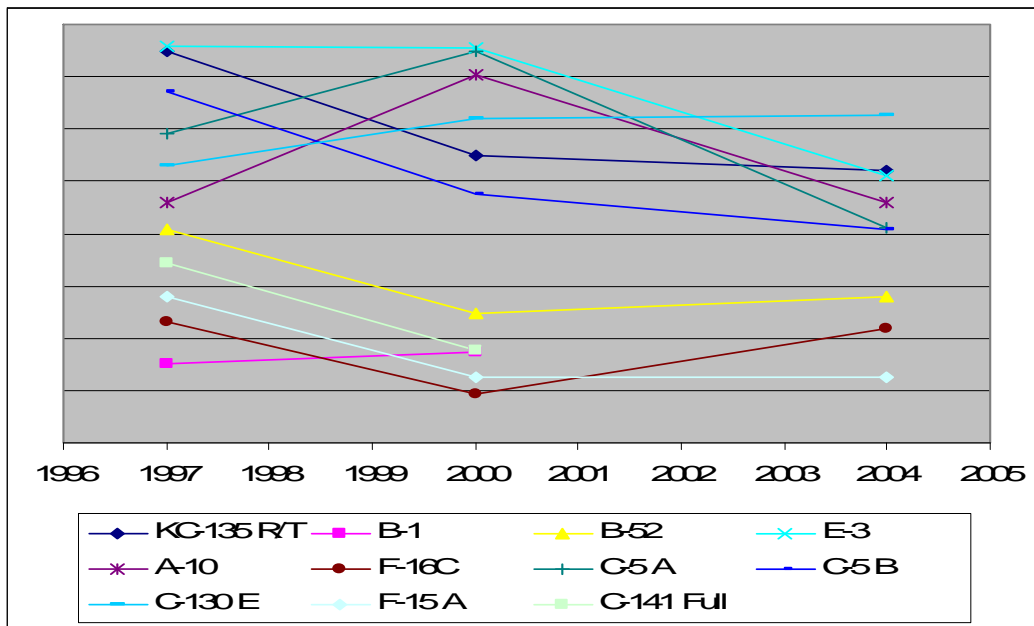
Figure 3-9: Corrosion Percentage of Depot Maintenance.

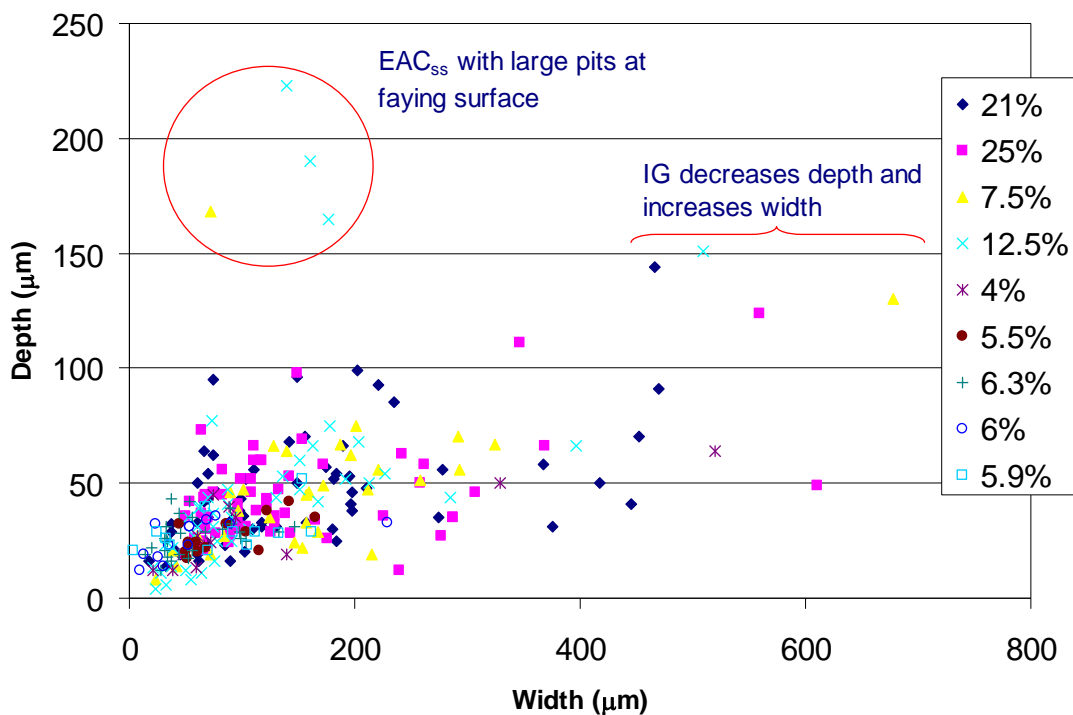
Figure 4-2: Corrosion Pit Sizes Measurements from Optical Micrographs of Naturally Corroded Components Progressively Polished.

From this type of study, the growth of different types of damage can be estimated, which could then be used to more accurately predict the life of components that are susceptible to corrosion. For example, a damage characterization study was carried out on corroded lap joints in which sections were taken and progressively polished [1]. From the different images, corrosion pit sizes were measured taking into account the presence of intergranular attack. The results, shown in Figure 4-2, indicated that as the thickness loss increased the pit shape tended to become elongated (shallow but long). As can be seen from this figure, as the thickness loss increased, the pit shapes tended to take on a high aspect ratio, shallow but long. The exception to this trend was the pits that were present at the base of environmentally assisted cracks, which occurred in the presence of a sustained stress, EAC_{ss} , and have been referred to as pillowing cracks. Previous studies have shown that these cracks usually occurred in areas where the thickness loss was small and only a small pit was present at the faying surfaces. Since the material thinning was high in the area examined during this study, it is assumed that these large pits developed over time after the environmentally assisted crack had nucleated.

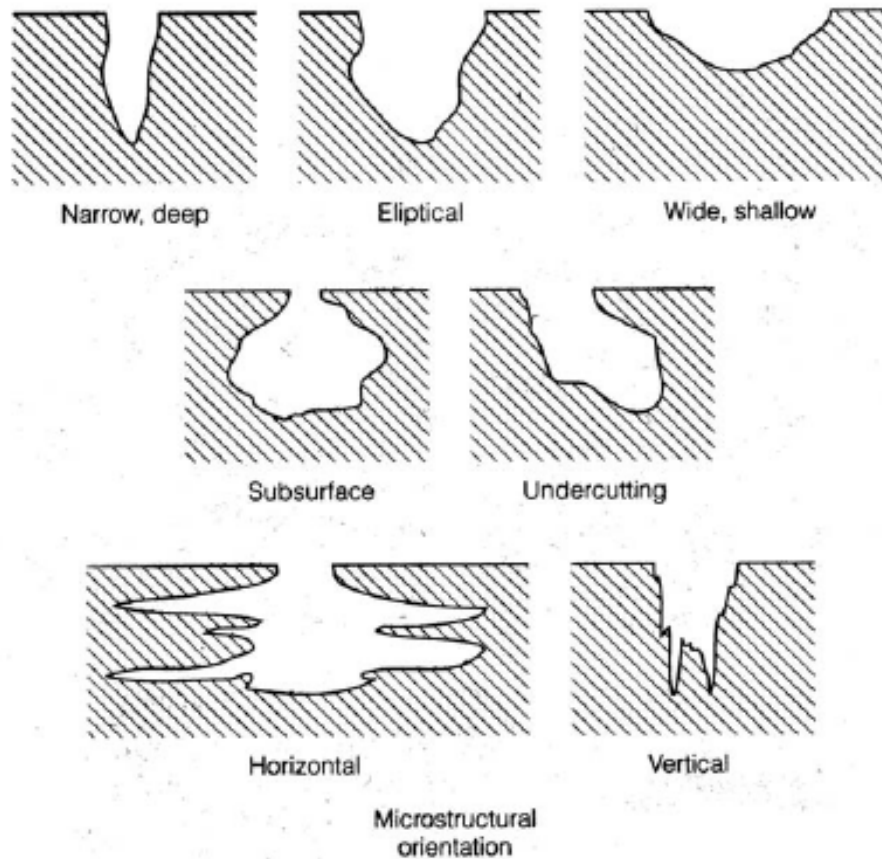
Variations in cross sectional shape of pits. (ASTM G 46)

Figure 5-3: ASTM Standard G46 Portion Showing Variation of Pit Character (Copyright ASTM).

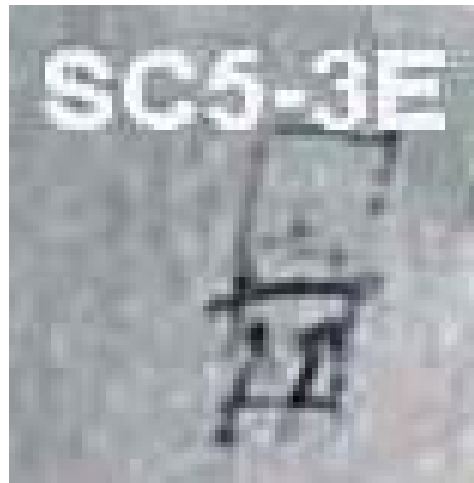
(a) Photograph of section SC5-3E.

(b) Photomicrograph of exfoliation present in section after first polish. Note presence of corrosion pit (circle).

(c) Photomicrograph of exfoliation present after second polish in same area as (b).

Figure 6-5: Exfoliation Present Along S-T Direction of Section Taken from 7075-T6 Upper Wing Skin.

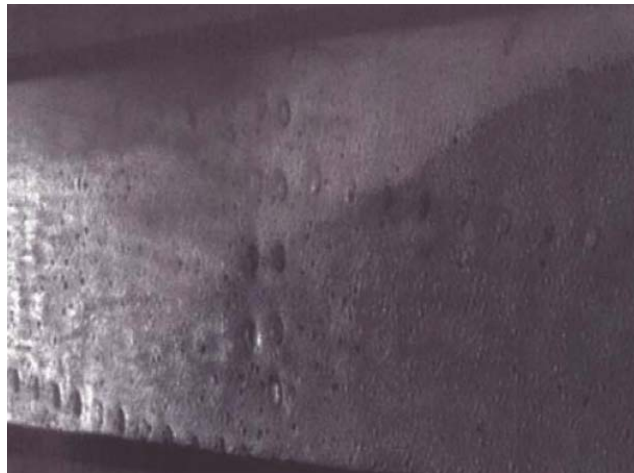
(a) No corrosion indications.

(b) Corrosion is present within the joint which is indicated by a bright to dark change in an area of the grayscale image.

Figure 7-2: Enhanced Visual Inspection Results (D-Sight™) of Fuselage Lap Joints.

The most common procedure is to inspect the fuselage joints visually from the aircraft exterior. Typically inspectors look at the lap joint surfaces for traces of corrosion products, and for corrosion pillowing deformation, most often with the aid of a flashlight. Figure 7-2, Figure 7-3 and Figure 7-4 show typical images of pillowing obtained using an optical inspection method, known as D-Sight™, designed to enhance the appearance of the surface perturbations. The fundamental assumption is that corrosion is not significant unless the inspector is able to see shadows cast by the deformed surface. Unfortunately, there is no data on the Probability Of Detection (POD) for corrosion pillowing using visual inspection.

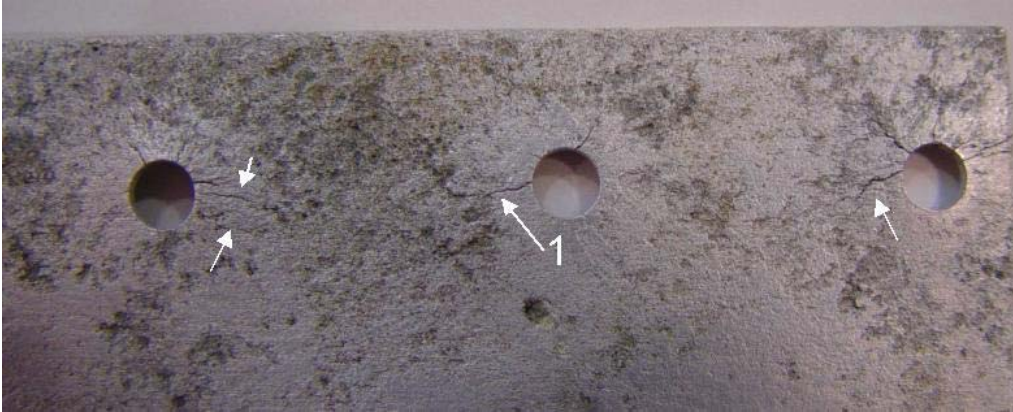
(a) Optical image of cracks in Boeing 707 longitudinal lap joints.

(b) X-ray micrograph showing cracks in L1011 lap joint.

Figure 7-6: Various Images Showing the Typical Star-Shape Pattern Associated with Pillowing Cracks.

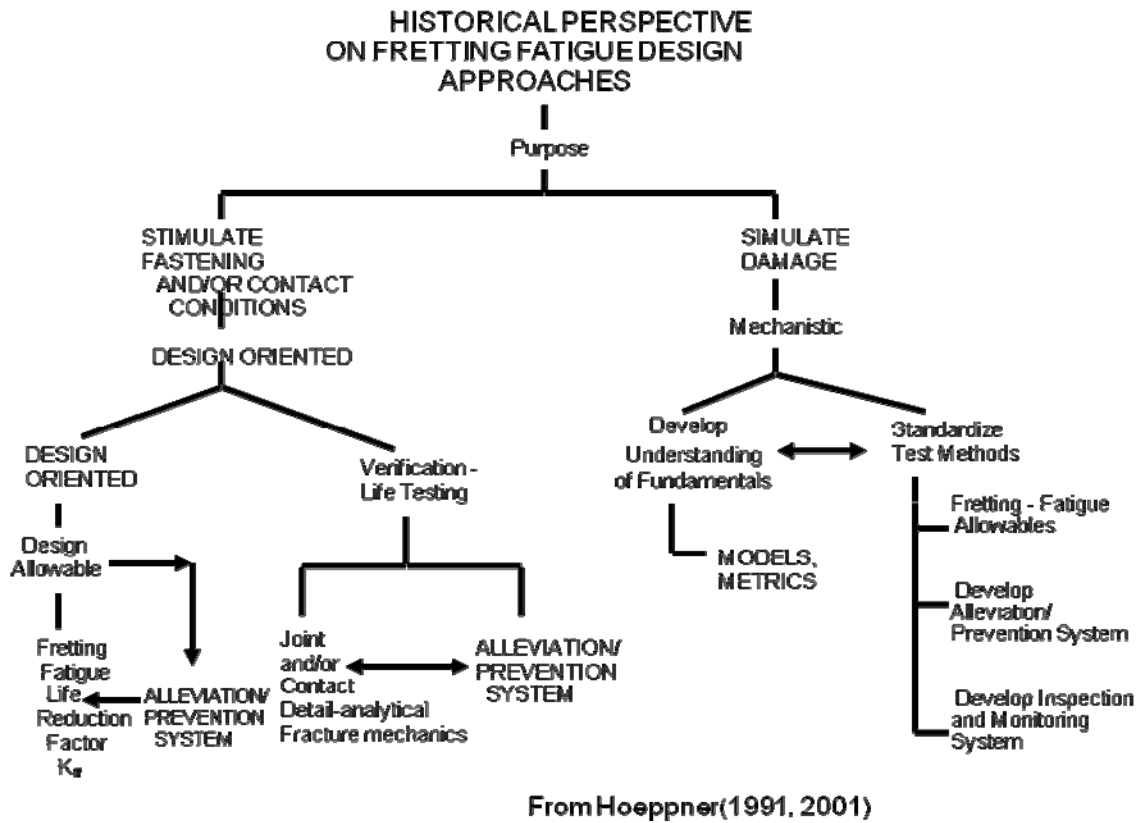
Figure 8-2: Historical Perspective of Approaches to Fretting Fatigue Design Studies.

Historically three approaches have been employed in fretting fatigue studies as shown in Figure 8-2 below. One approach is to perform fretting fatigue testing by simulating the contact or fastening conditions.

The fretting fatigue test results thus generated are used to determine the fretting fatigue life reduction factor K_{ff} . Although this approach has been to introduce a fretting fatigue life reduction factor into the fatigue design process this is not always a satisfactory procedure. A second approach is to develop the fatigue structural allowables by testing the mechanical joints and including fretting considerations in these tests including the alleviation or prevention schemes. Another approach is to use a fretting protection and control plan to focus on potentially blocking the occurrence of fretting or to prevent the propagation of cracks from fretting damage areas. This approach simulates fretting damage that will assist in developing greater understanding of the basic mechanisms of fretting which in turn will lead to the development of standardized fretting fatigue test methods. In addition, this approach will help to find some preventive systems to alleviate fretting fatigue problems on structural components. This mechanistic approach also will be useful to develop inspection systems. Some investigators are coupling damage tolerance concepts to fretting studies to assist in more accurate tracking of damage as well as setting more realistic inspection intervals. Therefore, one of the needs for improved fretting fatigue resistance is the development of adequate experimental procedures to simulate fretting fatigue phenomena.

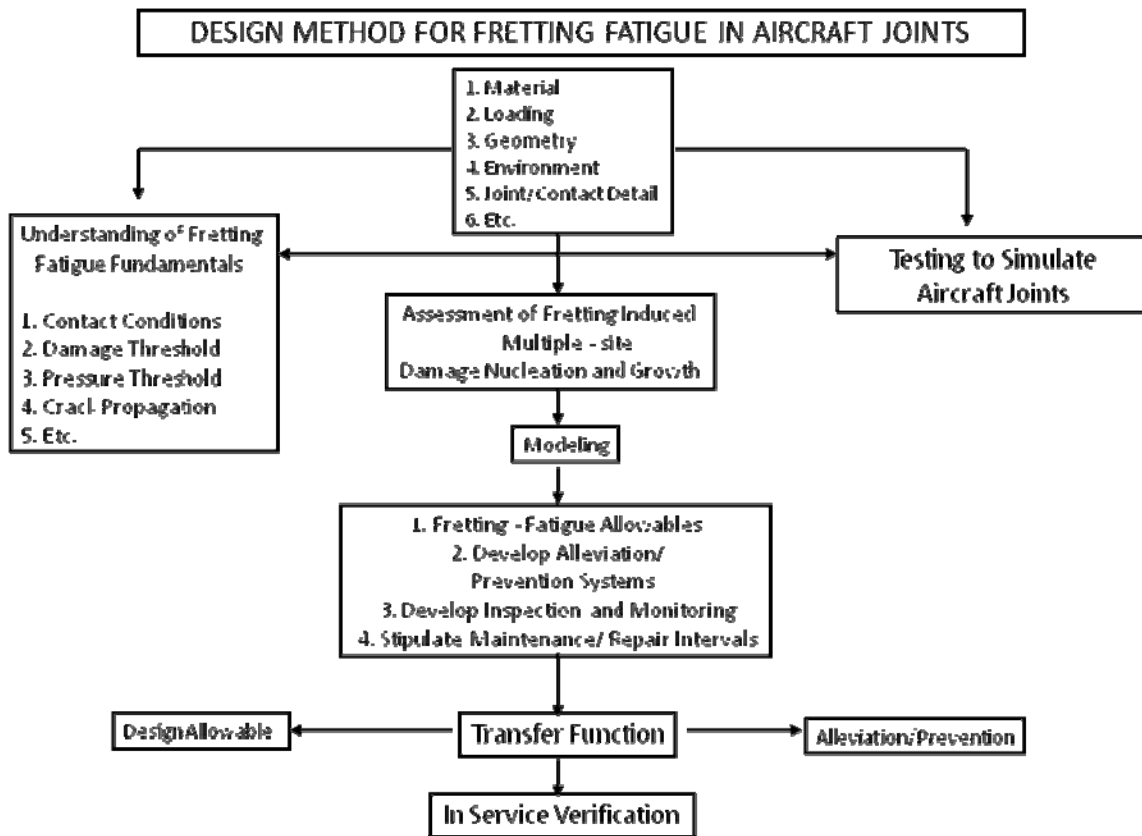
Figure 8-3: An Illustration of an Approach that has been Used to Design for Fretting Fatigue Resistant Aircraft Joints (4, 5).

Fretting fatigue has been observed as a potential degradation mechanism in aircraft structural components [3]. Many cracks have been found to originate at fasteners and on faying surfaces. Cracks may form due to fretting mechanisms from one or more rivet holes leading to the concept of multiple-site damage. Evidence supports that elimination of fretting with adhesives greatly increases fatigue life [4]. Also, it has been observed that cracks appear in lugs much sooner if fretting is present. In addition, failures observed originating at areas of fretting damage often occur away from fastener holes. Figure 8-3 shows a schematic of the design methods proposed in the past by Hoepfner [4],[5] to minimize the effect of fretting fatigue in aircraft joints. In addition, the methods to alleviate fretting fatigue challenge in aerospace components are provided in the next section.

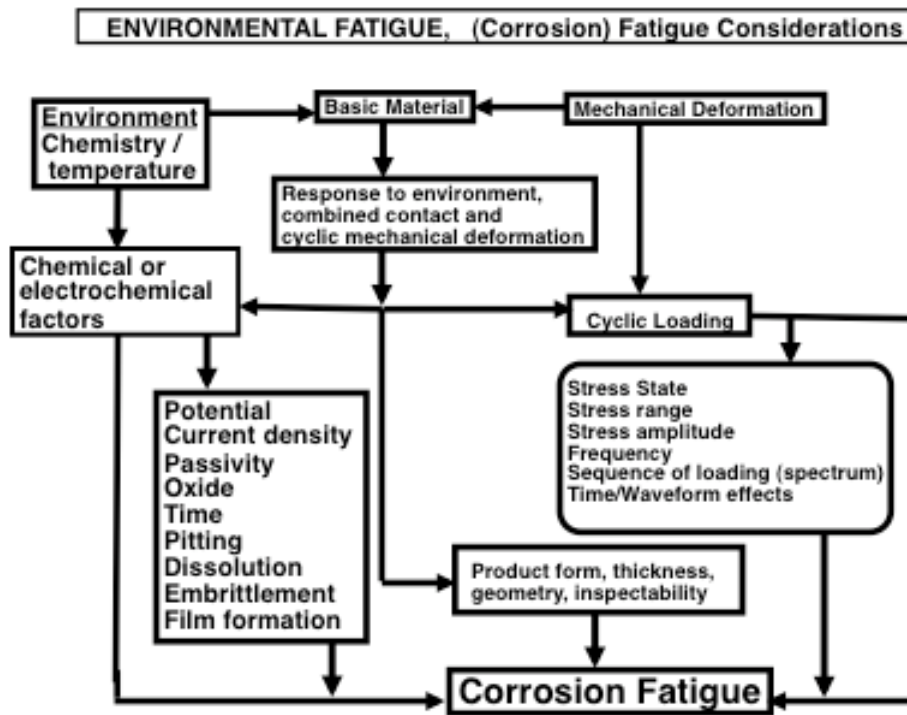
Figure 9-3: The Systems View of Corrosion Fatigue (see Hoepfner [5] and [7]).

In 1972 Hoepfner [7] suggested the corrosion fatigue process needs to be evaluated in a systems framework such as shown in Figure 9-3. Later work suggested this might be referred to within a Holistic Structural Integrity Process Paradigm (HOLSIP – see www.holsip.com). The reason this is important for corrosion fatigue as well as other time dependent interactions of failure mechanisms is the complexity of the processes involved and the need to formulate methods of life estimation/prediction to establish structural integrity over the component life of interest. With corrosion this is particularly important due to the different types of corrosion that may occur on structures in the field and the insidious nature of the degradation. Furthermore, if the fatigue and corrosion fatigue processes are divided into four phases of nucleation, short crack propagation, long crack propagation, and final instability/failure as has been suggested by Hoepfner [8] then the types of corrosion important in nucleation can be different than those involved in propagation.

The systems view, or more recently the HOLISTIC view, of corrosion fatigue [5],[7] can be viewed as shown in Figure 9-3. All of the basic elements of the fatigue systems view are included in this figure and the key issues of the chemical environment are added. It now becomes important for the engineer interested in designing a component to anticipate the chemical environments that the component will be exposed to along with the mechanical load/force spectra and these issues must be incorporated into the life estimation and all aspects related to it. In a manner similar to what the fatigue community has done to standardize load spectra for applications, and certainly as a minimum to define the force spectrum to the highest degree possible, so the chemical environmental spectrum must now be understood and defined as well. This is needed since the chemical environment composition, type of exposure, frequency of loading, and electrochemical parameters are all involved in determining the type of corrosion that will result and

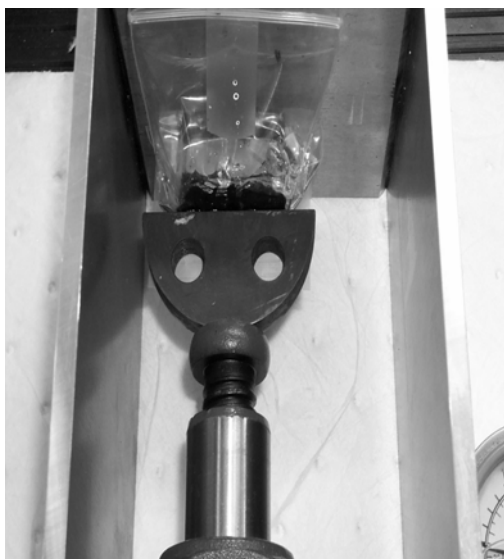
(a) Compression rig.

(b) Detailed specimen drawing.

(c) Specimen placement in compression rig.

(d) Exfoliation produced at countersink side of wing skin after 28 days of exposure to EXCO / compressive load combination for new hole / old material.

Figure 10-1: Configuration of Compression Rig Set-Up and an Example of the Exfoliation Damage Produced.

The ASTM G34 EXCO Standard Test Method [1] was developed to determine the susceptibility of 7XXX and 2XXX series material to exfoliation. The EXCO solution has been successful in generating near surface exfoliation at holes that were originally machined in the wing skin material. However, the results were inconsistent when the process was applied to newly manufactured material as well as new holes machined in old material. In an effort to produce exfoliation more consistently, it was suggested that a compressive load, emulating the predominant upper wing skin flight loading, be applied to the specimens. It was proposed that due to the Poisson effect the induced compressive stress, which would occur along the LT direction, would cause a tensile stress in the ST direction making the exposed grain boundaries along a machined edge more susceptible to intergranular corrosion (i.e., exfoliation). A proof-of-concept rig [2] was designed to introduce a static compressive load into simple specimens, Figure 10-1, which would be sectioned and progressively polished to characterize the exfoliation damage generated.

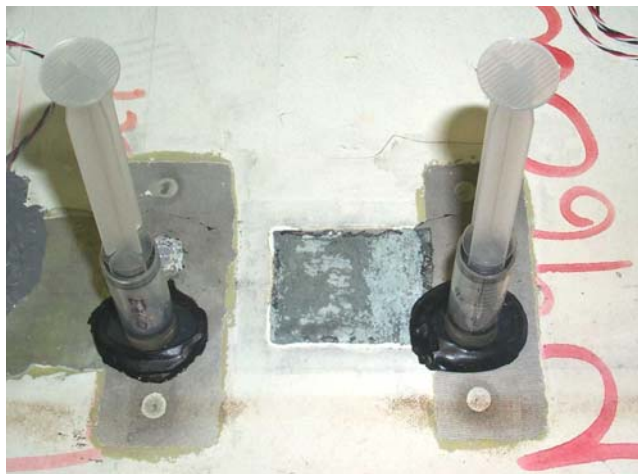
Figure 10-5: Typical Set-Up for Accelerated Exfoliation Protocol.

To artificially introduce exfoliation in undamaged wing skins, the surface of the test area within the hole was scratched with a probe to provide a nucleation site for the damage, after which the steel fastener was installed. In addition, the fastener can be modified according to Figure 10-4 in order to introduce exfoliation damage at specific locations along the countersink of a fastener hole. The top surface paint in the area of the fastener holes was removed and double sided-sealant tape was used to mask off the area that would be exposed. A syringe was then used to deliver the different solutions to the area of interest by moving the plunger periodically to force fresh solution into the test region. The double-sided tape was used to seal the syringe in order to prevent leakage of the solution. Figure 10-5 shows an image of the

syringes in which one contained the EXCO solution while the other held the ANCIT solution and the sealant tape that was located at two fastener holes, which prevented leakage.

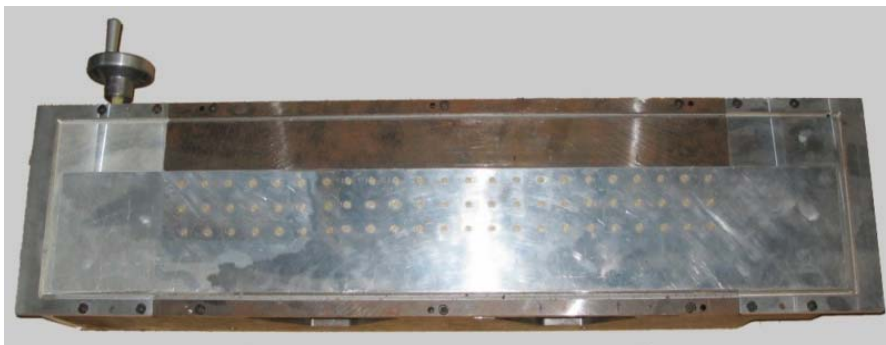
Figure 11-4: Top View of Mechanical Pillowing Simulator.

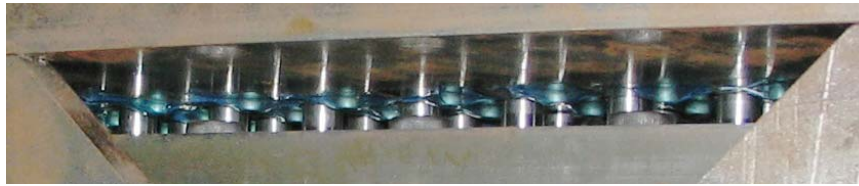
Figure 11-6: Close-Up Side-View of Pin Contact with Underside of Skin Sheet

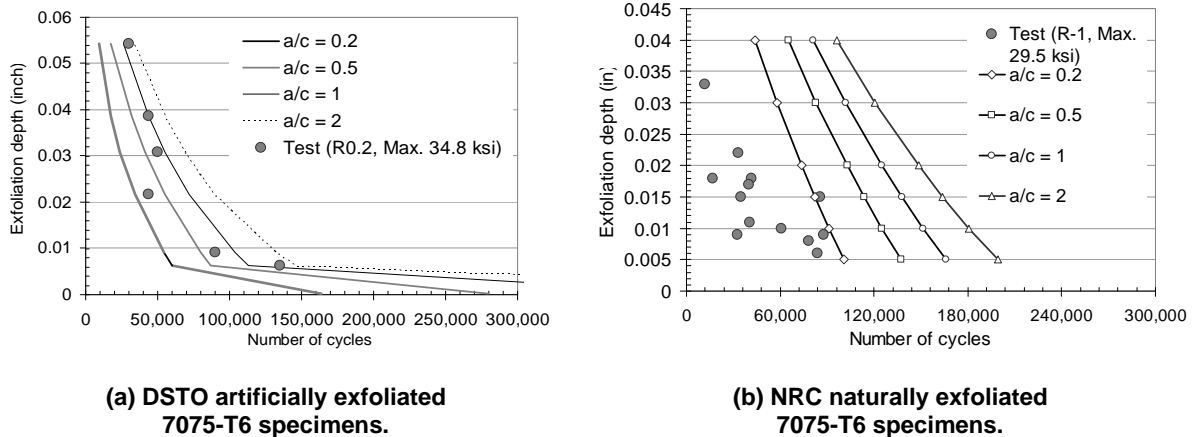
Figure 15-5: Predicted 7075-T6 Fatigue Life vs. Exfoliation Depth Using the 'Process Zone' Model and AFGROW [17].

Liao et al. also examined the ‘process zone’ concept using AFGROW [17]. Since AFGROW does not have a starter notch model, the ‘process zone’ was simplified as a semi-elliptical crack with a depth of 120 μm on the substrate material (i.e., similar to DSTO Model 4(b)), in which the exfoliation layer was removed and the net stress was increased correspondingly. Because the real aspect ratio of the corrosion pit was unknown, different crack aspect ratios were used in the analysis. The analytical results are presented in Figure 15-5(a), along with the DSTO test results. It is shown that the ‘process zone’ concept can be implemented using AFGROW to provide similar life estimations for the DSTO specimens, especially with aspect ratio of 1.0 to 2.0.

However, in an example in [17], the 'process zone' model largely over-estimated the life of the naturally exfoliated 7075-T6511 coupons under a fully reversed cyclic load ($R = -1$) (test details are described in Section 3.3, Example 2), even with the upper limit of pit depth of $100 \mu\text{m}$, plus remote stress increased based on the maximum depth of exfoliation (determined by ultrasonic Non-Destructive Inspection (NDI)), the model still over-estimated the lives, Figure 15-5(b). The over-estimation might be caused by the following factors:

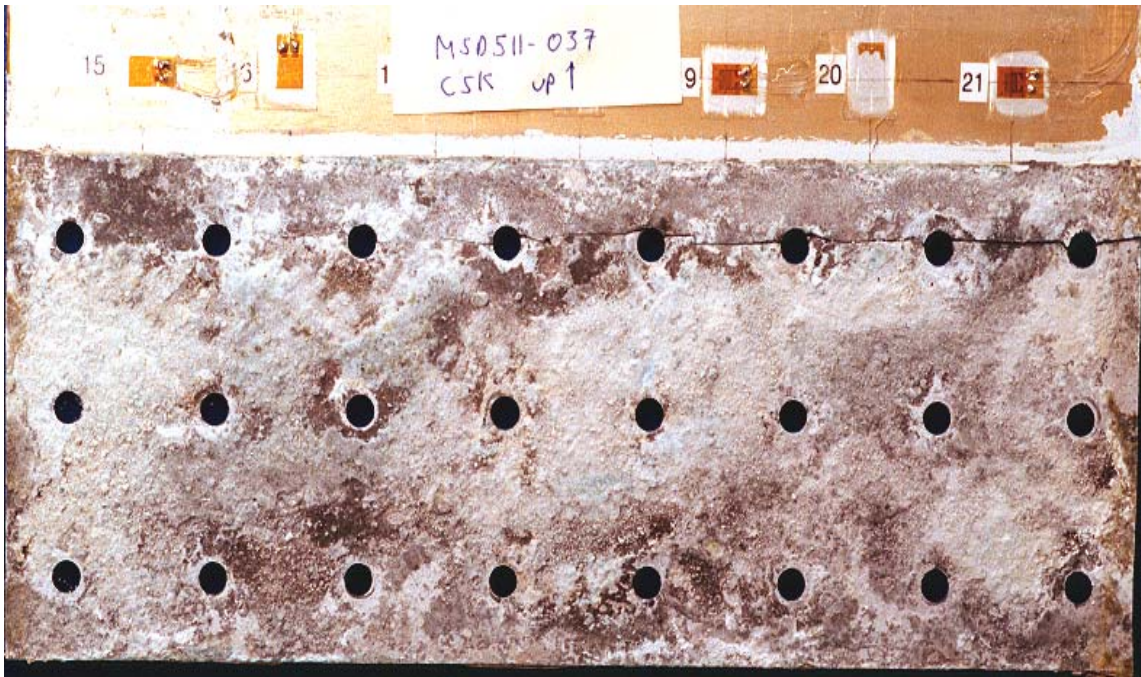
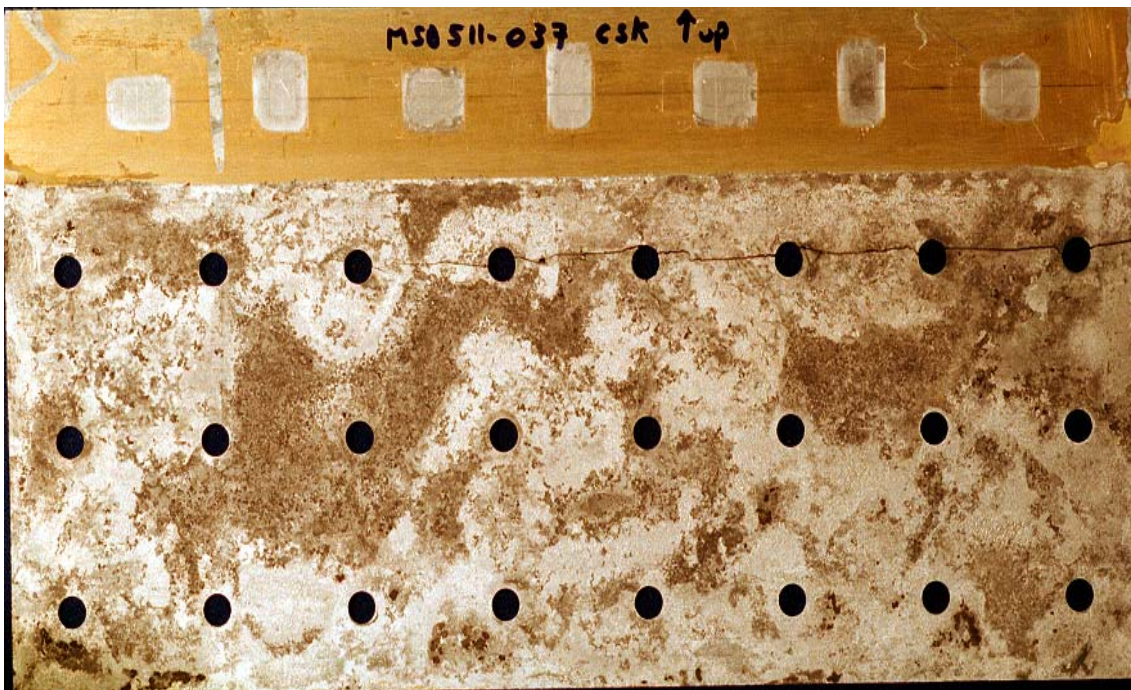
Figure 16-3: Faying Surface of the Countersunk Sheet of Specimen #037 Before and After the Removal of Corrosion Products.

In the case of fuselage splices, it is currently difficult to measure the hidden corrosion damage at the faying surfaces, i.e., the internal contacting surfaces, accurately and with high resolution using Non-Destructive Inspection (NDI). Therefore, the corrosion damage was measured throughout each sheet after dismantling the splices. An efficient method of doing this over large areas was developed by the NRC several years ago, and procedures have been progressively improved. It involves dismantling the splice and removing the corrosion products chemically from each sheet (Figure 16-3). Then each sheet is radiographed using X-rays. Various calibration pieces of known thickness are included in the radiograph. The radiograph is digitized, calibrated, and analyzed using custom and commercial image processing software. Measurements of the average thickness loss in specific areas of interest were obtained from the grey scale versions of the radiographs. The grey scale radiographs were also colorized to provide calibrated thickness maps for general study and comparison with NDI (Figure 16-4). The X-ray images are presented in standard orientation for this work, i.e., as though being viewed from the exterior of an aircraft. Thus, if the images for the countersunk and driven sheets were overlaid, they would indicate the total distribution of corrosion damage at the faying surfaces of the splice.

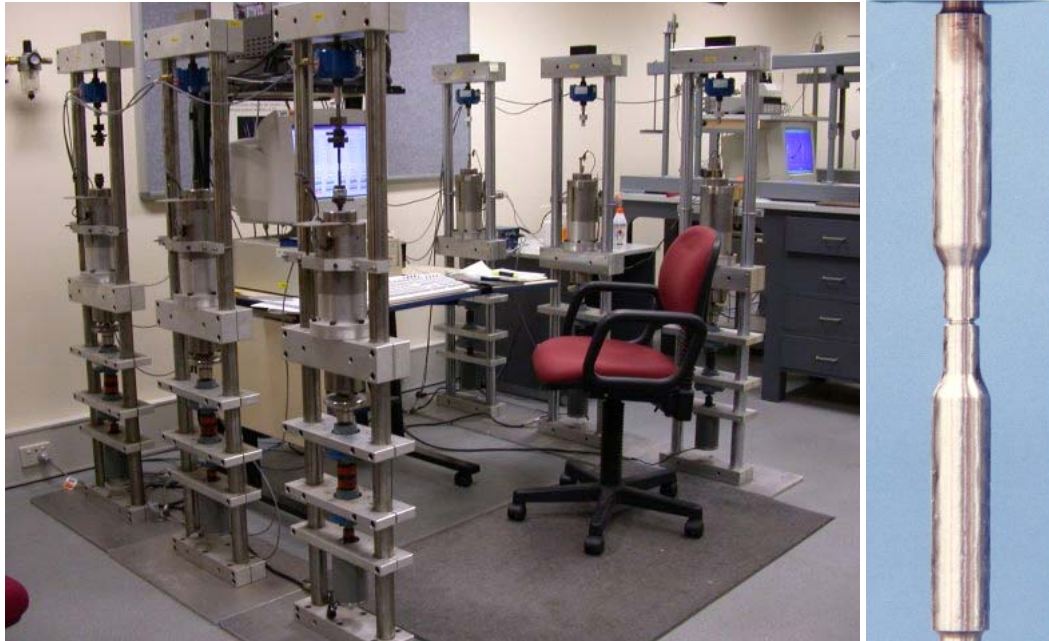
Figure 20-5 shows some SSRT test rigs and the specimen configuration. The SSRT tests are carried out to failure of the specimens and provide the notched tensile strengths or fracture stresses. These data are then compared with those of identical specimens known to be unembrittled. In addition, SEM fractography

Figure 20-5: Slow Strain Rate Tensile (SSRT) Test Rigs and Example Test Specimen.

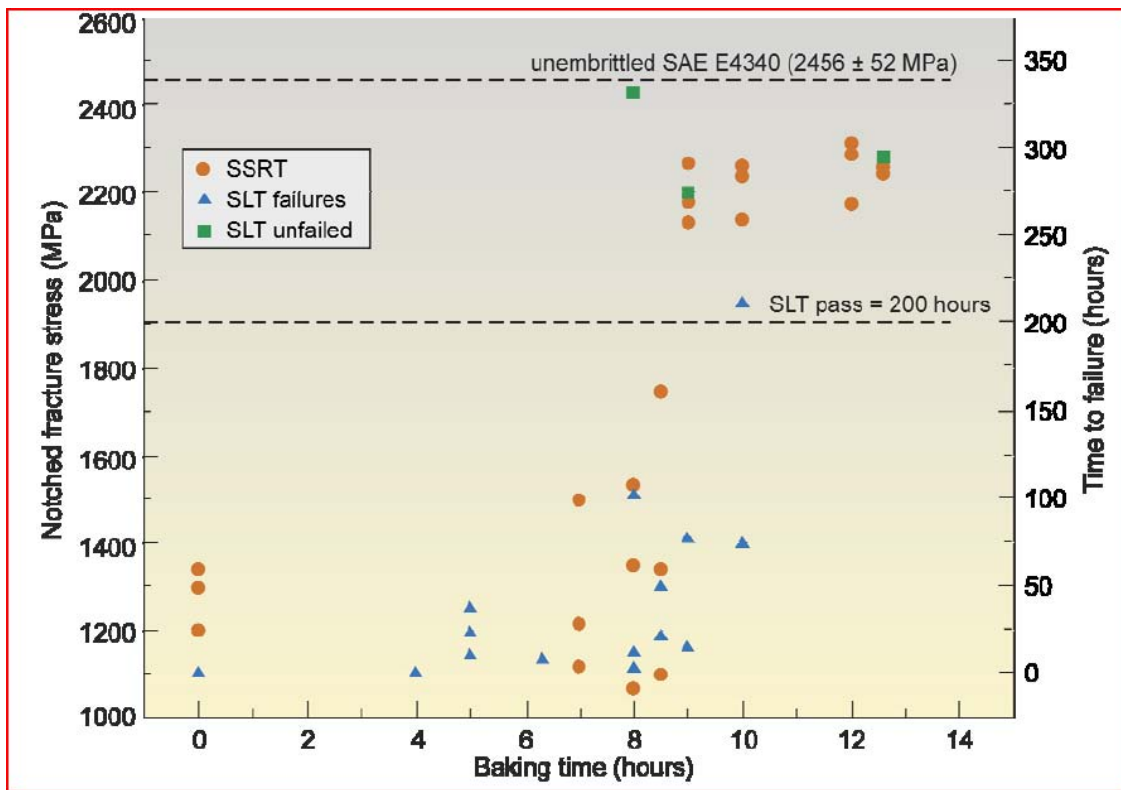
Correlation between SSRT and SLT data has been determined [13]. This was done by cadmium electroplating notched tensile specimens of SAE E4340 steel in an embrittling solution, followed by baking groups of specimens for differing times (0 – 13 hours) at 50°C. (Thirteen hours baking was known to be sufficient to eliminate IHE.) Figure 20-6 compares the SSRT and SLT data. It is seen that the baking time for the 200 hour pass in an SLT corresponds to a notched fracture stress of about 1900 MPa for the SSRT tests.

Figure 20-6: Comparison of SSRT and Sustained Load Test (SLT) Notched Fracture Stress Data for SAE E4340 Steel Specimens Cadmium Plated and Baked at 50°C for 0 – 13 Hours [13].

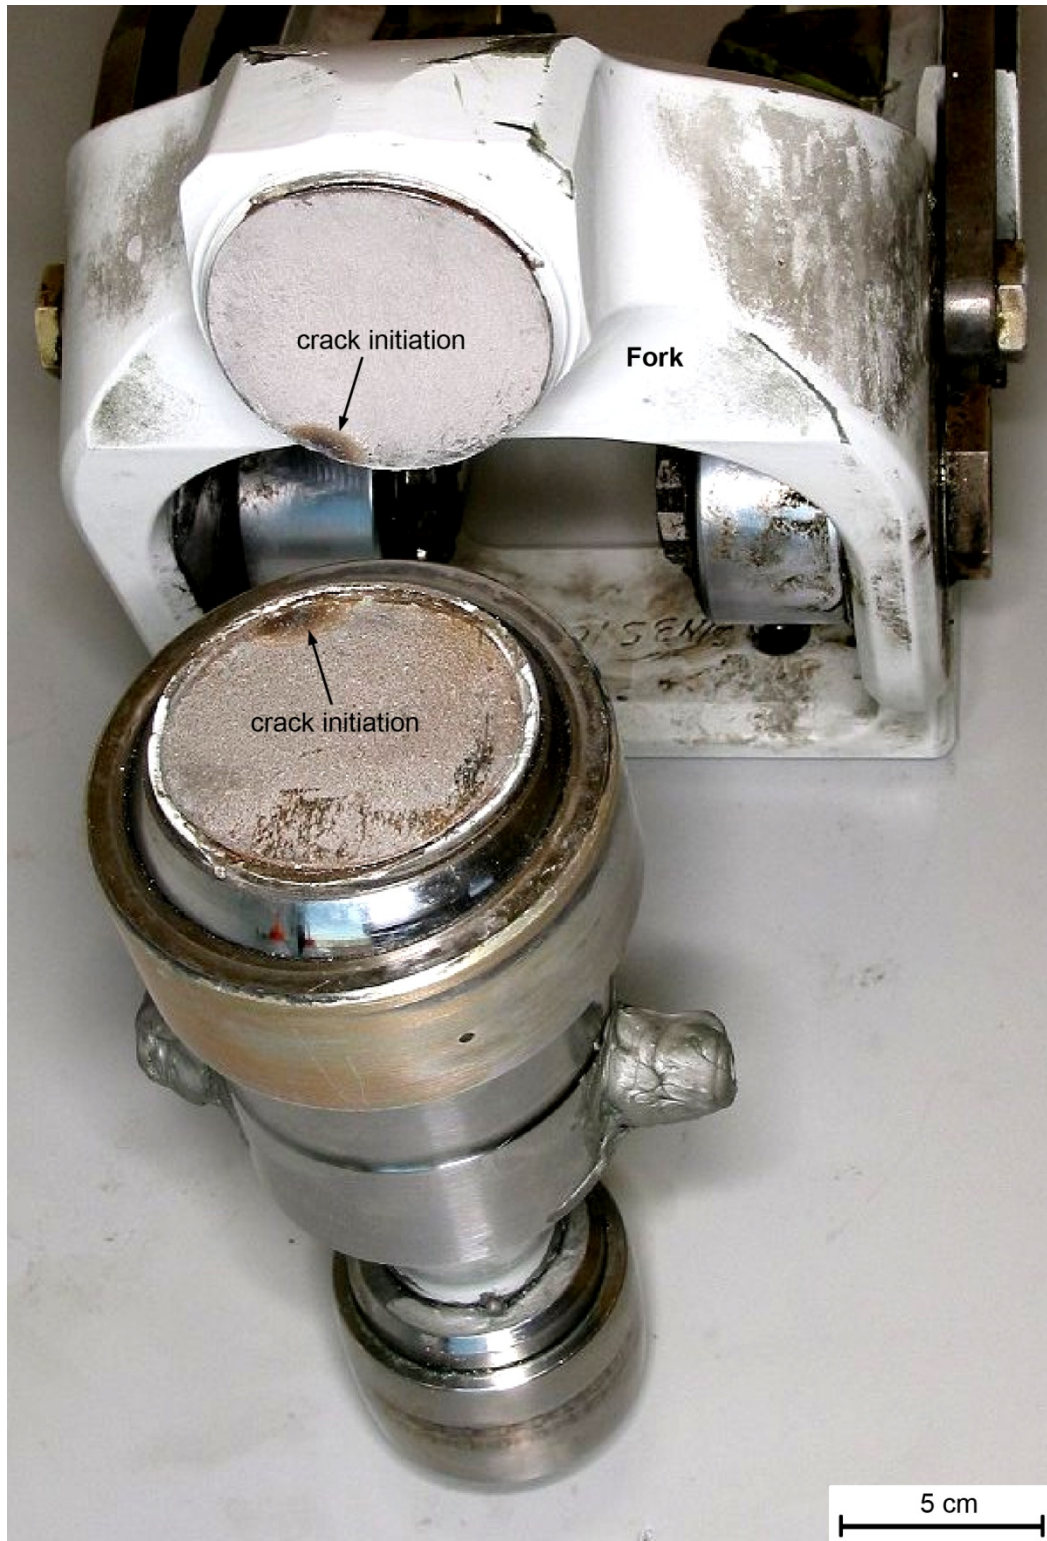
Figure 20-20: Case History 20.5.3 – Overview of the Fractured Spindle and Fork Assembly.

The inboard carriage assembly from a transport aircraft flap fractured at the transition radius between the spindle and fork, see Figure 20-20 and Figure 20-21. The operator carried out a failure investigation, which is described in Section 20.5.3.1. The National Aerospace Laboratory (NLR) in Emmeloord, Netherlands, was requested to review the investigation and provide comments. The NLR's contribution is given in Section 20.5.3.2. The remedial actions and final conclusions are presented in Section 20.5.3.3.

Figure 20-19 shows the broken carriage assembly *in situ*, and Figure 20-20 gives views of the mating fracture surfaces spindle-side and fork-side. Discoloured semi-elliptical crack initiation regions are visible in both figures. The entire fracture surface of the spindle is also discoloured, but less so.

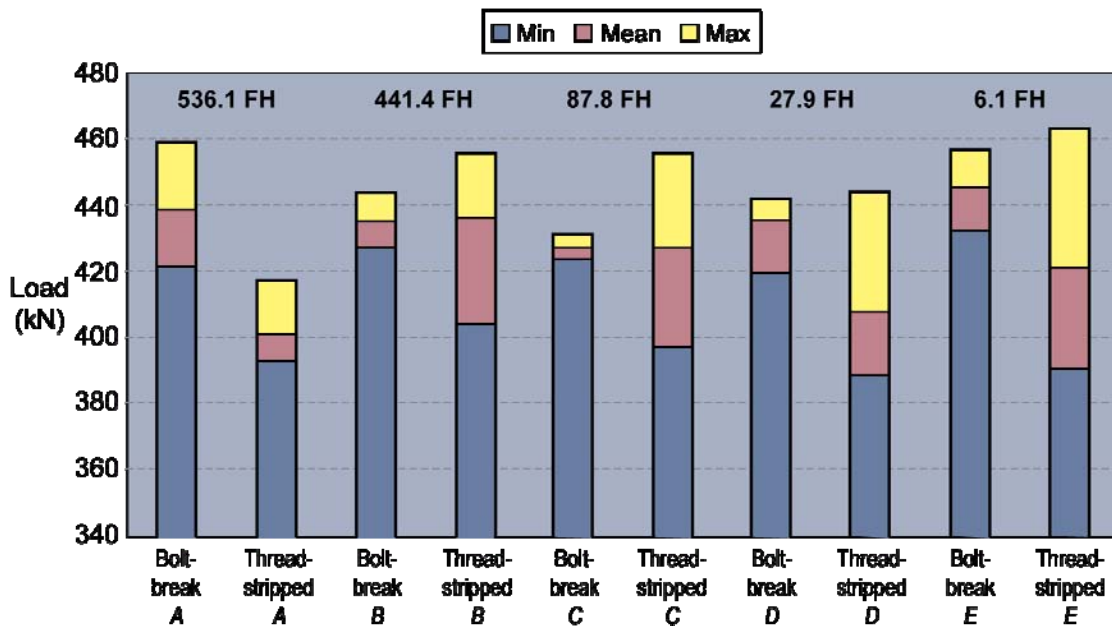
Figure 20-29 summarises the test data in a histogram. This gives the ranges in failure loads for the two failure modes, bolt-break (19 cases) and thread-stripped (31 cases). For each of the 5 aircraft the bolt-break failure mode resulted in minimum and average failure loads at least as high as those for the thread-stripped failure mode. Also, there is no apparent relation between the failure loads and flight hours since paint stripper treatment.

Figure 20-29: Case History 20.5.4 – Histogram of the Definitive Tensile Test Data (FH = Flight Hours since paint stripper treatment).

- 3) *Flight Hours since Paint Stripper Treatment* – The major differences in flight hours since paint stripper treatment (**A** and **B** versus **C**, **D** and **E** bolts) are indicated by filled and open symbols in Figure 20-30 and Figure 20-31. There is no clustering of the failure loads according to flight hours, in agreement with a lack of a trend in Figure 20-29.
