RTO AGARDograph

AG-AVT-140

Corrosion Fatigue and Environmentally Assisted Cracking in Aging Military Vehicles

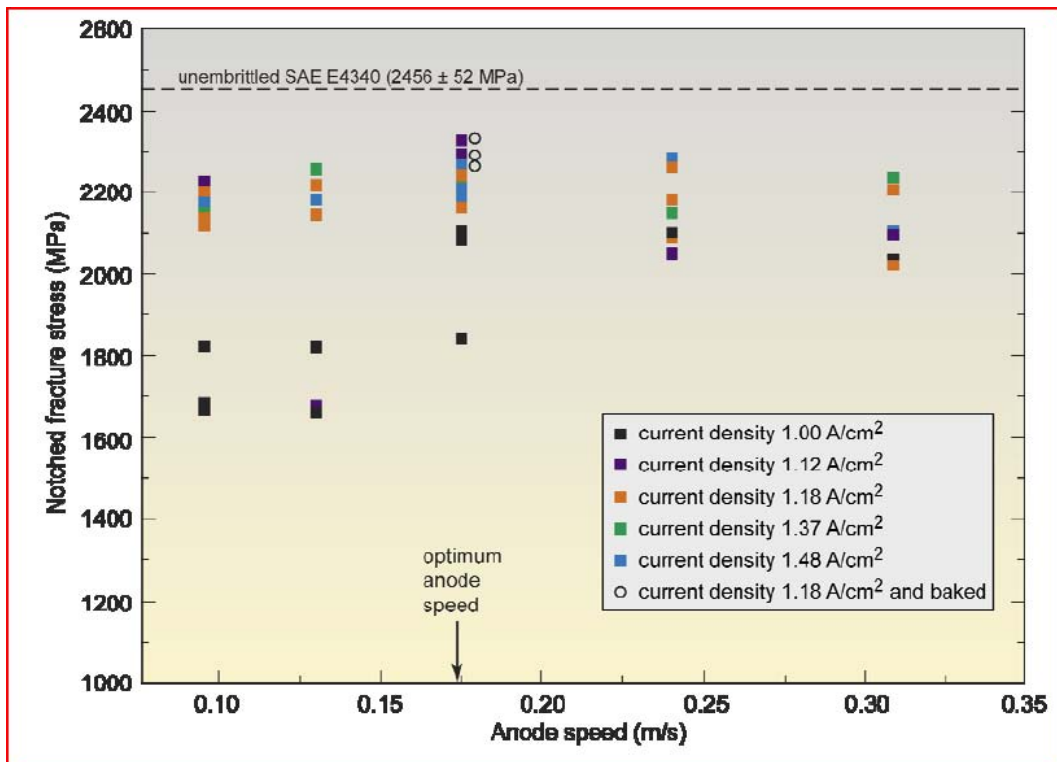
Figure 20-36: The Effect of Anode Speed on the Notched Fracture Stress of SAE E4340 Steel Specimens.

The SSRT results are shown in Figure 20-35 and Figure 20-36. The unembrittled notched fracture stress for SAE E4340 steel is also indicated (dashed horizontal line) to enable assessing the degree of embrittlement by any of the plating conditions, including the optimum conditions of plating and baking.

All of the SSRT specimens showed notched fracture stress reductions compared to the unembrittled fracture stress of 2456 ± 52 MPa. This was also observed in trials on Low Hydrogen Embrittlement (LHE) cadmium brush plated D6ac steel SSRT specimens [22]. More specifically, Figure 20-35 and Figure 20-36 indicate that the minimum reductions in fracture stress were obtained for SAE E4340 specimens plated under optimum conditions, whether subsequently baked or not. These results suggest that part of the fracture stress reductions may be due to some other phenomenon instead of IHE. One possibility is that the notch roots were slightly damaged by cleaning before plating.

The greatest reductions in SSRT notched fracture stresses were obtained from specimens plated with the lowest current densities and anode speeds. Some of these results were below the SSRT proposed acceptance criterion of 1840 MPa, which implies that specimens plated under these conditions might not have achieved the 200 hour SLT pass required by ASTM F519-06 (see Sections 20.4.1 and 20.4.6). This posed a potential problem for applying the Dalic Nickel Tungsten brush-plating process without subsequent baking.

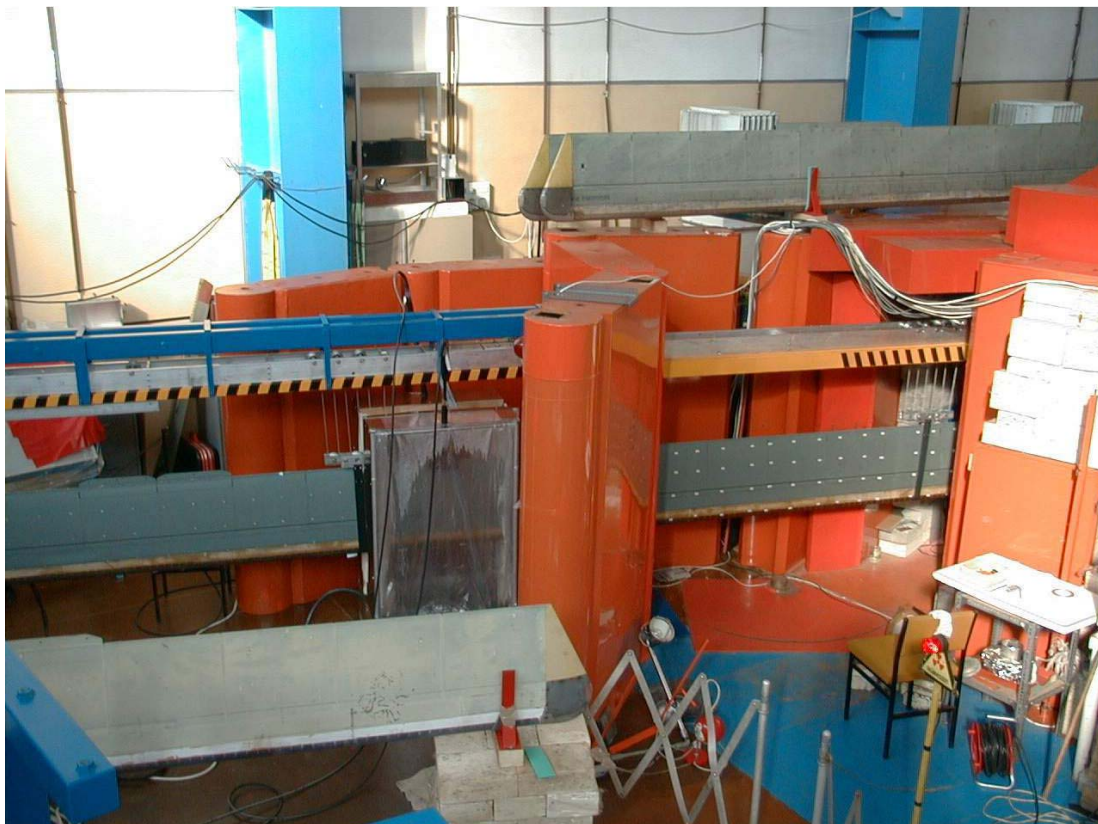
Figure 22-6: Mi-8 Rotor Blade Undergoing Moisture Conditioning.

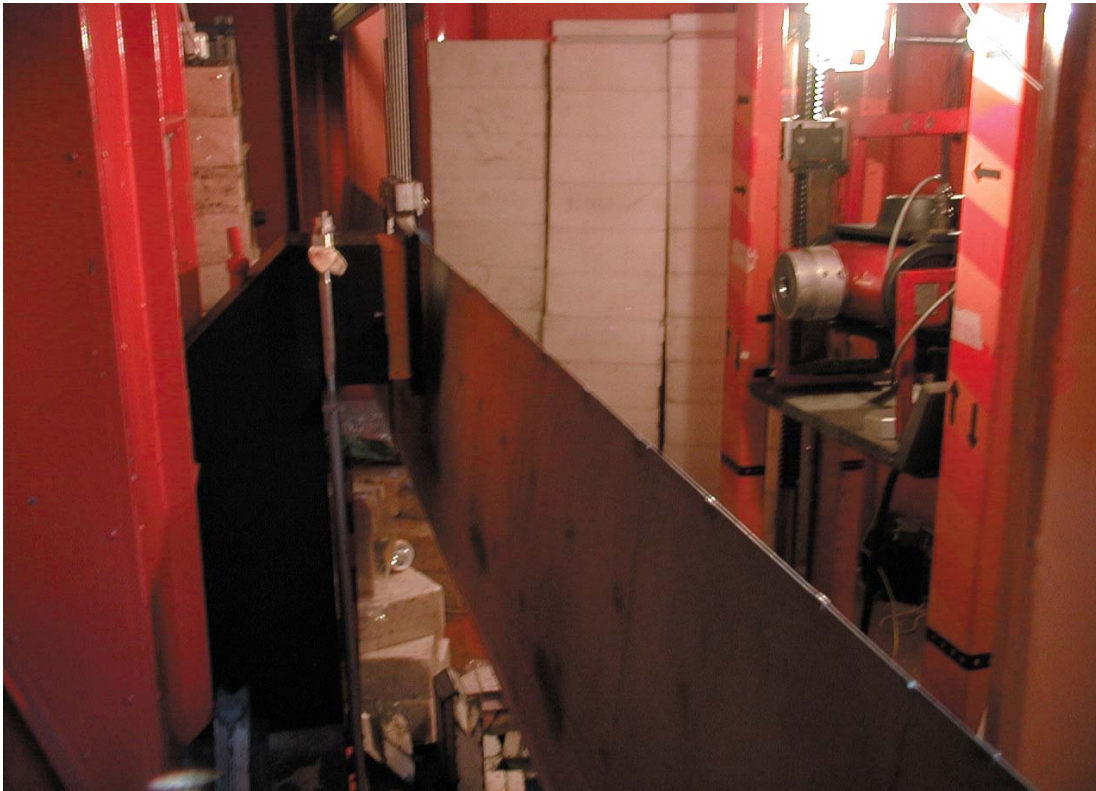
Figure 22-7: Mi-8 Type Rotor Blade Undergoing X-Ray Radiography.

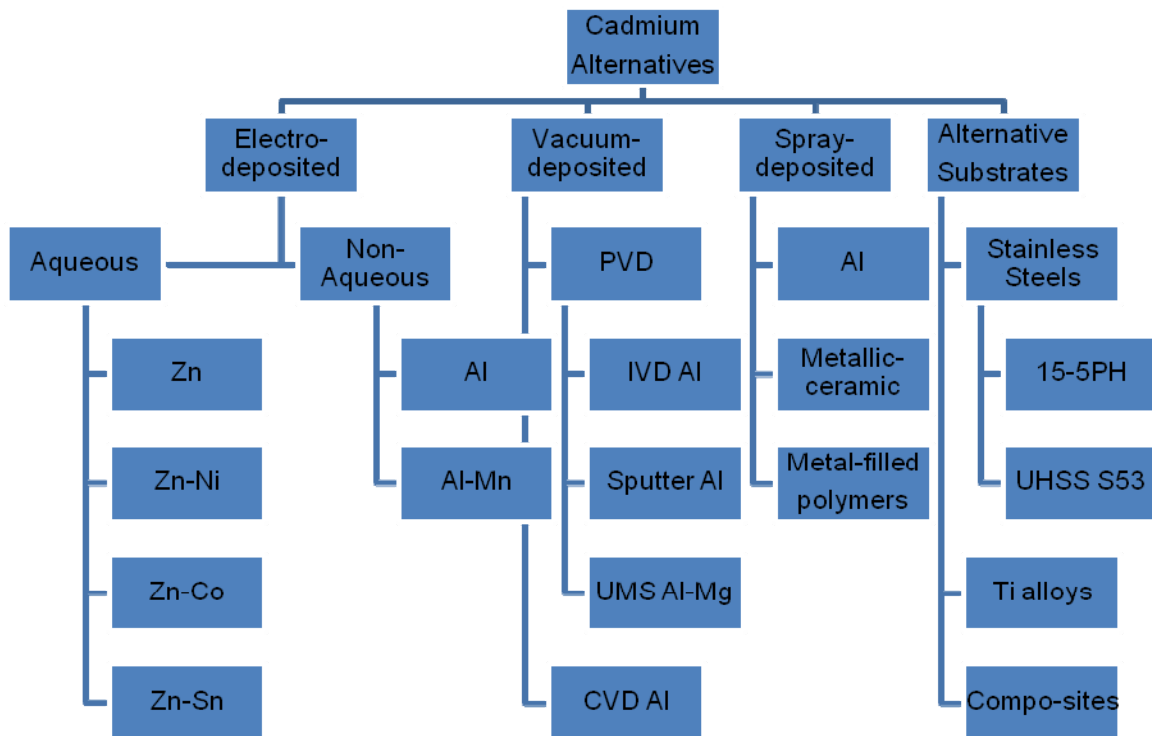
Figure 23-2: Cadmium Alternative Coatings and Materials.

In addition, alternative materials to replace cadmium-plated steels on the whole are also briefly reviewed. All discussed alternative technologies and coatings are presented in Figure 23-2.

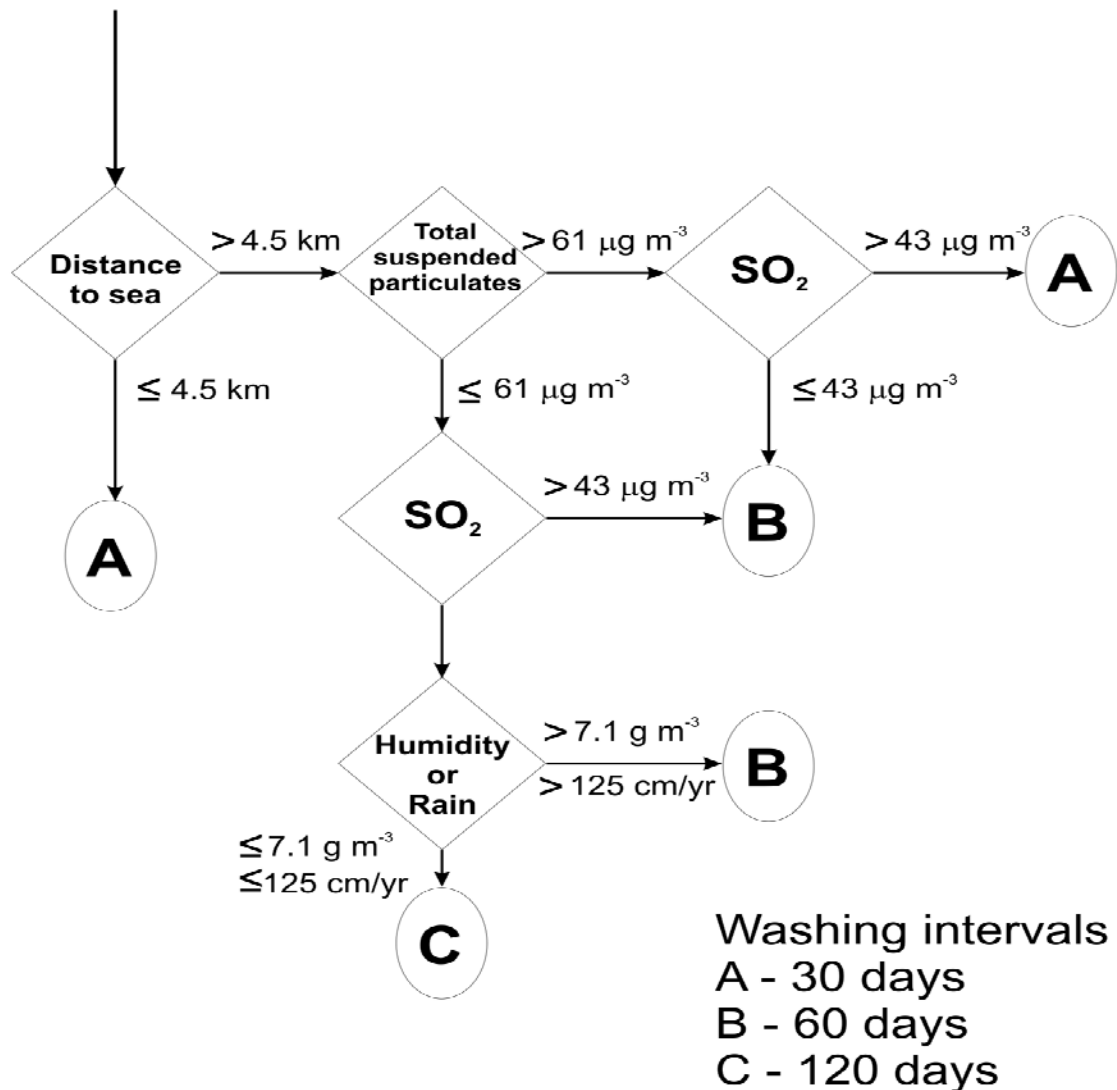
Figure 26-3: Section of the Corrosion Damage Algorithm for Planning a Washing Schedule.

An environmental assessment scheme based on atmospheric parameters has been developed for the United States Air Force (USAF) by Summitt and Fink as early as 1980 [1]. The scheme, code named PACER LIME, was constructed on the parametrically fitted corrosion behaviour of aircraft materials such as uncoated aluminum, steel, titanium and magnesium alloys. The ESI rankings were based on four parameters: proximity to the sea, total particulate level, sulphur dioxide concentration and amount of rainfall. An important advantage of this approach was that required data were typically available at most weather stations. The section of the Corrosion Damage Algorithm (CDA) presented in Figure 26-2, for example, considers distance to salt water, leading either to the very severe AA rating or lesser ratings based on a consideration of moisture factors. An algorithm for aircraft washing based on similar corrosivity considerations is presented in Figure 26-3.

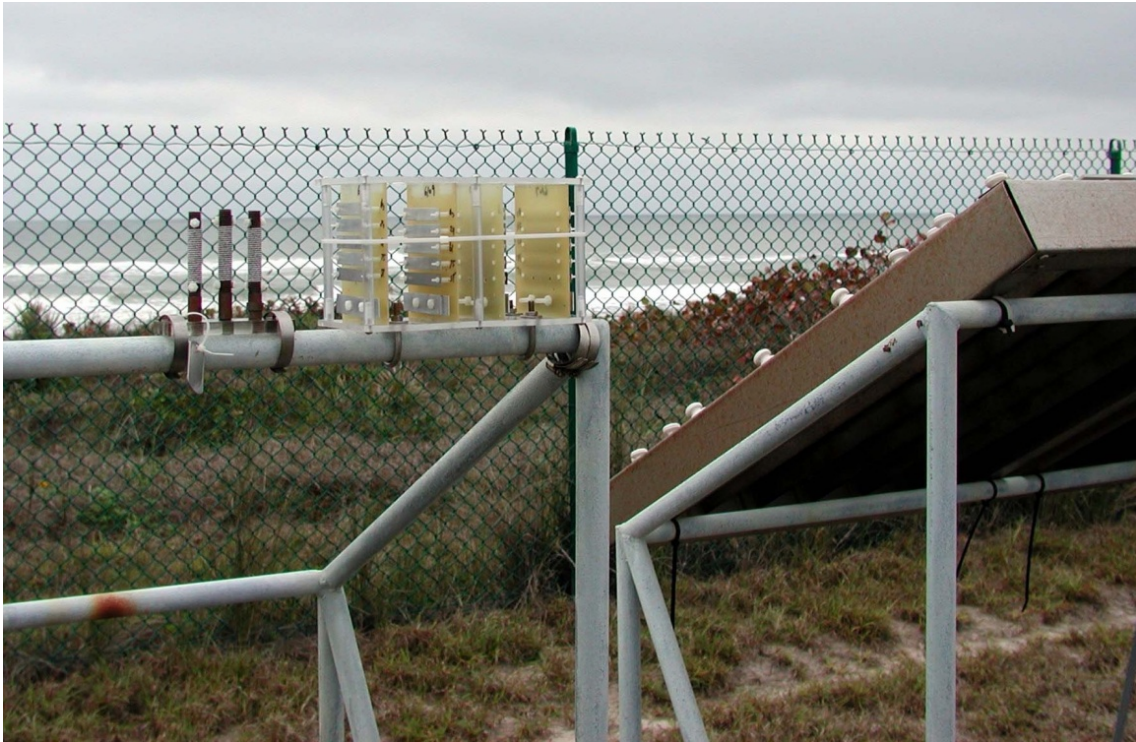
Figure 26-4: Metal Coupons in a Plastic Test Rack Exposed at the Kennedy Space Center Beach Corrosion Test Site Besides a CLIMAT Coupon (Courtesy of Battelle).

¹ The use of bimetallic specimens in which a helical A91100 aluminum wire is wrapped around a coarsely threaded bolt is described as the Classify Industrial and Marine Atmospheres (CLIMAT) coupon [4],[5].

Data have been collected for metals directly exposed to the outdoor environment in a standard sample mounting configuration and test package. A typical plastic test rack with its metallic coupons is shown in

Figure 26-4 besides a CLIMAT coupon¹ exposed at the Kennedy Space Center (KSC) beach corrosion test site, a test site renowned for having the highest corrosivity in the continental United States [6]. Figure 26-5(a) shows a close-up view of the coupons before exposure. Once exposed to the environment for a given period of time the corroded metal strips (Figure 26-5(b)) are sent back to the laboratory for mass loss measurements following standard methods [7] and further analysis.

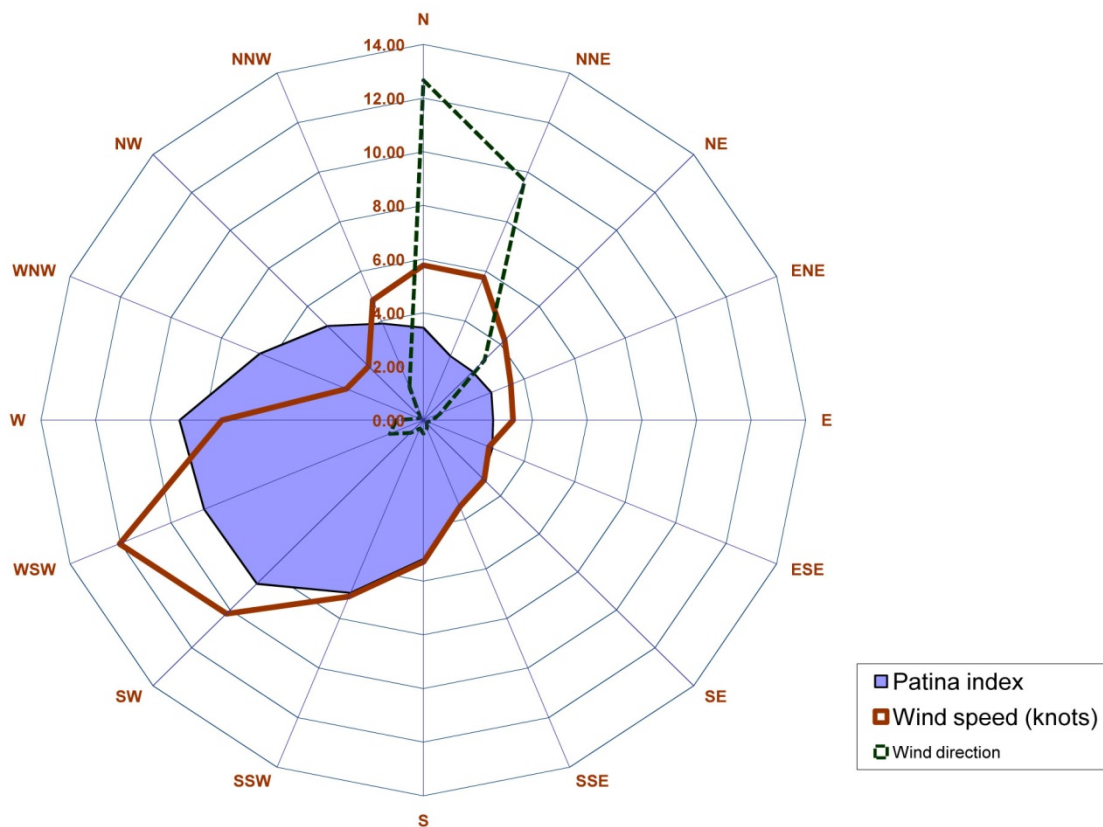
Figure 26-7: Average Corrosion Index for the Copper Rods Exposed on the Rooftop and the Average Wind Speed Recorded at the Local Weather Station as a Function of the Sixteen Points of the Compass.

A template with the sixteen points of the compass was placed on the outside of each boldly exposed coupon in order to visually quantify the intensity of the bluish-green color. The relative degree of corrosion for each compass point was assessed by assigning a number between zero and ten with zero corresponding to zero bluish-green patina and ten corresponding to 100% coverage of the coloured corrosion product. The average corrosion index for each of the sixteen points of the compass for the copper rods is shown in Figure 26-7. One attempt to correlate the directional corrosivity observed on the copper rods with weather data was to plot the fraction of time that winds came from the sixteen points of the compass during the three-month exposure period. The dominant direction was the north to north-east. However, the pattern of corrosion product did not correspond to the most frequent wind direction but did correspond to the direction with the highest wind speeds, which were in the west to south quadrant at this particular site (Figure 26-7).

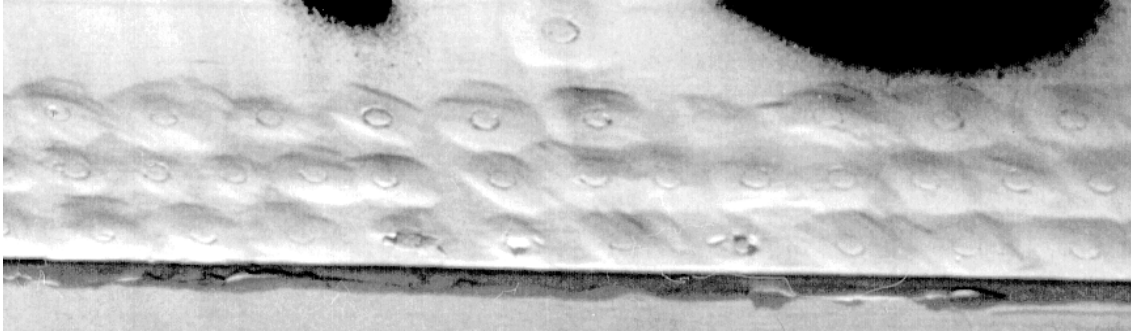
Figure 27-11: Exterior Spot Grinding.

Exterior surface corrosion damage may be exacerbated when addressed with rigid abrasive tools and a lack of appreciation for the damage that can quickly be done. In the case illustrated in Figure 27-11 the effort to remove filiform corrosion damage around rivets succeeded only in grinding the heads off the rivets and thinning the adjacent skin, in some cases completely through the thickness. The minor damage and appearance issues were thus transformed into a completely ruined joint. As with the faying surface

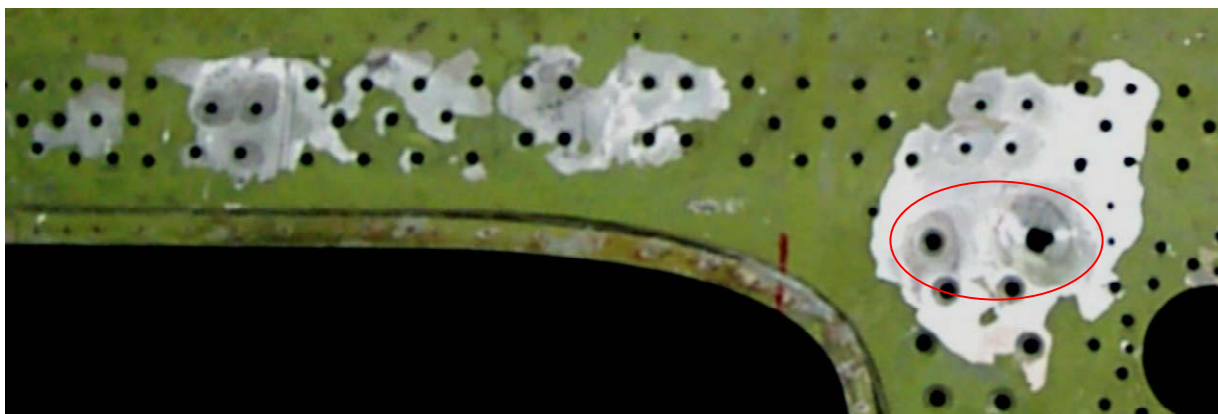
Figure 27-14: Upper Wing Skin with Exfoliation Corrosion Damage at Fastener Holes.

Figure 27-14 gives an example where severe exfoliation corrosion was removed from an upper wing skin plank. Unfortunately, the material removal and blending at two fastener holes (circled) went far beyond the allowed minimum thickness, and this resulted in the entire wing plank having to be replaced.

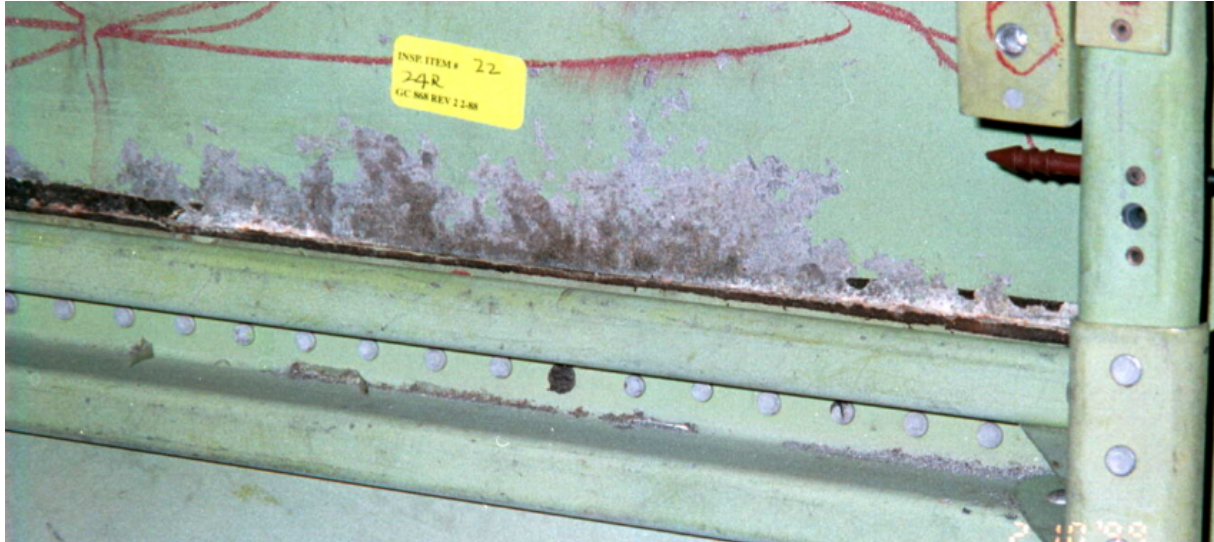
Figure 27-16: View of Surface Corrosion on INBD Side of Upper Skin at Lap Joint.

Figure 27-16 shows inside surface corrosion of an upper skin from a lap joint. This occurs more often and more severely than one might expect, for reasons given below.

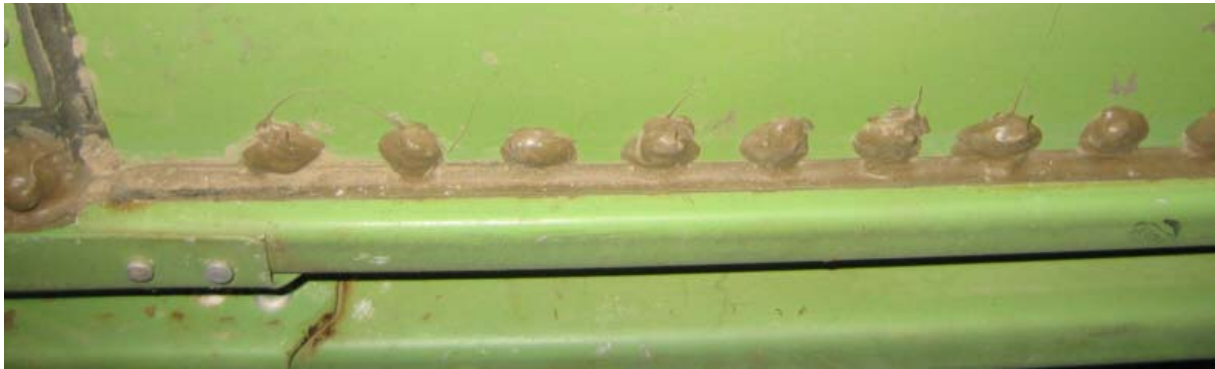
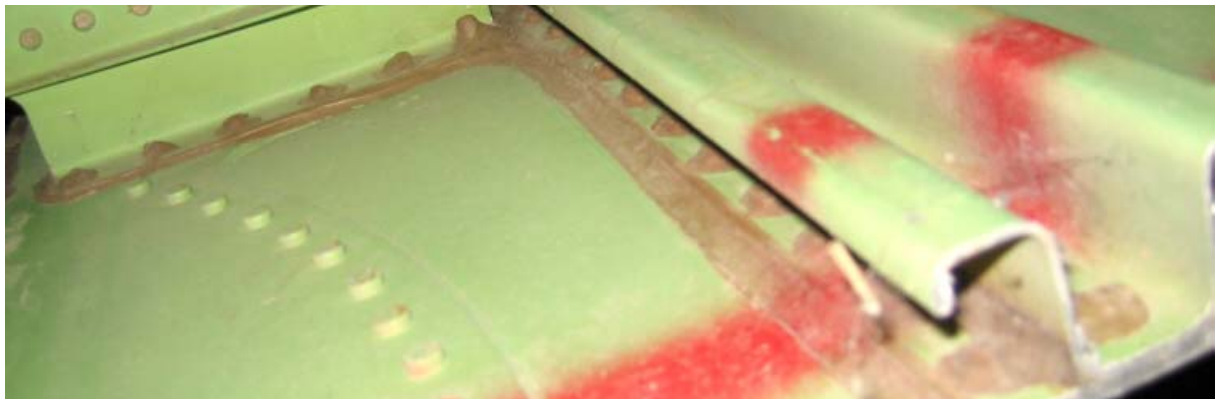
(a) Lap joint top row fasteners and stringer sealant application.

(b) View along lower surface of stringer on lap joint and body station frame attachment.

Figure 27-17: Rivet Shop Head and Stringer Edge Sealant Applications.

In response to the heightened awareness of how important corrosion can be for the integrity of ageing aircraft lap joints, some manufacturers mandated a comprehensive sealant program where every internal joint and fastener was potted or received additional sealant. Even the upper and lower edges of the stringer were sealed. This succeeded in only one thing: the moisture that was already in the joint was locked in, and inside corrosion was inevitable. Figure 27-17 is an example: sealants were comprehensively applied to exclude moisture intrusion in an attempt to avoid the development of crevice corrosion. The result was that every section harvested from the fuselage of this retired aircraft suffered corrosion inside the joints.

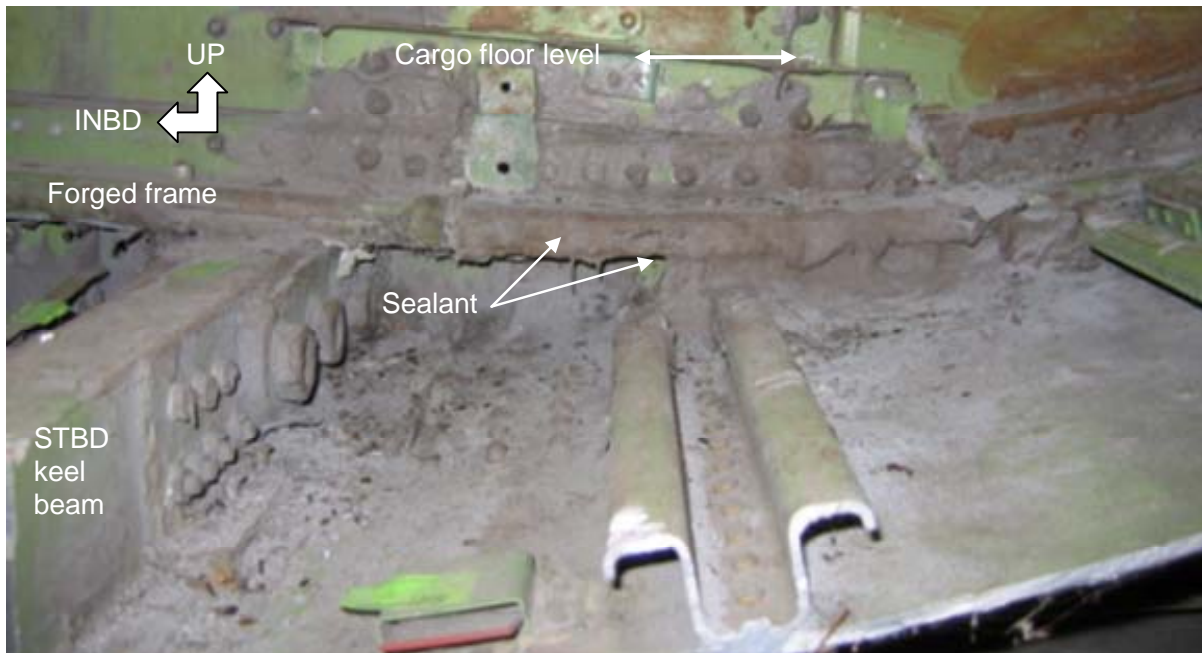
(a) View of area below cargo floor at fuselage frame, PORT.

(b) View of area below cargo floor at fuselage frame, STBD.

Figure 27-18: Views of Exfoliated Frame Treated with Sealant.

Figure 27-18(a) is a view of the port side of a bilge area in a fuselage where a heavy forged frame passes close to the bottom. The bottom surface of the frame has begun to exfoliate. This is a difficult location to inspect, since it is under the cargo floor and below the flange of the frame.

Figure 27-18(b) is the view of the starboard side of the frame. As may be inferred, exfoliation corrosion of the frame had been discovered previously, and following (any) remedial actions the frame was liberally covered with sealant. This prevented any later assessment of ongoing corrosion and the integrity of the frame. In fact, the area suffered significant further damage: large pieces of the frame could be pulled out from below, although the sealant was in good condition.

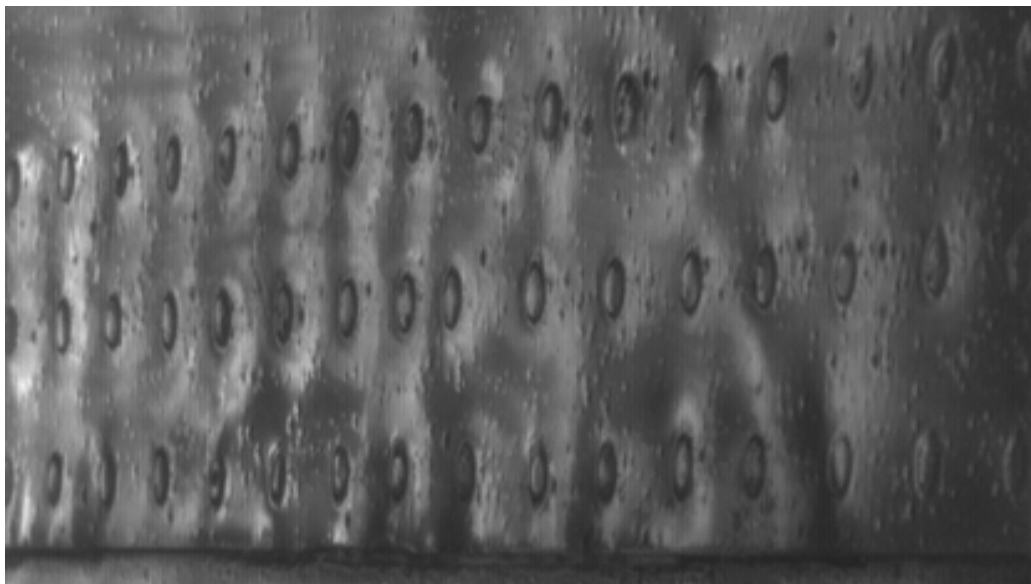
Figure 27-20: Surface Deformations from Excess Sealant in Repaired On-Aircraft Lap Joint.

On the other hand, a sealant layer is required to be between the inner and outer fuselage skins in order to prevent fretting and achieve pressurization requirements. Care must be taken in applying a thin even layer (recommended 0.02 inch (0.5 mm) thick) otherwise the joined sheets may be deformed by any excess sealant, see Figure 27-19 and Figure 27-20. This deformation will confuse subsequent exterior visual inspections for corrosion pillowing unless the repairs are documented and subsequently referred to before re-inspection.

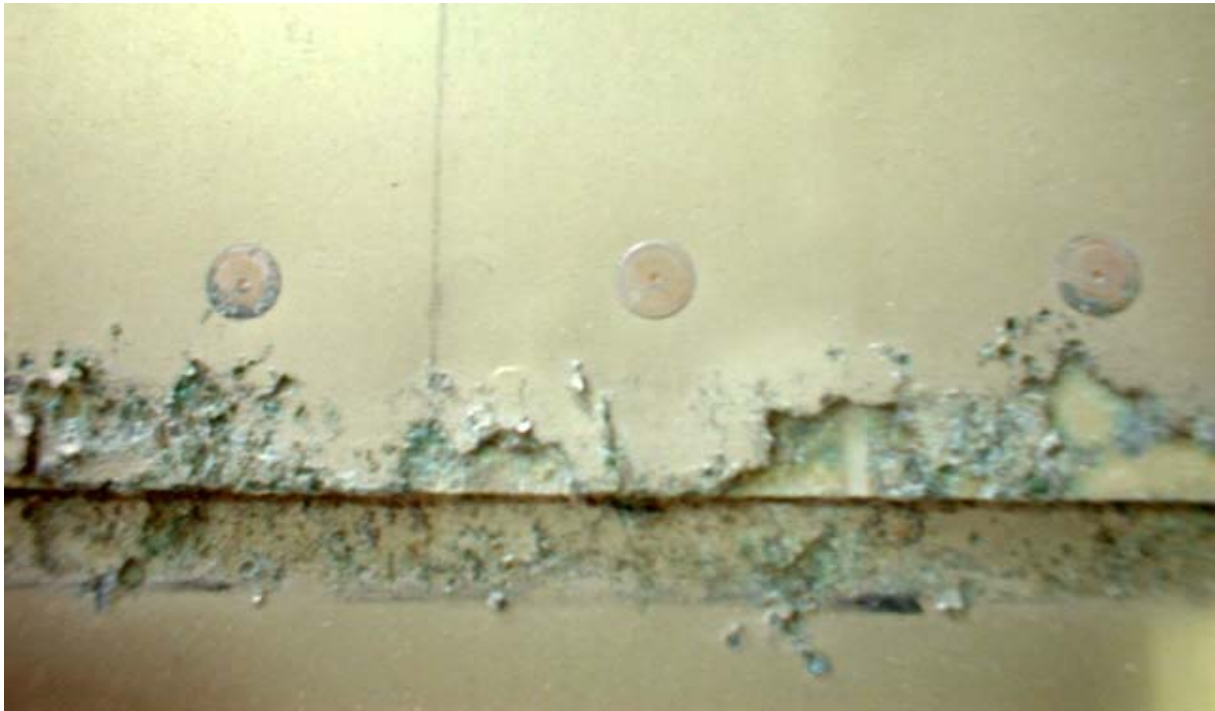
Figure 27-22: Corrosion Damage on Outer Surface of Glare Lap Joint.

Glare is considered to be resistant to corrosion because the damage should penetrate only the outer aluminum layer and then stop at the adjacent fiber/epoxy layer. However, once damaged, the outer surface will become an aerodynamic smoothness issue and someone will try to clean this up, also for cosmetic reasons, see Figure 27-22.

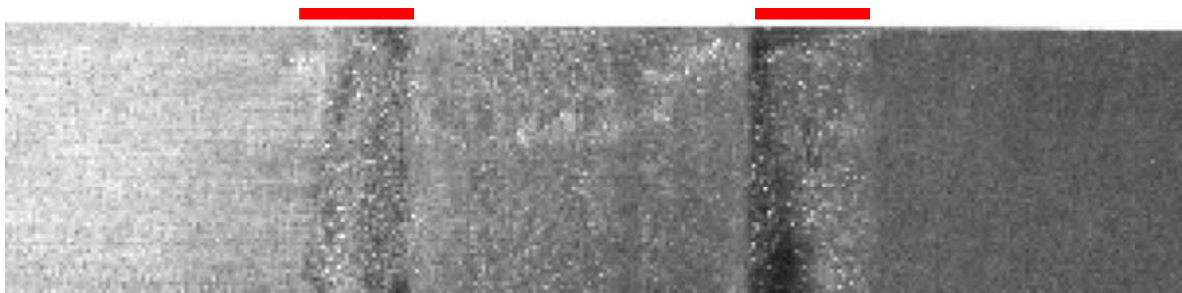
(a) Cross section through joint identifying regions of the weld zone.

(b) Outer surface showing exfoliation corrosion (ASTM G-34).

Figure 27-25: FSW Joint Structure and Corrosion Damage.

A friction-stir weld is typically characterized as being comprised of three primary zones: the Heat-Affected Zone (HAZ), the Thermomechanically Affected Zone (TMAZ), and the Dynamically Recrystallised Zone (DXZ) or weld nugget. Tensile failure in transverse tensile tests most often occurs within the HAZ or the section between the HAZ and the TMAZ. Due to the change in precipitate morphology, this region is also generally susceptible to corrosion (red lines in Figure 27-25). One way to potentially improve the resulting corrosion properties is through post-weld heat ageing treatments. Another would be to coat the susceptible surface area with another, more resistant, alloy.

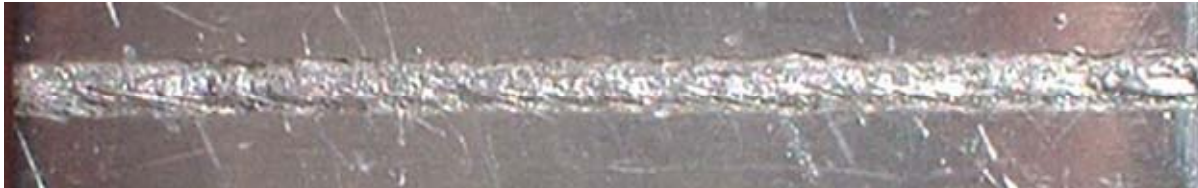
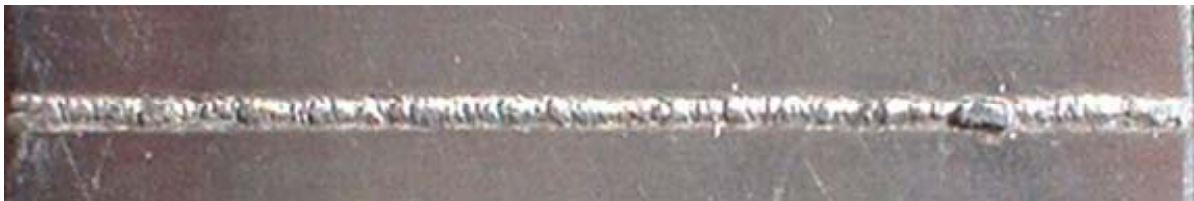
(a) Front surface.

(b) Rear surface.

(c) Cross-section.

Figure 27-26: Laser Welded Skin Butt Joint.

A development laser welded skin butt joint of two equal thickness sheets is shown in Figure 27-26.

Laser welding may eliminate lap joints by enabling butt welds. As with FSW, there may corrosion-prone areas adjacent to the laser weld, owing to microstructural differences relative to the parent material. The welds are quite narrow, and early detection of corrosion and fatigue damage will therefore require the use of sophisticated inspection equipment. Repairs will have to be done using riveted aluminum patches, since field repair laser welding will not be possible.

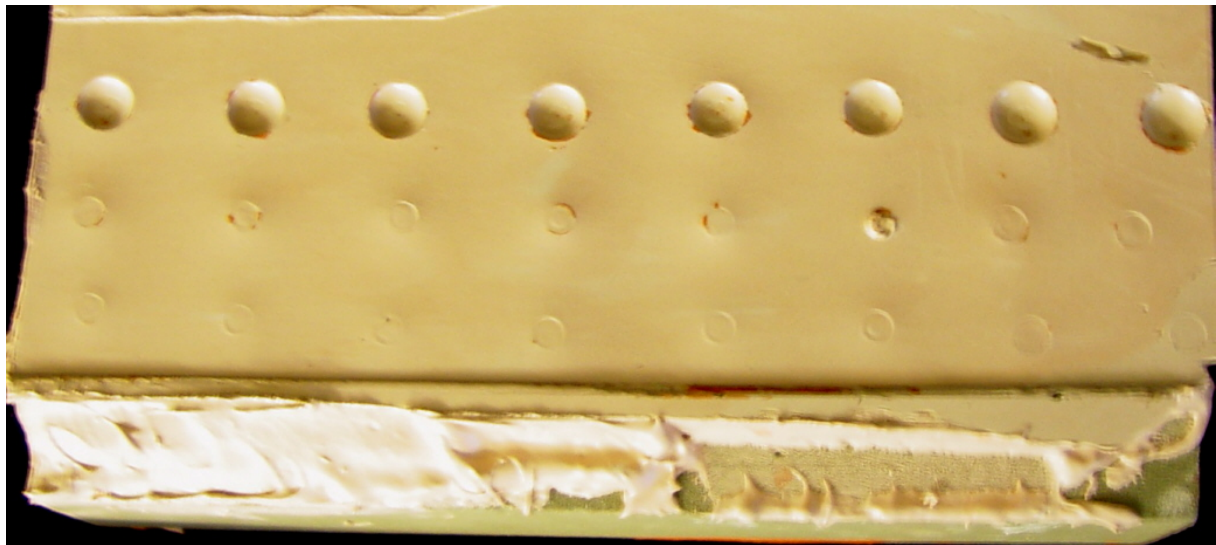
(a) Surface replica of joint discussed in Post Teardown (Figure 27-38 – Figure 27-40).

(b) Replica of a replica recreates surface for further analysis.

Figure 27-27: Replicas on Rigid Foam Backing of Damaged Fuselage Joints.

Physical replicas of the entire sample surfaces are impractical, and measurement data would still have to be collected. Hence surface replication is done on a smaller scale, for example parts of lap joints. Both rigid and flexible (but dimensionally stable) replicas can be, and have been, made. These provide surface topography records, e.g., Figure 27-27, which are available for investigation after teardown. For example, after disassembly it might be found useful to relate corrosion-induced pillowing (a surface topography effect) directly to internal corrosion product accumulation and any permanent deformation of the skin material.

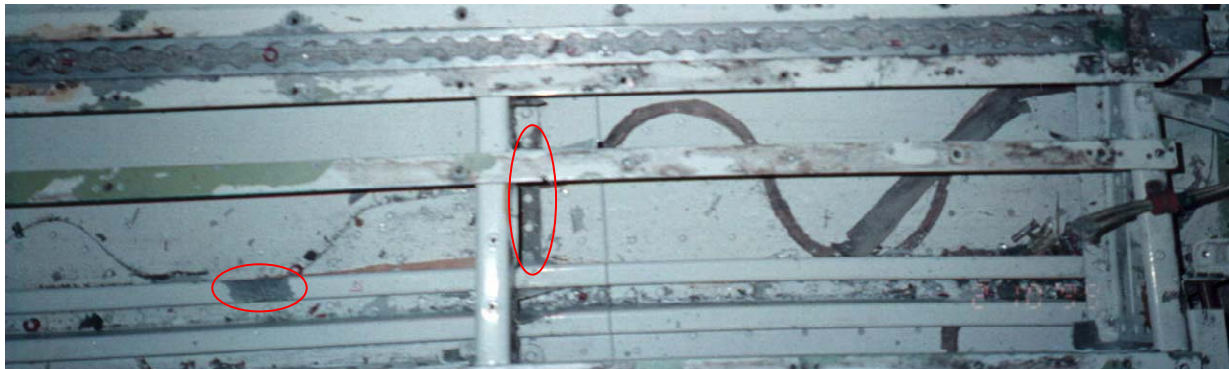
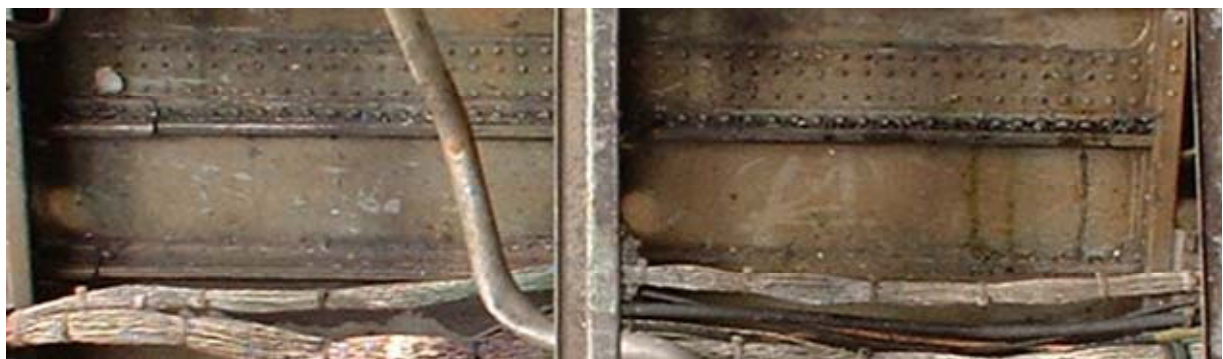
(a) White paint over primer (corrosion circled).

(b) White paint coated with CPC.

Figure 27-29: Bilge Areas Below Cargo Floor (Floor Panels and Insulation Blankets Removed).

Corrosion Prevention Compounds (CPCs) are applied internally to large areas of ageing aircraft structures. Inspections cannot be completed with these coatings in place because they accumulate dirt and debris and obscure direct viewing of the surfaces. These will often have had multiple applications of CPCs, which bind the dirt and debris in place, and the CPCs become increasingly difficult to remove as they harden with age. Another disadvantage is that the dirt-collecting nature of CPCs discolors white-painted bilges, see Figure 27-29. This discoloration reduces the visibility of corroded areas.

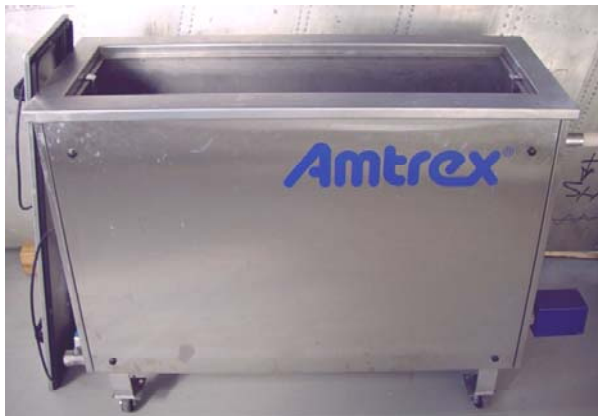
Figure 27-32: Ultrasonic Immersion Corrosion Cleaning Tank.

The method of corrosion product removal should be chosen to ensure that no additional damage is done to the structure. This is especially true if cracks are to remain undisturbed. It has been proven that corrosion product removal by chemical dissolution is greatly assisted by ultrasonic vibration in an immersion tank, for example Figure 27-32.

Rather than filling the tank with the chemical cleaning solution, the samples are placed in solution-filled bags which are then suspended in water in the tank. This minimizes the amount of cleaning solution required. Various chemical solutions can be used. To verify the selected chemical removal process, long exposure tests are required to demonstrate that no damage is done to the remaining base material, see Figure 27-33.

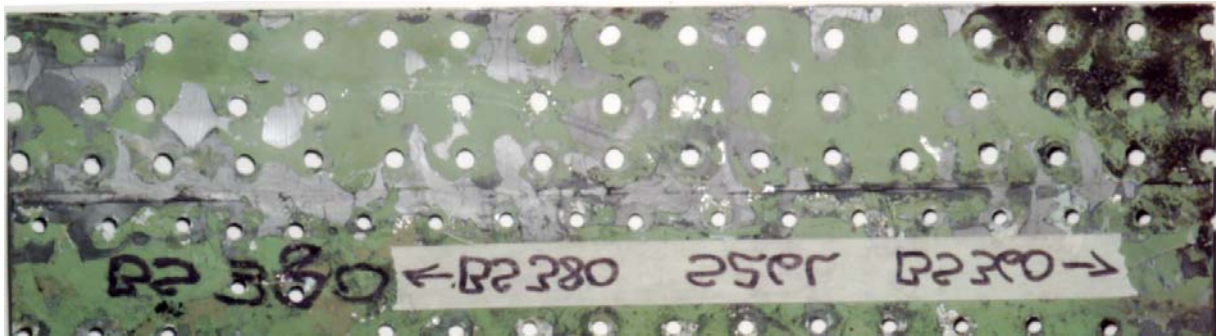
Figure 27-35: Rear Surface of Outer Skin.

The protruding-head rivets made it impossible to inspect the intact joint by eddy current NDI. Consequently the rivets were drilled out to separate the outer and inner skins. Figure 27-35 shows the rear surface of the outer skin. The black and gray areas are the remains of faying surface sealant from the prior maintenance, which had also included applying a primer. Significantly, there was no visual evidence of corrosion at the time of the teardown. This means that the pillowing observed in the DAIS inspection, Figure 27-34, was due to corrosion product accumulation up until the maintenance action, and that the subsequent visible persistence of pillowing was due to permanent deformation of the skin.

The outer skin inner surface shown in Figure 27-35 was cleaned chemically to remove the sealant and primer. This was followed by X-radiography that included a ramped master calibration tool to enable thickness measurements. The NRC/IAR NDI Analysis™ software was used to obtain the calibration and skin thickness measurements from the digitized image file of the X-ray film, Figure 27-36.

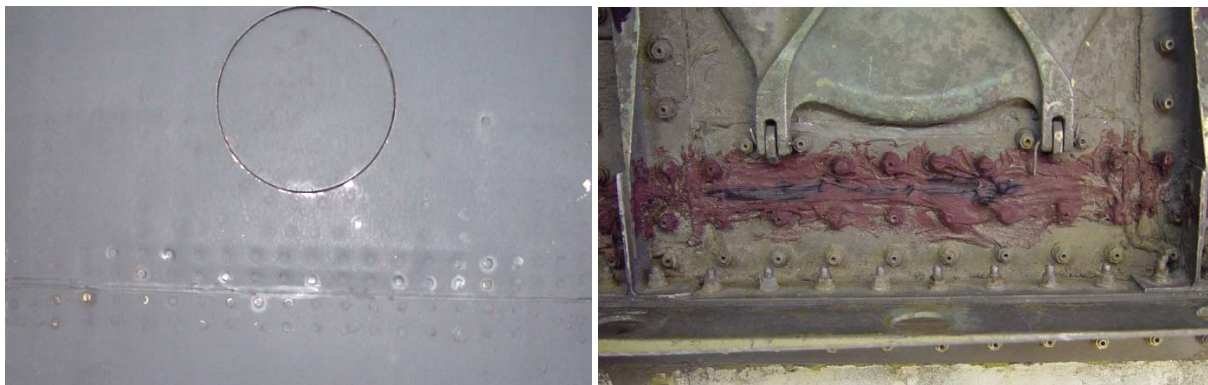
Figure 27-38: A Visual Inspection of the Exterior Surface Indicated Corrosion Pillowing (left) While the Interior Showed Sealant Added (red) Indicating Maintenance for Same (right).

Field inspection of a C-141 airframe located classic visual evidence for corrosion induced pillowing at the joint on Stringer 32 Right, see the left-hand photograph in Figure 27-38. The skin was buckled between the steel fasteners (Hi-Lok® HL19, 100°, Reduced Flush, shear bolts), and some fastener heads were being pulled through the outer skin. Furthermore, this damage was at a known corrosion site, below the sewage access port for the hospitality pallet. The right-hand photograph in Figure 27-38 shows that sealant had been added to the original protection scheme on the inner surface, indicating maintenance for corrosion damage.

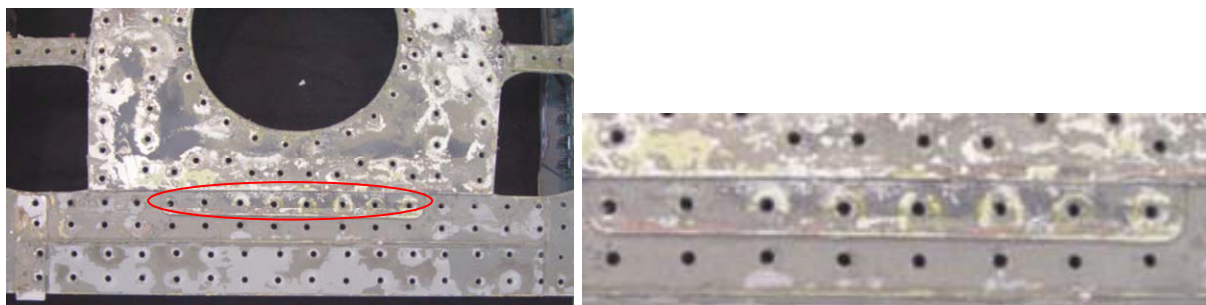
Figure 27-40: A 0.080 Inch (2.03 mm) Thick Shim In-Situ (left, circled), Enlarged (right).

Laboratory DAIS and UT inspections gave the results shown in Figure 27-39. The DAIS inspection indicates corrosion-induced pillowing, and the UT inspection apparently indicates corrosion product build-up along two fastener rows below the access port. However, teardown revealed something totally different. Figure 27-40 shows that a shim had been placed along one bolt row, presumably during maintenance. Tightening of the steel bolts caused the outer skin to buckle, and where it was unsupported by the shim the fastener heads tended to be pulled through the skin. The resulting incomplete clamp-up confused the UT inspection, since air gaps were interpreted as corrosion build-up.

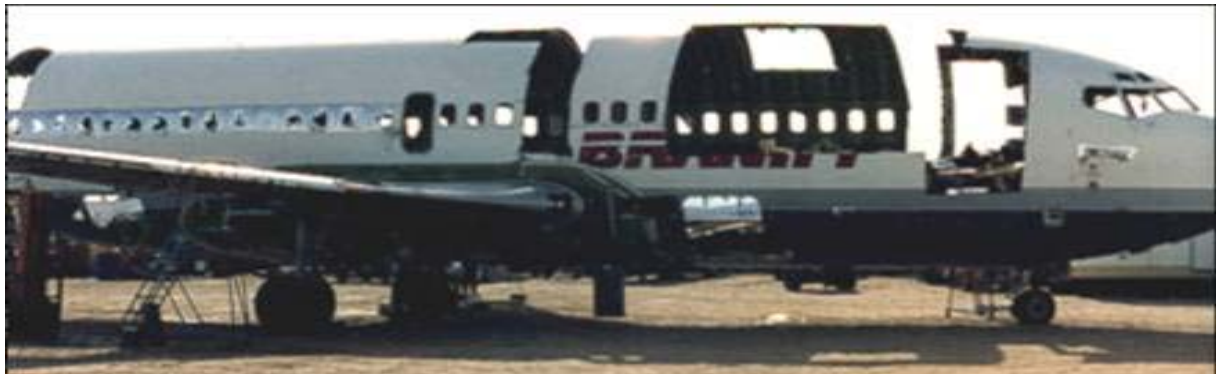
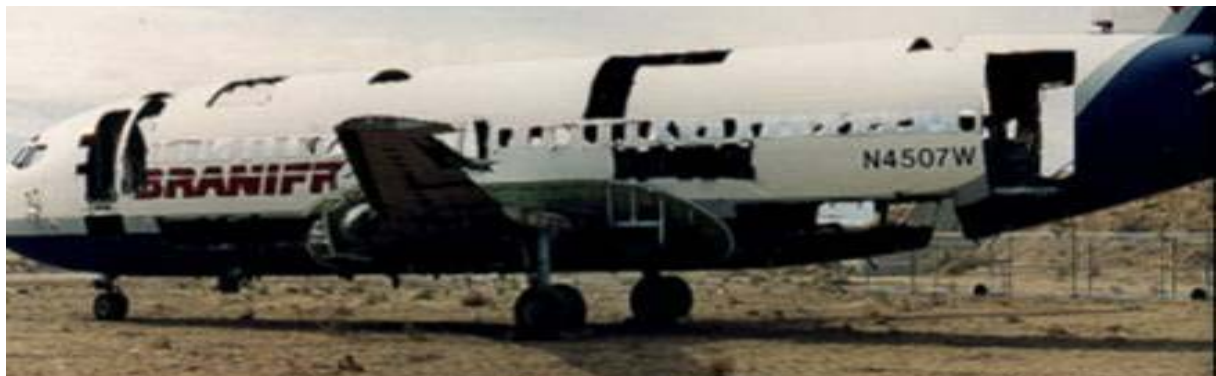
Figure 27-42: Cut-Outs Show where Fuselage Structure was Harvested from WFU Airframes.

If possible, both naturally damaged and pristine structures are collected. The usual sources for these original components have been wrecks and airframes Withdrawn From Use (WFU), see Figure 27-41 and Figure 27-42. Operators of new designs have been known to purchase additional airframes intended as immediate sources of spare parts, but these can also serve as sources for materials and assemblies.

Note from Figure 27-42 that these WFU aircraft are parked in desert environments. Actually, deserts are *not* the best places to store aircraft that have been in service. It has been assumed that the arid climate minimizes corrosion activity. This may be true for the exterior surfaces, but experience has shown that the closed-off internal environments still support corrosion processes, and the high daytime temperatures may well accelerate them. Consequently, desert storage areas have proven to be productive sources of examples of service and post-service corrosion, Figure 27-43 and Figure 27-44.

From nose to tail and top to bottom the materials, structural elements and assemblies of transport aircraft fuselages generally remain the same. The upper and lower wing skins are usually made from different alloys (7XXX upper skin, 2XXX lower skin) and they vary in thickness from root to tip. However, apart from these differences both fuselage and wing structures can be sampled for collection, i.e., it is not necessary to obtain entire airframes. Figure 27-42 illustrates that the samples can be relatively small.

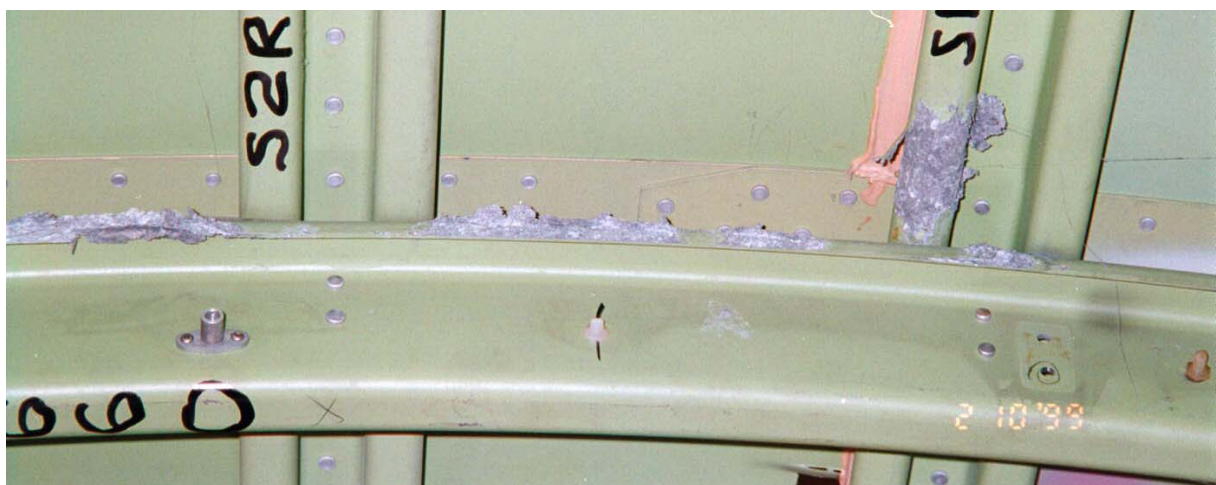
Figure 27-43: Stringer and Frame Corrosion in the Crown of a Stored Fuselage Due to Moisture Remaining in Insulation Blankets (Removed).

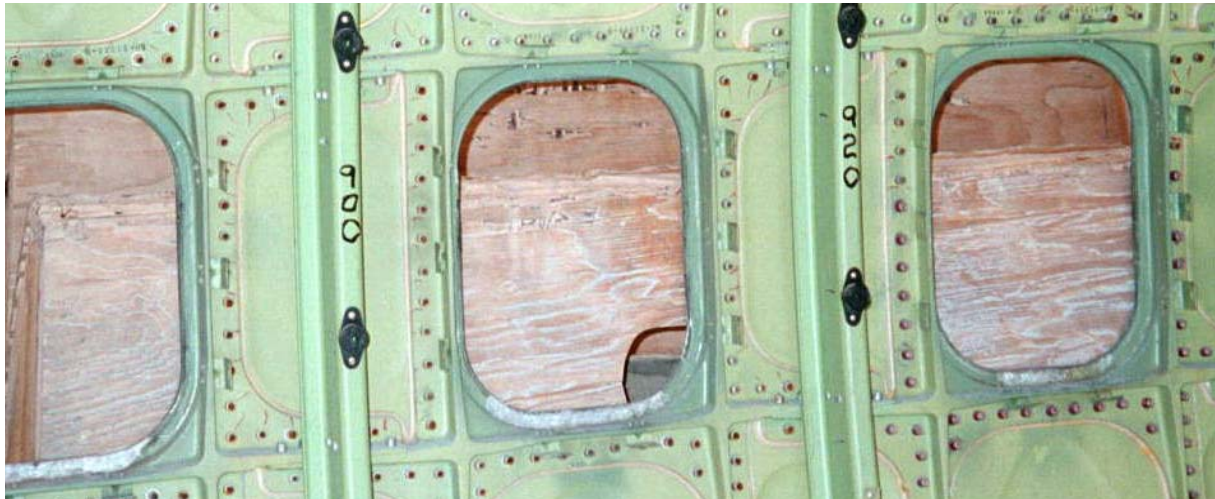
Figure 27-44: Lower Window Frame Corrosion Due to Moisture Accumulating Between Seal and Structure of Stored Airframe.

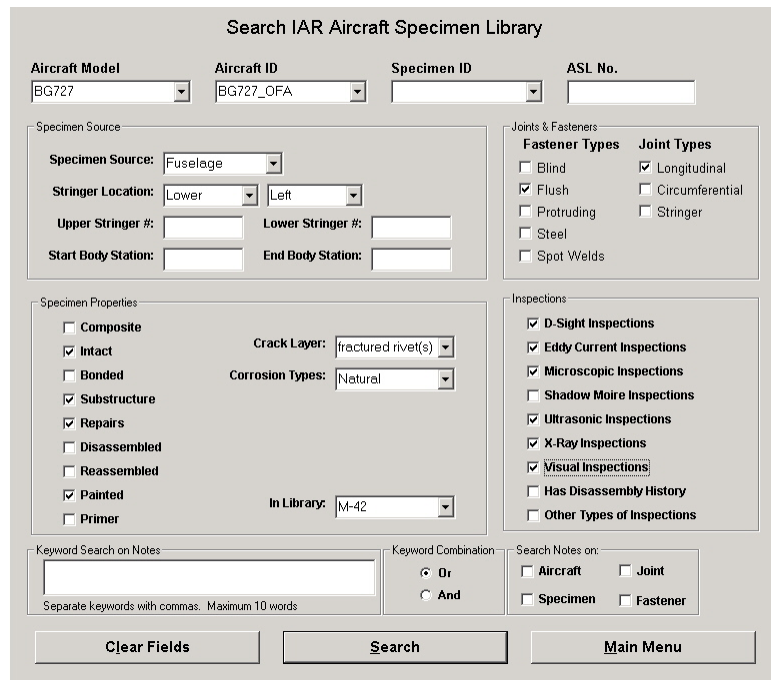
(a) Search pick-list has 27 parameters to choose from.

Figure 27-45: NRC/IAR Aircraft Specimen Library Database.

Storage space is always an issue, especially when the use of collected samples is uncertain. Linking collections via databases could enable users to avoid a heavy storage burden, but still have the benefit of access to representative material, available when the need arises. Figure 27-45 shows details from a database set up by the NRC/IAR in Canada.
