RTO AGARDograph

AG-AVT-140

Corrosion Fatigue and Environmentally Assisted Cracking in Aging Military Vehicles

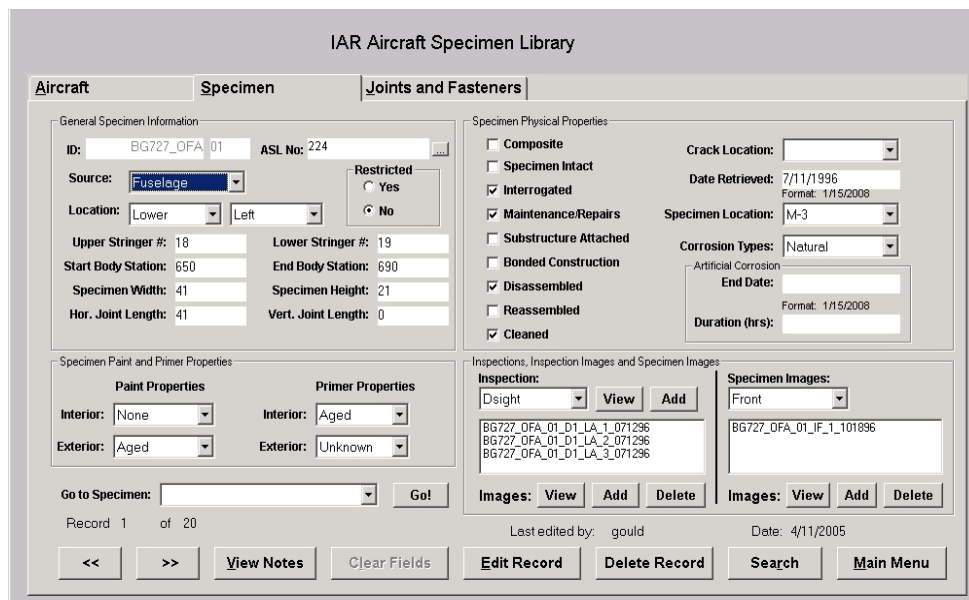
(b) Information on the parent aircraft, the condition of each specimen and detailed inspection results are all accessible through the database.

Figure 27-45: NRC/IAR Aircraft Specimen Library Database.

Storage space is always an issue, especially when the use of collected samples is uncertain. Linking collections via databases could enable users to avoid a heavy storage burden, but still have the benefit of access to representative material, available when the need arises. Figure 27-45 shows details from a database set up by the NRC/IAR in Canada.
