# **PMP LESSONS LEARNED**

**GLENN BENNINGER**  
**ADVISORY COORDINATOR**  
**30 AUGUST 2011**

# PMP Advisories

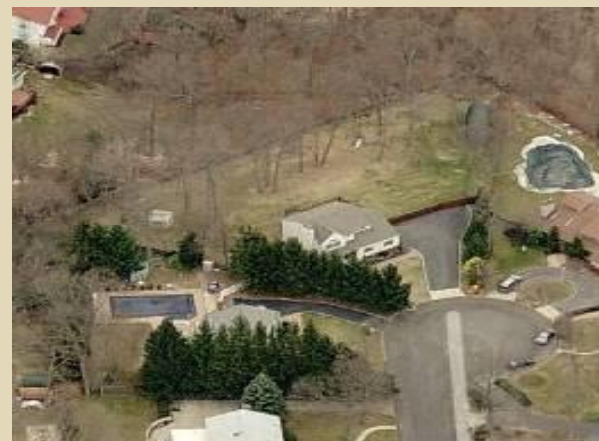
**Actual “facility”**

**Both distributors sell (sold) to defense contractors. Both advertise availability to thousands of components. Both are residential businesses.**

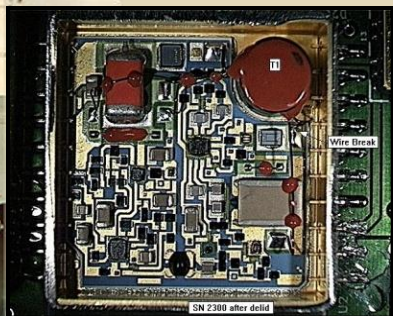
- No matter how hard you try, part failures happen, often because of seemingly innocuous reasons
  - Chip capacitor failures because the sintering oven experienced a power glitch at the factory (process control)
  - Power supply failure due to a tiny transformer breaking loose inside a hybrid. The epoxy pre-form used to glue it down was found to be contaminated by mishandling with silicone
  - SMA jacks with intermittent signal loss found caused by a bad batch of poorly formed center contact barrels making it into finished product

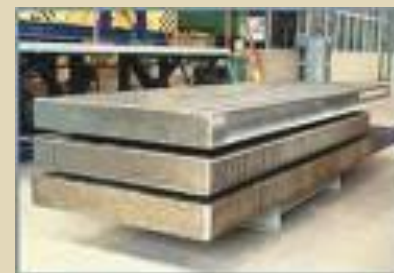
- Critical materials are occasionally a tempting thing to take shortcuts to save money or increase profit
- Titanium billet supplier was skipping a couple process steps to reduce cost on billet (an intermediate form of metal)
  - Was not rolling it to spec size, was cutting it
  - Was not performing spec heat treatment
- Resulted in potentially reduced material strength of titanium going into making aerospace parts

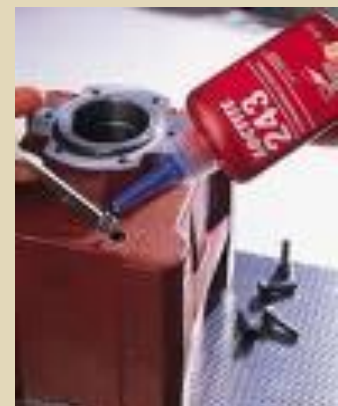
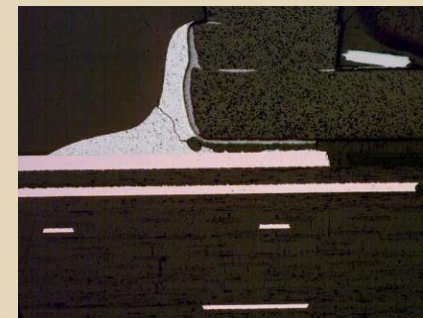
- **Tin Whiskers**
  - Pure tin plating, plus Zinc and Cadmium plating, will whisker given enough time – awareness and mitigation
- **Red Plague**
  - Silver plated wire will be destroyed by red plague (copper galvanic corrosion) given time, moisture, and plating damage
- **Silicone and Loctite Migration**
  - Silicone lubricants never cure, and creep and migrate to virtually any surface – avoid use where it can cause issues
  - Loctite (thread lock compound) does not cure, and creeps to unwanted areas – wipe off excess
- **Gold Embrittlement** – solder will become brittle if mixed with gold from gold plated pads
  - Remove 95% of gold from pads prior to soldering by tin/remove process
