**CREEP BEHAVIOR IN INTERLAMINAR SHEAR OF A CVI SIC/SIC
COMPOSITE AT ELEVATED TEMPERATURE IN AIR AND IN STEAM**

THESIS

Matthew T. Pope, Captain, USAF

AIR FORCE INSTITUTE OF TECHNOLOGY

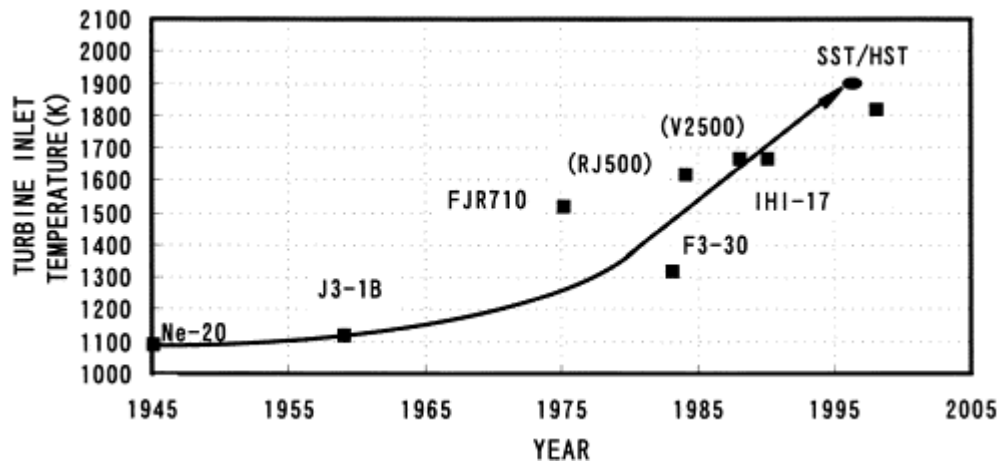
Modern aero-engine designs require higher performance, lighter weight, lower emissions, lower noise, and lower life cycle costs. These requirements demand increased thrust-to-weight ratios and increased turbine inlet temperatures (TIT) [2]. Figure 1 shows historical trends of TIT in jet engines over the past several years.

Figure 1 - Trends of TIT in a jet engine [reproduced from 2]

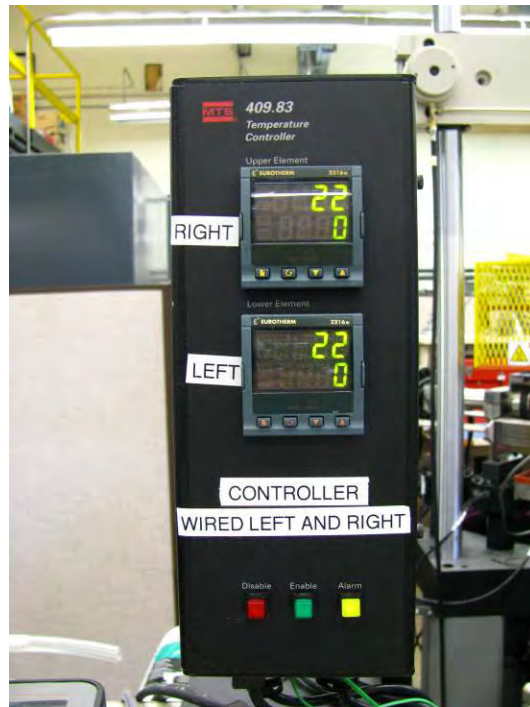
An AMTECO Hot Rail two-zone furnace system and two MTS 409.83 Temperature Controllers were used in all high-temperature tests.

Figure 8 - MTS 409.83 Temperature Controller

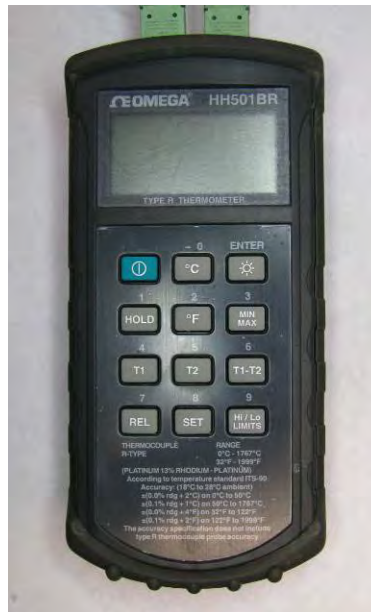
Figure 9 - Omega HH501BR thermometer

The two-zone furnace employed two R-type non-contacting thermocouples to measure the temperature inside the furnace. For testing at high temperature, a specimen was instrumented with R-type thermocouples in order to calibrate the furnace on a periodic basis. An Omega HH501BR thermometer (see Fig. 9) was employed to read the temperature measurements from thermocouples attached to the specimen. The furnace controllers (using non-contacting R-type thermocouples exposed to the ambient

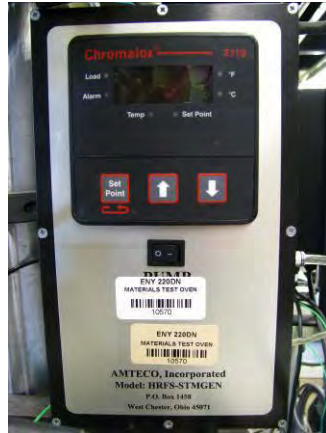
Figure 13 - Chromalox Steam Generator

An Amteco Chromalox 2110 Steam Generator supplied with deionized water was used to produce steam during tests conducted in steam environment. The steam generator and the feeding tube that delivers steam into the susceptor are shown in Figures 13 and 14, respectively.

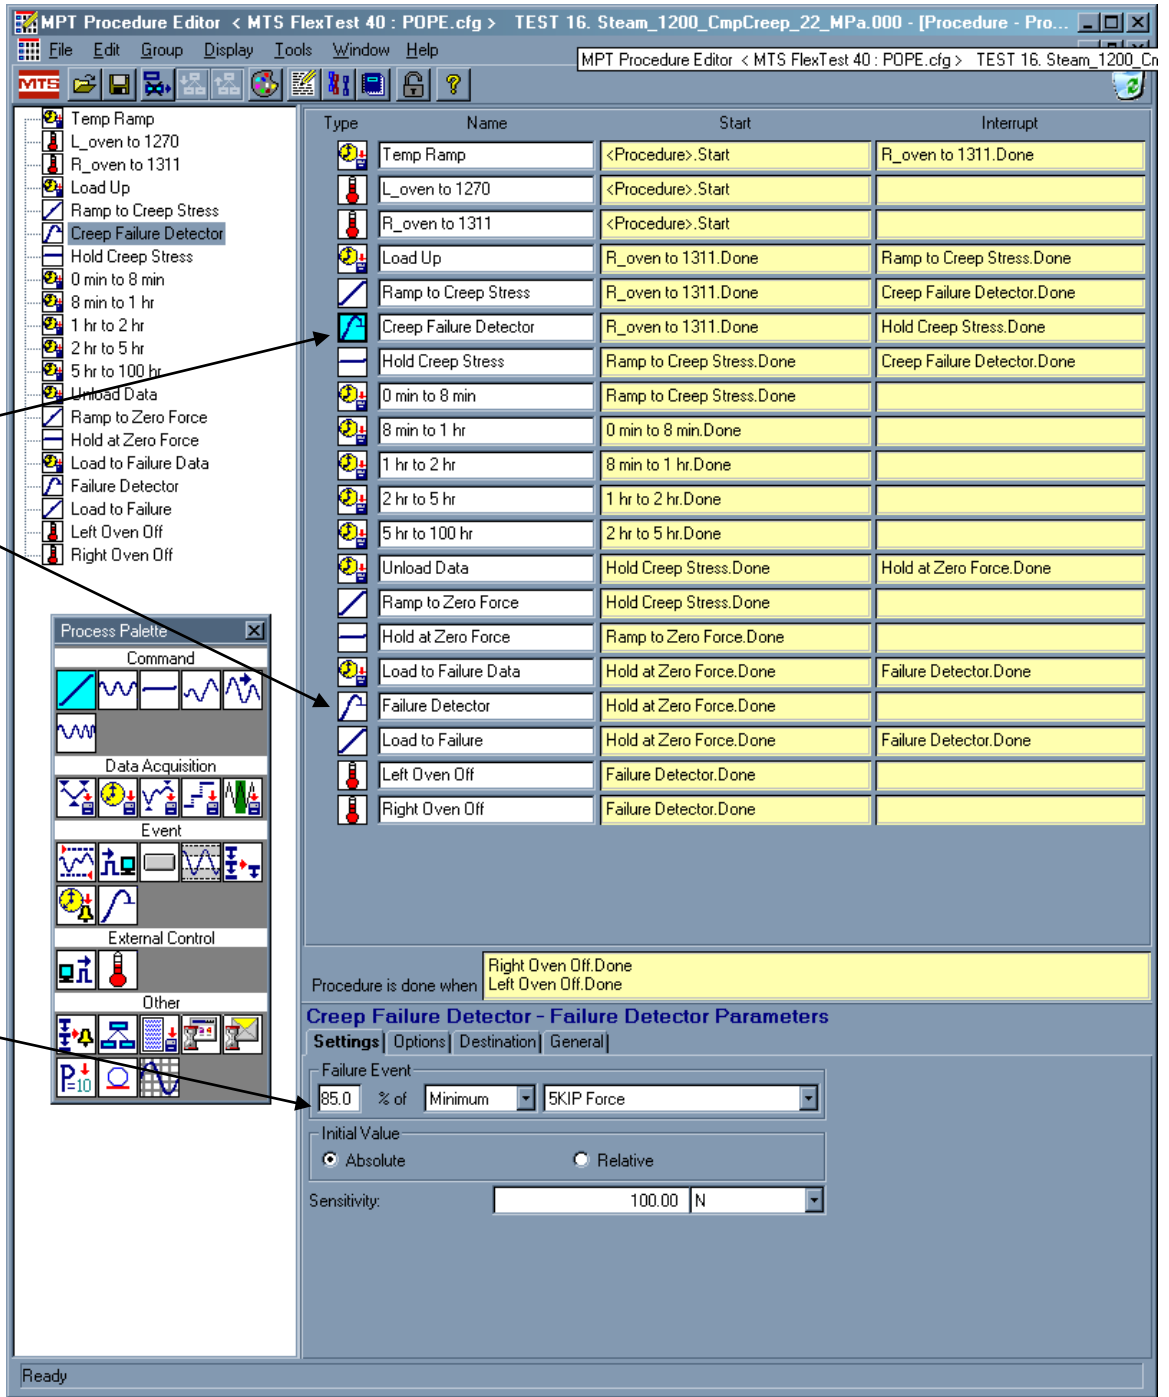
Figure 15 - MTS procedure showing failure detectors

An MTS Flex Test 40 digital controller was used for input signal generation and data collection. The MPT procedures used in this research were similar to those used by Mehrman, Siegert, and Laffey [22-24]. Laffey noted that the experiment had to be stopped instantaneously when failure occurred in compression, otherwise the fracture surfaces would be destroyed. The procedures used here monitored the load and shut off the hydraulics when the error between load command and load feedback exceeded the

failure detection parameters given in Figure 15. Creep runout was defined as 100 h at creep stress. The retained properties of all specimens that achieved run-out were characterized. The same failure detector that was previously used for monitoring failure during creep was used to detect failure during the test for retained properties.

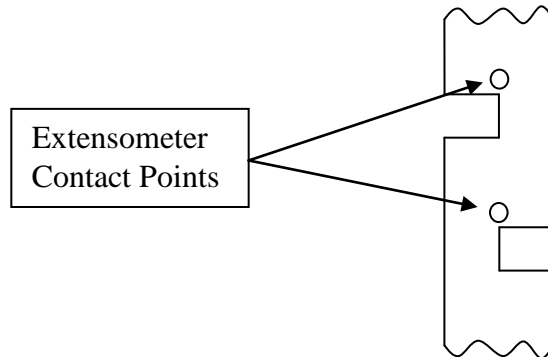
The extensometer rod contact positions on the specimen relative to the specimen notches were carefully chosen. The 13-mm distance between specimen notches was selected specifically to enable the measurement of compressive strain between the notch tips with an MTS high-temperature extensometer of 12.5-mm gage length. For strain measurement, the extensometer rods were placed as close to the notch tips of the specimen as possible (see Fig. 17).

Figure 17 - Locations of extensometer rod tips

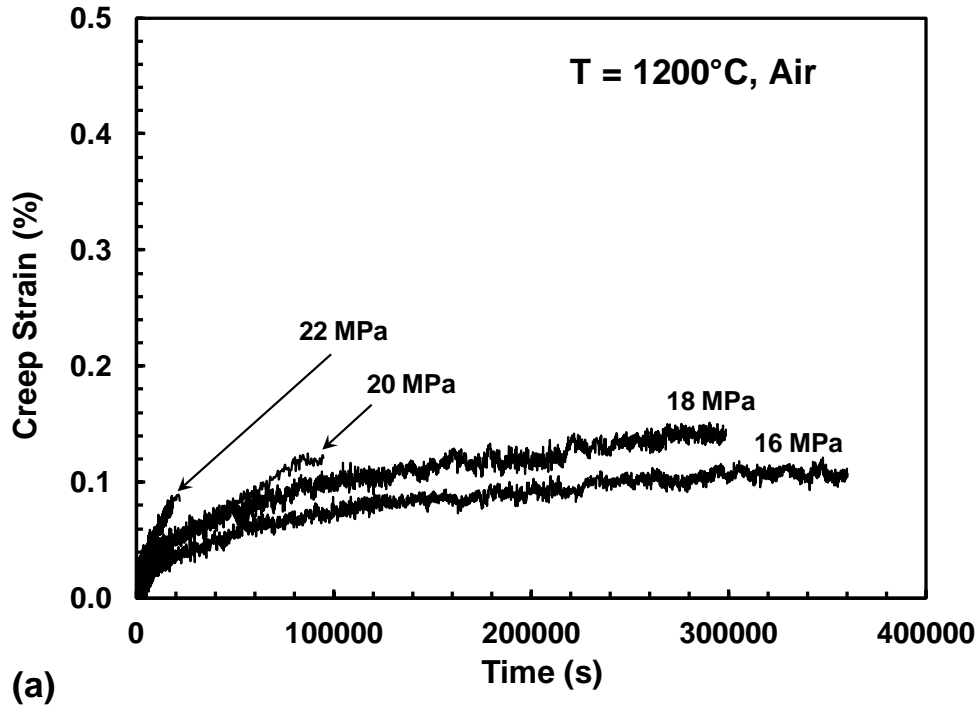
Figure 19 - ABS Creep Strain vs. Time curves for interlaminar shear creep tests on Hi-Nicalon/SiC-B4C Hi-Nicalon/PyC/HyperSiC Ceramic composite obtained at applied interlaminar shear stresses in the 16-22 MPa range at 1200 °C in air at 1200°C

At 1200 °C in air compressive creep tests were performed at the stress levels of 16, 18, 20 and 22 MPa. Results of the creep-rupture tests are summarized in Table 8, where rupture time and creep strain accumulation are shown for each applied shear stress level. Creep strain vs. time curves obtained at 1200 °C in air are shown in Fig. 19.

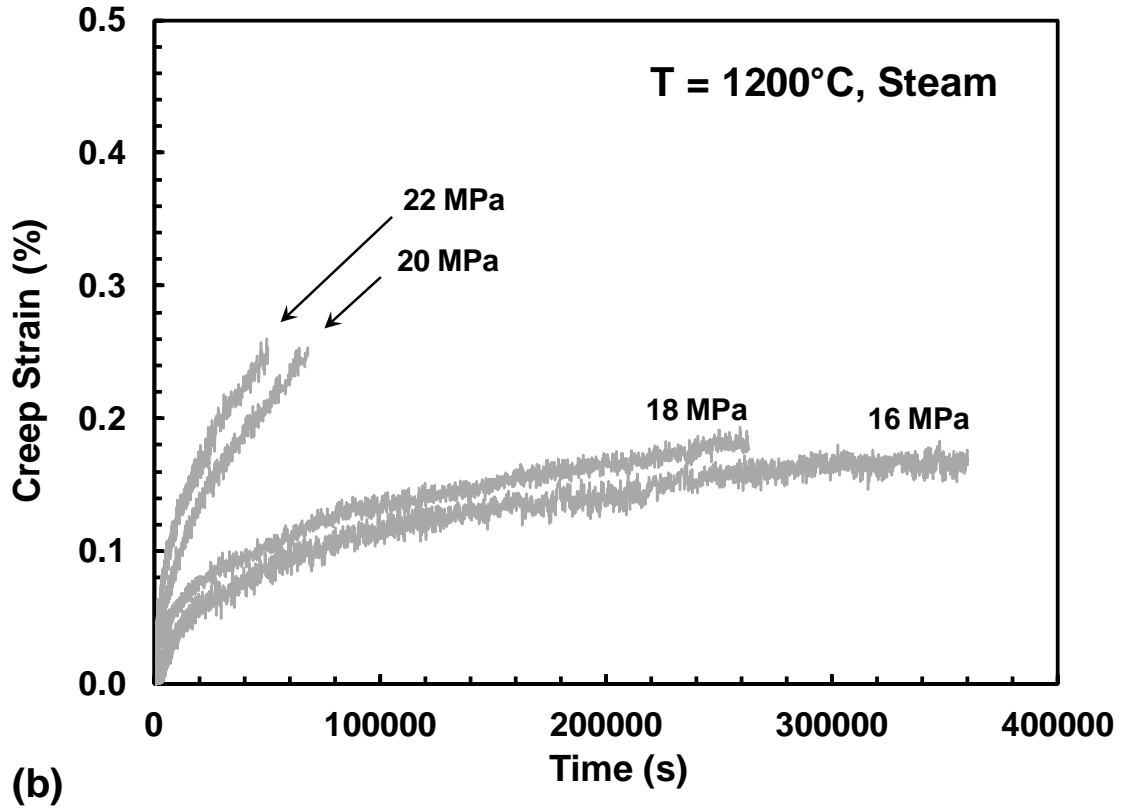
Figure 20 - - Creep strain vs. time curves for Hi-Nicalon/PyC/HyperSiC Ceramic Composite obtained at applied interlaminar shear stresses in the 16-22 MPa range at 1200 °C in steam

Results of the creep-rupture tests performed at 1200 °C in steam are summarized in Table 9, where results of the creep-rupture tests performed at 1200 °C in air are included for comparison. Creep strain vs. time curves obtained at 1200 °C in steam are shown in Fig. 31. Additionally the creep curves produced at 1200 °C in steam are compared to those obtained at 1200 °C in air in Fig. 20.

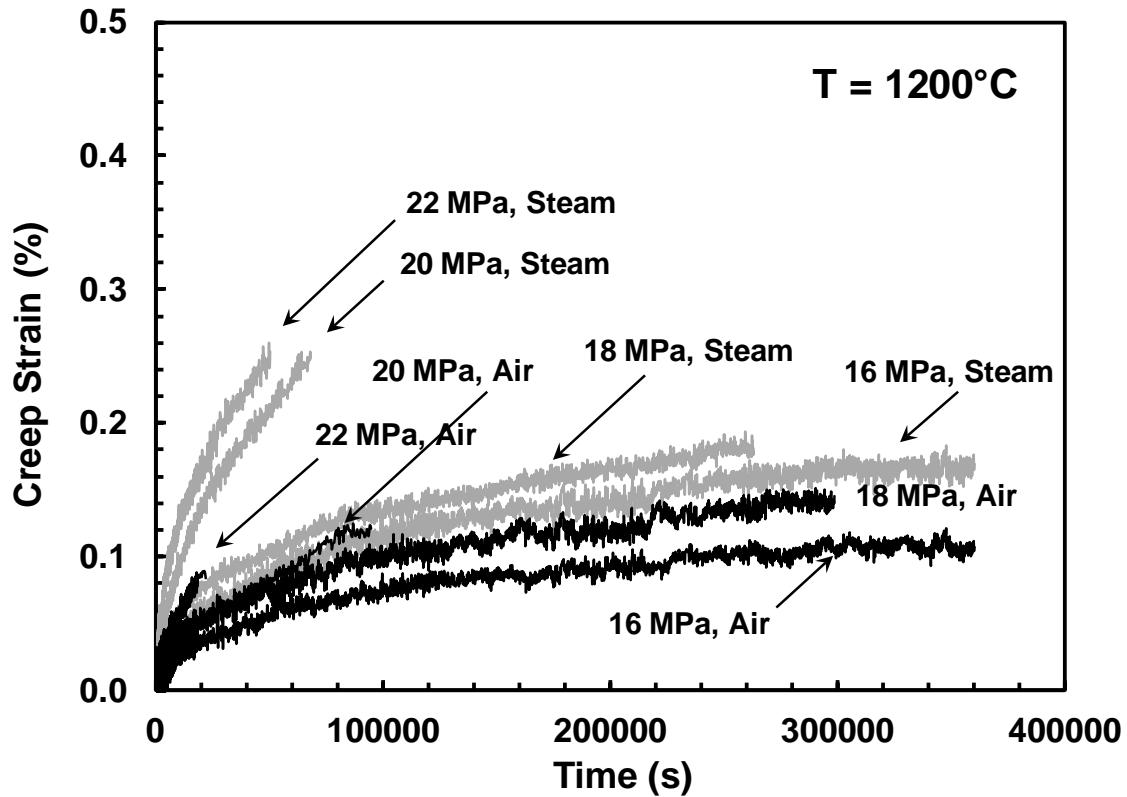
Figure 21 – Creep strain vs. time curves for Hi-Nicalon/PyC/HyperSiC Ceramic Composite obtained at applied interlaminar shear stresses in the 16-22 MPa range at 1200 °C in air and in steam

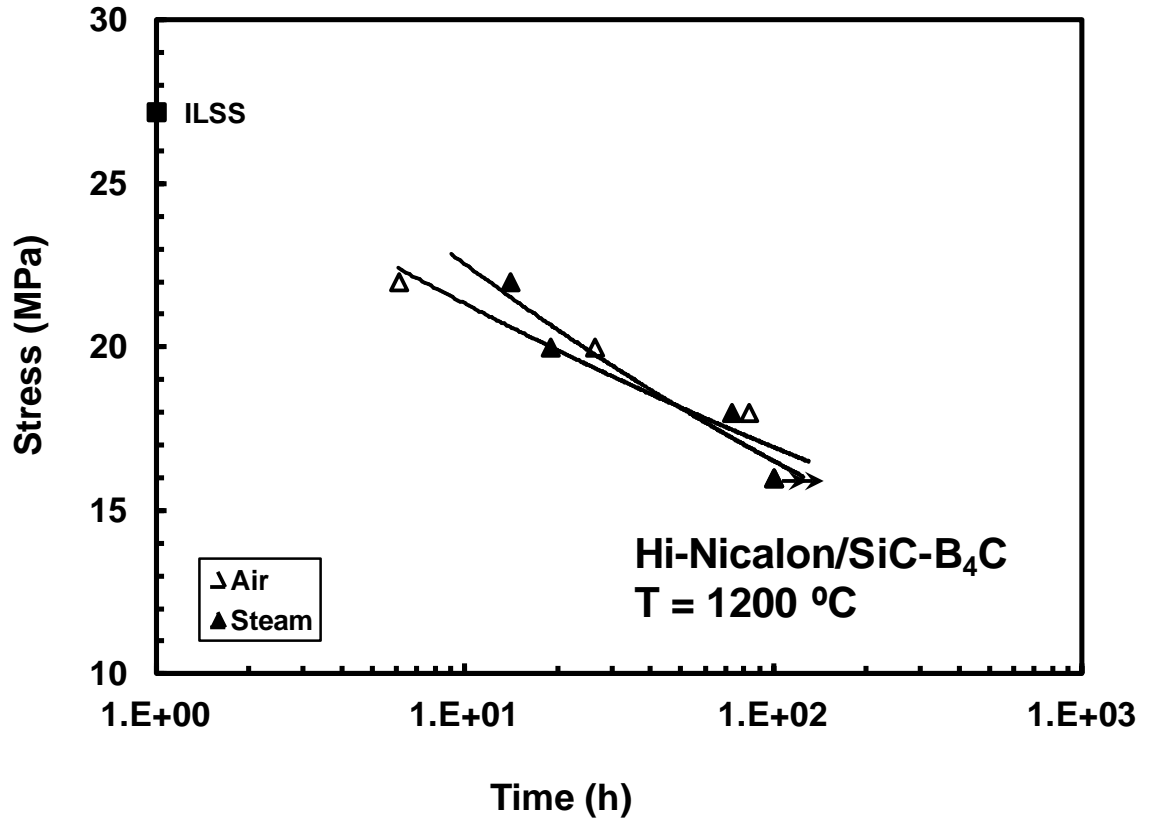
Stress-rupture behavior is summarized in Fig. 22, where applied shear stress is plotted vs. time to rupture at 1200 °C in air and in steam. In air and in steam, creep run-out of 100 h was achieved at 16 MPa (58.8% ILSS). For applied shear stress of 18 MPa the presence of steam has little effect on creep lifetime. The reduction in creep lifetime due to steam was limited to 12%. At 20 MPa, the reduction in creep life due to steam was more significant at 28%. However, at 22 MPa, the presence of steam appeared to be beneficial and extended creep lifetime.

Figure 22 - Interlaminar shear stress vs. time to rupture for Hi-Nicalon/PyC/HyperSiC Ceramic Composite at 1200 °C

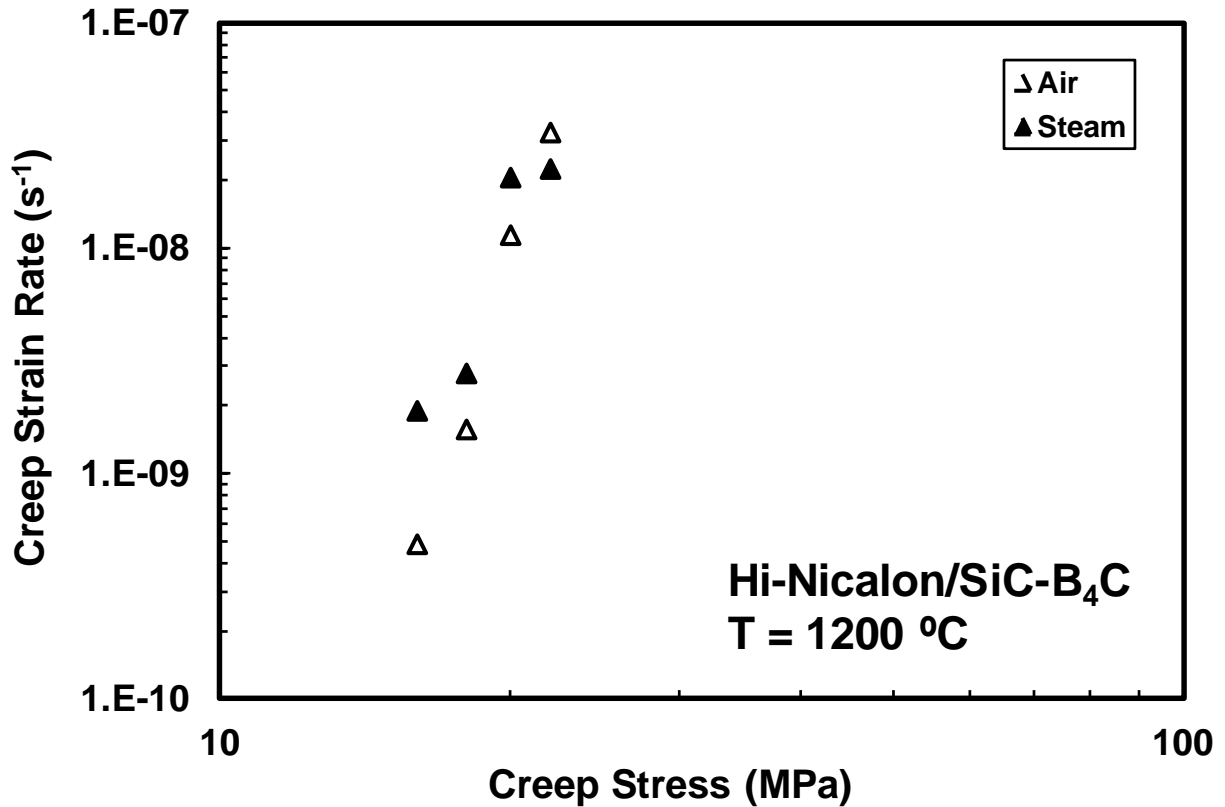
Minimum creep rate was measured in all tests. Creep strain rate as a function of applied stress is shown in Figure 23. In steam, the minimum creep rate increases by a factor of ~12 when applied stress increases from 16 to 22 MPa. At the lowest (runout) creep stress of 16 MPa, the creep rate in steam is ~4 times more than that in air at the same stress. At the highest creep stress of 22 MPa, creep rate in steam is only about 70% of that observed in air.

Figure 23- Minimum creep rate as a function of applied stress for Hi-Nicalon/PyC/HyperSiC Ceramic Composite at 1200 °C

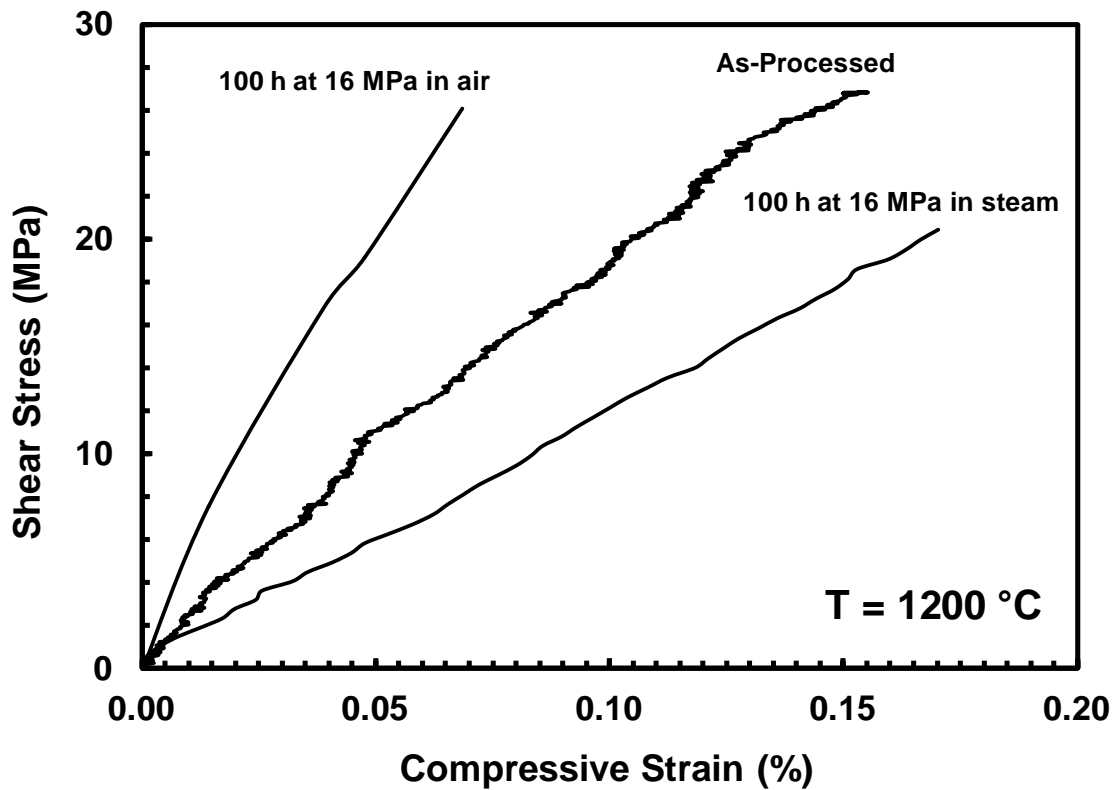
Figure 24 - Effects of prior creep in interlaminar shear on interlaminar shear stress - compressive strain behavior of Hi-Nicalon/PyC/HyperSiC Ceramic Composite at 1200 °C

Specimens that achieved the 100-hour runout were subjected to compression tests to failure to characterize the retained interlaminar shear properties. Retained ILSS values of the specimens that achieved a run-out at 16 MPa in air and in steam are given in Table 10. The stress-strain curves obtained for the Hi-Nicalon/SiC-B₄C specimens subjected to prior creep in interlaminar shear in air and in steam are presented in Fig. 24. The ILSS of the specimen pre-crept at 16 MPa in air has decreased only by ~4% compared to the ILSS of the as-processed specimen. Conversely, prior creep in steam has degraded the ILSS of Hi-Nicalon/SiC-B₄C by a considerable 25%. The specimen

pre-crept at 16 MPa in steam retained approximately 75% of its ILSS. As seen in Fig. 24, prior creep in either environment had little qualitative effect on stress-strain behavior.

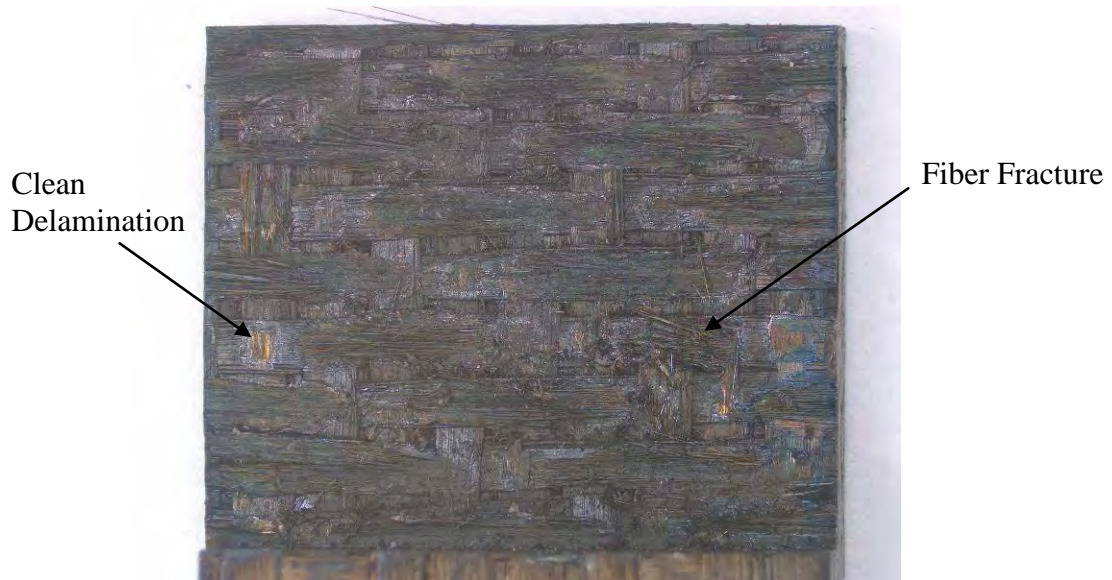
Figure 25 - Fracture surface of the Hi-Nicalon/SiC-B₄C DNS specimen tested in compression to failure at 1200 °C in air. Test duration < 5 s.

Figure 25 shows a typical fracture surface of the DNS specimen tested in compression to failure at 1200 °C in air. Delamination of the woven 0°/90° fiber layers from the matrix-rich regions appears to be the primary mechanism of interlaminar shear failure. Most of the fracture surface in Fig. 25 (a) is fairly smooth and clean, indicating that only a single fiber layer is associated with delamination. However, some rough areas exposing debris and fiber fracture (Fig. 25(a)) are also visible. Higher magnification images (Figs. 25 (b) and (c)) show that in the process of delamination the departing fibers leave distinct troughs in the remaining matrix. It is seen that small amounts of the matrix material remain bonded to the fibers exposed during delamination.

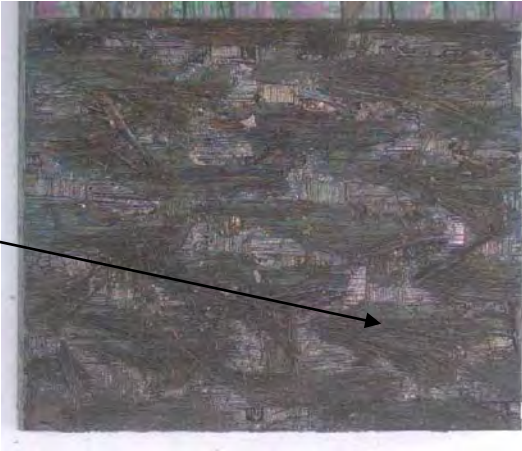
Figure 30 - Fracture surface of the Hi-Nicalon/SiC-B₄C DNS specimen tested in creep at 18 MPa and 1200 °C in air. Time to rupture = 83 h.

Figure 30 presents the micrographs of the fracture surface obtained in creep test performed at 18 MPa at 1200°C in air. Creep lifetime produced in this test was 83 h. Fracture surface in Figs. x (a) and (b) shows a large amount of fiber fracture and matrix damage and is dominated by areas exposing multiple 90° fiber bundles. As the test duration increased to 83 h, the failure mechanism has changed dramatically to include extensive fracture of fiber tows.

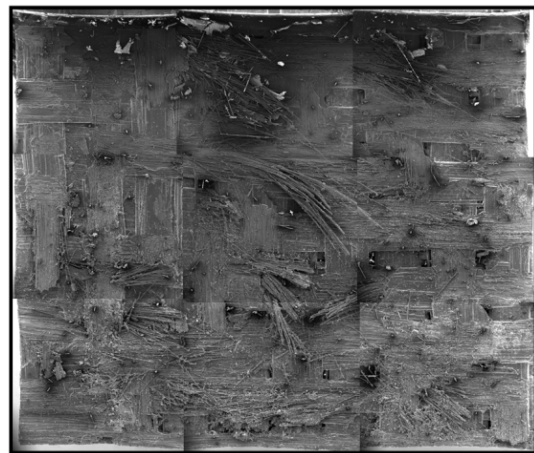
Figure 31 -Fracture surface of the Hi-Nicalon/SiC-B₄C DNS specimen tested in creep at 18 MPa and 1200 °C in steam. Time to rupture = 73 h.

Fracture surface produced in creep test performed at 18 MPa at 1200°C in steam is shown in Figure 31. Creep lifetime produced in this test was 73 h.

Fracture surface in Figs. 31 (a) and (b) shows extensive fiber fracture and matrix damage. Areas of clean interply delamination are not observed. As in the case of the test performed in air, the increase in test duration to 73 h caused a dramatic change in the failure mechanism. Fiber fracture is now the primary failure mechanism. Longer test duration also translates into increased exposure to oxidizing environment at elevated

temperature, which causes pervasive formation of the glassy phase throughout the fracture surface (Figs. 31 (d)-(m)). Additionally, extensive fiber-matrix bonding is observed (Fig. 31 (c)). It appears that the glassy phase has crystallized near the edges of the fracture surface (see Fig. 31 (k) and (l)). It is likely that borosilicate glass is the glassy phase present on this fracture surface. However, it is possible that due to prolonged test duration in steam, only silica remains in some areas. The EDS analysis would have to be performed to reach a definitive conclusion.

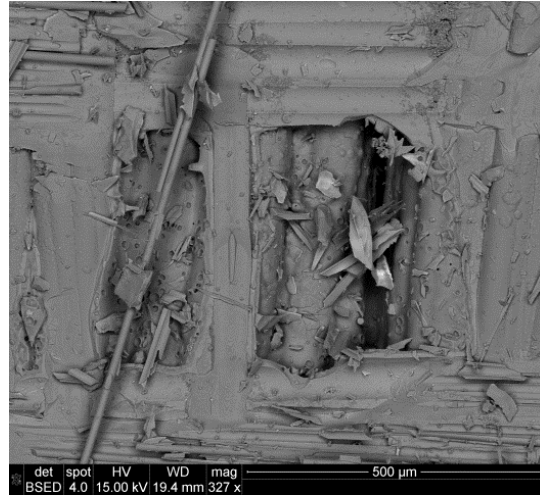
Figure 33 - Fracture surface of the Hi-Nicalon/SiC-B₄C DNS specimen subjected to 100 h of creep at 16 MPa then failed in compression and 1200 °C in steam.

Pervasive formation of the glassy phase is observed throughout the fracture surface. It is recognized that the increased amounts of the glassy phase are caused by the increased (>100 h) exposure at 1200°C in steam under load. It is likely that the oxidation of the B₄C matrix layers is followed by the oxidation of the SiC in the matrix, thus resulting in the formation of the borosilicate glass during the test. However, the EDS analysis would have to be performed to reach a definitive conclusion. Figures 33 (i) and (j) shows glassy phase present on the fracture surface. Note the “craters” in Figs. 33 (i) and (j), which are left in the glassy layer by escaping gases. Recall that gaseous reaction products are formed along with the glassy phase. If the viscosity of the glassy layer is high, the gases can only diffuse relatively slowly through the glassy layer. In the presence of steam, viscosity of the glassy layer decreases, allowing the gaseous reaction products to escape thereby leaving behind the craters in the glassy layer. Figure 33 (k) shows a larger deposit of the glassy phase near the edge of the fracture surface.

Furthermore, it appears that the glassy phase in Fig. 33 (k) has crystallized and cracks have formed after cooling down to room temperature.

Figure 33 presents the micrographs of the fracture surface subjected to 100 h of creep at 16 MPa then failed in compression at 1200°C in steam. Fracture surface in Figs. 33 (a) and (b) is dominated by extensive fiber fracture. Areas of violent failure exposing multiple 0°/90° fiber layers (shown Figs. 33 (c) and (d)) are seen throughout the fracture surface. Extensive fiber/matrix bonding is also observed throughout the fracture surface. Damaged fibers and matrix (shown in Figs. 33 (e)-(h)) are observed in multiple areas of the fracture surface. No areas of clean interply delamination can be found. The primary failure mechanism has completely changed from interply delamination to fracture of fiber tows.

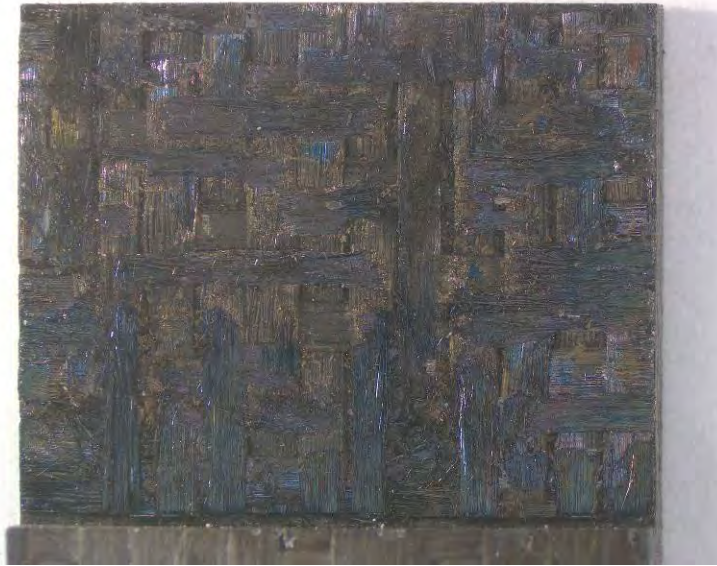
Figure 34 – P6-3, Fracture surface of Hi-Nicalon/PyC/HyperSiC Ceramic Composite specimen tested in compression to failure at 1200 °C in air

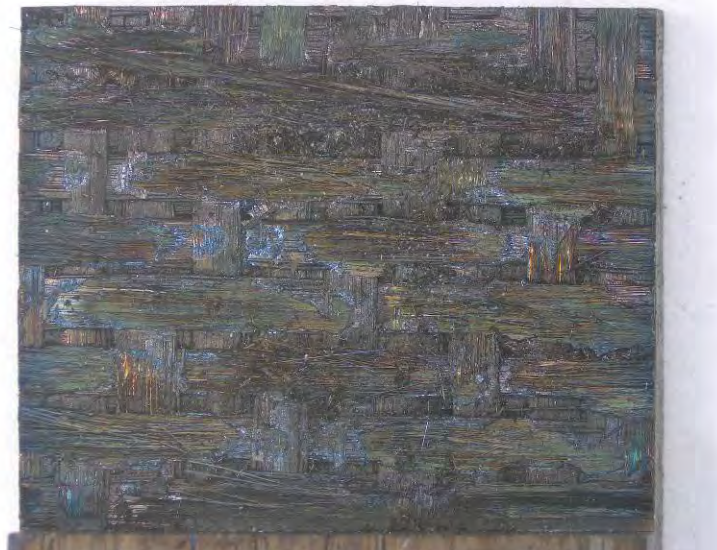
Figure 35 – P8-1, Fracture surface of Hi-Nicalon/PyC/HyperSiC Ceramic Composite specimen tested in compression to failure at 1200 °C in air

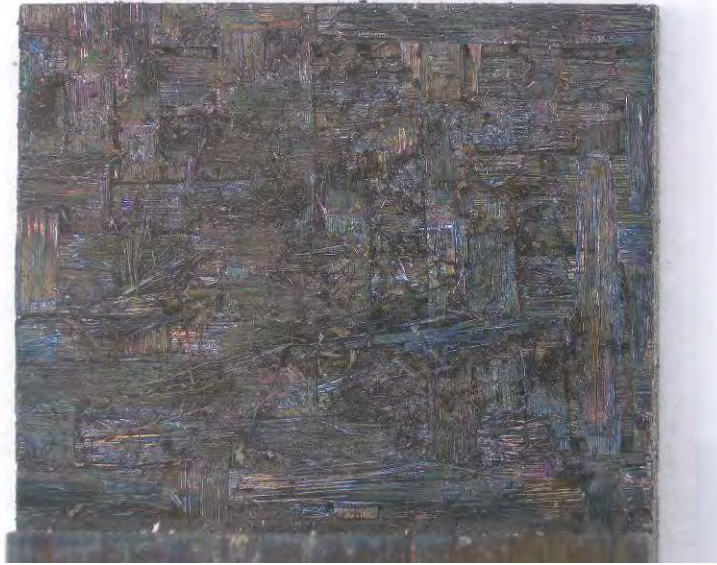
Figure 36 – P2-3, Fracture surface of Hi-Nicalon/PyC/HyperSiC Ceramic Composite specimen tested in compression to failure at 1200 °C in air

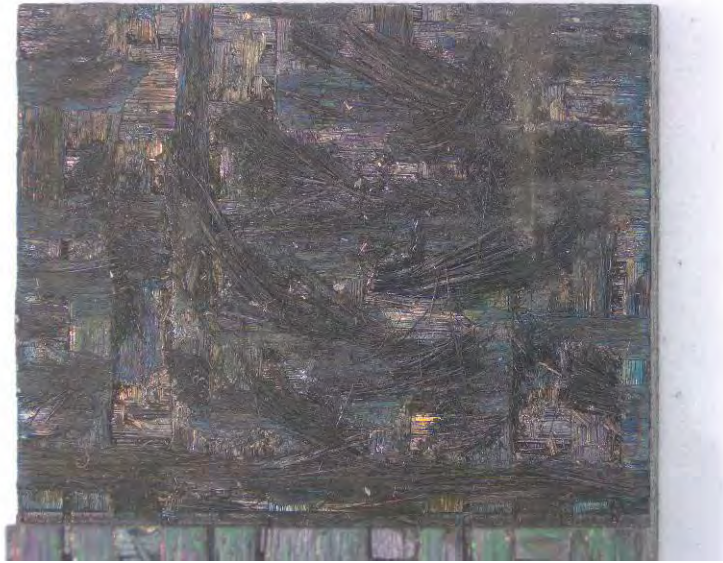
Figure 38 – P6-4, Fracture surface of Hi-Nicalon/PyC/HyperSiC Ceramic Composite specimen tested in creep at -16 MPa and 1200 °C in air

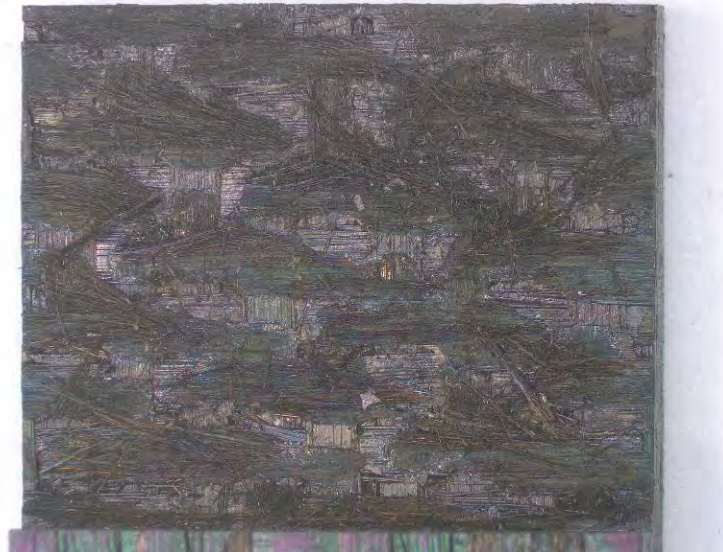
Figure 39 – P9-2, Fracture surface of Hi-Nicalon/PyC/HyperSiC Ceramic Composite specimen tested in creep at -18 MPa and 1200 °C in air

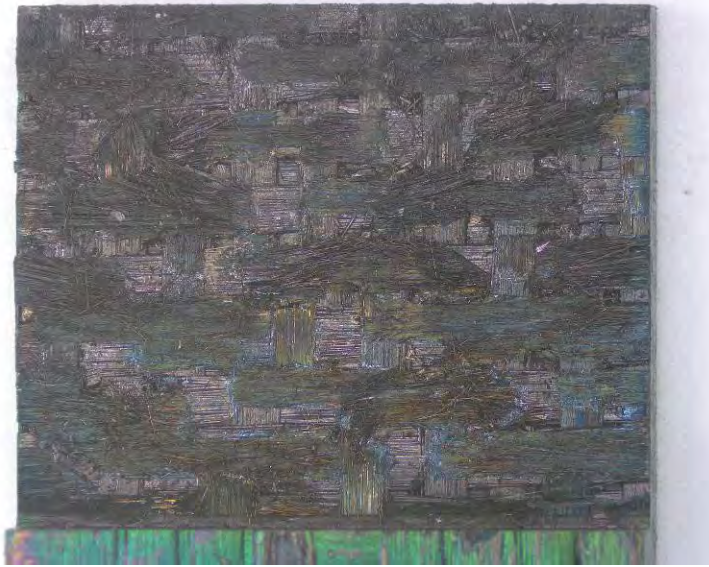
Figure 40 – P8-4, Fracture surface of Hi-Nicalon/PyC/HyperSiC Ceramic Composite specimen tested in creep at -20 MPa and 1200 °C in air

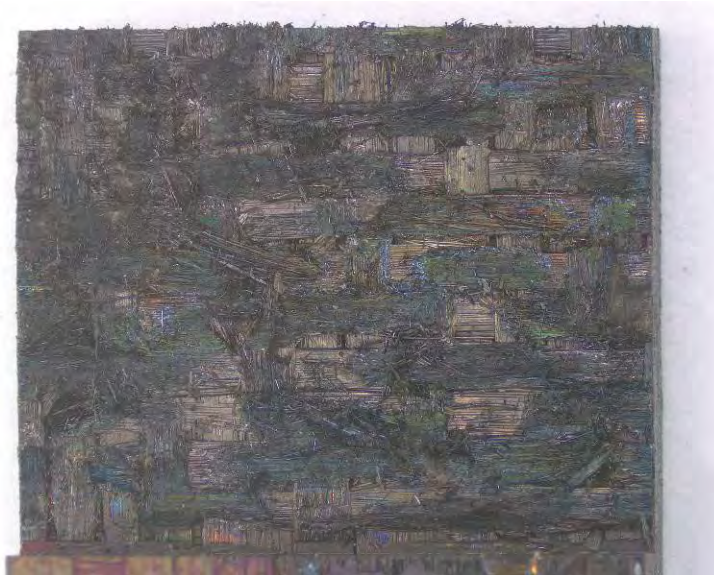
Figure 41 – P2-6, Fracture surface of Hi-Nicalon/PyC/HyperSiC Ceramic Composite specimen tested in creep at -22 MPa and 1200 °C in air

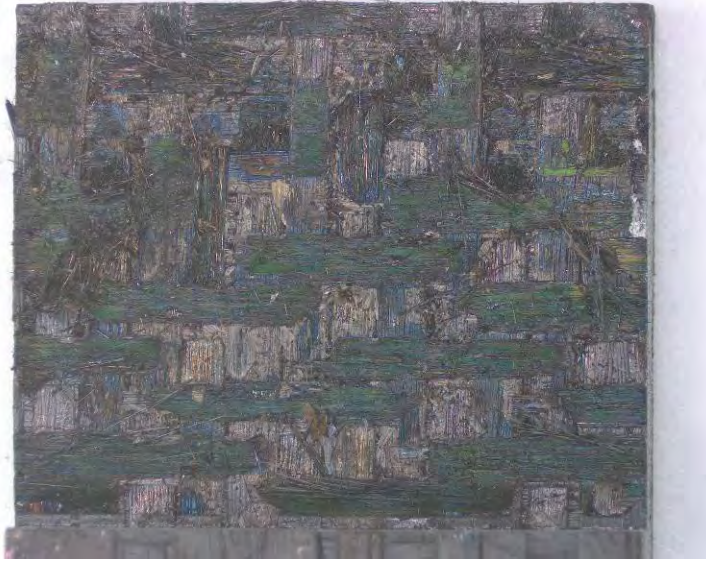
Figure 42 – P2-5, Fracture surface of Hi-Nicalon/PyC/HyperSiC Ceramic Composite specimen tested in creep at -16 MPa and 1200 °C in steam

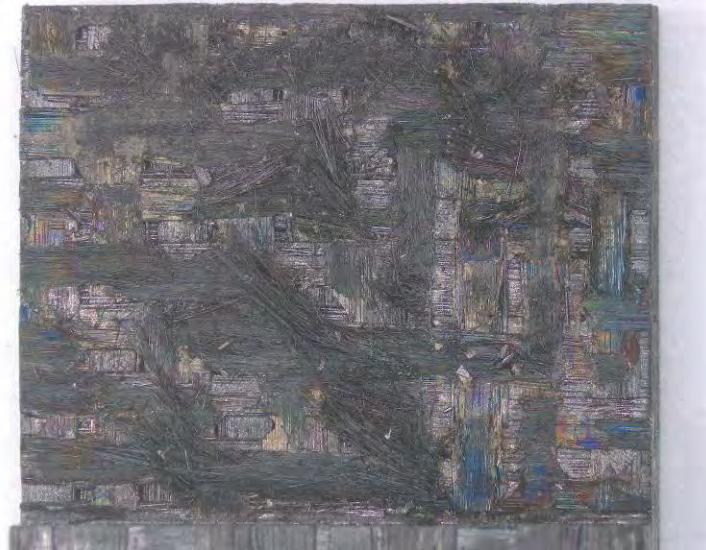
Figure 43 – P8-5, Fracture surface of Hi-Nicalon/PyC/HyperSiC Ceramic Composite specimen tested in creep at -18 MPa and 1200 °C in steam

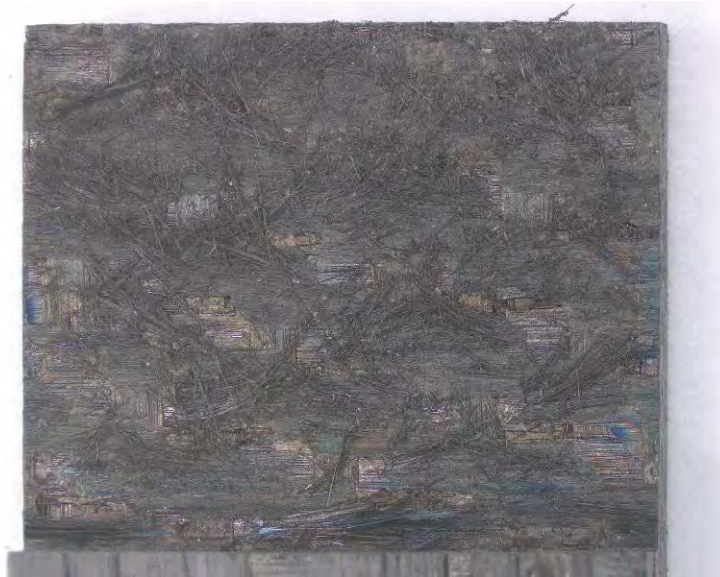
Figure 44 – P9-3, Fracture surface of Hi-Nicalon/PyC/HyperSiC Ceramic Composite specimen tested in creep at -20 MPa and 1200 °C in steam

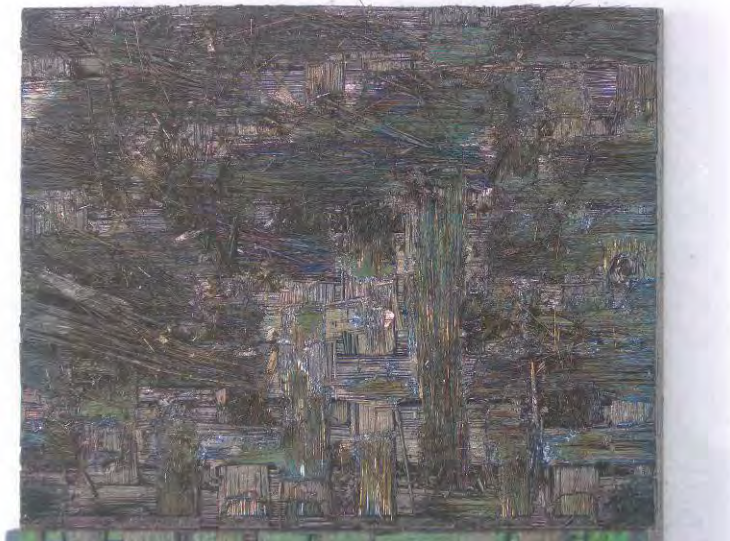
Figure 45 – P9-4, Fracture surface of Hi-Nicalon/PyC/HyperSiC Ceramic Composite specimen tested in creep at -22 MPa and 1200 °C in steam

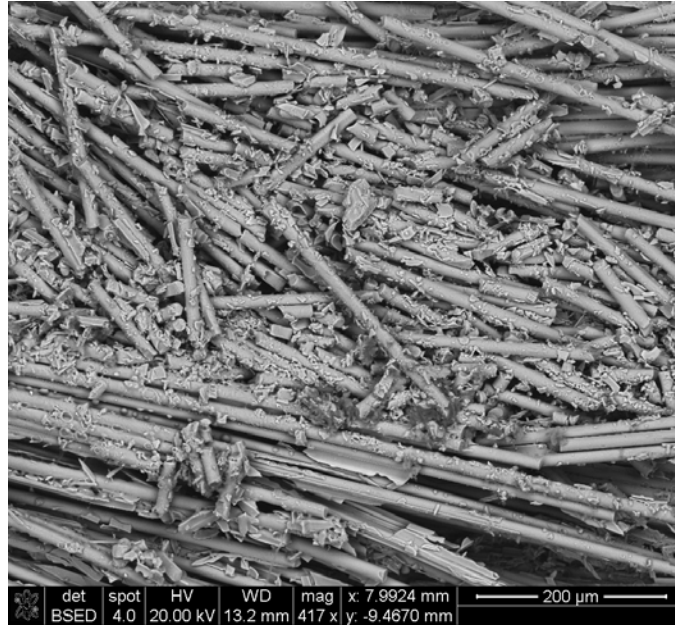
Figure 76 - SEM image showing fractured fibers bound with glass and matrix of Hi-Nicalon/PyC/HyperSiC Ceramic Composite specimen tested in compression at 20 MPa at 1200 °C in steam

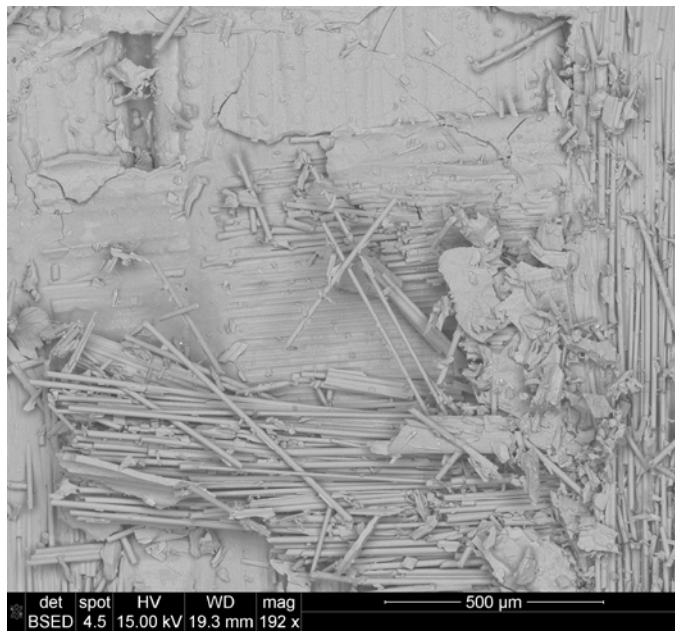
Figure 79 - SEM image showing delamination zone with debris of Hi-Nicalon/PyC/HyperSiC Ceramic Composite specimen tested in compression at 22 MPa at 1200 °C in air

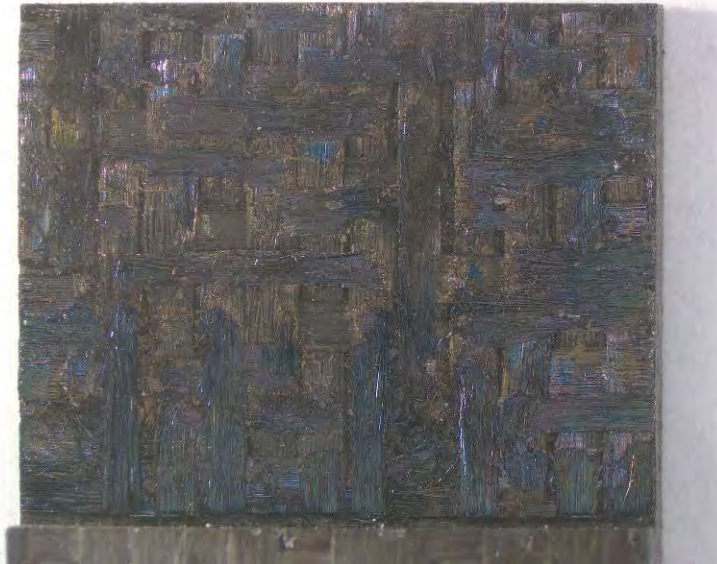
Figure 90 – P6-3, Fracture surface of Hi-Nicalon/PyC/HyperSiC Ceramic Composite specimen tested in compression to failure at 1200 °C in air

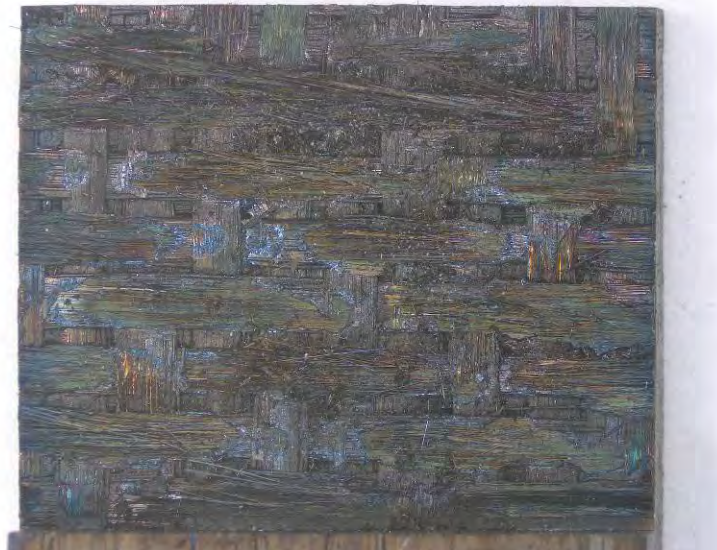
Figure 91 – P8-1, Fracture surface of Hi-Nicalon/PyC/HyperSiC Ceramic Composite specimen tested in compression to failure at 1200 °C in air

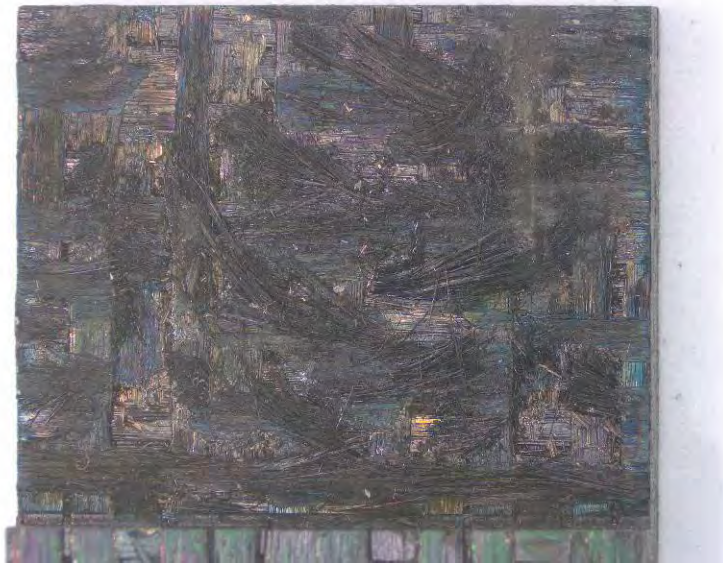
Figure 94 – P6-4, Fracture surface of Hi-Nicalon/PyC/HyperSiC Ceramic Composite specimen tested in creep at -16 MPa and 1200 °C in air

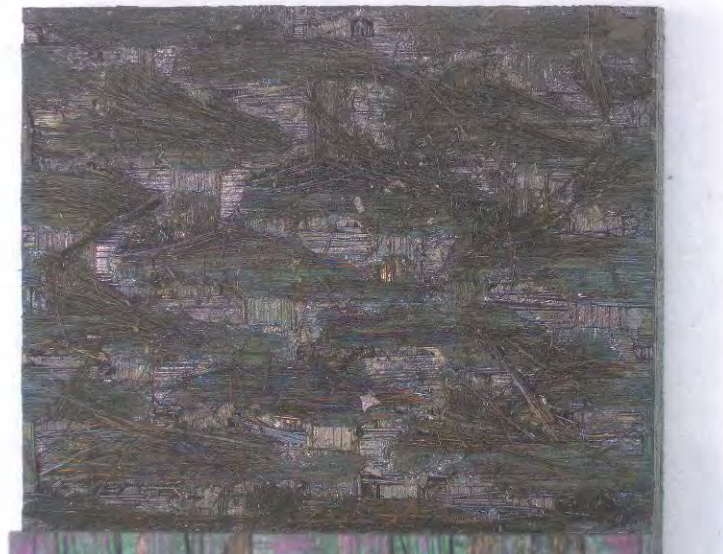
Figure 95 – P9-2, Fracture surface of Hi-Nicalon/PyC/HyperSiC Ceramic Composite specimen tested in creep at -18 MPa and 1200 °C in air

Figure 95 – P9-2, Fracture surface of Hi-Nicalon/PyC/HyperSiC Ceramic Composite specimen tested in creep at -18 MPa and 1200 °C in air 98

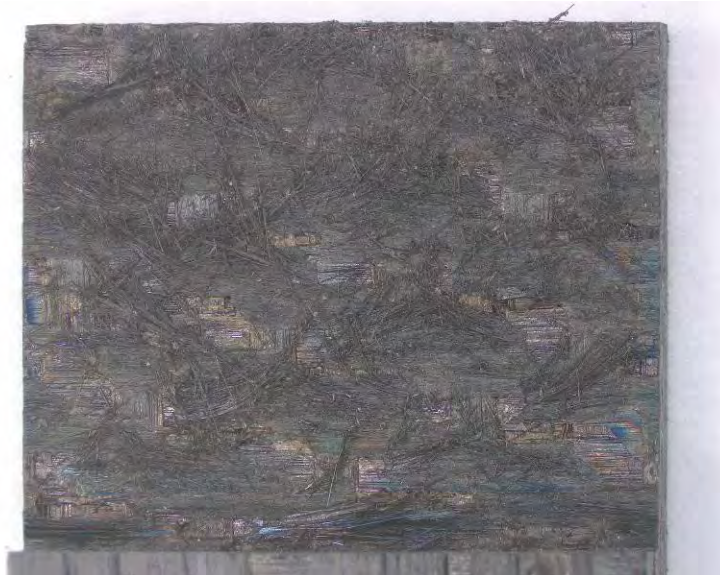
Figure 100 – P9-3, Fracture surface of Hi-Nicalon/PyC/HyperSiC Ceramic Composite specimen tested in creep at -20 MPa and 1200 °C in steam

Figure 100 – P9-3, Fracture surface of Hi-Nicalon/PyC/HyperSiC Ceramic Composite specimen tested in creep at -20 MPa and 1200 °C in steam 101

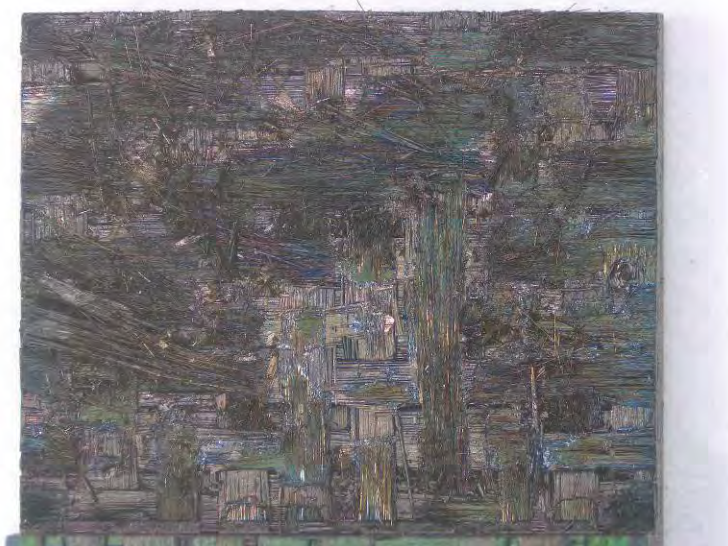
Figure 101 – P9-4, Fracture surface of Hi-Nicalon/PyC/HyperSiC Ceramic Composite specimen tested in creep at -22 MPa and 1200 °C in steam

Figure 101 – P9-4, Fracture surface of Hi-Nicalon/PyC/HyperSiC Ceramic Composite specimen tested in creep at -22 MPa and 1200 °C in steam 101
