**CERAMIC MATRIX COMPOSITE CHARACTERIZATION UNDER A GAS  
TURBINE COMBUSTION AND LOADING ENVIRONMENT**

THESIS

Dustin J. Bertrand, Captain, USAF

AFIT-ENY-14-M-08

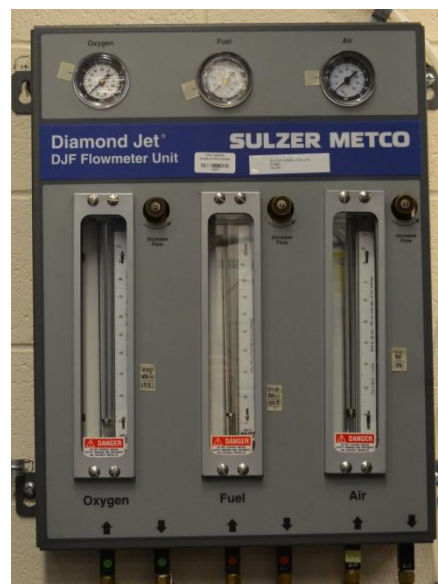
To control the gas flow of the flame gun, a DJF Diamond Jet Gas Flowmeter unit was used. The flowmeter unit consists of three rotameters to control oxygen, propane, and air flow independently. These three rotameters allow the accurate control of the amount of each gas being fed to the spray gun to control the flame being produced. Figure 13 shows the DJF gas flowmeter unit.

**Figure 13 - DJF Flowmeter Unit Used To Control Spray Gun**
