# *NDCEE*

## Corn Hybrid Polymer Media for Coatings Removal from Delicate Substrates

Brian Yallaly, NDCEE

| Report Documentation Page | | | | Form Approved<br>OMB No. 0704-0188 | |
|---|---|---|---|---|---|
| 13. SUPPLEMENTARY NOTES<br><b>JSEM - Joint Services Environmental Management Training Conference &amp; Exposition Conference, 5-8 May 2008, Denver, CO.</b> | | | | | |

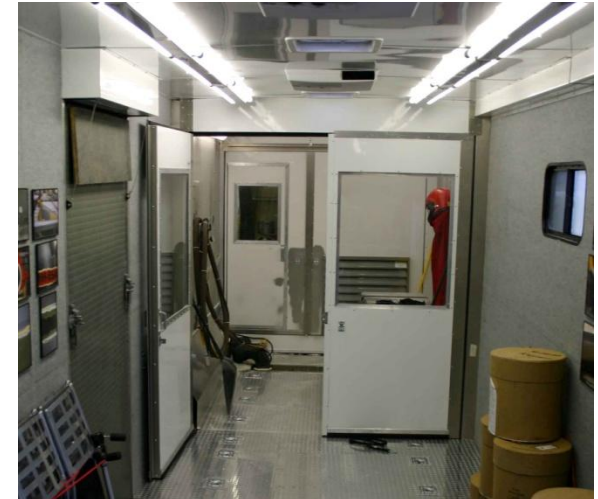
Midvale's mobile demonstration facility

The mobile facility includes a fully enclosed blast room, media delivery system, material recovery system, and personal protective equipment

- Demonstrations were conducted inside of Midvale's mobile demonstration facility, facility blast booths, or in-situ (ship bulkhead)
- Media is recovered inside of the mobile facility and then disposed of by host facility personnel or Midvale

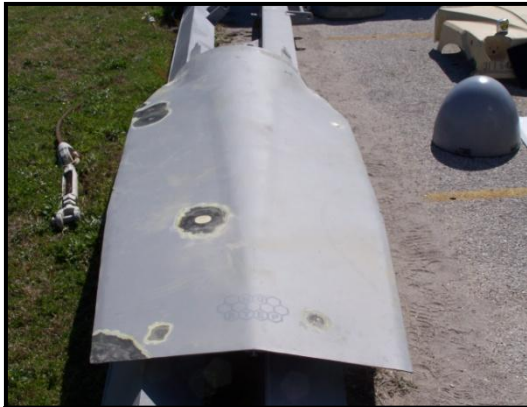
F-15 speed brake  
(Fiberglass substrate)  
(prior to coating removal)

| Component | Coating System | Substrate | BASELINE PROCESS | | | CHP | | |
|---|---|---|---|---|---|---|---|---|
| <b>F-15 Speed Brake</b> | Wash Primer, followed by polyurethane, finished with antistatic topcoat (15 mils total) | Fiberglass | Hand Sanding | 0.3 | Extremely time consuming and substrate damage often noted | 33 | 9.1 | Coatings removed to primer with no visible substrate damage |

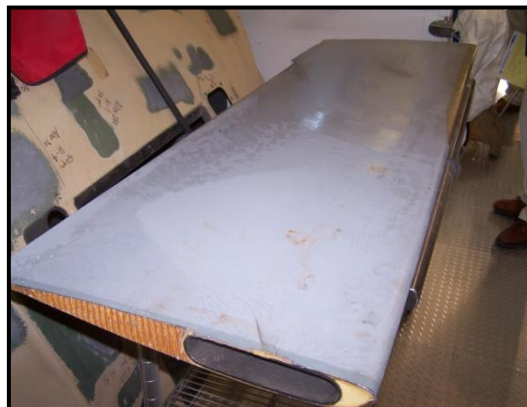
SH-60 helicopter blade  
(Titanium/fiberglass/carbon graphite  
substrate)  
(prior to coating removal)

| Component | Coating System | Substrate | BASELINE PROCESS | | | CHP | | |
|---|---|---|---|---|---|---|---|---|
| <b>SH-60 Helicopter Blade</b> | Polyurethane | Titanium, fiberglass, and carbon graphite matrix | Hand Sanding | 1.0 | Fiber waste is not contained and sanding process is not worker friendly | 26 | 29.0 | Coating removed to primer with no visible substrate damage |

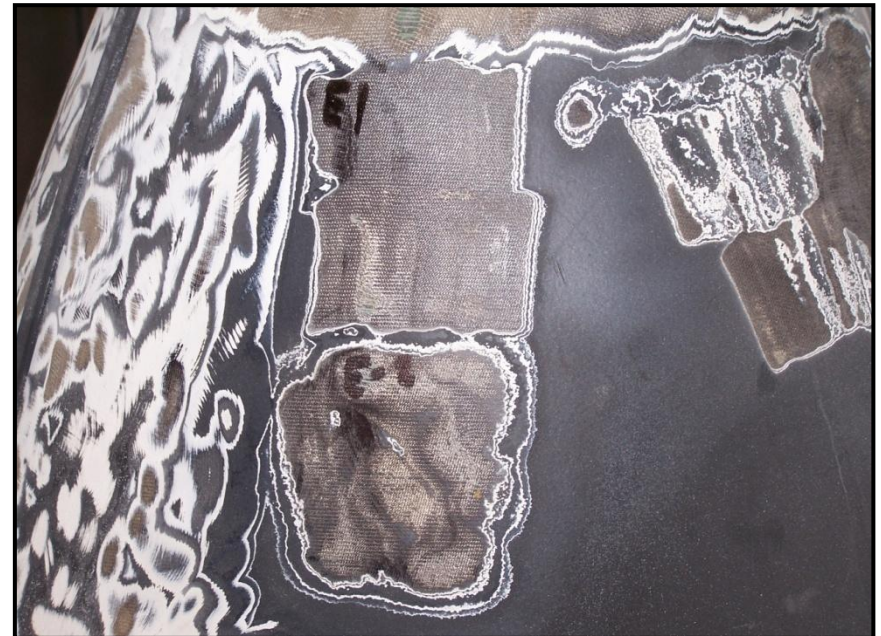
Coating removed from C-130 spinner cap at a rate of 10 ft<sup>2</sup>/hr with no visual damage to the substrate (fiberglass) or embedded electrical wires

| Component | Coating System | Substrate | BASELINE PROCESS | | | CHP | | |
|---|---|---|---|---|---|---|---|---|
| <b>C-130 Spinner</b> | Surface primer with polyurethane erosion resistant coating (7-9 mils total) | Fiberglass with electrical wires embedded | Hand Sanding | 0.6 | Significant damage to substrates and wires embedded within | 35 | 9.8 | Coating removed to the substrate with no visible damage |

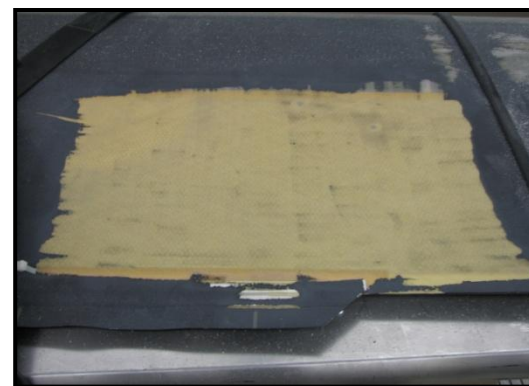
Coatings removed to fiberglass  
substrate at a rate of 34.4 ft<sup>2</sup>/hr (@  
32psi) with no substrate damage

| Component | Substrate | Baseline Process | CHP | | |
|---|---|---|---|---|---|
| <b>UH-60 Rotor Blade</b> | Kevlar with Section of Aluminum Lightning Mesh | Hand Sanding | 32 | <b>34.4</b> | Coating removed completely to substrates (i.e., Kevlar and aluminum) with no visual substrate damage |

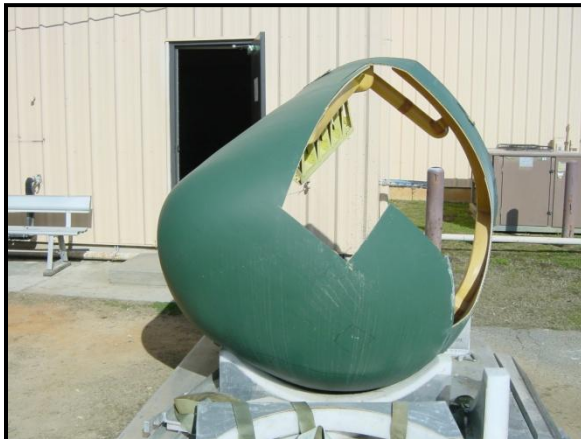
## Scrap MC-130 Nose Radome for Demonstration

- Fiberglass Honeycomb Substrate
- Coating System:
  - MIL-PRF-23377 Type 1 Primer
  - MIL-C-83231 Type II Polyurethane Rain Erosion Coating
  - MIL-C-85285 Polyurethane Topcoat
- Strip Rate 42.35 ft<sup>2</sup>/hr (@35psi)
- Coating removed to bare fiberglass substrate
- No visible substrate damage

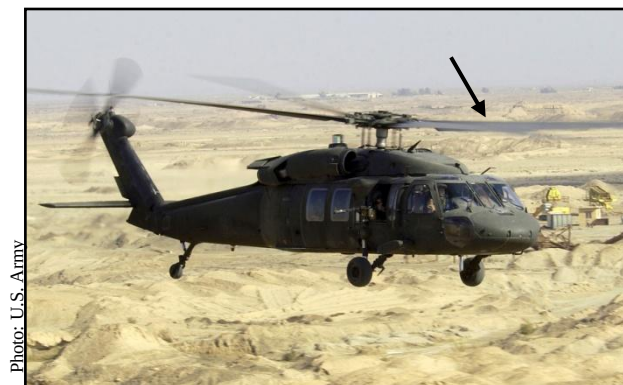
- Fiberglass Honeycomb Substrate with Aluminum Lightning Mesh
- Coating System:
  - MIL-PRF-23377 Primer
  - MIL-C-46168 Topcoat
- Strip Rate 15.3 ft<sup>2</sup>/hr (@30psi) (Baseline: 1.5 ft<sup>2</sup>/hr)
- Coating removed to bare fiberglass substrate
- No visible substrate damage

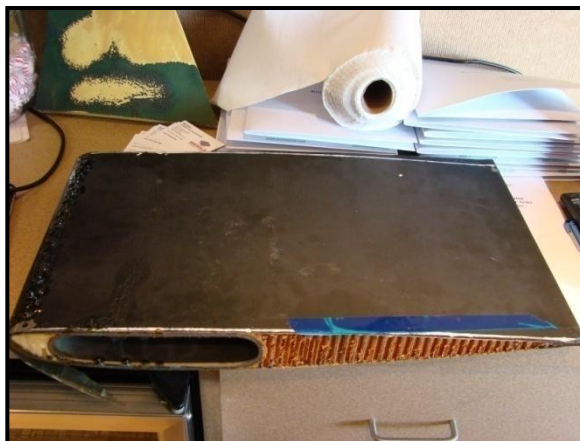
UH-60 Rotor Blade Section  
Prior to CHP Blasting

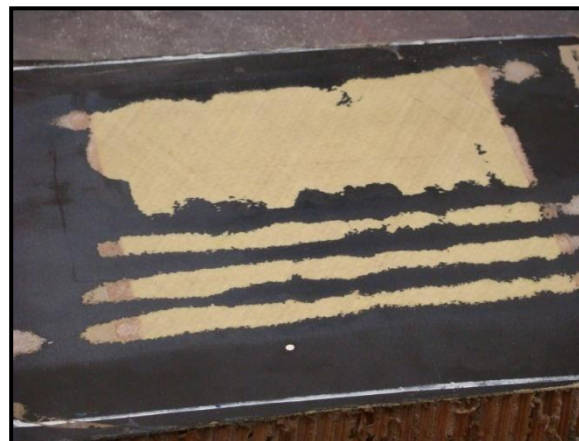
UH-60 Rotor Blade Section  
CHP Blasting Various Pressures
