*Infrared Reflectance Imaging for Environmentally  
Friendly Corrosion Inspection Through Organic Coatings  
Project Number WP-0407*

Mr. John Weir, P.E., Northrop Grumman Corporation  
Mr. Jack Benfer, NAVAIR Jacksonville FL

ESTCP Conference  
Tempe, AZ

25-29 February 2008

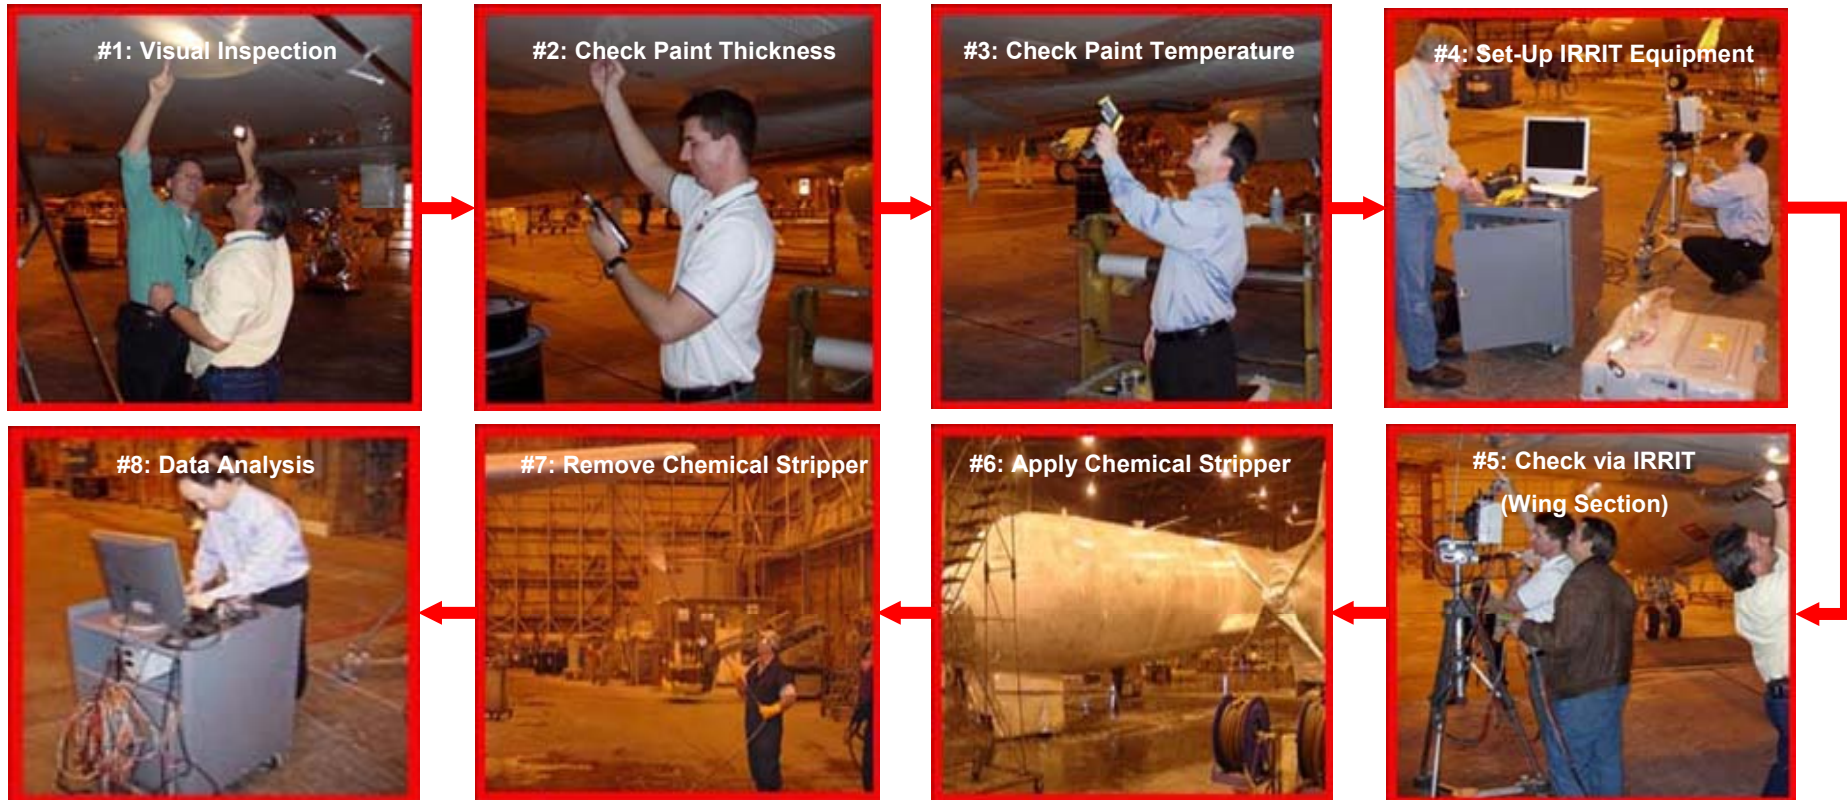
## Dem/Val Process

- Consolidate and Review all data
- Statistical analysis of the number of corrosion sites identified
- Compare Visual versus IRRIT results for accuracy

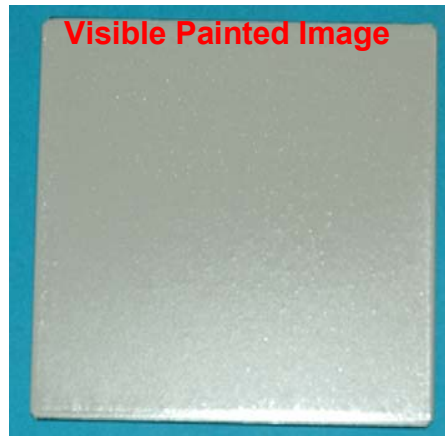
# IRRIT Examples

This standard was used in the laboratory to check the camera's resolution with and without various coatings applied to the surface. This standard was also checked prior and post all IRRIT inspections during the Dem/Val process. This standard ensures that the system is operating normally.

*Note: This standard is painted with the same type of primer and topcoat that is on the P-3 aircraft.*

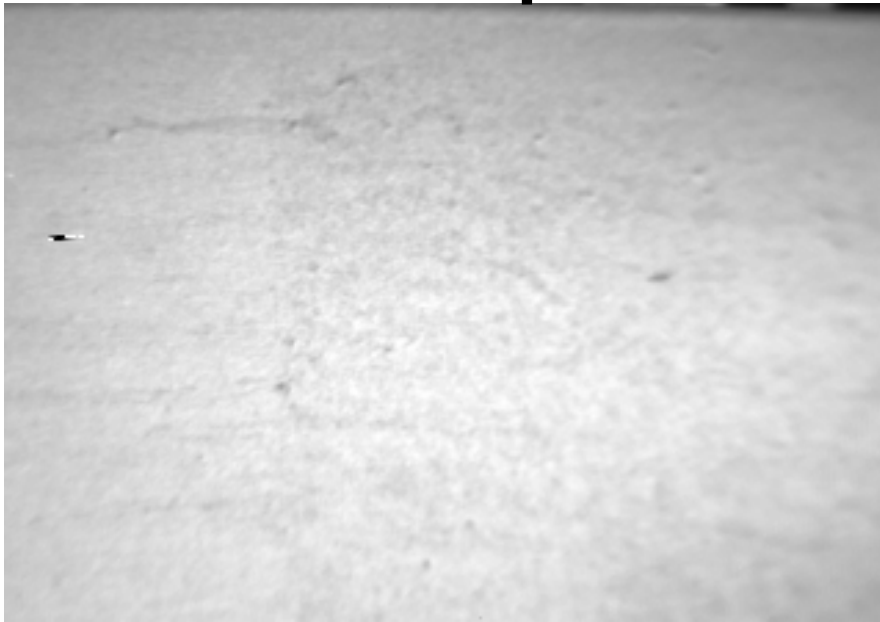
## Optimized Filter Results

**3-5  $\mu\text{m}$ : STANDARD FILTER**

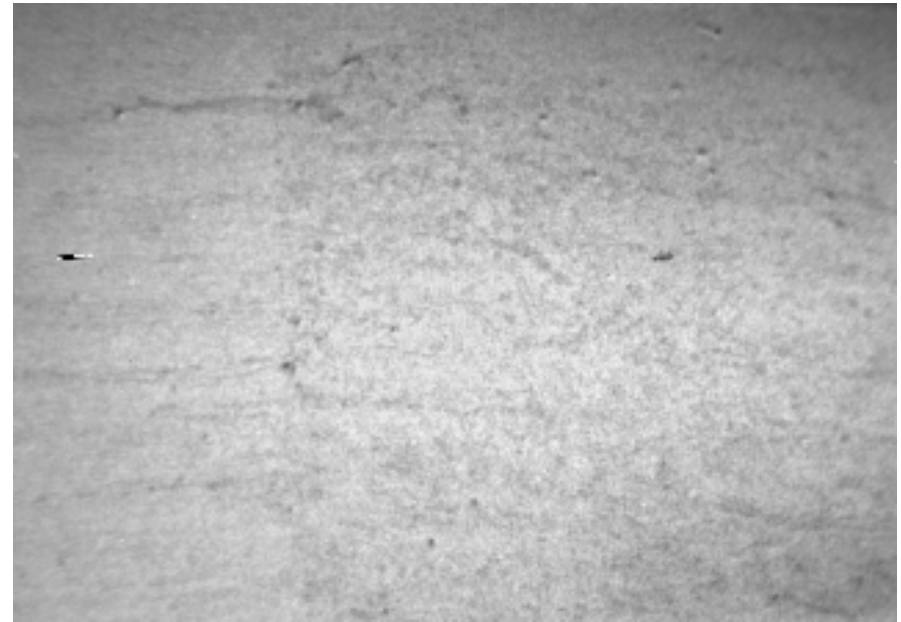
**3.75-5  $\mu\text{m}$ : OPTIMIZED FILTER**

***\*\*Received new Merlin IR camera with internal 3.75-5 micron filter.***
