**2015 NDIA GROUND VEHICLE SYSTEMS ENGINEERING AND TECHNOLOGY SYMPOSIUM
MODELING & SIMULATION, TESTING AND VALIDATION (MSTV) TECHNICAL SESSION
AUGUST 4-6, 2015 – NOVI, MICHIGAN**

**INTERIOR HEAD IMPACT PROTECTIVE COMPONENTS AND MATERIALS FOR
USE IN US ARMY VEHICLES**

**Julie Klima
Rebecca Marquardt**
Ground Systems Survivability
TARDEC
Warren, MI

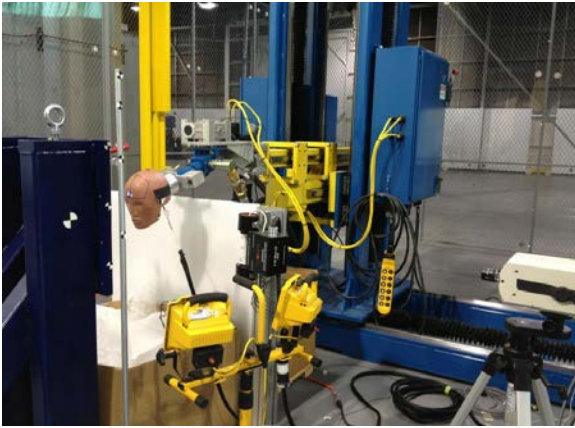
Figure 1: Head impact fixture

TARDEC utilized the Soldier System Interface Impactor Laboratory located at Selfridge Air National Guard Base, Harrison Township, Michigan (SANG SSII) to conduct head impact testing, Figure 1. The SANG SSII is equipped with head impact test equipment consistent with the FMVSS 201U standard using a Free Motion Headform.

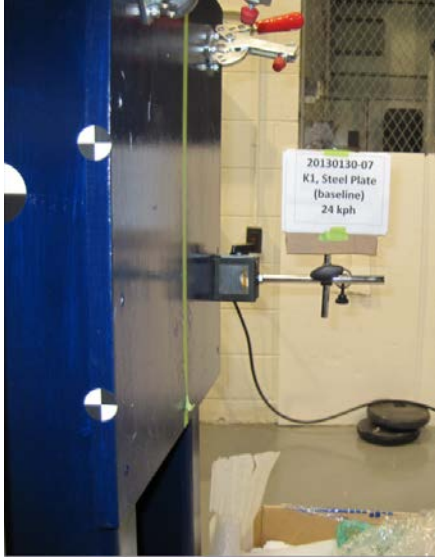
Figure 2: Rigid Flat Fixture

TARDEC tested different COTS energy attenuating (EA) core materials at the SANG SSII laboratory using a rigid flat fixture, Figure 2. The core material requires an additional layer of protection for durability. The additional durable layer of material is referred to by TARDEC as an exposed surface sheet. Each core material was tested with a different durable exposed surface sheet to understand the effects the exposed surface sheet had on the energy attenuation characterizes of the core materials.

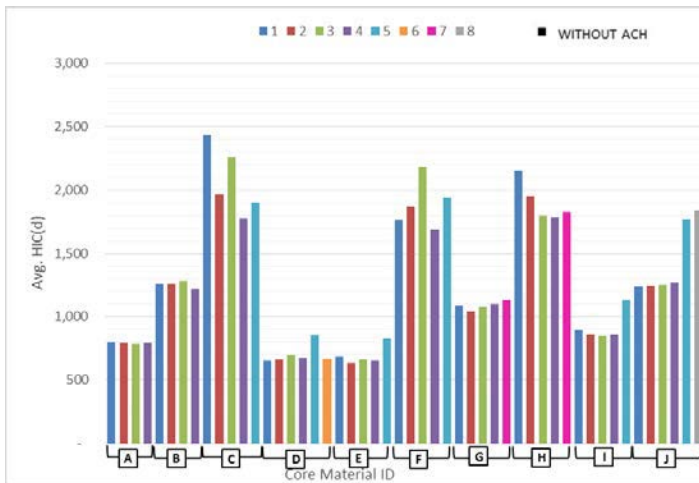
Figure 6: Material AoA HIC(d)

The material samples with fabric exposed surface sheets generally performed better than the hard exposed surface sheet samples, facesheet material IDs 1 through 4, 6, and 7. Figure 6 shows the data from the flat fixture testing. The thicker core materials with fabric based surface sheets, core material IDs D and E, performed below HIC(d) ≤ 1000 requirement at HIC(d) 636 to 855 for the 38 mm (1.5 inch)

thick TPE engineered core material and HIC(d) of 847 to 1131 with the 41 mm (1.6 inch) thick aluminum non-resilient core material, core material ID I. The foam covered in fabric in 25.4 mm (1 inch) thick samples covered in fabric, core material ID G, also showed results around the HIC(d) threshold at HIC(d) 1088. None of the thinner samples tested performed below the HIC(d) requirement, core material IDs B, C, F, H and J. The lowest HIC(d) value of the thinner samples was HIC(d) of 1254 which is a resilient plastic core material covered in fabric, core material ID B. The thin material samples, core material IDs B, C, F, H, and J, with hard surface sheets, facesheet material ID 5 and 8, showed significantly higher test results with the lowest HIC(d) value of 1768.

One of the TPE engineered materials, core material ID A, test results showed an average HIC (d) of 792 at a thickness of 35.56 millimeters (1.4 inches). A non-resilient material, core material ID I and J, (does not retain fit and form after impact) such as aluminum formed in a tubular shape, also uses air-space for enhanced energy attenuation. The 40mm (1.6 inch) thick non-resilient material, core material ID I, resulted in an average HIC(d) of 919.

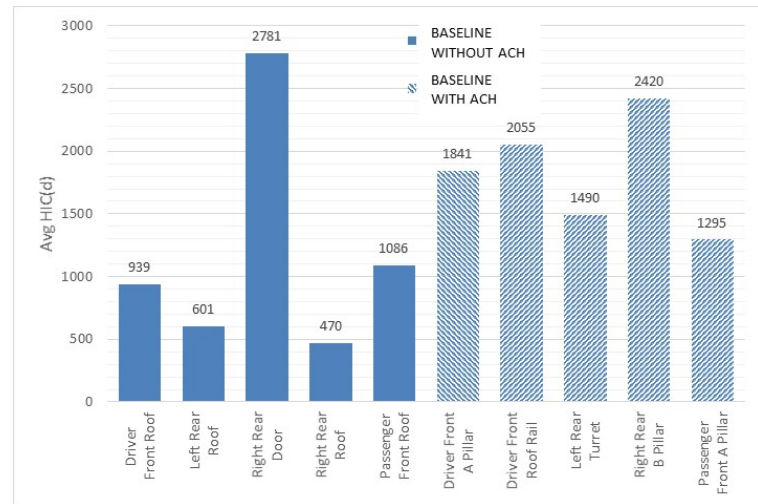
Figure 7: Vehicle A HIC(d)

location without an ACH was on average 601. The right rear roof location without an ACH had an average HIC(d) of 470.

The baseline testing at the following locations exceed the injury criteria: right rear door, passenger front roof, driver front a-pillar, driver front roof rail, left rear turret, right rear b-pillar, passenger front a-pillar. The HIC(d) for the driver front a-pillar location with an ACH was on average 1,841. The driver front roof rail with an ACH had an average HIC(d) of 2,055. The HIC(d) for the a-pillar with ACH target location had a HIC(d) of 1,294. The roof target location without an ACH had an average HIC(d) of 1,086. The turret location with an ACH had an average HIC(d) of 1,489. The HIC(d) for the b-pillar location with an ACH was on average 2,420. The door location without an ACH had an average HIC(d) of 2,781.

Vehicle baseline testing was conducted using the head impact laboratory facility at SANG. In order to quantify the injury reduction due to the introduction of the IIPS, baseline testing was conducted with and without an ACH affixed to the FMH. The baseline testing data of vehicle A can be seen in Figure 7.

The baseline testing at the driver front roof, left rear roof, and right rear roof were within the threshold requirement of HIC(d). The driver front roof impact position without an ACH has HIC(d) of 939. The HIC(d) for the left rear roof target

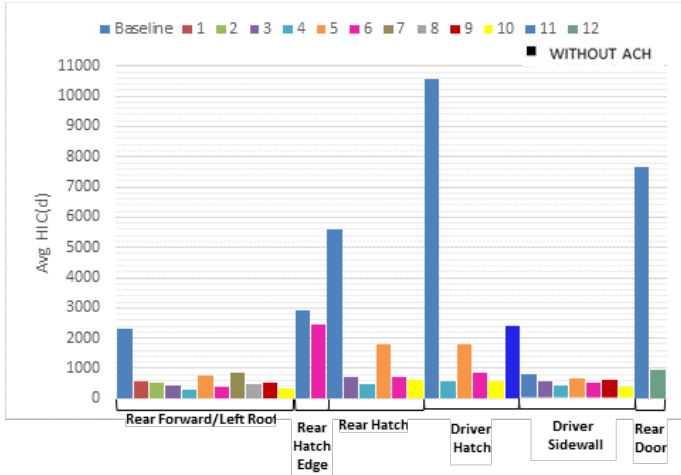
Figure 8: Vehicle B HIC(d)

The vehicle B has a very rigid interior design, testing for the vehicle was conducted without the helmet on the FMH, to improve test repeatability. Figure 8 shows the data from vehicle baseline testing at head impact test locations: driver hatch, driver sidewall, rear passenger roof and the rear hatch.

All of the locations that were baseline tested with the exception of the driver sidewall, far exceeded the performance criteria of HIC(d) ≤ 1000. The driver hatch showed the highest test results at HIC(d) 10,556.8. The rear hatch also showed high test results at HIC(d) 5596.0 and the rear passenger roof results were HIC(d) 2308.5.

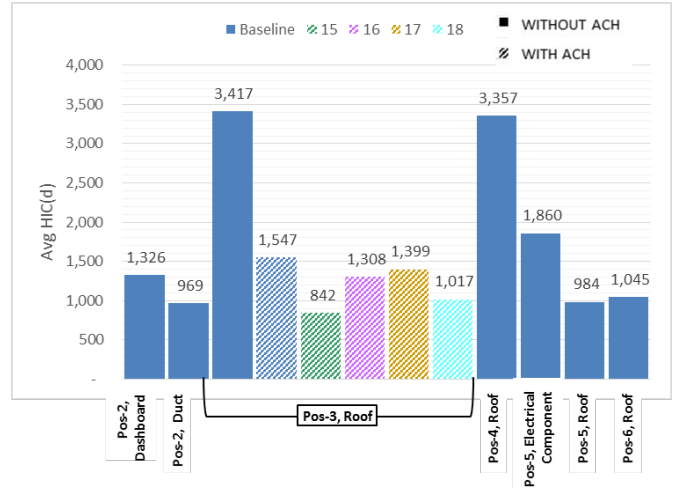
Figure 9: Vehicle C HIC(d)

Figure 9 shows Vehicle C baseline testing data. Baseline testing without an ACH at the following locations exceed the injury threshold requirement: Pos-2 dashboard, Pos-3 roof, Pos-4 roof, Pos-5 electrical component, and Pos-6 roof. Pos-2 duct and Pos-5 roof did meet the threshold requirement for baseline testing with a HIC(d) of 969 and 984 respectively.

Further head impact testing was conducted on Pos-3 roof, which had a baseline HIC(d) of 3,417. Baseline testing as repeated with the addition of an ACH, the resulting HIC(d) was 1,547. Four EA materials were impact tested at this position. One of the four EA materials tested met the threshold requirement with a HIC(d) of 842.

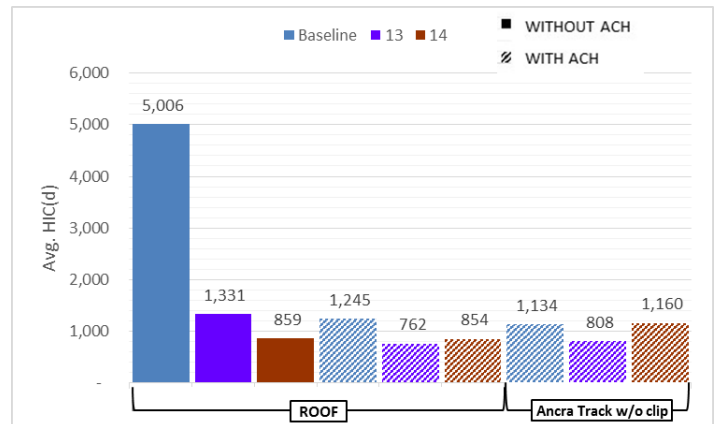
Figure 10: Trim Buck HIC(d)

Baseline testing was conducted in the two target locations in trim buck: roof and Ancra track without clip. The Ancra track clip’s function is to secure basic issue items, bii. The baseline testing on the roof was conducted with and without an ACH. This baseline testing exceeded the injury threshold criteria with an HIC(d) of 1,245 and 5,006 respectively. Ancra track baseline testing was not conducted without a helmet due to the probability of damage to the FMH skin. The design intent of Trim Buck is to have the Ancra track located out of the head impact zone. Baseline testing on the Ancra track was conducted with an ACH and resulted in a HIC(d) of 1,134, which exceeded the injury threshold requirement. The data from this testing can be seen in Figure 10.

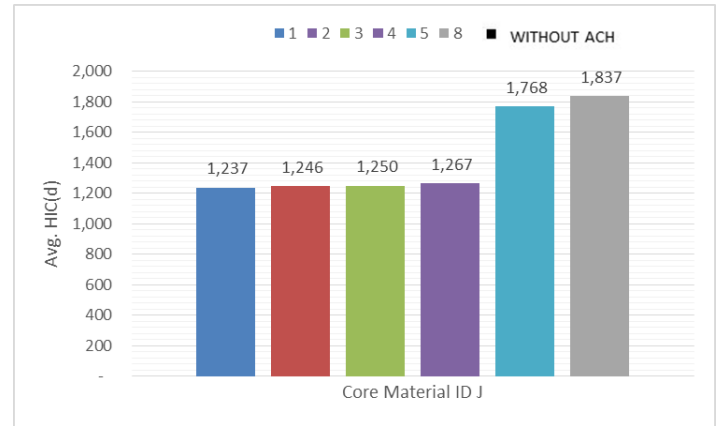
Figure 12: Core Material ID J, 19.8 mm (0.78 inch) thickness

Only some of the fabric based surface sheet samples with the low profile core material thickness, performed below the threshold HIC(d) < 1000 requirement and only one of the hard surface sheet samples with low profile core materials achieved the threshold requirement. These observations indicate the low profile core materials are more sensitive to the type of surface sheet material used, than the high profile, thicker core materials. AoA Test Material Matrix shows that facesheet material IDs 1 through 4, 6, and 7 are fabric and facesheet material IDs 5 and 8 are rigid. Figure 12 shows core material ID J with a thickness 19.8 mm (0.78 inch) and how the fabric and rigid face sheets directly affect the core material's response to the injury criteria. The rigid face sheet increases the HIC(d) by an average of 553.

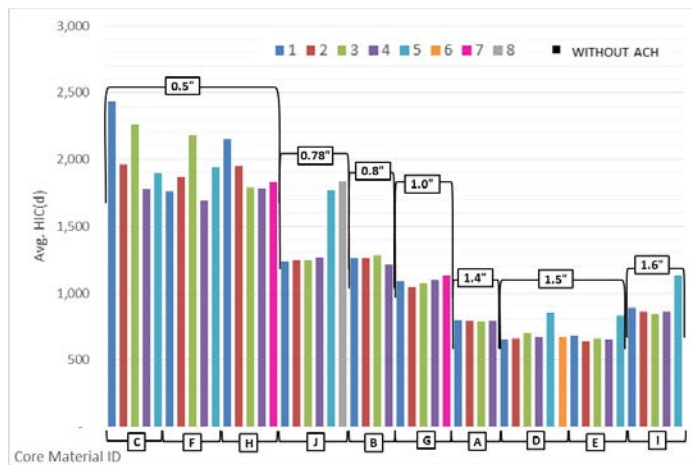
Figure 11: AoA Flat Fixture Material Thickness

Core material thickness appears to be the main characteristic affecting HIC(d) energy attenuating performance independent of the type of surface sheet material or attachment method as seen in Figure 11. The thicker core materials performed better than the thinner core materials. The average peak value of HIC(d) for the materials with a thickness of 12.7 mm (0.5 inch) is 1,953. The materials with a thickness of 25.4 mm (1 inch) has an average peak value of HIC(d) equal to 1,088. As the core material increases its thickness to 38.1 mm (1.5 inch) the average peak HIC(d) value continues to decrease to 693, supporting the observation that a thicker material reduces the head impact criterion. Looking at the materials with a thickness of 25.4 mm (1 inch) and less have an average peak HIC(d) value of 1,612. Whereas materials with a thickness of greater than 25.4 mm (1 inch) has an average peak HIC(d) value of 772. The material thickness threshold for achieving the head injury criteria is greater than 25.4 mm (1 inch).

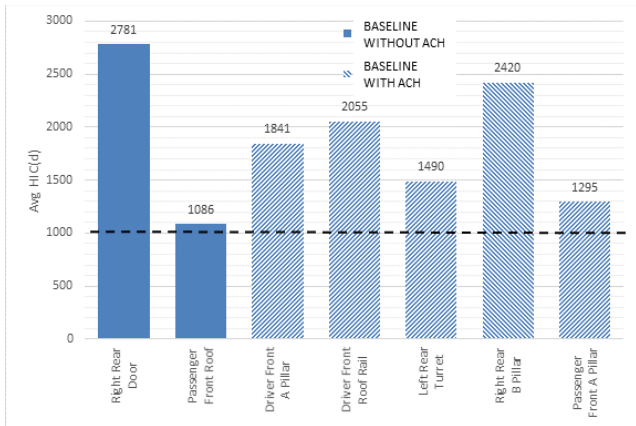
Figure 13: Vehicle A Positions that Exceeds Threshold

As shown in the Figure 13, the average HIC (d) for baseline testing on Vehicle A shows that the vehicle exceeds the threshold requirement for HIC (d) of equal to or less than 1,000 on the impact positions associated with the right rear door and passenger front roof without an ACH and driver front a-pillar, driver front roof rail, left rear turret, right rear b-pillar, passenger front a-pillar with an ACH.

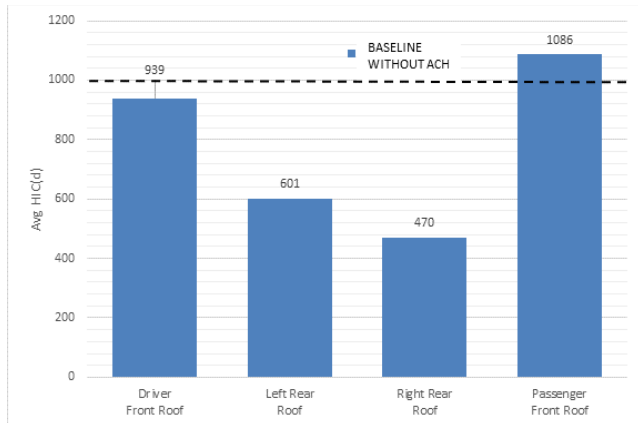
Figure 14: Vehicle A Roof Position Head Impact Testing

The baseline testing on the roof location testing was conducted without an ACH, Figure 14. In three of the four roof locations tested the head injury criterion was below the threshold and in two of three locations was also below the objective. The passenger front roof location had an average HIC(d) of 1,086.4 without an ACH. Previous testing has indicated that the ACH can reduce HIC(d) by 100 to 300. There is confidence that with an ACH the HIC(d) would be below the threshold requirement.

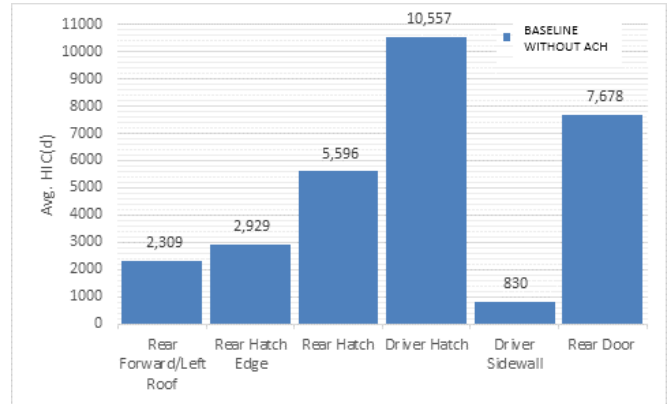
Figure 15: Vehicle B Baseline Head Impact Testing

Figure 15 shows the HIC(d) test results of the vehicle baseline without energy attenuating materials and the HIC(d) test results with the material samples. The baseline HIC(d)

results are significantly higher than the injury criteria requirements (HIC(d) < 1000) with the exception of the driver sidewall location. The driver sidewall location consists of an electrical door panel which may act as an energy attenuator providing enough energy dissipation to prevent impact related head injuries without needed additional protection.

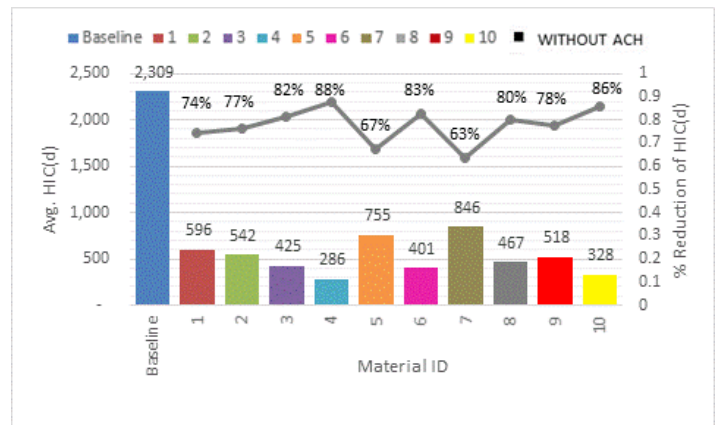
Figure 16: Rear Forward/Left Roof HIC(d) and Percent Reduction

IIPS solutions were testing at the rear forward/left roof position. Material IDs 1 through 10 were impacted to evaluate the influence EA materials have on HIC(d). Figure 16 shows the percent reduction and average HIC(d) values. All ten material ID solutions proposed met the injury threshold requirement for HIC(d) and had a significant percent reduction over the baseline testing ranging from 63% to 88% reduction.

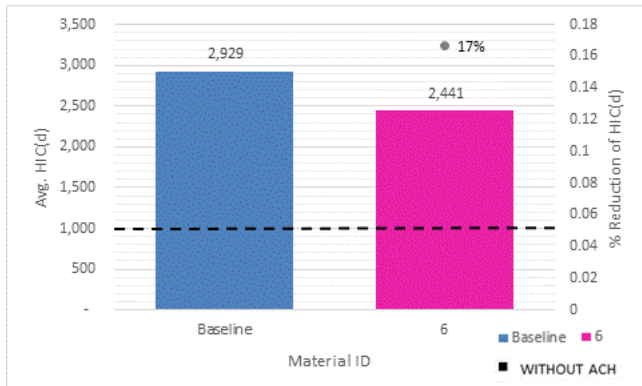
Figure 17: Rear Hatch Edge HIC(d) and Percent Reduction

Material ID 6 was tested at the rear hatch edge position in Vehicle B, Figure 17. Material ID 6 improved the performance of HIC(d) by 17%, but still exceeded the injury threshold requirement. Additional material ID testing at this location needs to occur.

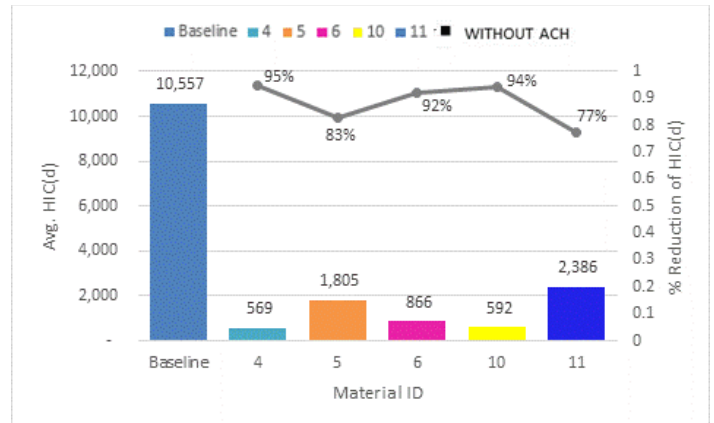
Figure 19: Driver Hatch HIC(d) and Percent Reduction

The driver hatch position had a baseline HIC(d) of 10,557, which exceeds the injury threshold criteria. Material ID solutions 4, 5, 6, 10, and 11 were tested to see if viable solutions to achieve the threshold injury criteria. The results can be seen in Figure 19. The material IDs showed a 77% to 95% reduction of HIC(d) over baseline testing. Material IDs 4, 6, and 10 are solutions for the driver hatch position to meet the injury threshold criteria.

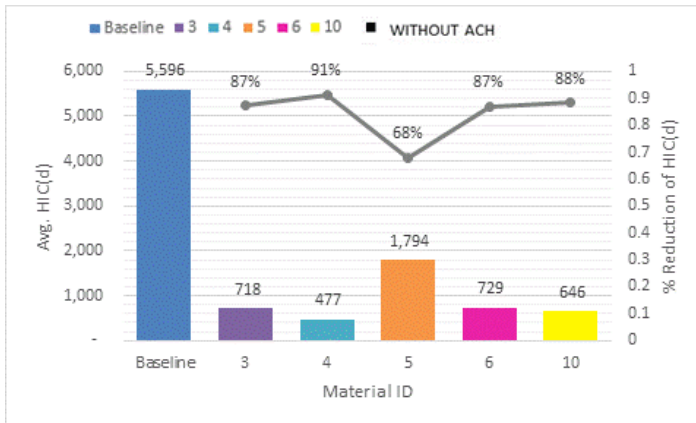
Figure 18: Rear Hatch HIC(d) and Percent Reduction

The rear hatch vehicle position was tested with material IDs 3, 4, 5, 6, and 10 to see if reduction of baseline would occur, Figure 18. Material IDs 3, 4, 6, and 10 meet the injury threshold criteria. Material ID 5 exceeded the injury threshold criteria and is not a viable solution. However each material ID provided significant percent reduction over baseline HIC(d) ranging from 68% to 91% reduction.

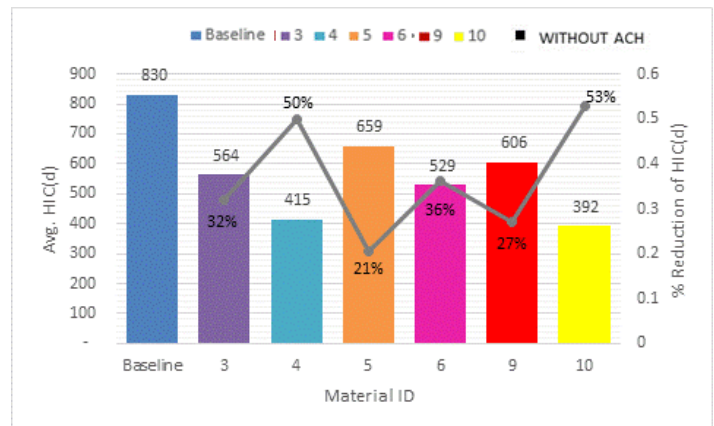
Figure 20: Driver Sidewall HIC(d) and Percent Reduction

The driver sidewall position baseline HIC(d) value is 830. This position meets the injury threshold criteria, however material ID solutions were tested at this position, Figure 20. There was a reduction in HIC(d) from 27% to 53%, all material solutions are viable options to continually reduce the head injury criteria.

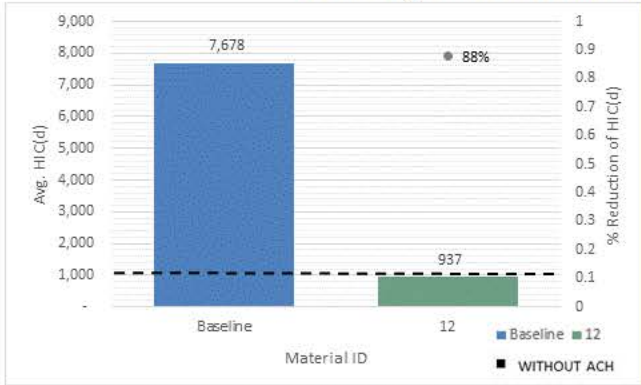
Figure 21: Rear Door HIC(d) and Percent Reduction

The rear door position was impact tested using material ID 12, Figure 21. The HIC(d) value during baseline testing was 7,678 and the IIPS solution reduced the value by 88%. The rear door position with material ID 12 meets the injury threshold value and is a solution at this location.

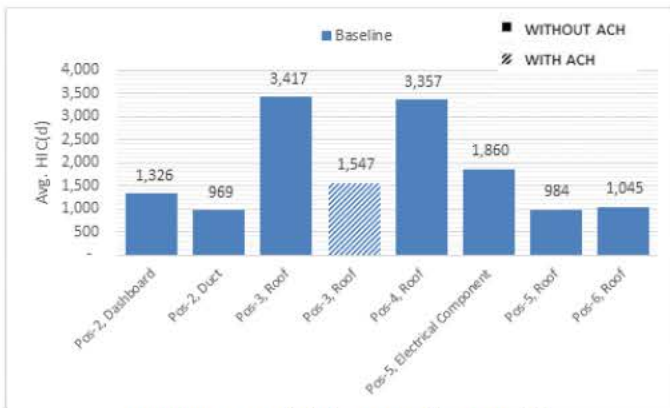
Figure 22: Vehicle C Baseline HIC(d)

As shown in the Figure 22, the average HIC (d) for baseline testing on Vehicle C without and ACH shows that the vehicle exceeds the threshold requirement for HIC (d) at the impact positions associated with position two: dash board, position 3: roof, position 4: roof, and position 5: electrical component, roof. Pos-2 duct and Pos-5 roof did meet the injury threshold requirement during baseline testing without an ACH. IIPS are needed at the locations that exceeded the injury threshold.

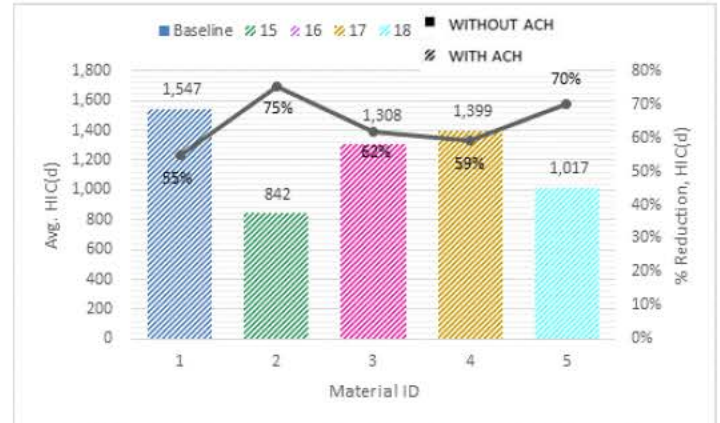
Figure 23: Pos-3 Avg. HIC(d) and Percent Reduction

Figure 23 shows percent reduction and the average HIC(d) for the additional head impact testing was conducted on Pos-3 roof. Pos-3 roof baseline testing was conducted with an ACH, which yielded a 55% reduction over baseline without an ACH. Material IDs 15 through 18 were then tested with an ACH on impact location Pos-3 roof. Material ID 15 met the injury threshold requirement with a HIC(d) of 842. Material IDs 16 through 18 exceeded the injury threshold requirement with an average HIC(d) of 1,308, 1,399, and 1,017 respectively. All materials ID solutions had a significant percent reduction in HIC(d) from the baseline without ACH testing ranging from 59% to 75% reduction. Material ID 15 is

the only viable solution tested that could be utilized in Pos-3 roof to meet the threshold requirements.

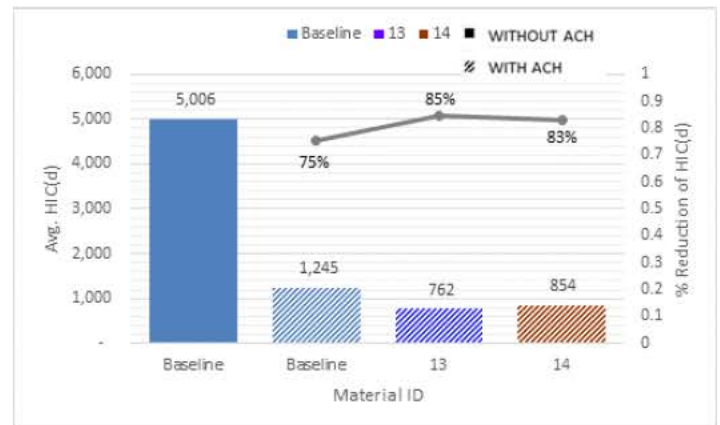
Figure 24: Roof HIC(d) and Percent Reduction

The HIC (d) for baseline testing on the roof location with and without an ACH shows that the introduction of a helmet greatly reduces HIC (d). The introduction of an ACH into the baseline testing produces a 75% reduction over the baseline testing without an ACH. The use of Material ID 13 with an ACH has an 85% reduction over the baseline testing without an ACH. The minimal crush pattern on the Material ID 13 core material show that the Material ID 13 exposed surface sheet absorbs significant amounts of energy during impact. Material ID 14 with an ACH reduced the value of HIC(d) by 83% over the baseline testing without ACH. Figure 24 illustrates the reduction an ACH and the introduction of EA material solutions have on reducing the injury criteria to meet the threshold requirement.

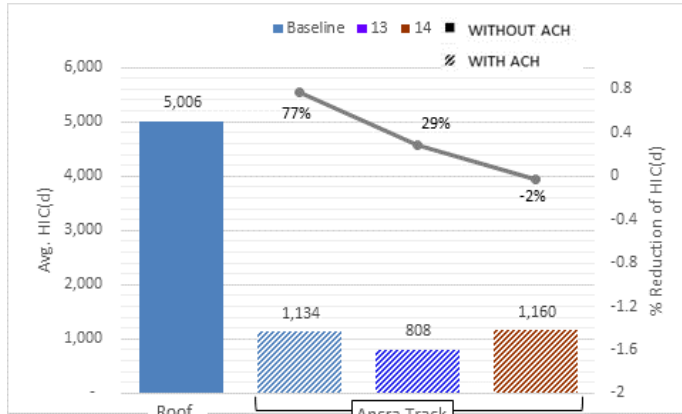
Figure 25: Ancra Track HIC(d) and Percent Reduction

Figure 25 shows the Ankra track testing head injury criteria results. The baseline testing on the Ankra track conducted

with an ACH show a 77% reduction in head injury criterion from the roof baseline testing without a helmet. Material ID 13 with an ACH has a 29% reduction in the head injury criteria over the baseline Ancra track testing with an ACH. The HIC(d) of material ID 13 with an ACH at the Ancra track is 808 meeting the injury threshold requirement.

Material ID 14 had a -2% reduction, Figure 25, over the baseline Ancra track testing with an ACH. This was the result of the core material not being fully engaged on the Ancra track. The backing of material ID 14 was reinforced with steel, this resulted in the core material being too rigid and simulated testing equivalent to the stand alone fixture. In the second test of the material ID 14 with ACH Ancra track series, the FMH impacted the steel reinforcement through the IIPS resulting in a HIC(d) of 1,435. This result is greater than the average HIC(d) of the Ancra track baseline testing. The properties of the Material ID 14 core material and the ability to absorb energy are affected by the addition of the steel backing. A different attachment method needs to be developed to keep form while using a non-formed exposed surface sheet.
