US Army Corps  
of Engineers

TECHNICAL REPORT REMR-CO-5

**STABILITY OF DOLOS OVERLAYS FOR  
REHABILITATION OF DOLOS-ARMORED  
RUBBLE-MOUND BREAKWATER AND JETTY  
TRUNKS SUBJECTED TO BREAKING WAVES**

June 1988

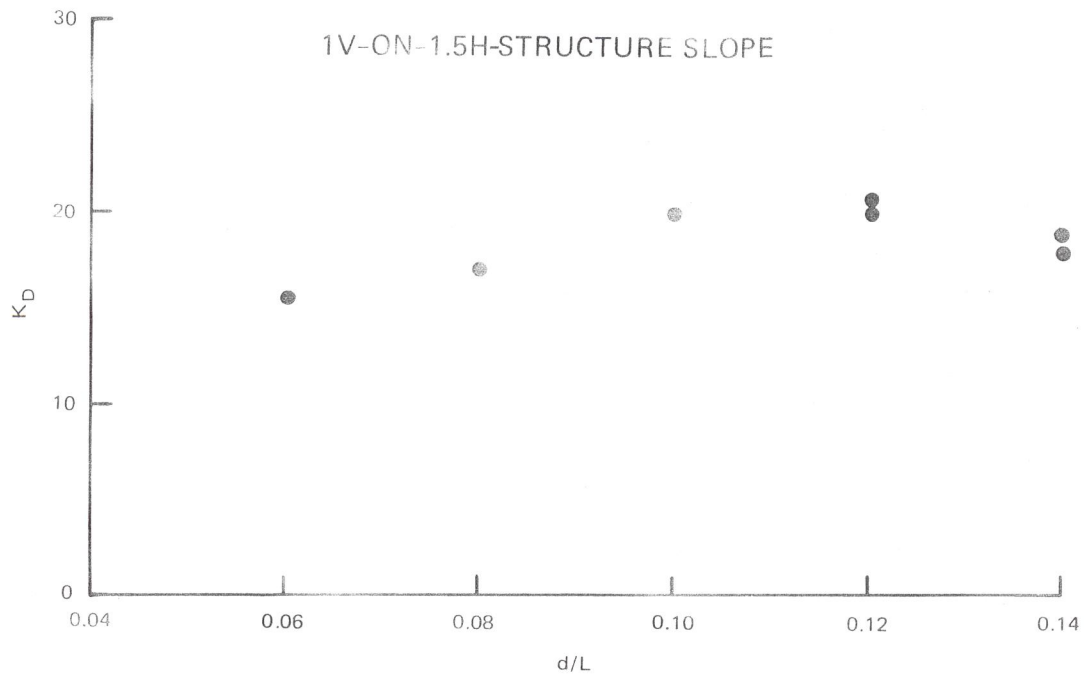
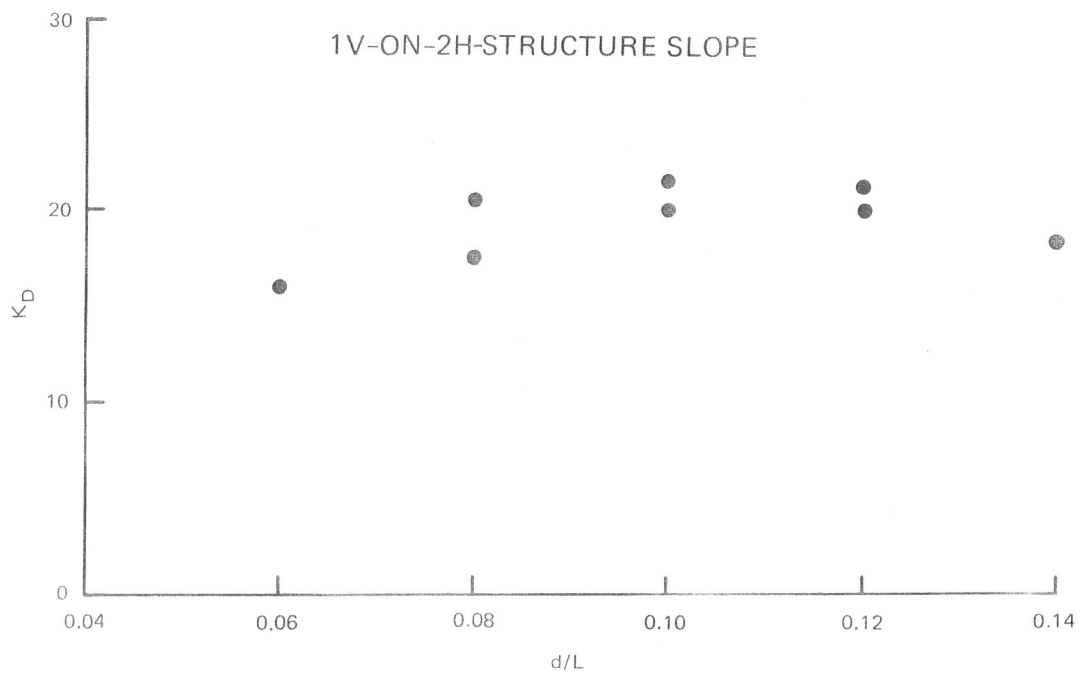
Figure 2. Stability coefficient  $K_D$  versus relative depth  $d/L$

20. Figures 2 and 3 present  $K_D$  as a function of  $d/L$  and  $H/d$ , respectively. These data show some dependency on both  $d/L$  and  $H/d$  with minimum stability occurring at the lower values of  $d/L$  and higher values of  $H/d$ , i.e. longer wave periods in shallower water. These trends are consistent with those observed by Carver (1983) for dolos used in new construction. The minimum stability coefficient observed is very similar to that currently recommended for new construction (15.6 versus 15).

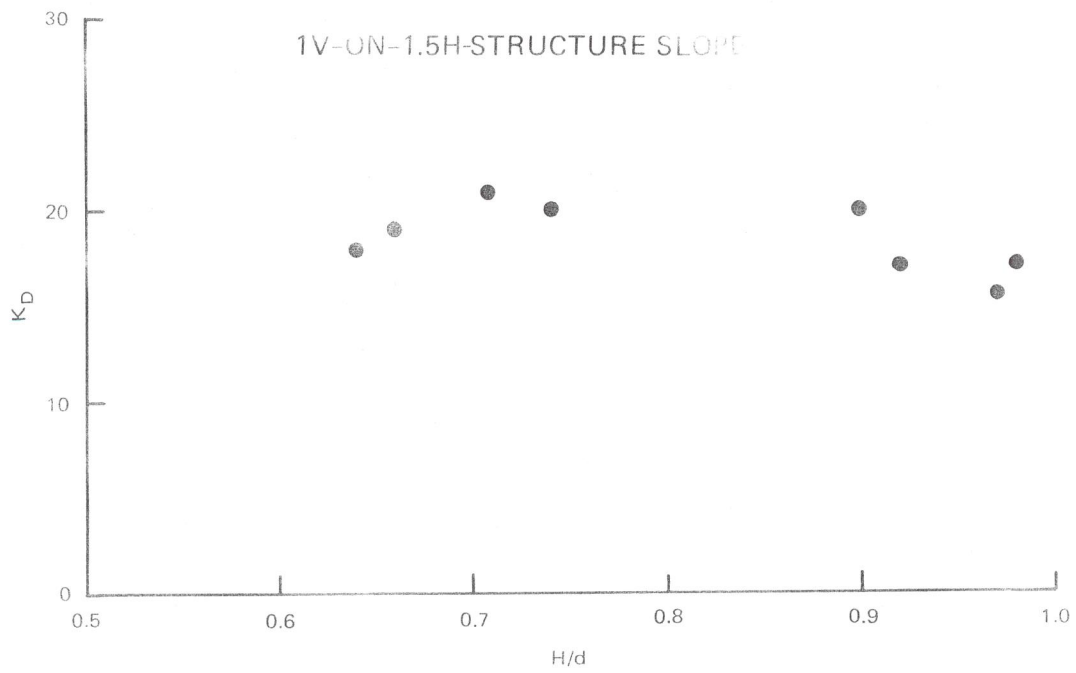
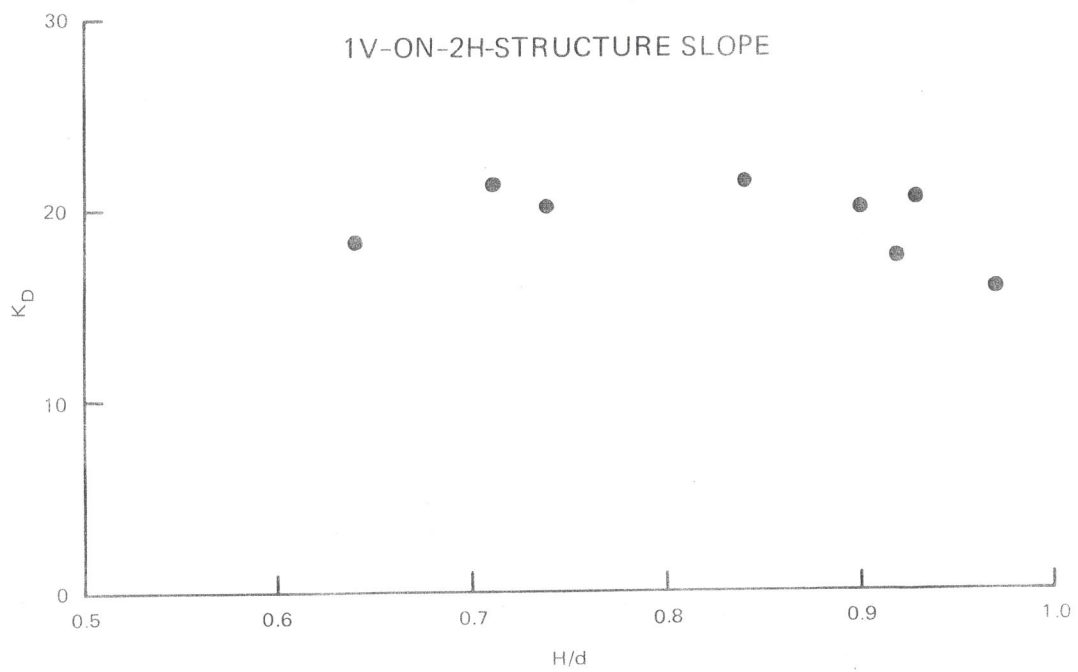
Figure 3. Stability coefficient  $K_D$  versus relative wave height  $H/d$

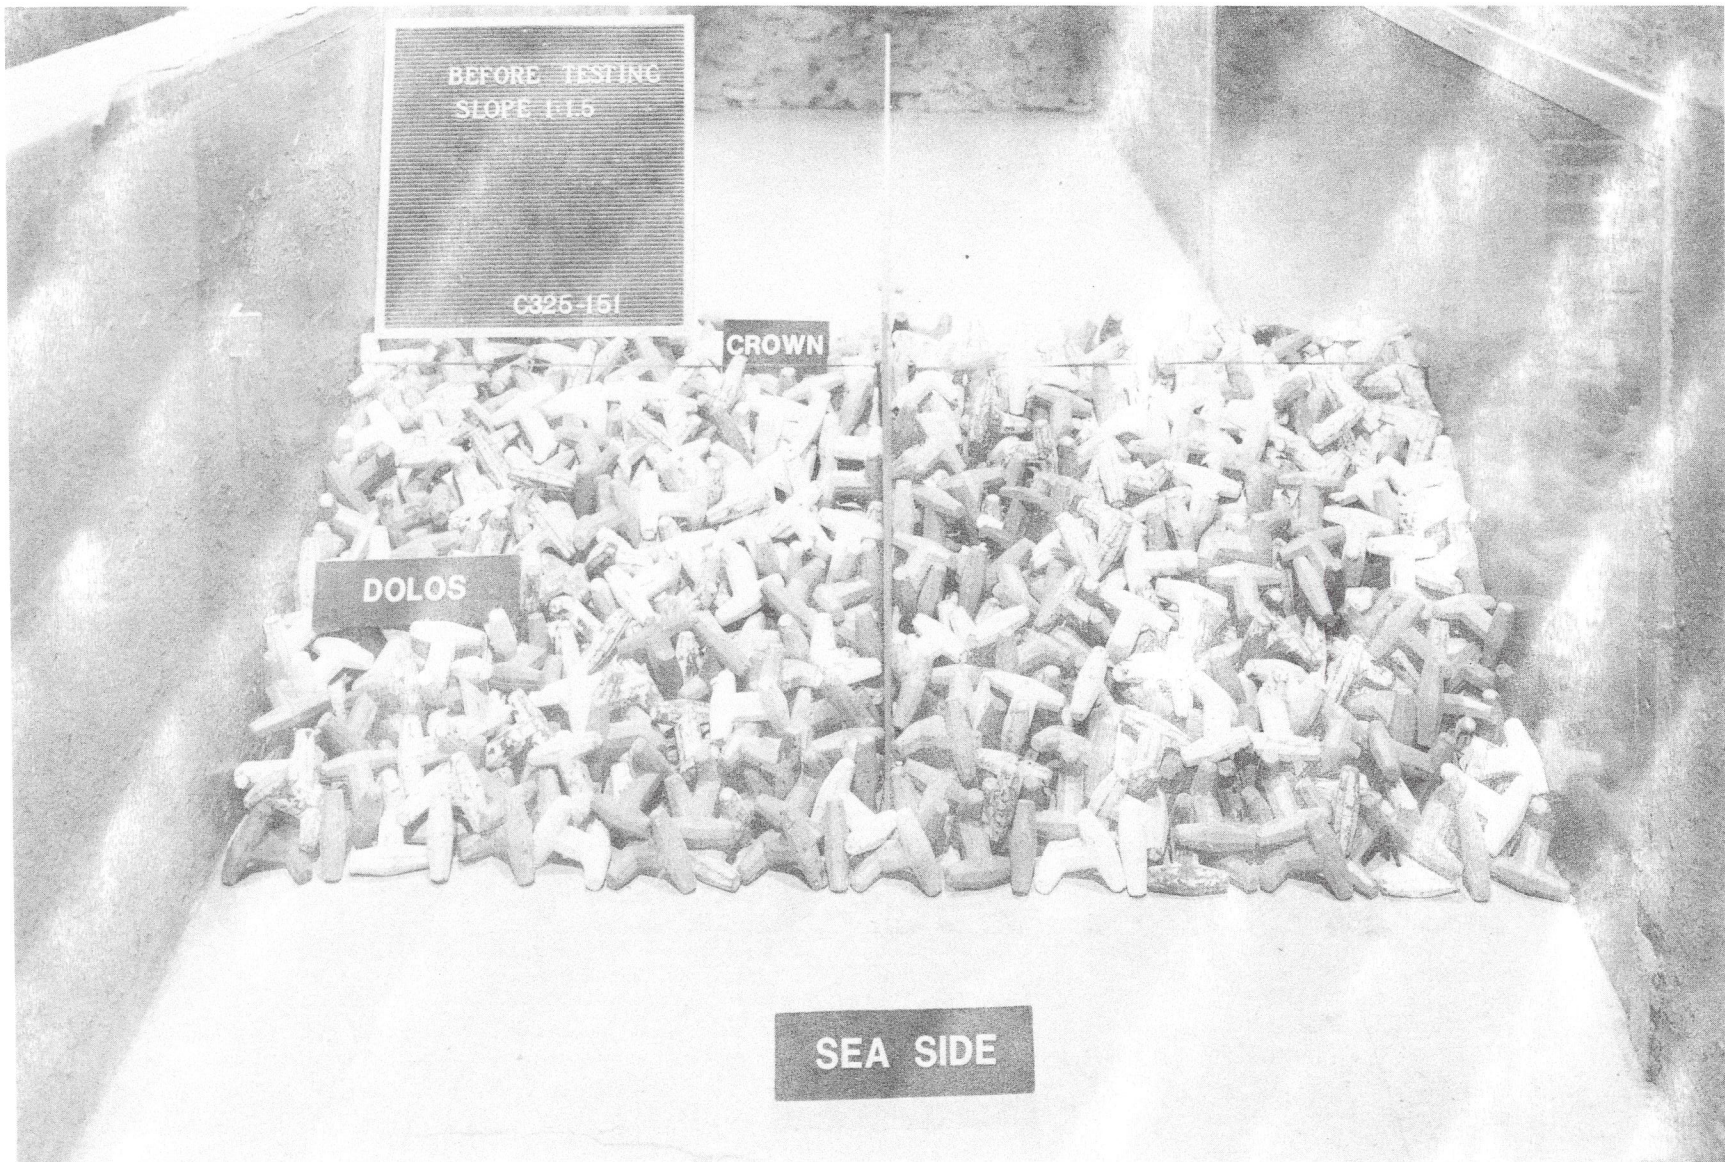
Photo 2. Sea-side view of a typical test section before wave attack at a 1V-on-1.5H-sea-side-structure slope;  $W_a = 0.589 \text{ lb}$

17. All stability tests were conducted on sections of the type shown in Figure 1 and Photos 1-4. Sea-side slopes of 1V on 1.5H and 1V on 2H were investigated, while the beach-side slope was held constant at 1V on 1.5H. Heights of the simulated existing structures (prior to placement of the dolos overlays) varied from 1.0 to 1.2 ft. The height necessary to prevent wave overtopping of the existing structure was determined from slopes and estimated water depths and wave heights to be investigated in determining stability coefficients for the dissimilar armor overlays.

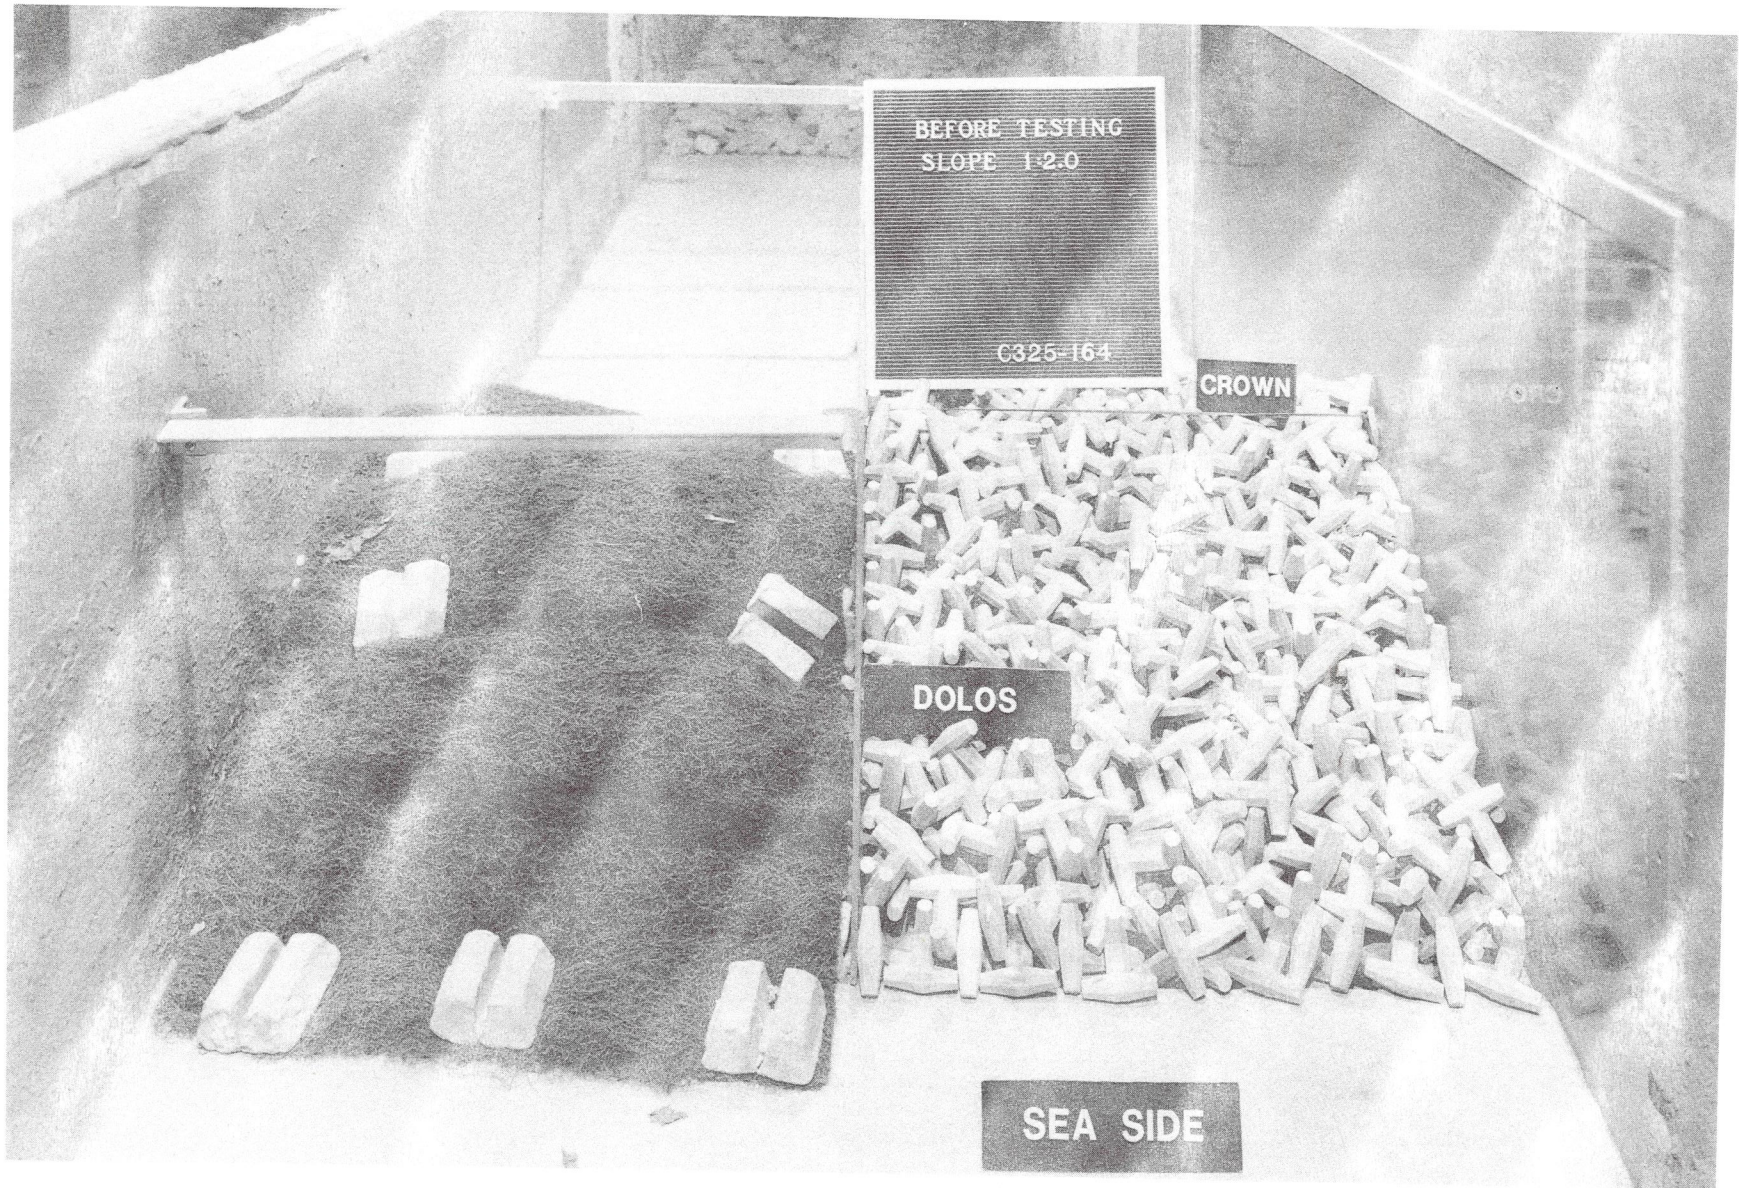
Photo 4. Sea-side view of a typical test section before wave attack at a 1V-on-2H-sea-side-structure slope;  $W_a = 0.442 \text{ lb}$

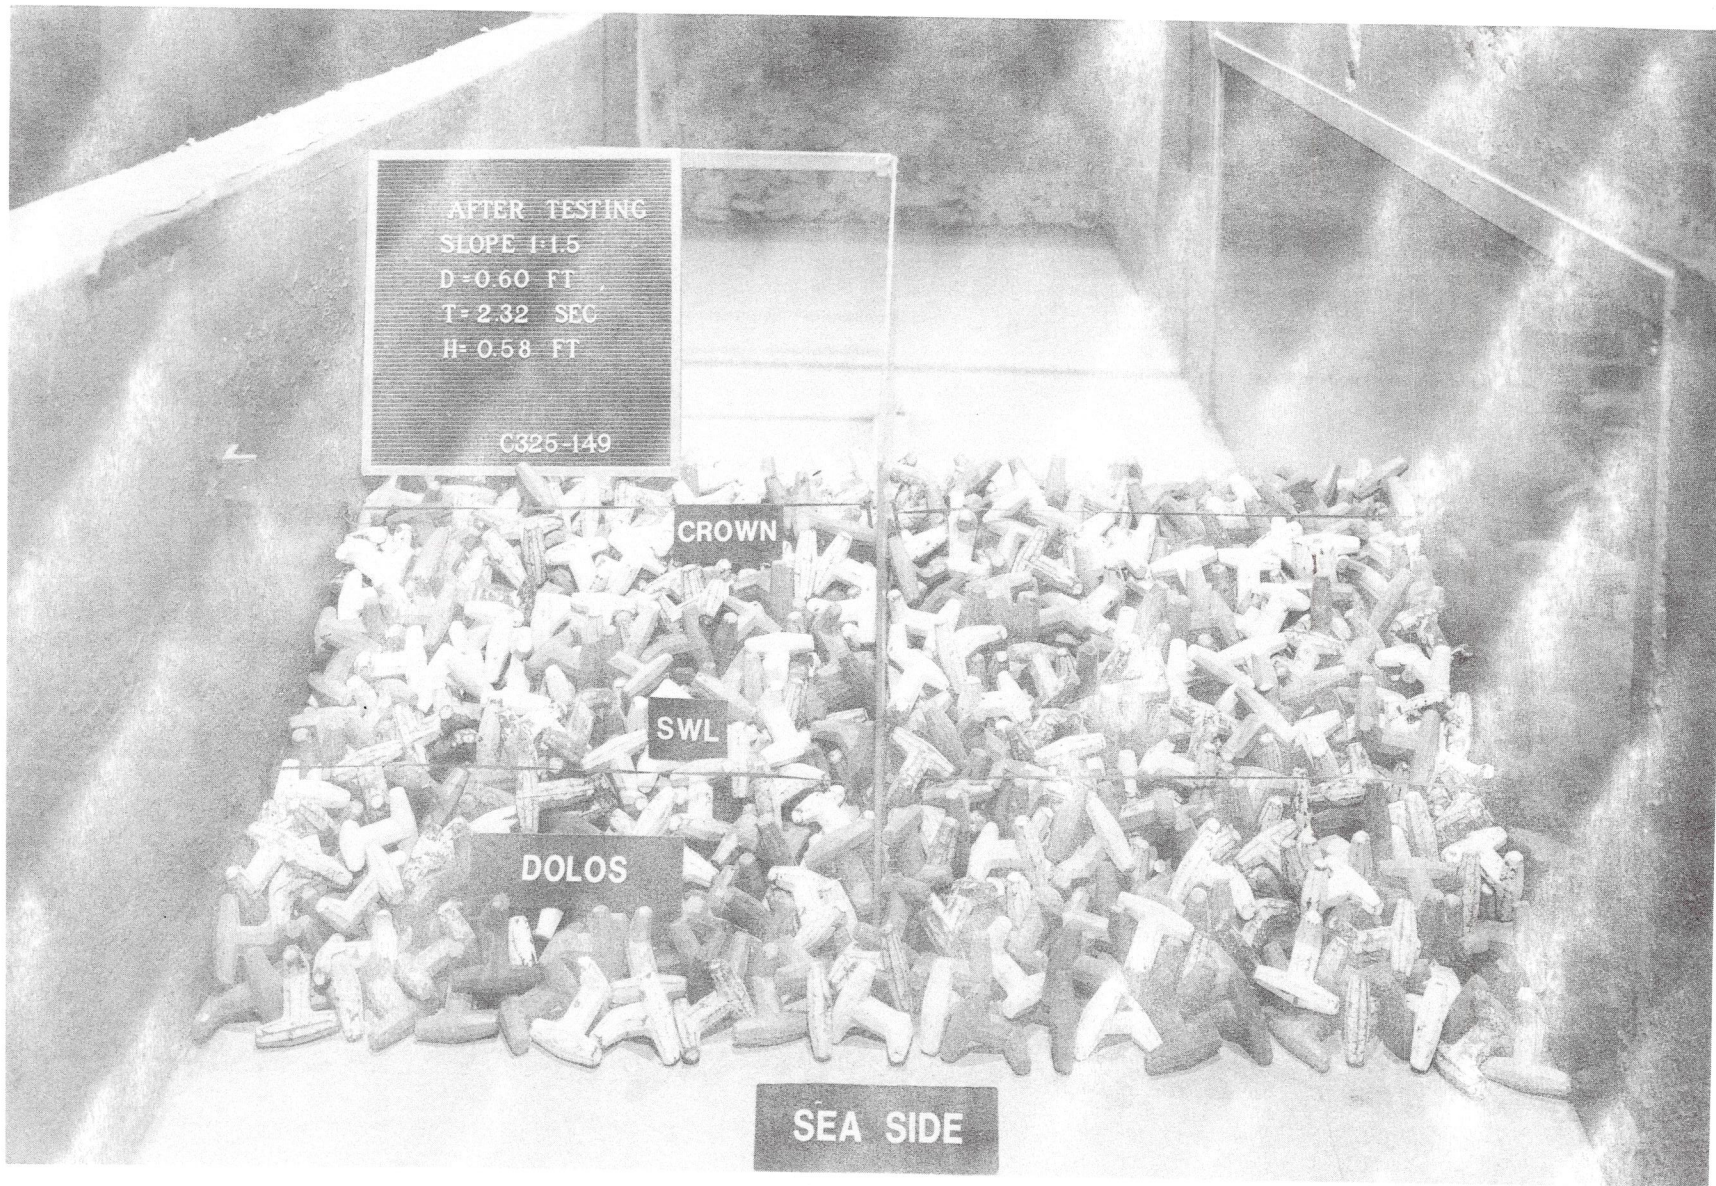
Photo 7. Sea-side view after attack of 2.32-sec, 0.58-ft waves;  $d = 0.60$  ft;  
 $W_a = 0.589$  lb; 1V-on-1.5H-structure slope

Armor units were placed randomly in two layers, and the number of armor units per given surface area was equal to that presently recommended for new construction in EM 1110-2-2904 (Headquarters, Department of the Army 1986). Photos 5-20 show typical after-testing conditions of the structures.

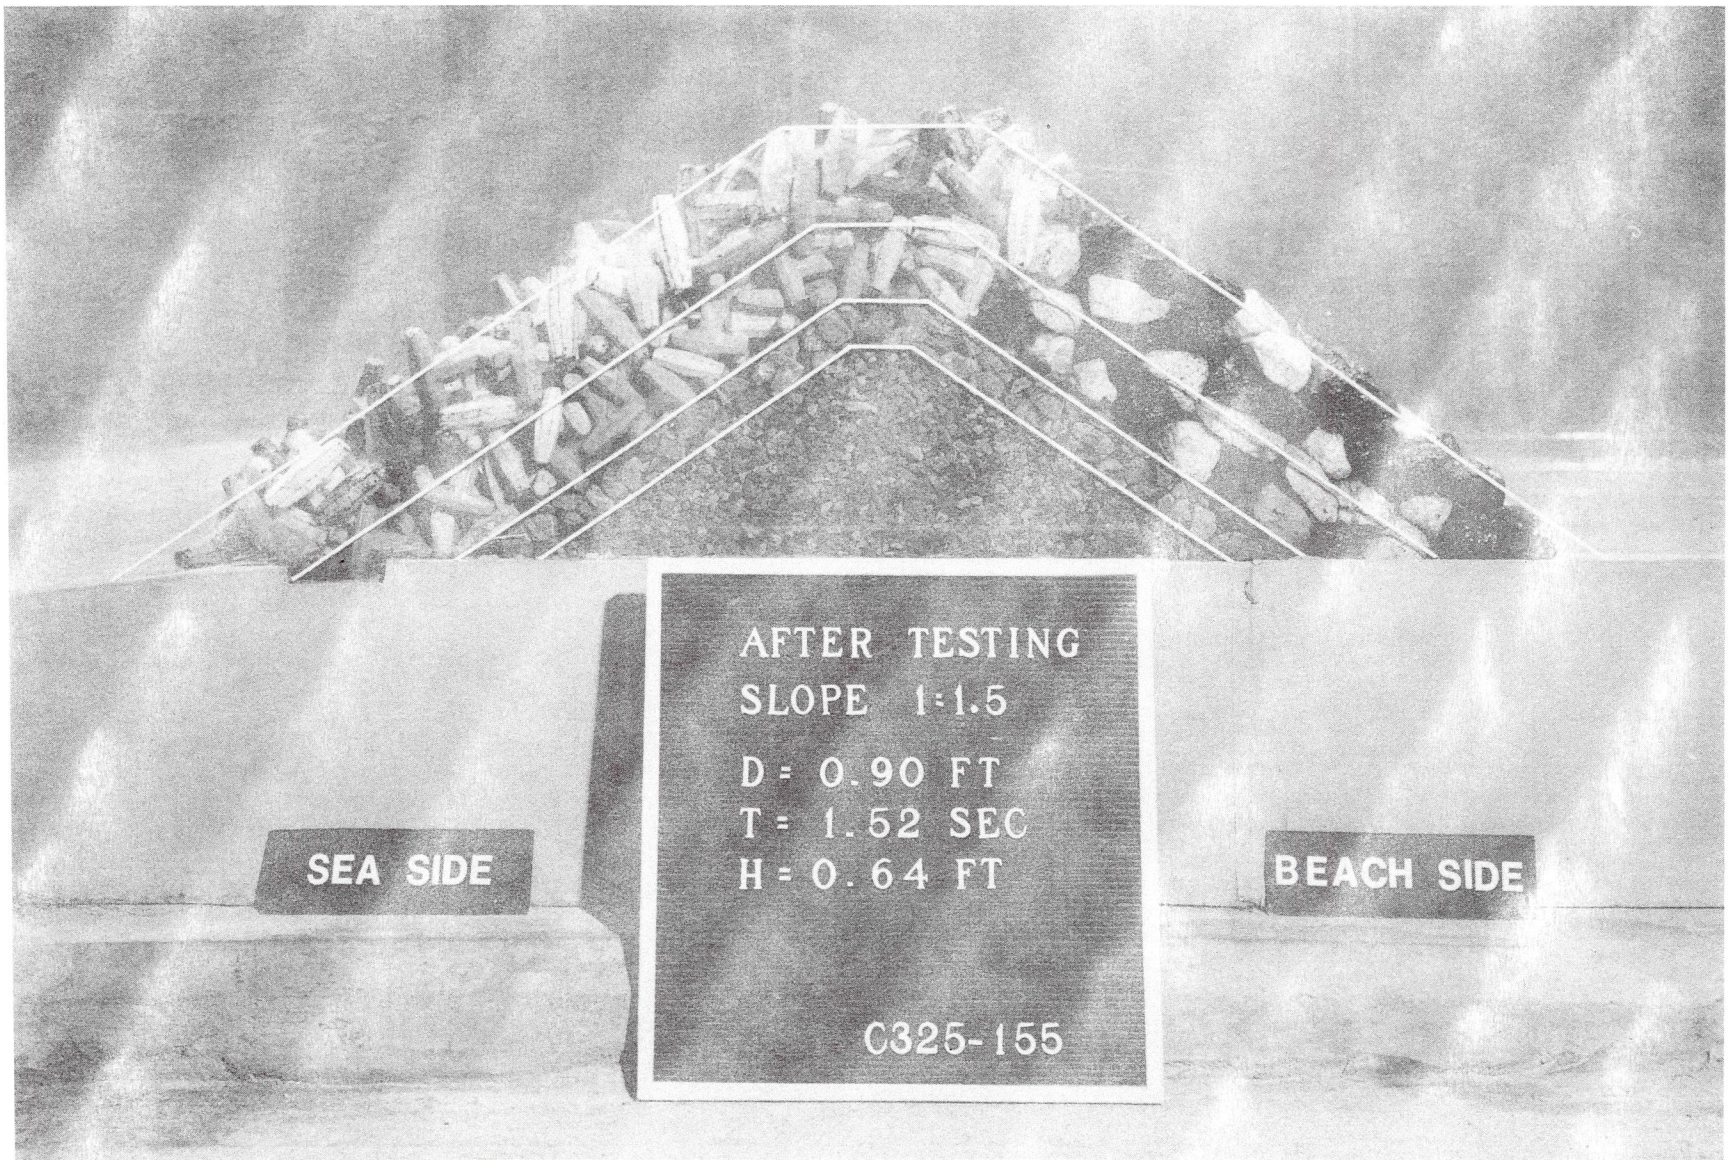
Photo 11. End view after attack of 1.52-sec, 0.64-ft waves;  $d = 0.90$  ft;  
 $W_a = 0.589$  lb; 1V-on-1.5H-structure slope

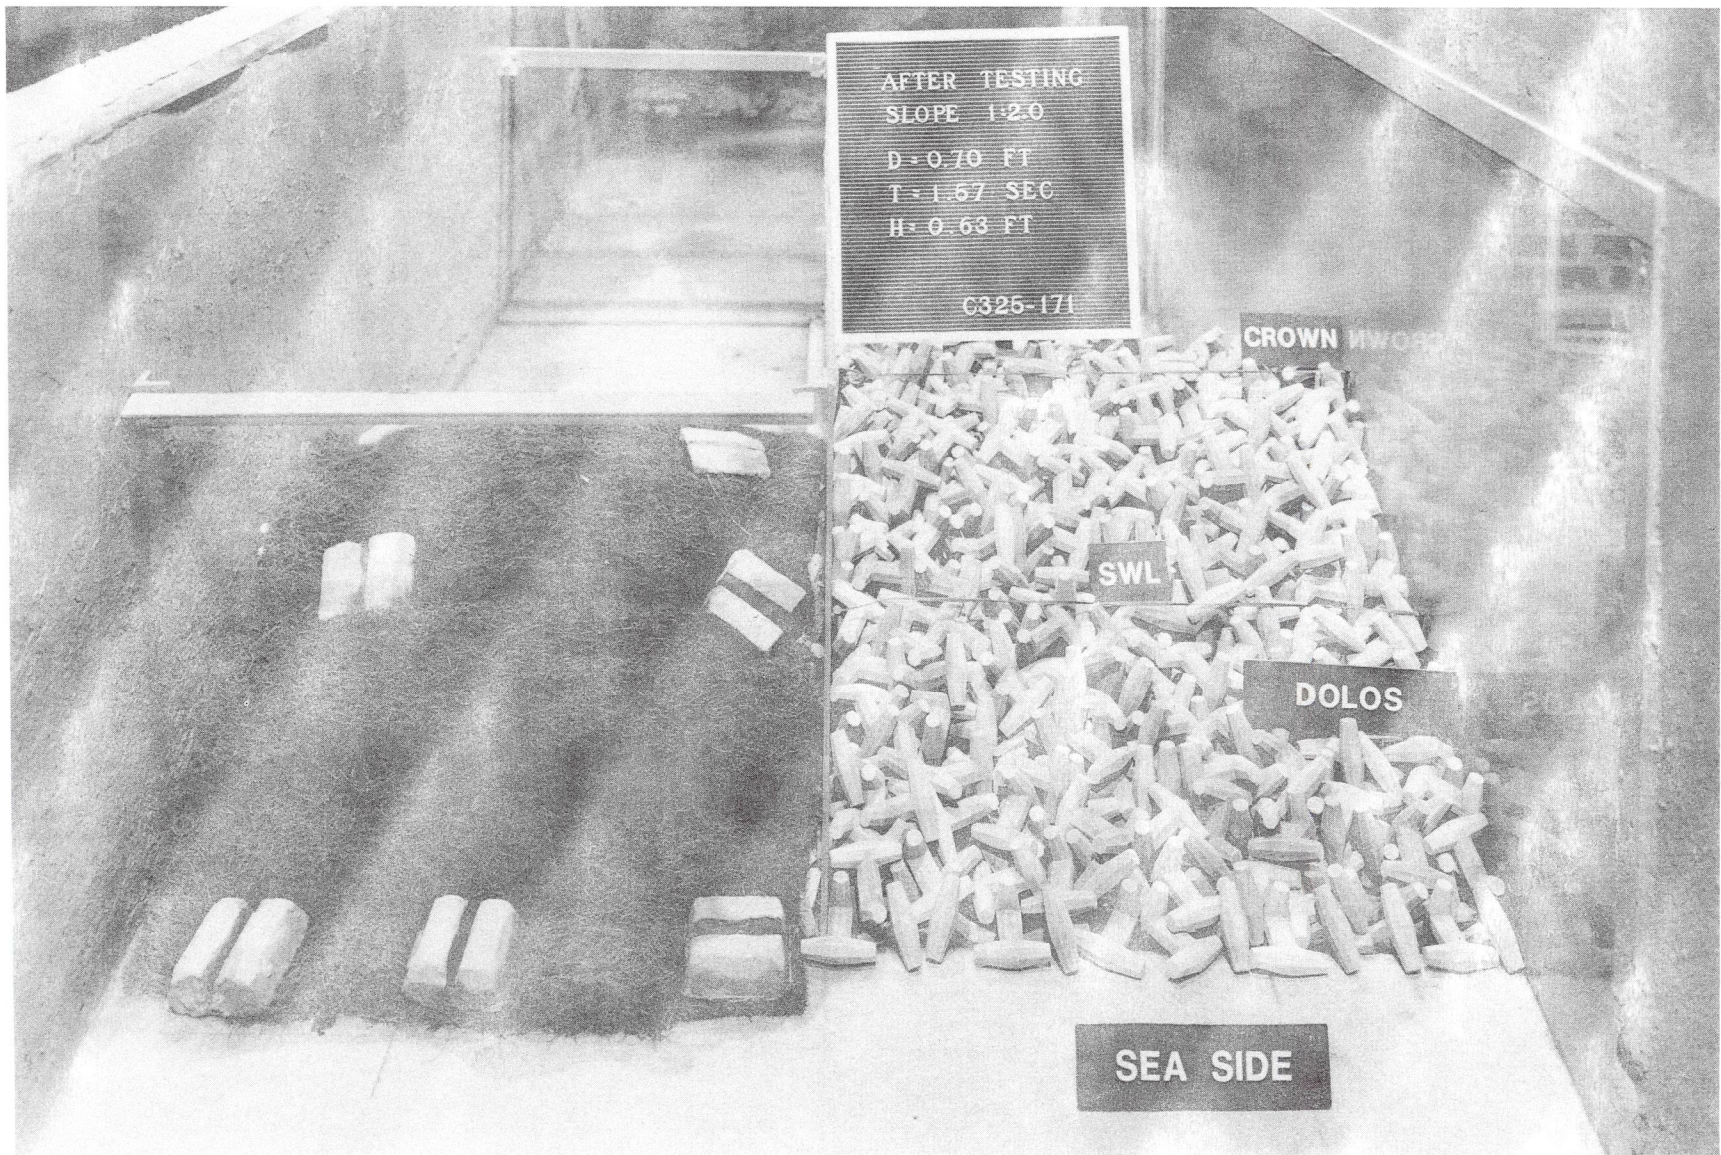
Photo 15. Sea-side view after attack of 1.57-sec, 0.63-ft waves;  $d = 0.70$  ft;  
 $W_a = 0.442$  lb; 1V-on-2H-structure slope

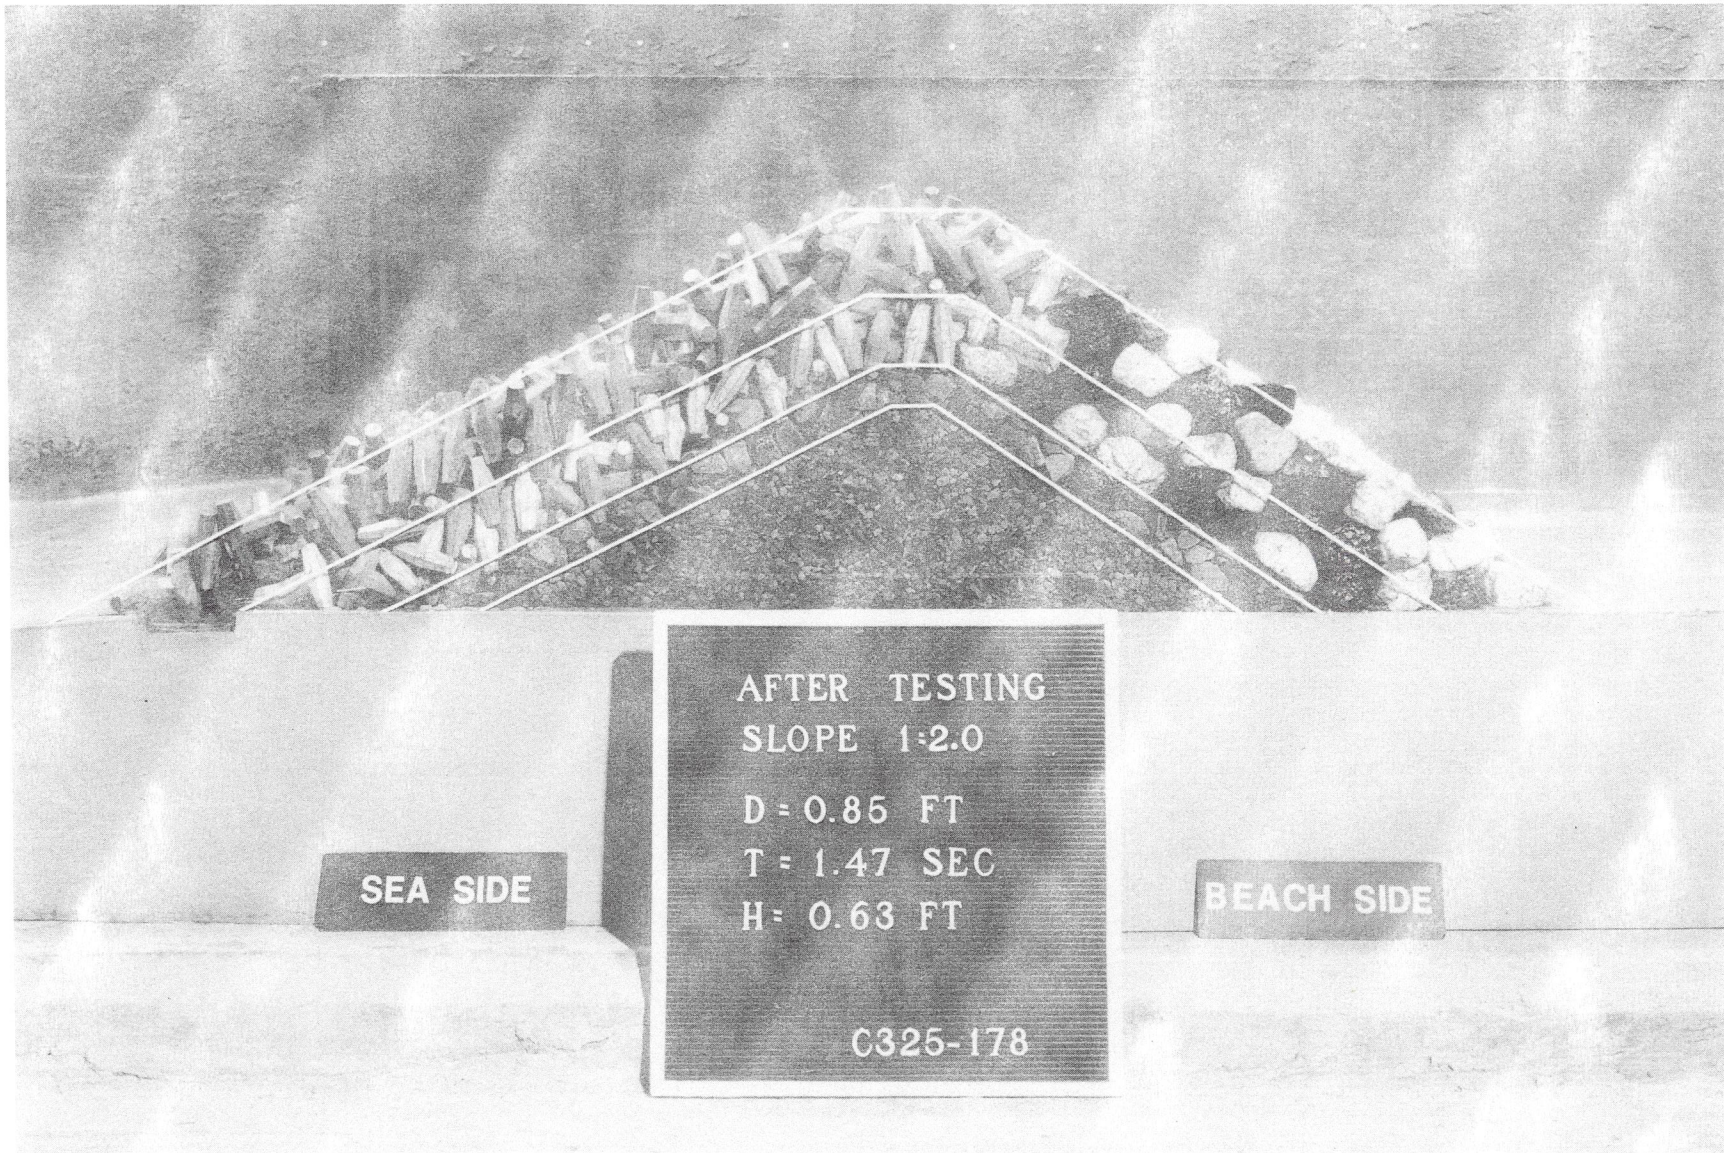
Photo 16. End view after attack of 1.47-sec, 0.63-ft waves;  $d = 0.85$  ft;  
 $W_a = 0.442$  lb; 1V-on-2H-structure slope
