TECHNICAL NOTE

No. 1203

A FLIGHT INVESTIGATION TO INCREASE  
THE SAFETY OF A LIGHT AIRPLANE

By P. A. Hunter and J. R. Vensel

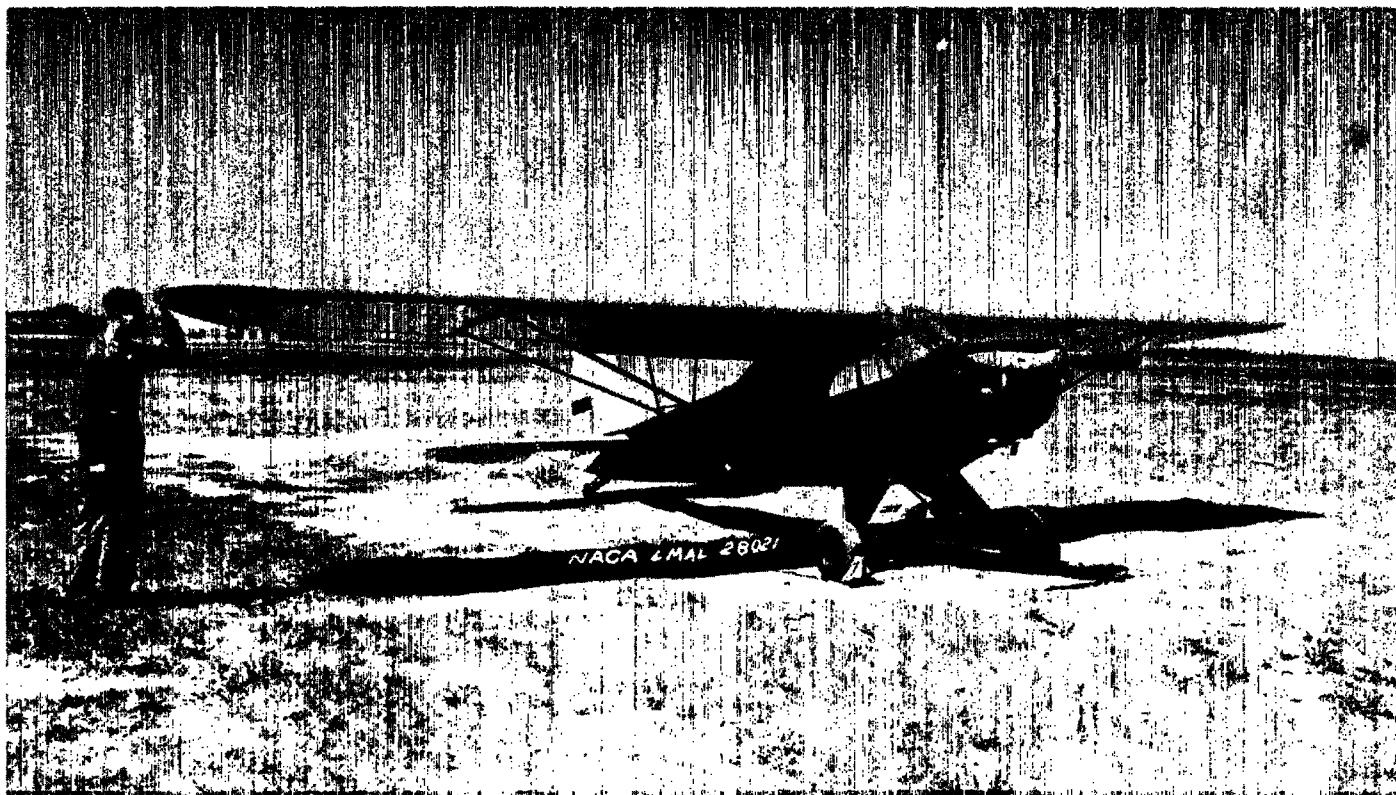
(a) Three-quarter front view.

Figure 1.- Airplane used in tests.

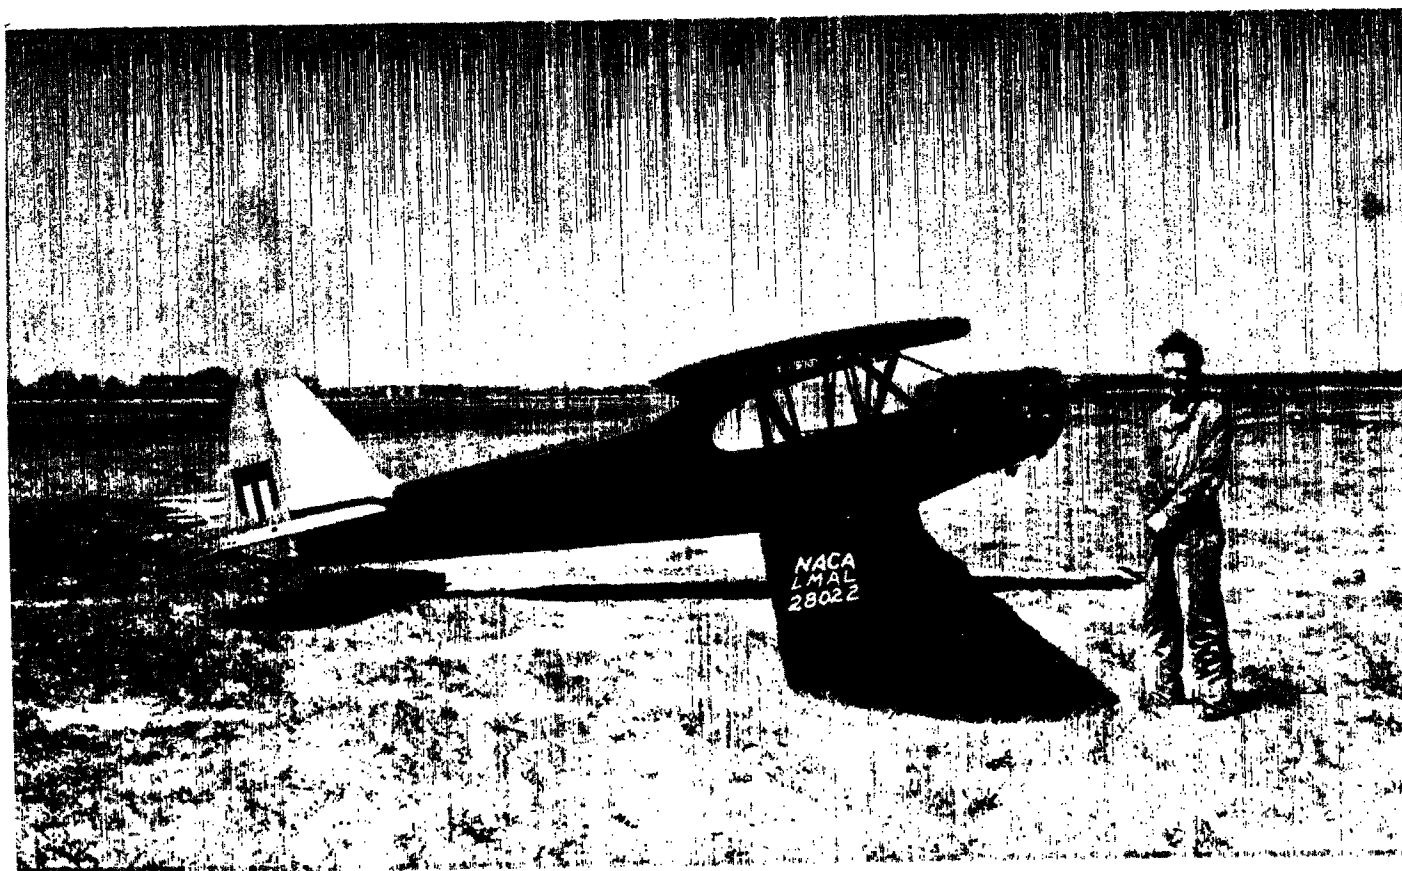
(b) Side view.

Figure 1.- Continued.

| | Original | Modified<br>(dashed line indicates<br>no change) |
|---|---|---|
| Washout (see fig. 1(b)), deg . | Approx. 3 | 5 |
