INVESTIGATION OF SURFACE IRREGULARITIES ON AN
NACA 63(420)-416, $a = 1.0$ AIRFOIL SECTION FOR
THE GLENN L. MARTIN COMPANY DESIGN 195

By Albert L. Braslow

Langley Memorial Aeronautical Laboratory
Langley Field, Va.

MEMORANDUM REPORT

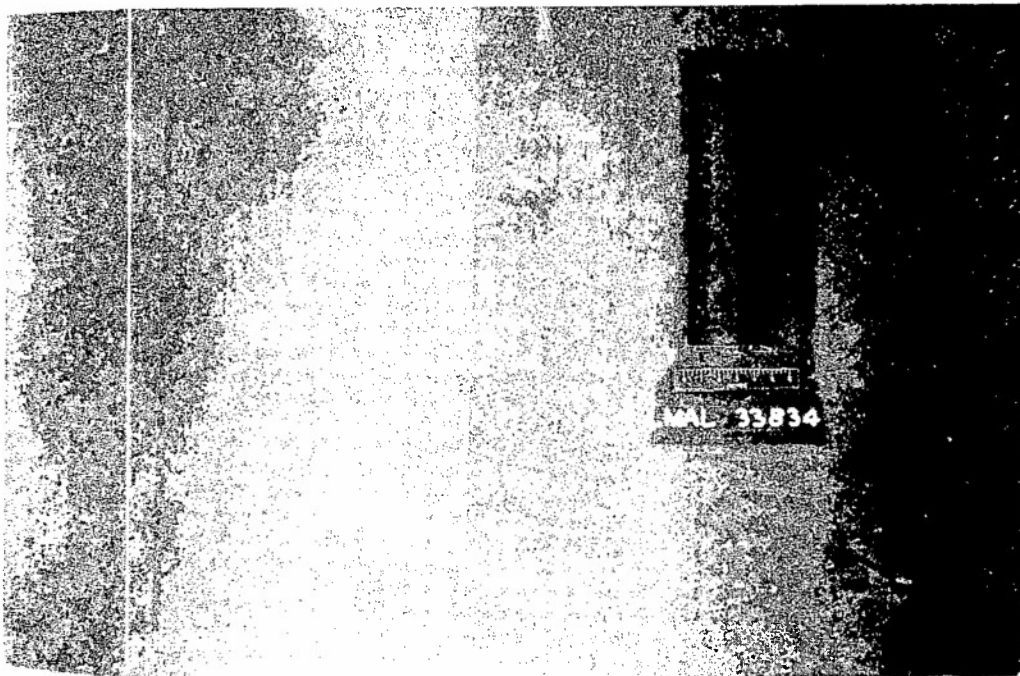
Figure 5.- Bottom view of 60-inch-chord, Martin design 195, roughness model, NACA 63(420)-416, $a = 1.0$ airfoil section showing riveted skin joint with skin gap filled at front spar, fabric-sealed piano-hinge skin joint at rear spar, and aileron slat; model sprayed with camouflage paint.

(d) Spanwise skin gap filled with plaster after spraying model with camouflage paint and lightly sanding as in the preceding condition (fig. 5).
