## EFFECT OF DEFECTS ON AIRCRAFT COMPOSITE STRUCTURES

R. A. Garrett

McDonnell Aircraft Company

This paper describes the effects of manufacturing and service-induced damage on the static and fatigue strength of aircraft composite structures.

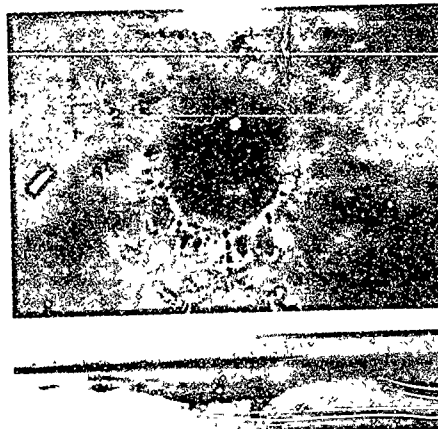
a) Carbon/Epoxy Specimen

b) Aluminum Specimen

Figure 52. Typical Damage of Composite Specimen Compared to Metal Specimen

The relative behavior of carbon/epoxy and aluminum skins having the same flexural stiffness was also evaluated. The test setup was for simulating damage to the exit-side from a projectile with a delayed fuze. Test results are shown in Figure 52. The plasticity of the aluminum permitted to the blast/impact energy to be absorbed by permanent deformation of the metal. The composite specimen remained flat; however, it exhibited numerous penetrations and delaminations throughout the damage zone.
