Response of a Structure
to an Explosive-Generated Ground Shock

by
D. E. Hudson, J. L. Alford, and
G. W. Housner

September 1952

THIRD TECHNICAL REPORT

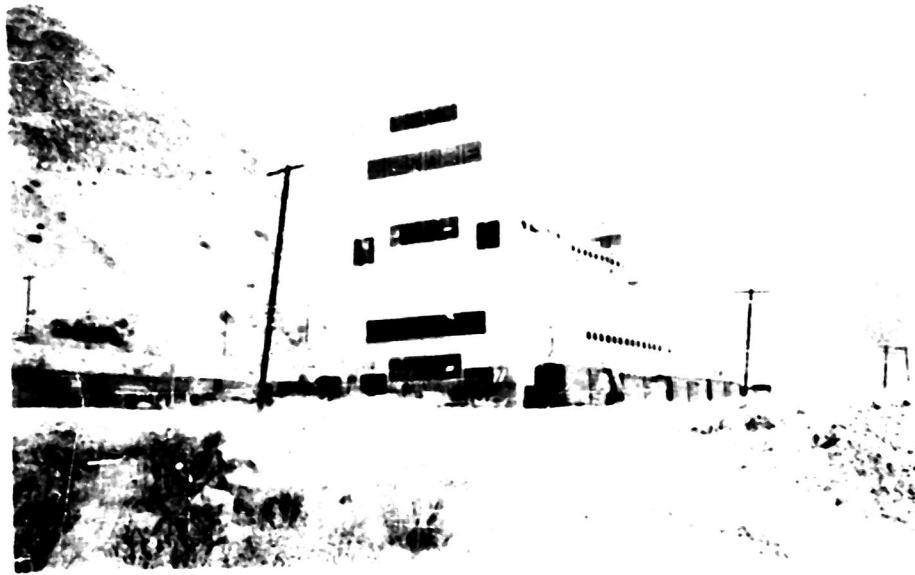
Figure 3. Looking west at steel-frame mill building. Explosion occurred at face of hill just left of upper part of building.

The building in which the measurements were made is a steel-frame mill building constructed in 1947. It has corrugated iron siding and roofing and its plan dimensions are 65 feet by 285 feet. A photograph of the building is shown in Figure 3, looking west. The face of the hill where the explosives were detonated is visible just to the left of the building. The east end of the building is taller than the west end which is a typical one-story mill building. Details of the framing of the one-story portion are shown in Figure 4. The east end of the building has plan dimensions of 65 feet by 37 feet. The overall height of this portion of the building is 103 feet above the ground floor. At an elevation of 45' - 8" above the ground floor there is a 6" thick concrete floor slab (65' x 37'). This floor slab is at approximately the same elevation as the roof of the one-story portion so that the heaviest mass of the building is concentrated at this elevation. Above this floor slab there is the steel wall and roof framing, the corrugated iron siding and roofing, and a steel deck floor at an elevation 84' - 6" above the ground floor. The framing of the east wall is shown in Figure 5. The ground floor of the building is an 8" reinforced concrete slab. There is a single basement beneath the one-story portion of the building and a double basement beneath the east end of the building, with 18" thick reinforced concrete walls. The sub-surface structure of the building thus is essentially a concrete box upon which the steel frame building is standing. A plan of the building is shown in Figure 6.

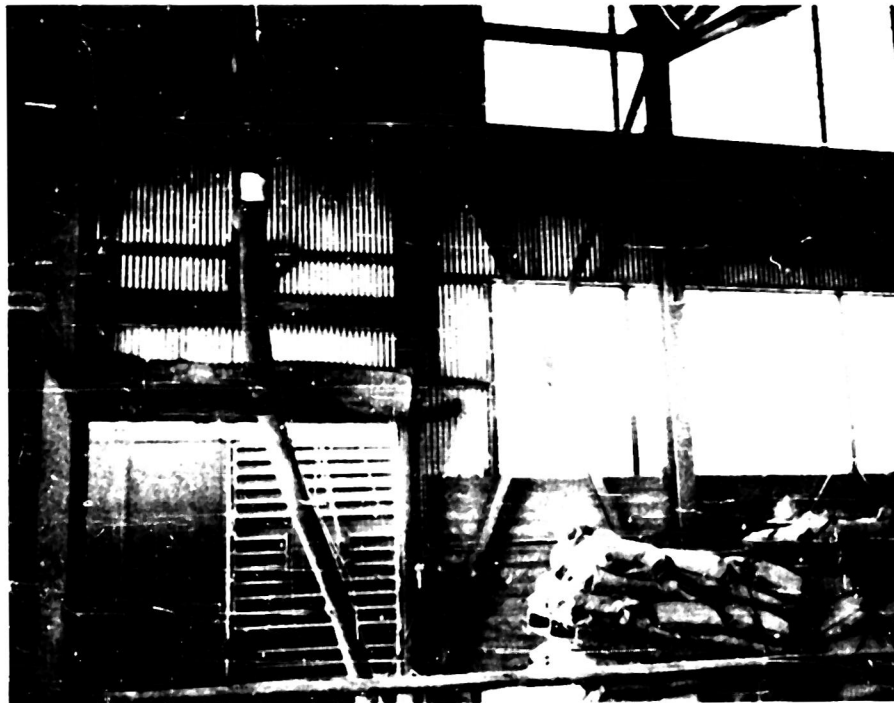
Figure 5b. South wall of mill building.
