U. S. NAVAL PROVING GROUND  
DAHLGREN, VIRGINIA

REPORT NO. 1095

RECOVERY FIRING OF 40MM PROJECTILE  
COATED WITH MOLYBDENUM DISULFIDE

FINAL Report

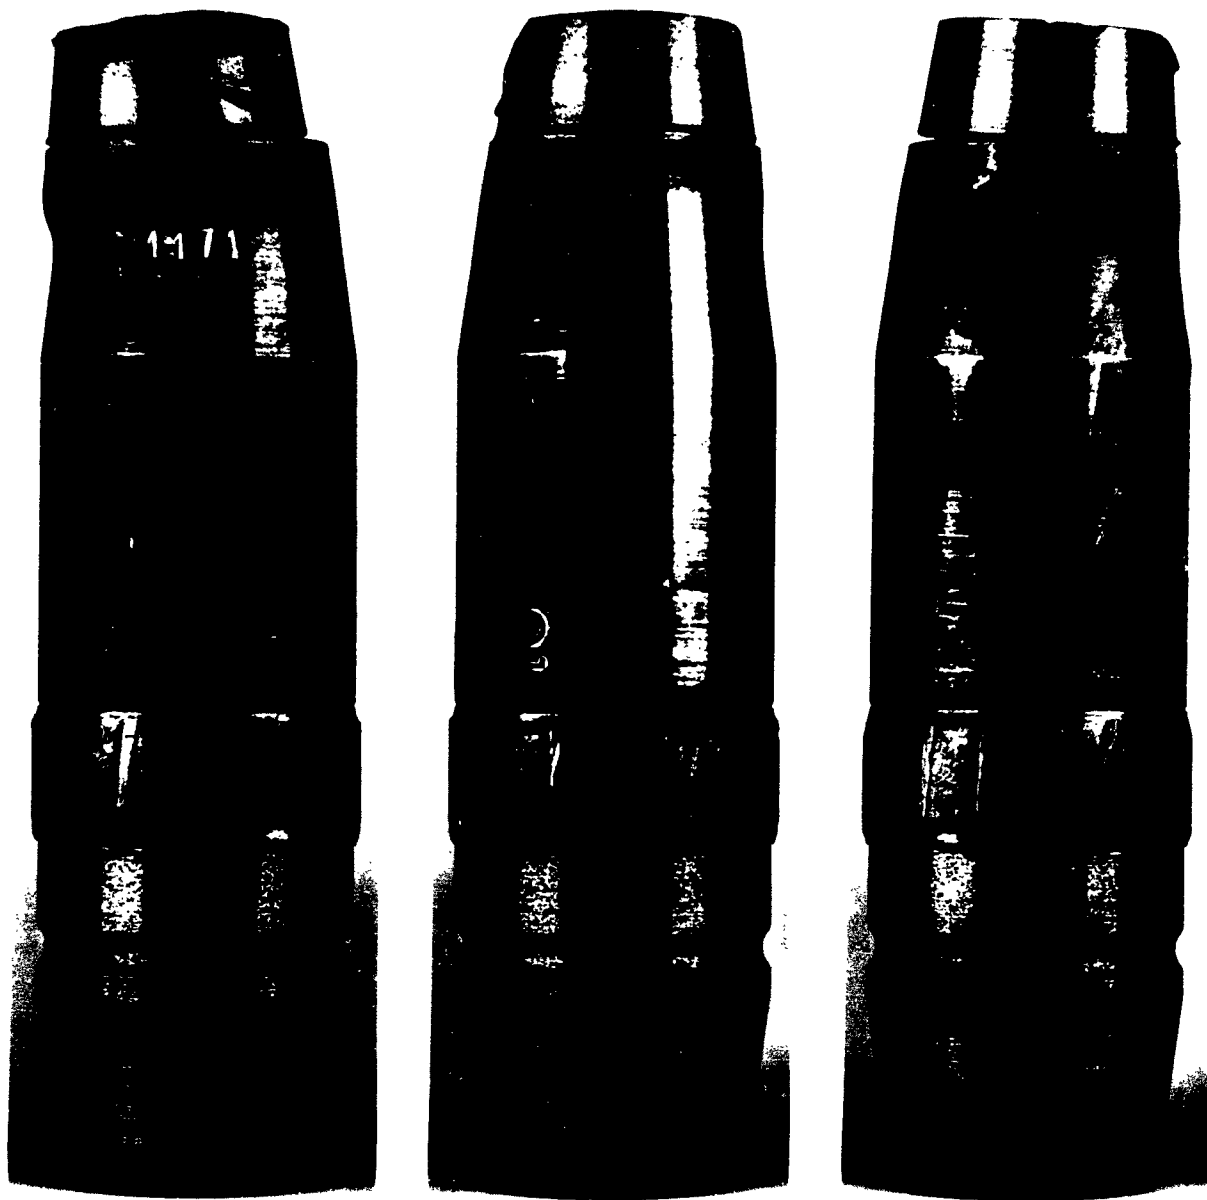
Figure 2

Three views (120° apart) of recovered 40mm T1E1 projectile (uncoated projectile and barrel). Projectile No. 1171.

Complete before and after firing data are given in Table I (Appendix (A)), and photographs of the recovered projectiles are included as Figures 1-20, inclusive. Strain gage measurements taken at four (4) points along the gun barrel are included as Table II. Photographs of the oscillograph records are included as Figures 22-27, inclusive.

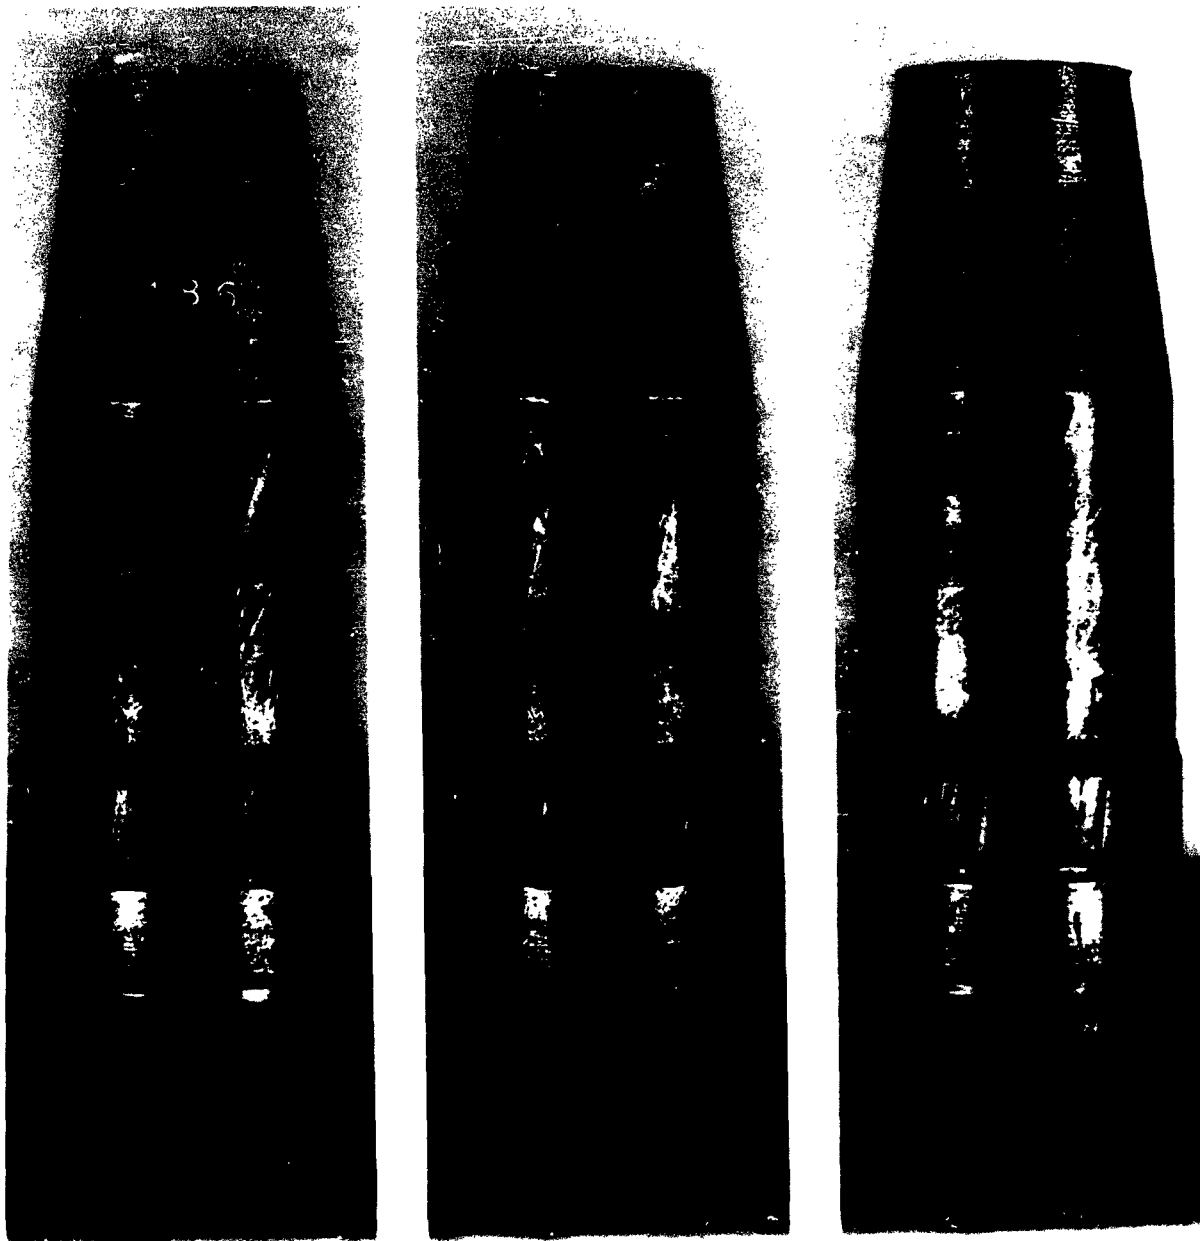
Figure 17

Three views (120° apart) of recovered 40mm T1E1 projectile (projectile completely coated, barrel initially coated for three round group). Projectile No. 1186.
