TECHNICAL NOTE WCLC 53-2

**THE EFFECT OF WATER AND ICE  
ON  
MICROWAVE TRANSMISSION THROUGH RADOMES**

**Wright Air Development Center  
Air Research and Development Command  
United States Air Force  
Wright-Patterson Air Force Base, Ohio**

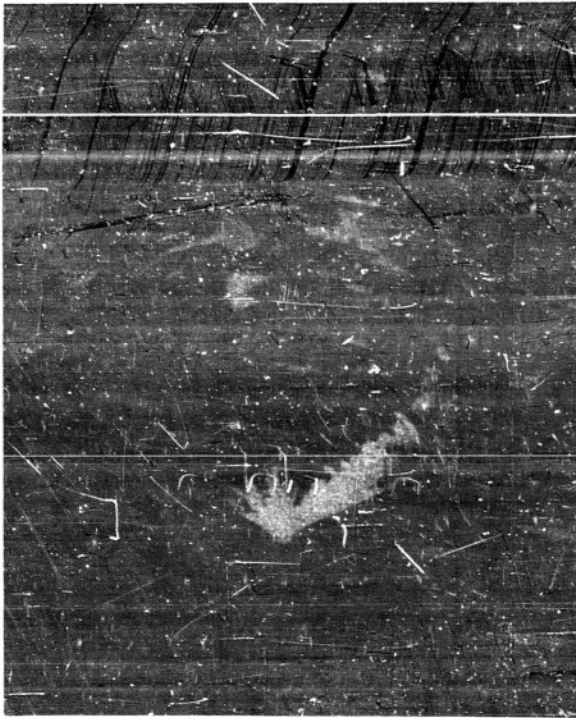
1. 5 mile range on flight line.
2. Same with 1/8" sheet of water on radars.

Photograph SML35642, page 5, was taken while the radome was under test on the ground. A fire hose was used to produce the 1/8-inch thick sheet of water on the surface of the radome. A comparison of the scope picture made under dry conditions with the scope picture taken when the radome had a thick surface water sheet gives evidence of a major reduction in microwave energy transmission through the radome.
