# RESEARCH MEMORANDUM

DE-ICING AND RUNBACK CHARACTERISTICS OF THREE CYCLIC  
ELECTRIC, EXTERNAL DE-ICING BOOTS EMPLOYING  
CHORDWISE SHEDDING

By Robert S. Ruggeri

May 25, 1953

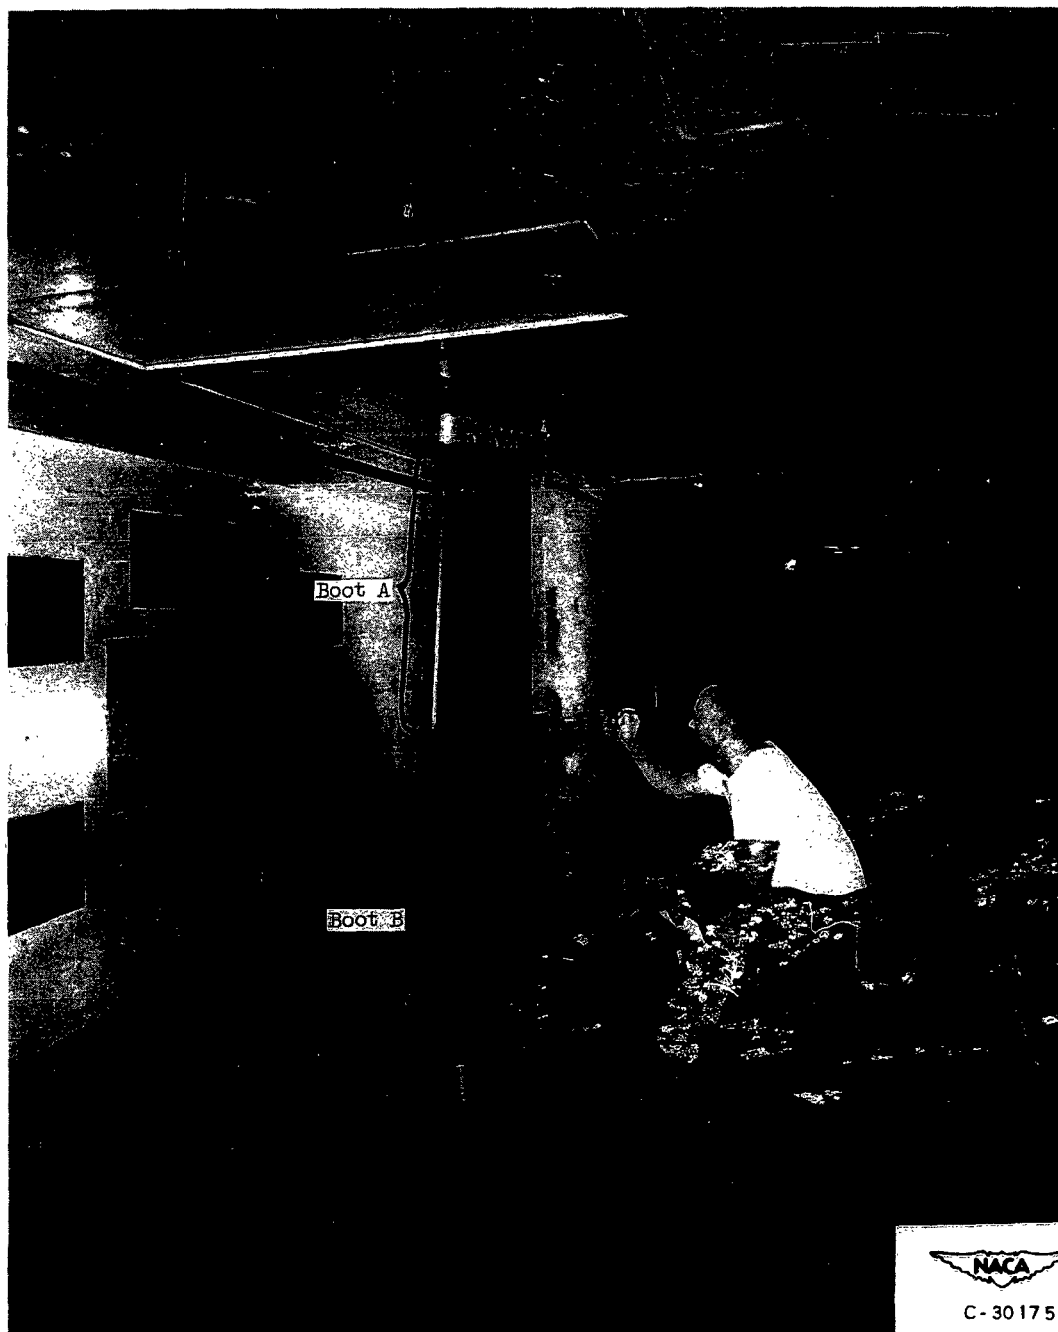
Figure 1. - Installation of airfoil model in test section of icing research tunnel.

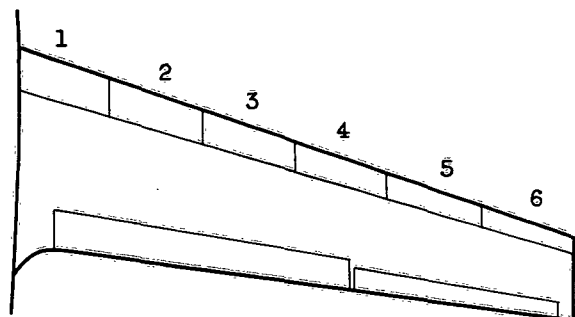
(a) Spanwise shedding.

(b) Chordwise shedding.

Figure 2. - Schematic drawing of de-icing boot installation showing spanwise and chordwise shedding.

Whereas previous NACA investigations of cyclic de-icing have all employed models using the principle of spanwise shedding, the boots included in this investigation employed the principle of chordwise shedding of ice. Chordwise shedding differs from spanwise shedding only in the manner in which the cycled portions of the boot are divided into segments. A sketch showing two hypothetical de-icing-boot installations on the wing of the same fighter-type jet aircraft is shown in figure 2. The boot shown in figure 2(a) provides spanwise shedding of ice, whereas the boot installation shown in figure 2(b) provides chordwise shedding.

If the boots are assumed to be comparable in every respect, the boot employing spanwise shedding might operate as follows: Heat is first applied to cycled area 1 (upper and lower surface) for a specified period of time. When heat is discontinued on area 1, it is immediately applied to area 2; proceeding in a spanwise direction until all areas have been heated. For the case of chordwise shedding (fig. 2(b)), the boot is divided into six segments distributed three on the upper and three on the lower surface of the airfoil. Heat might again be applied first to area 1, then to area 2, and so forth, progressing in a chordwise direction across the upper surface of the airfoil and then in like manner across the lower surface.

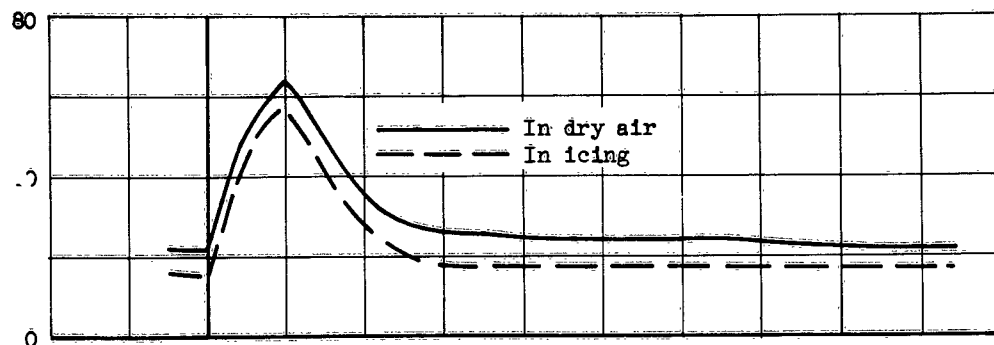
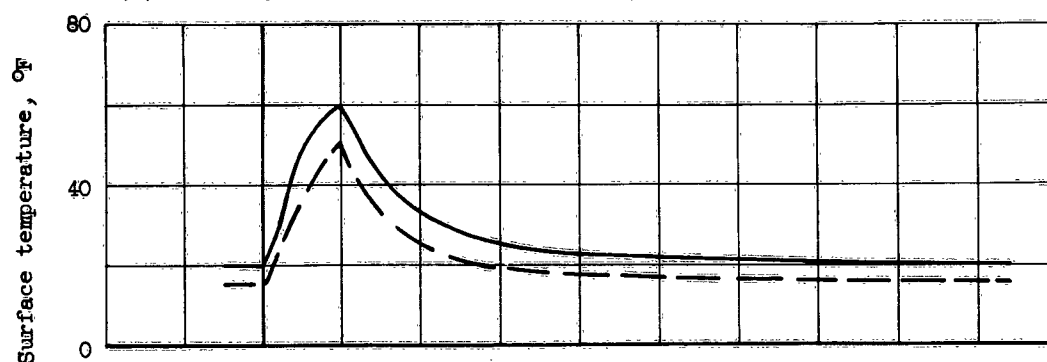
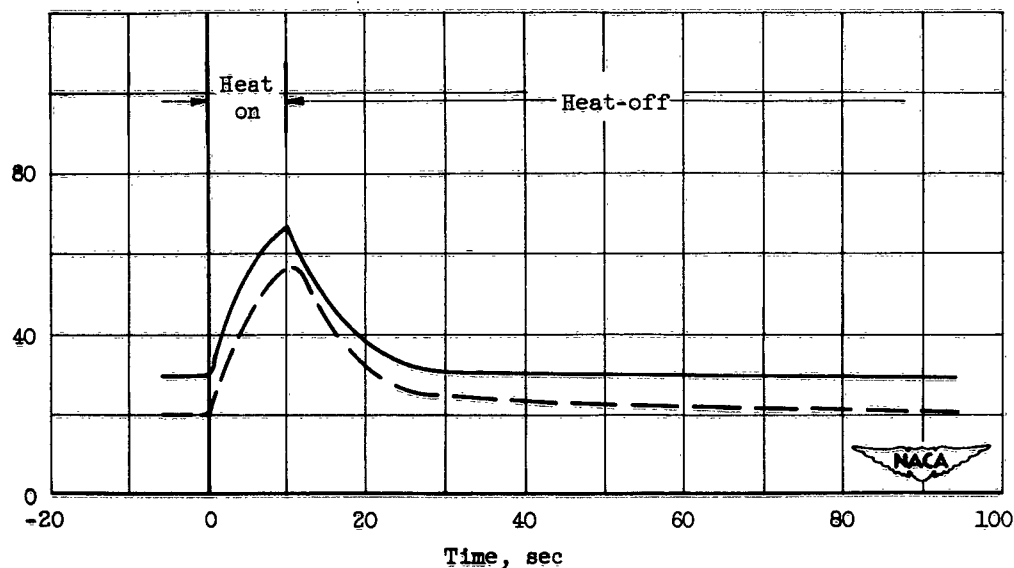
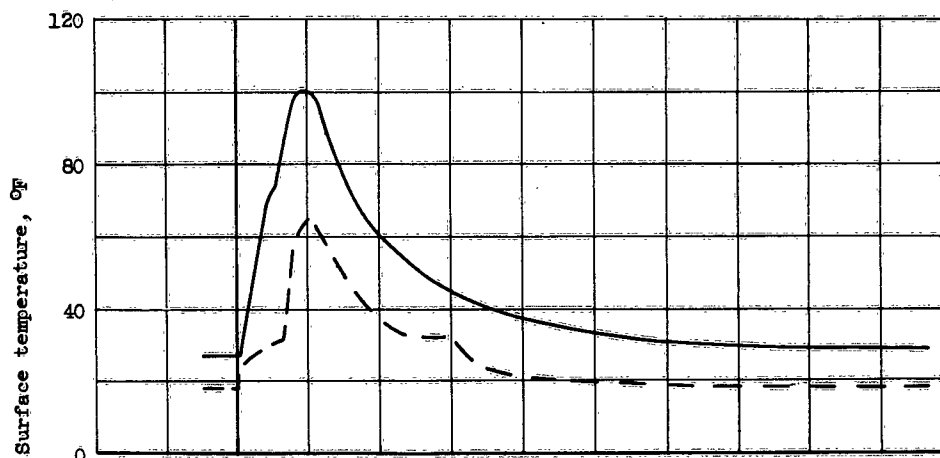
Figure 8. - Typical variation of local surface temperature, upper and lower surfaces, measured in dry air and in icing for three boots. Free-stream total temperature, 15° F; free-stream velocity, 396 feet per second; liquid-water content, 0.57 gram per cubic meter; droplet diameter, 12 microns; angle of attack, 2°; heat-on time, 10.2 seconds; cycle ratio, 10.

Figure 8. - Concluded. Typical variation of local surface temperature, upper and lower surfaces, measured in dry air and in icing for three boots. Free-stream total temperature,  $15^{\circ}\text{F}$ ; free-stream velocity, 396 feet per second; liquid-water content, 0.57 gram per cubic meter; droplet diameter, 12 microns; angle of attack,  $2^{\circ}$ ; heat-on time, 10.2 seconds; cycle ratio, 10.

Several curves showing typical variations of measured local surface temperatures with time are presented in figure 8. The time-temperature curves were obtained with the boots operating in an icing condition identical to that presented in figure 7. The curves are presented for various points on the surface of the boots and represent a portion of the data from which the surface-temperature-distribution curves of figure 7 were obtained. The values of  $s/c$  listed correspond to the approximate center of the most forward segments, upper and lower surfaces, of the three boots. A comparison of figures 8(a), (b), and (c) shows that the peak surface temperatures measured on the most forward segments of the upper surface of the boots are lowered approximately  $10^{\circ}\text{F}$  by the presence of an icing cloud. This relatively small drop in surface temperature indicates the relatively small amount of impingement and runback occurring over a large portion of the upper surface at an angle of

attack of  $2^\circ$ . Comparison with figures 8(d), (e), and (f) shows that the temperature drop experienced on the lower surface of the boots is about 2.0 to 3.5 times as great as those measured on the upper surface for the values of  $s/c$  shown. The irregularities and breaks noted in figures 8(d), (e), and (f) occurred at random intervals and are associated with slow or incomplete shedding of ice, sliding of ice back over the thermocouple junctions, and freezing of water as the surface of the boot falls below the freezing level. For example, the time-temperature curve presented in figure 8(e) shows rapid changes occurring in both the heating and cooling portions of the curve. The abrupt rise in temperature experienced at 6.5 seconds indicates a sudden removal of ice from the surface at that time, while the break noted at 30 seconds is due to the freezing of water on the surface of the boot.

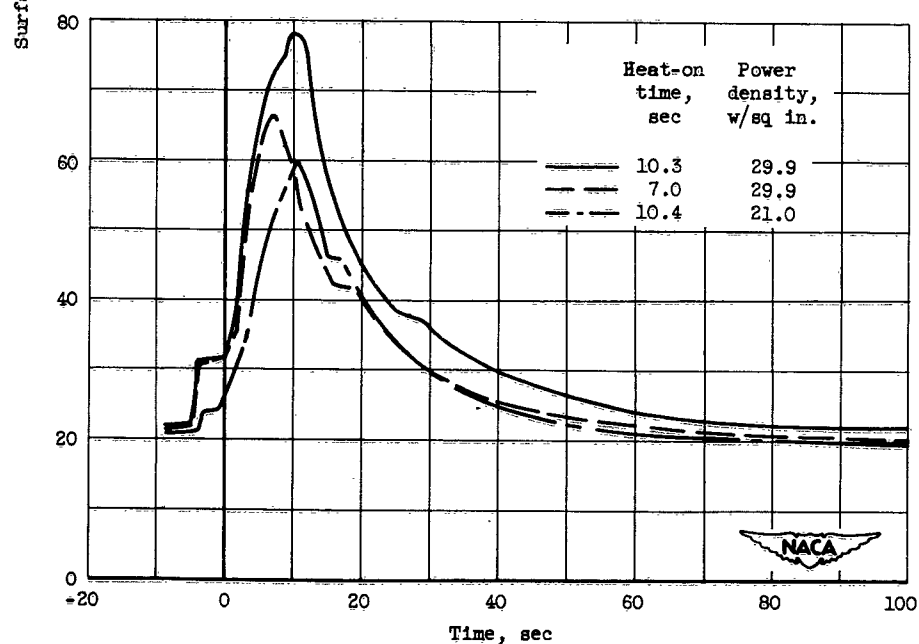
Figure 12. - Variation of local surface temperature at  $s/c$  value of 8.86 percent, upper and lower surfaces, for various values of heat-on time and power density. Boot B; free-stream total temperature, 150° F; free-stream velocity, 395 feet per second; liquid-water content, 0.55 gram per cubic meter; droplet diameter, 12 microns; angle of attack, 2°.

Typical variations of local surface temperature measured at a value of s/c of 8.86 percent, upper and lower surfaces, for boot B in icing are shown in figure 12 for several values of power density and heat-on time. The temperatures were measured at the approximate center of segments BU2 and BL2 and in an icing condition identical to that presented in figure 11. In figure 12(b) it can be noted that, for a power density

of approximately 30 watts per square inch, the temperature measured at the center of segment BL2 rose to approximately 32° F even before heat was applied to that segment. This rise was probably due to runback resulting from the application of heat to segment BL1 forward of BL2.

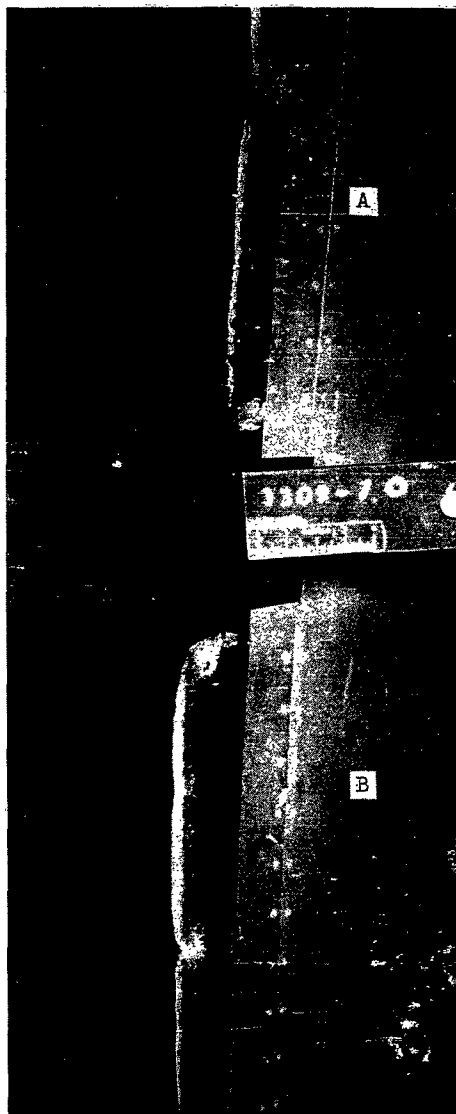
Figure 14. - Runback pattern obtained on boots A and B after 56 minutes in icing. Free-stream total temperature,  $20^{\circ}$  F; free-stream velocity, 396 feet per second; liquid-water content, 0.54 gram per cubic meter; droplet diameter, 12 microns; angle of attack,  $2^{\circ}$ ; heat-on time, 11 seconds; heat-off time,  $1\frac{2}{3}$  minutes; normal power densities.

The runback pattern obtained on boots A and B after 56 minutes in icing at a free-stream total temperature of  $20^\circ$  F and a liquid-water content of 0.54 gram per cubic meter is shown in figure 14 for a free-stream velocity of 396 feet per second and a  $2^\circ$  angle of attack. The thickness

of the runback ice shown in figure 14 was about the same for both boots, measuring approximately  $1/8$  inch thick on the upper surface and  $1/4$  to  $5/16$  inch thick on the lower surface. With the boots operating at design power densities and a heat-on time of 11.0 seconds, the heated portion of the boots shed completely clear of ice on each cycle. In general, at the higher tunnel air temperatures and for a free-stream velocity of approximately 395 feet per second, the runback increased in thickness and chordwise extent because of the longer time at which the boot surface remained above the freezing level after a heat-on period.

As can be noted from a comparison of figures 14 and 15, the effect of decreasing speed in a given icing condition is an increase in chordwise extent of runback icing, with a corresponding decrease in runback ice thickness. Although figures 14 and 15 present runback patterns obtained in different icing conditions, the conditions are not so different as to preclude a comparison or an effect due to changes in free-stream velocity.

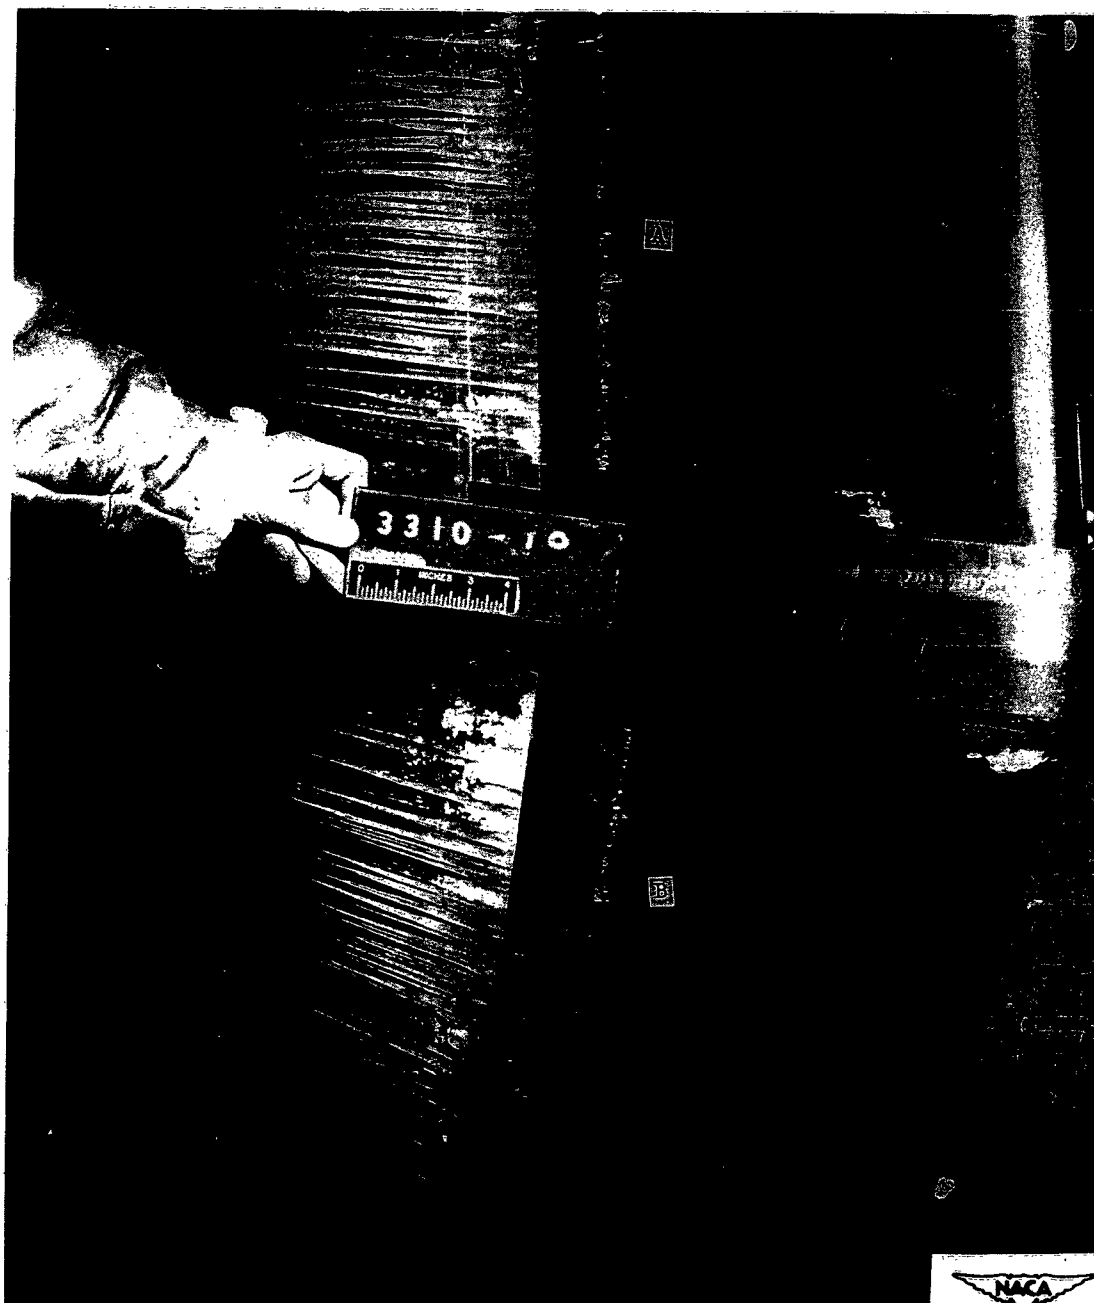
Figure 15. - Runback pattern obtained on boots A and B after 32 minutes in icing. Free-stream total temperature,  $20^{\circ}$  F; free-stream velocity, 288 feet per second; liquid-water content, 0.66 gram per cubic meter; droplet diameter, 14 microns; angle of attack,  $2^{\circ}$ ; heat-on time, 10.0 seconds; design power densities.

Figure 15. - Concluded. Runback pattern obtained on boots A and B after 32 minutes in icing. Free-stream total temperature,  $20^{\circ}$  F; free-stream velocity, 288 feet per second; liquid-water content, 0.66 gram per cubic meter; droplet diameter, 14 microns; angle of attack,  $2^{\circ}$ ; heat-on time, 10.0 seconds; design power densities.

The runback pattern obtained on boots A and B after 32 minutes of operation in icing at the lowest value of free-stream velocity investigated (288 ft/sec) is presented in figure 15. The runback pattern was obtained in an icing condition having a free-stream total temperature of  $20^{\circ}$  F, a liquid-water content of 0.66 gram per cubic meter, and a droplet size of 14 microns. The boots were operated at design power density, a heat-on time of 10.0 seconds, and an angle of attack of  $2^{\circ}$ . The runback pattern and nature of the ice formations observed on the upper and lower surfaces of both boots were found to be very similar. The runback ice was rather clear and smooth. On the lower surface, the runback ice formed a solid sheet approximately  $1/4$  inch thick for a distance of approximately 3 to 4 inches behind the heated area before changing into a rivulet-like formation which extended back an additional 4 to 8 inches. On the upper surface of the airfoil, the runback ice was approximately  $1/8$  inch thick with thin rivulet-type ice formations extending as far back as 12 inches behind the heated area.

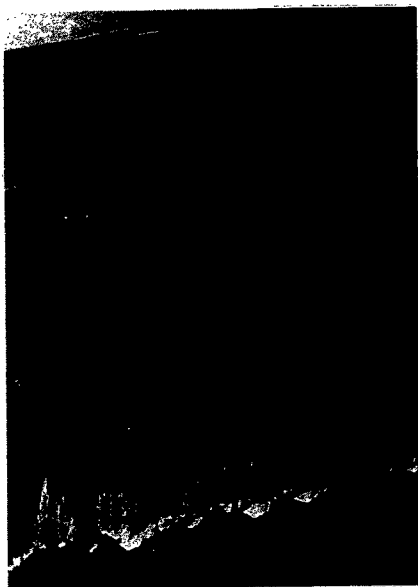
Figure 17. - Appearance of boots A and B after 6 and 22 minutes in icing. Free-stream total temperature,  $0^{\circ}\text{F}$ ; free-stream velocity, 400 feet per second; liquid-water content, 0.56 gram per cubic meter; droplet diameter, 10 microns; angle of attack,  $2^{\circ}$ ; heat-on time, 11 seconds; normal power densities.

Boots A and B were investigated in an icing condition having a free-stream total temperature of 0° F, a free-stream velocity of 400 feet per second, and a liquid-water content of 0.56 gram per cubic meter. Their icing characteristics in this condition at normal power densities but at approximately 11-seconds heat-on time are shown in figure 17. Photographs were taken after 6 and 22 minutes in the icing condition. Both boots began icing on the forward cycled segments, upper and lower surfaces, from the beginning of the icing exposure. After 15 minutes of icing, the parting strip of each boot was narrowed by approximately 1/2 inch because of the building forward of ice from the cycled area. The parting strip of each boot was completely bridged with ice after 20 minutes in the icing condition. In order to determine the de-icing ability of the boots after leaving an icing condition, the tunnel cloud

was discontinued after 22 minutes while boot power remained on. After 9 minutes of cyclic operation in clear air, no ice was removed from the surface of either boot.
