REPORT NO. 1136

**BOMBS AND ASSOCIATED COMPONENTS**

Test of Mk 77 Mod 0 Bomb (Fire-750 lbs.) with Canted Fins

**Date: JUN 8 - 1953**

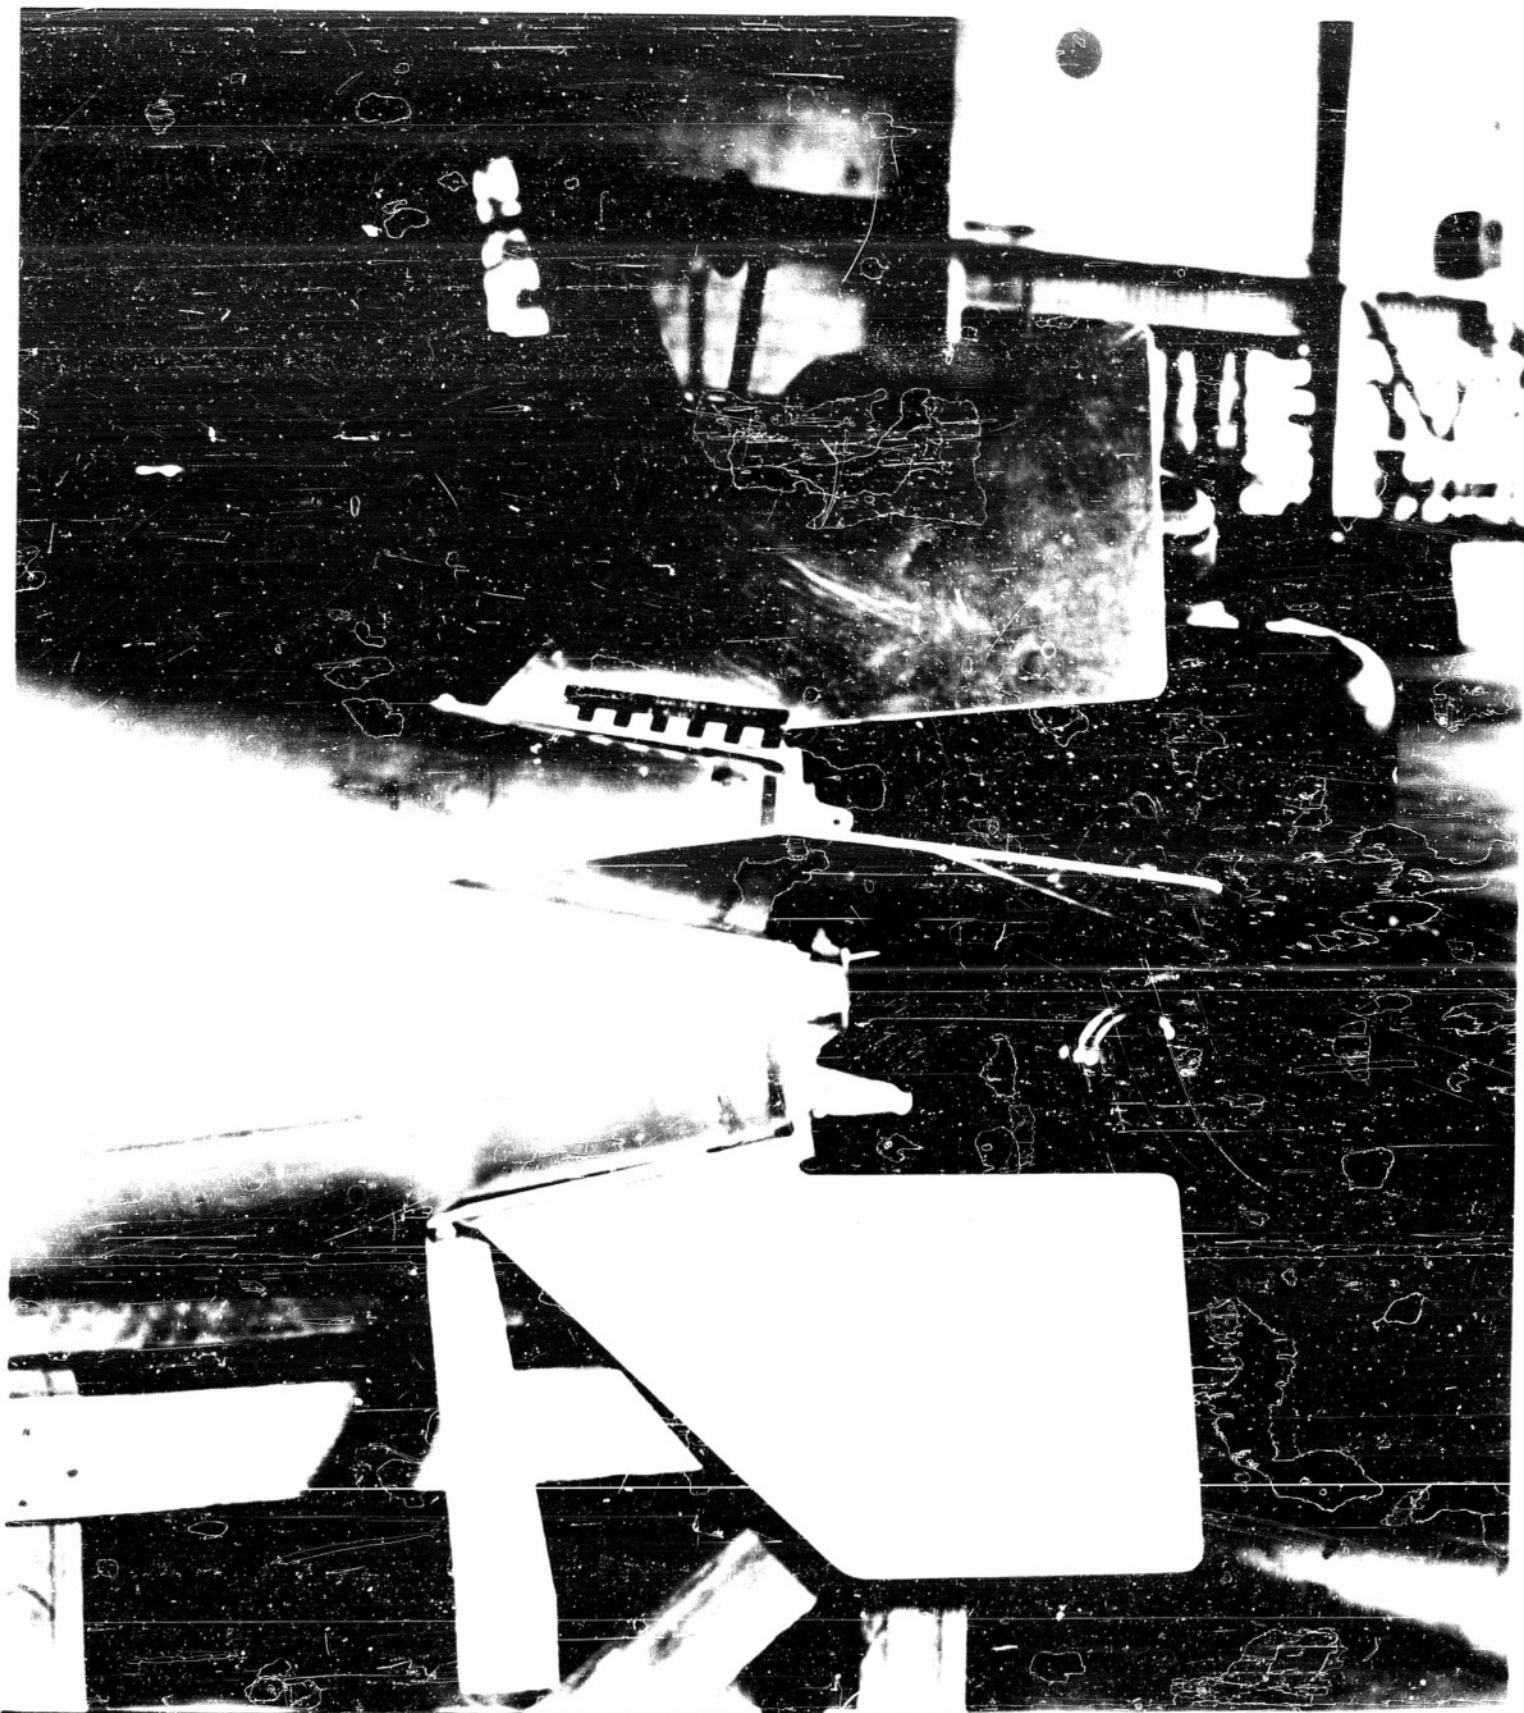
Figure 2

M7 Mod 0 Fire Bomb equipped with canted fins before modification,  
side view.

The bomb tested was a standard Mk 77 Mod 0 Bomb (Fire-750 lbs.) inert loaded and equipped with inert M23 Igniters and inert M173 Fuzes and further equipped with modified canted fins instead of the standard fins or fins and shrouds. The nose and tail cones were not installed. The fins are manufactured of ST aluminum, 3/16 inch in thickness and 18 inches in length along the root chord. The fins were welded at an angle to an adapter which bolted to the bomb. The angle of fin to the fore and aft centerline of the bomb, and to the adapter, is about 10 degrees. Actual measurements are given in Table I. Reference (c) authorized the modification of the fins as follows: The fins were strengthened by bolting a 3/8 inch steel rod 1-1/2 inches down and in from the outboard after corner of two (2) adjacent fins, and bolting rods between the next two (2) fins as close as practical to the bolts used in the first two (2) fins. Figures 1 through 4 show the bomb before and after modification.

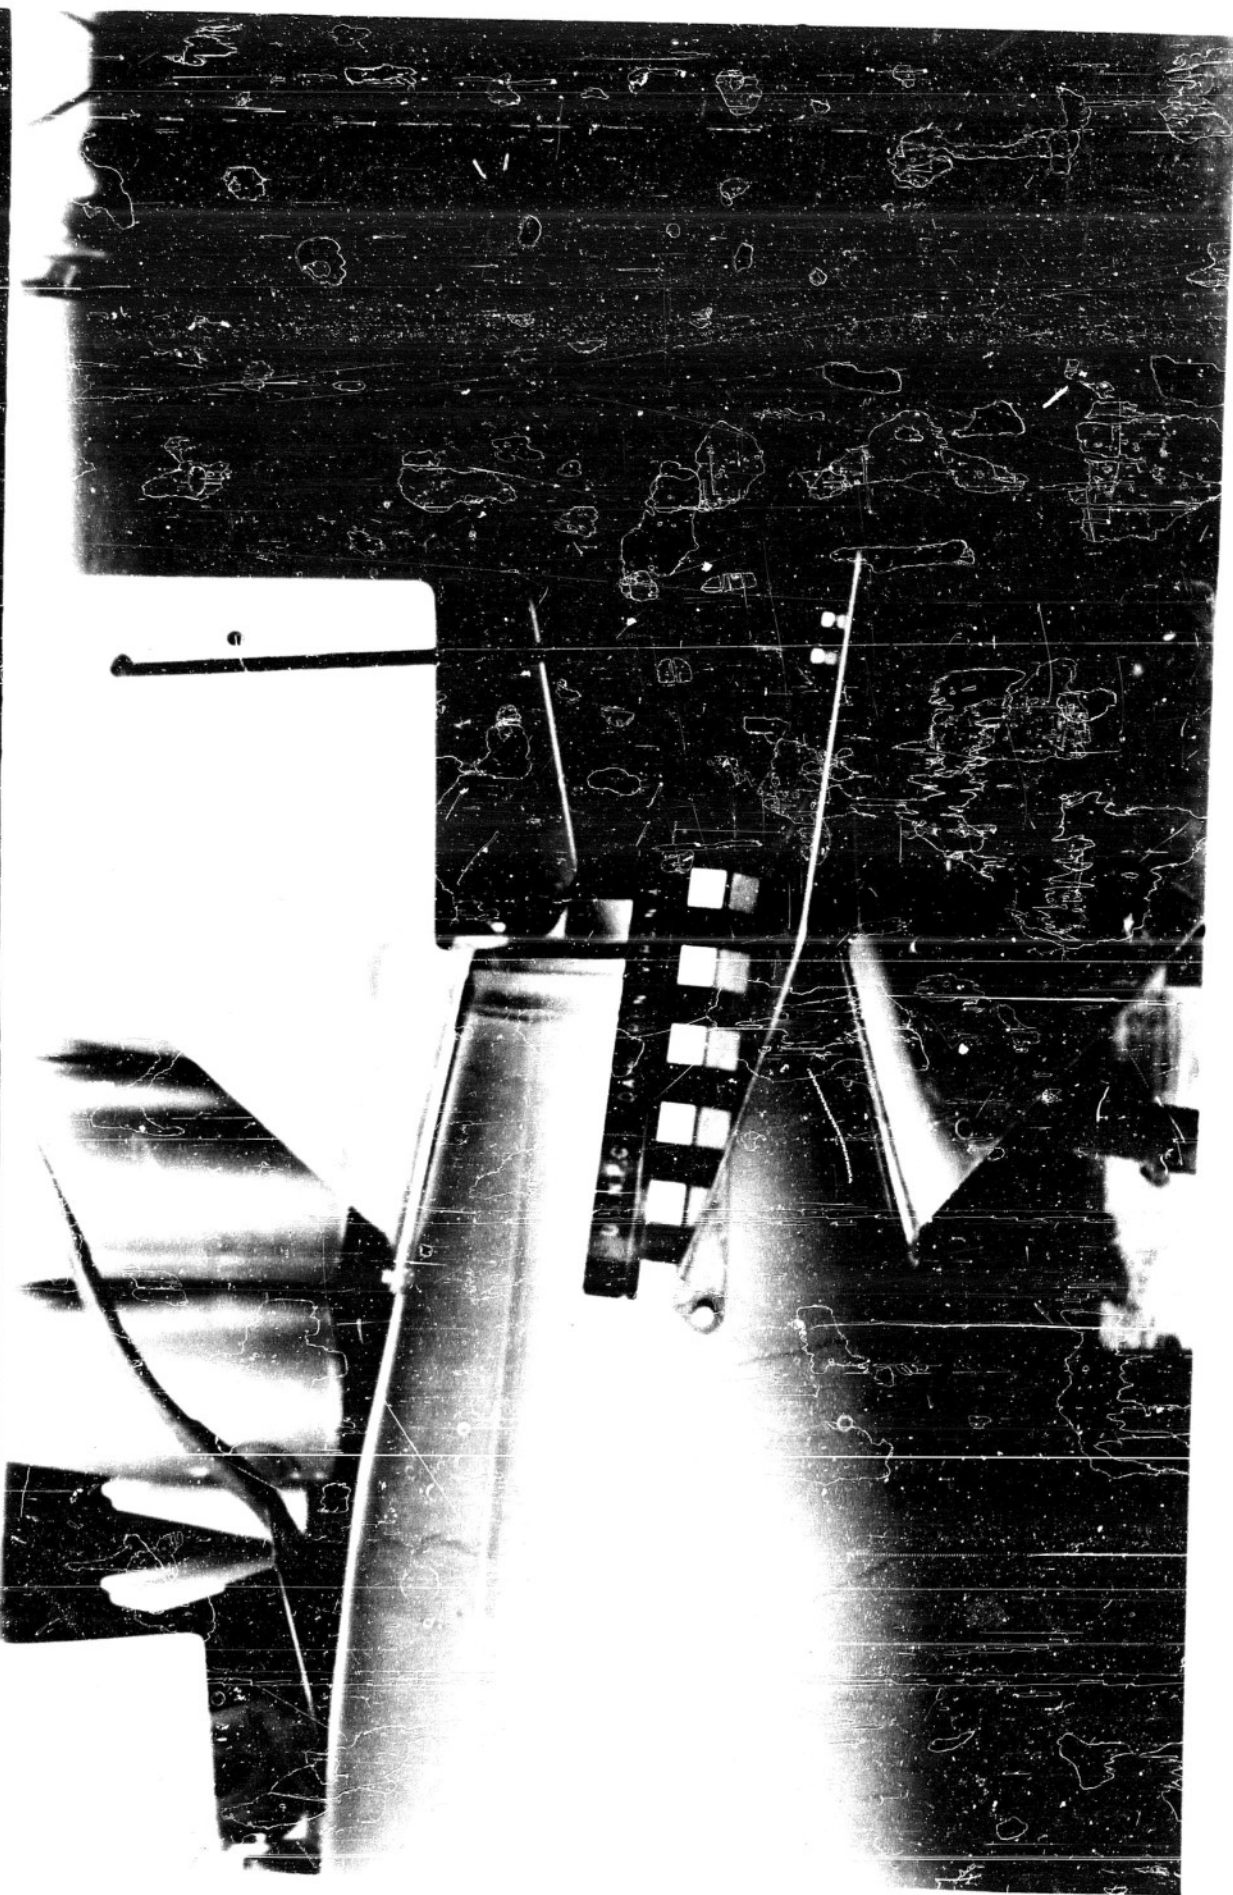
Figure 3

EX 77 Mod O Fire Bomb equipped with canted fins, after modification, side view.
