STUDY OF THE STRAIN AND MOTIONS  
OF THE USCGC CASCO AT SEA

Norman H. Jasper

May 1953

Report 781

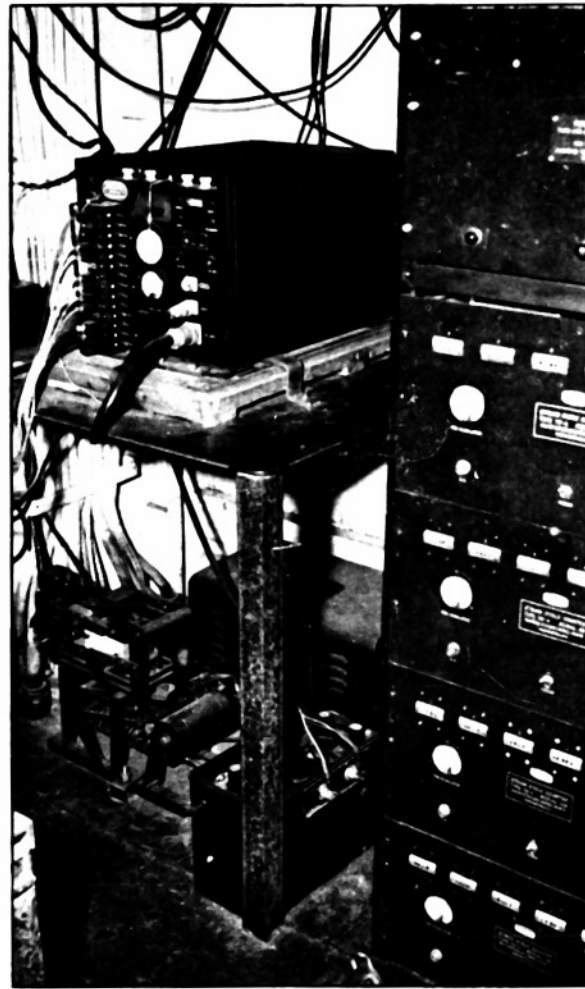
Figure 8 - Photograph Showing Installation of Strain-Cycle Counters, Pallograph, and Consolidated Oscillograph

Section B-13 of Figure 4.
