Experiments Toward an Underwater  
Electromagnetic Detection Scheme

Ray W. Jackson

Technical Report No. 26  
(ESL:521:Serial 010)  
22 March 1954

A system for setting up an alternating-current field between two parallel electrodes was laid on the bottom of the West Passage of Narragansett Bay in May, 1953, for the purpose of investigating the feasibility of a scheme for detecting mines (1,2). This report will describe the laying of pick-up coils and the development of apparatus on shore up to the point of detecting the passage of ships in October, 1953. The problems remaining for the further development of sensitivity will be discussed.

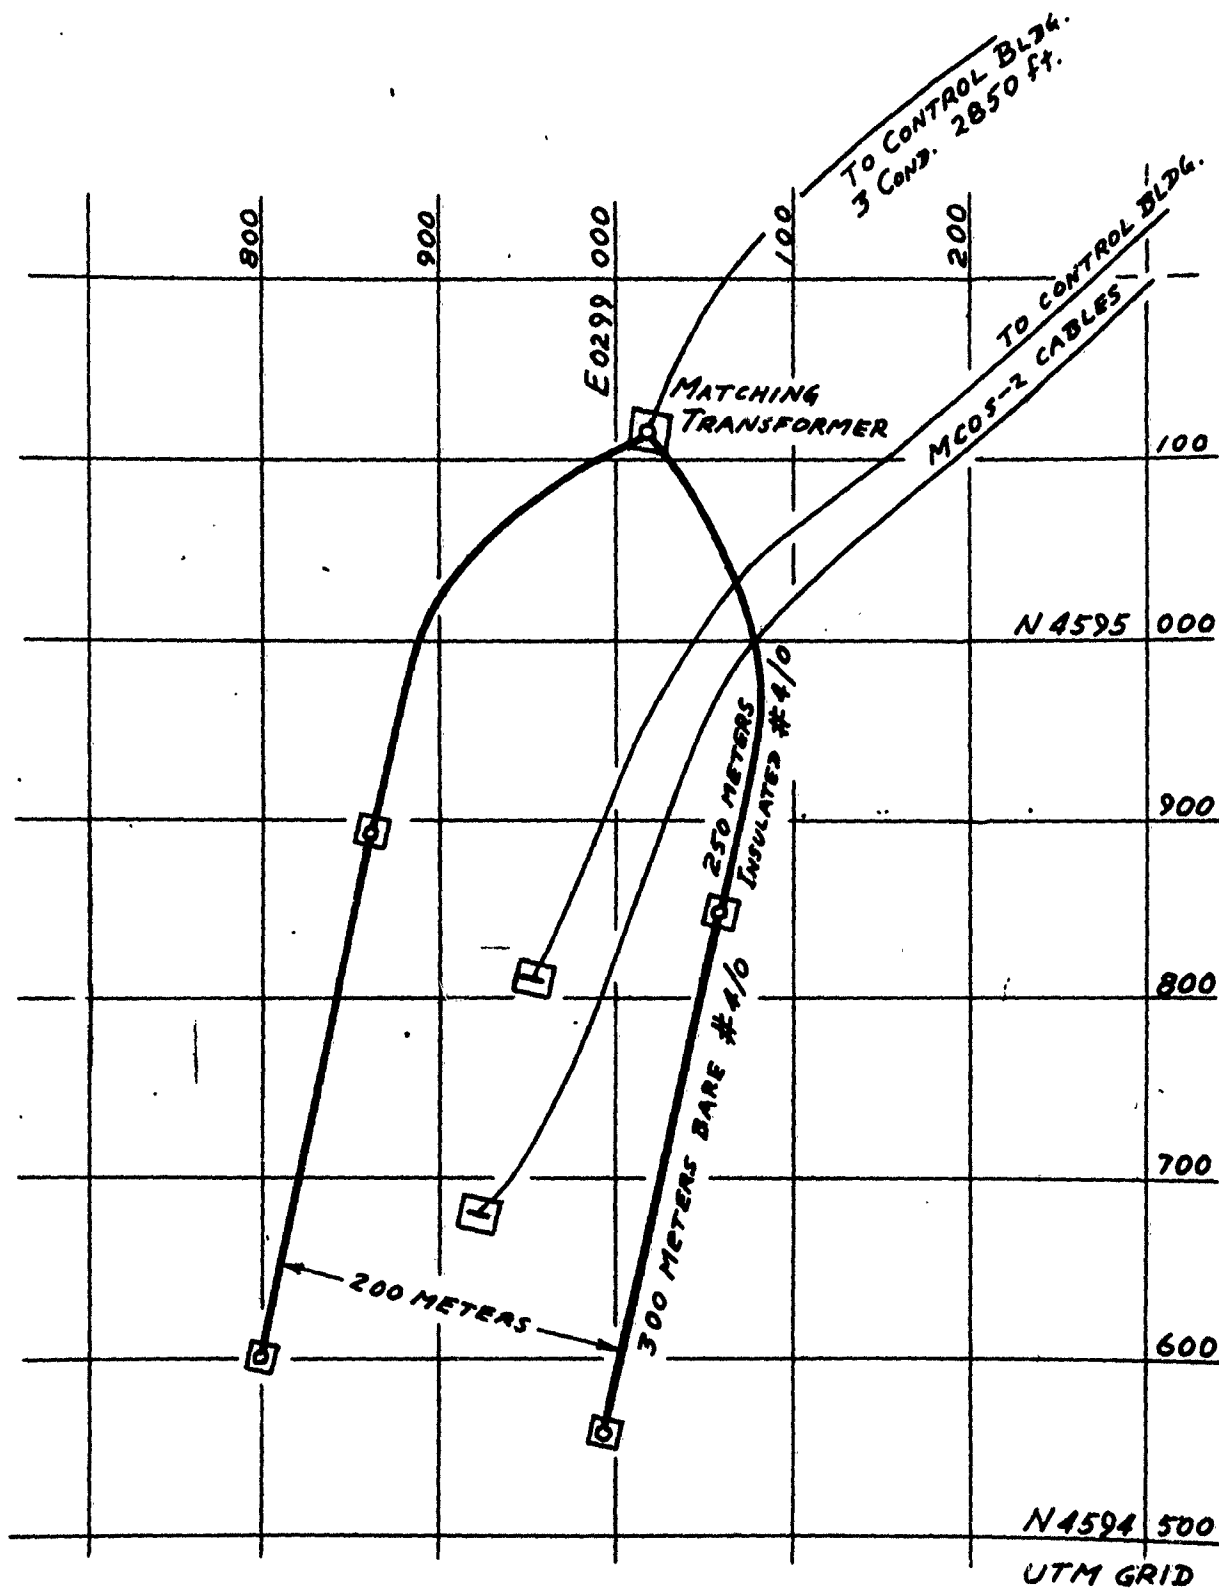
FIG. 1. GENERAL LAYOUT OF SYSTEM

The parallel electrodes were bare copper cables, gauge 0000, 300 meters in length and 200 meters apart. They were fed at one end by insulated cables, also 0000 gauge, from a submerged matching transformer. The matching transformer was connected to a 30 c/s one kilowatt generator on shore by a 3-conductor rubber-insulated cable 2850 feet in length. The general layout of the system is shown in Fig. 1. The depth of water was 30 to 45 feet. A more detailed description of the splicing, laying, and anchoring of the feeder system, and a description of the generating apparatus on shore is given in (3). An estimated 30 watts A-C power was fed into the sea water by the parallel electrodes.

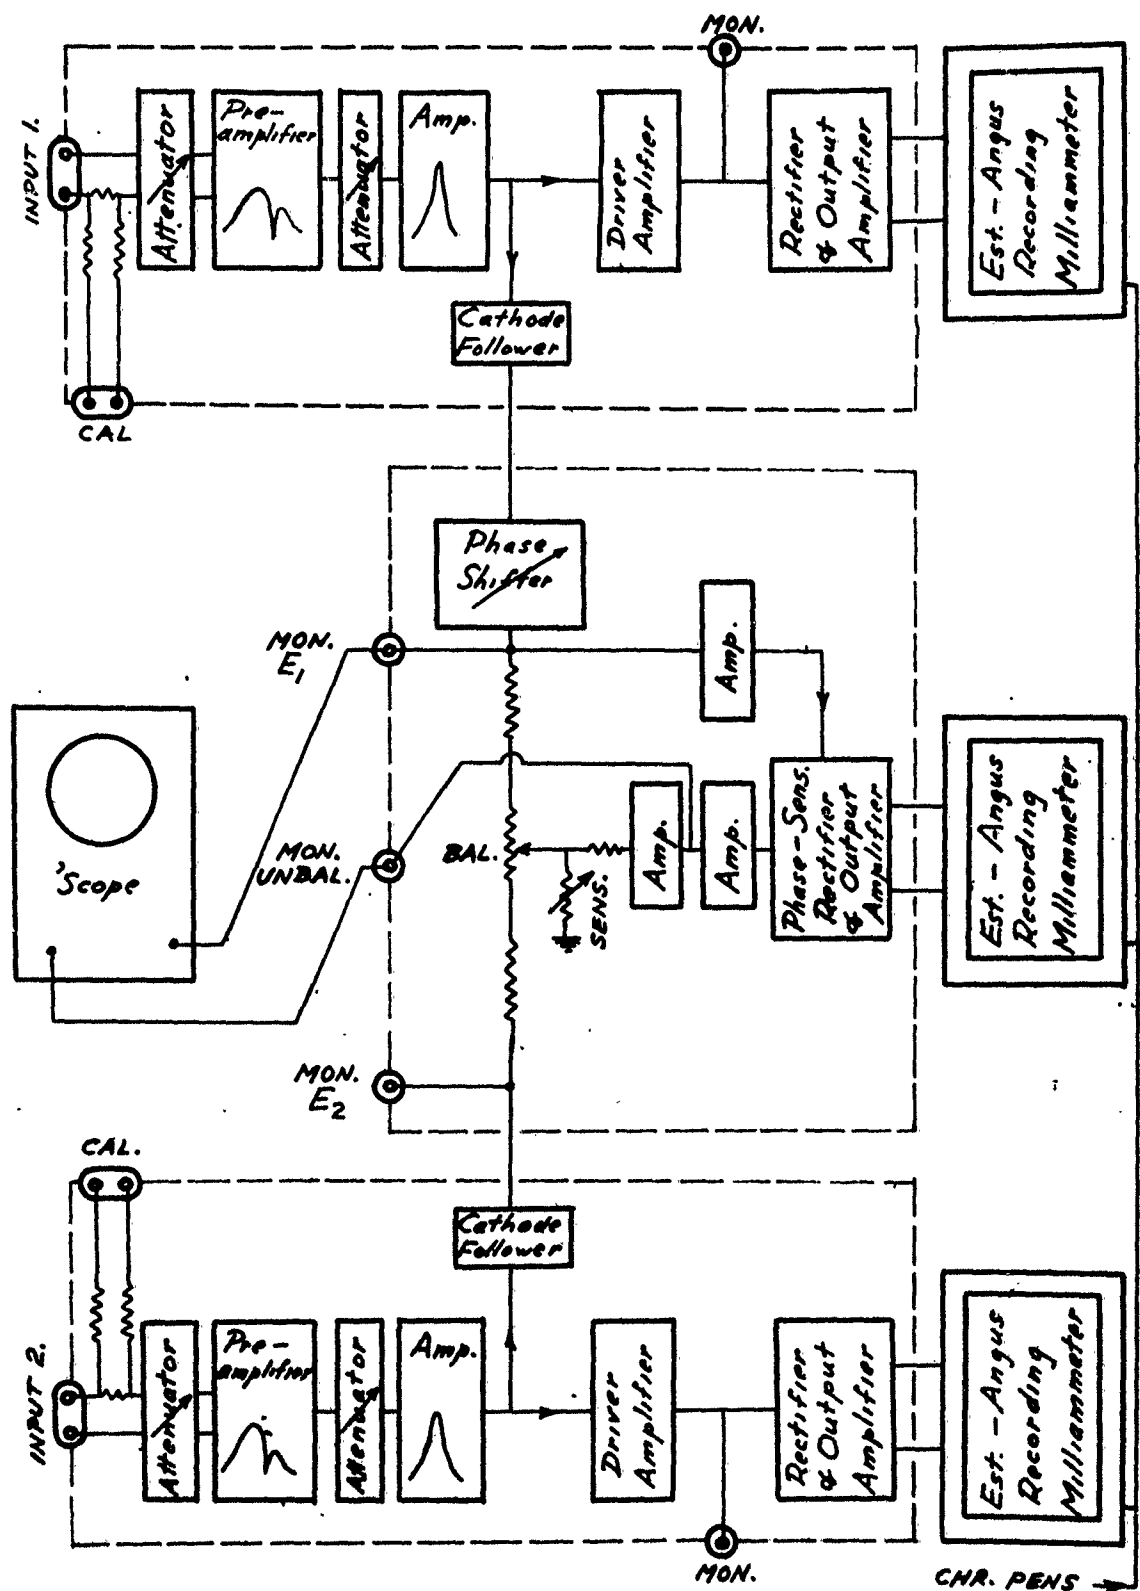
FIG. 4. BLOCK DIAGRAM OF DETECTION CIRCUITS.

Two low-noise frequency-selective amplifiers on shore were used to amplify the signals from the two coils. Let us call the amplified signals  $E_1$  and  $E_2$ .  $E_1$  was then shifted in phase by a variable amount and balanced against  $E_2$  in a mixing network. The difference signal was again amplified, then rectified in a phase-sensitive rectifier circuit for display by a recording meter. The reference phase for the phase-sensitive rectifier was obtained from  $E_1$  after phase-shifting. In this way it was hoped to balance out the constant, standing component of voltage induced in the coils by the primary field and show up the differential perturbations due to local changes in the fields around one coil or the other. A block diagram of the system is shown in Fig. 4. Two recording meters kept track of the amplitudes of the two coil signals separately, and an oscilloscope was used to monitor the phase of the unbalance signal with reference to  $E_1$ .

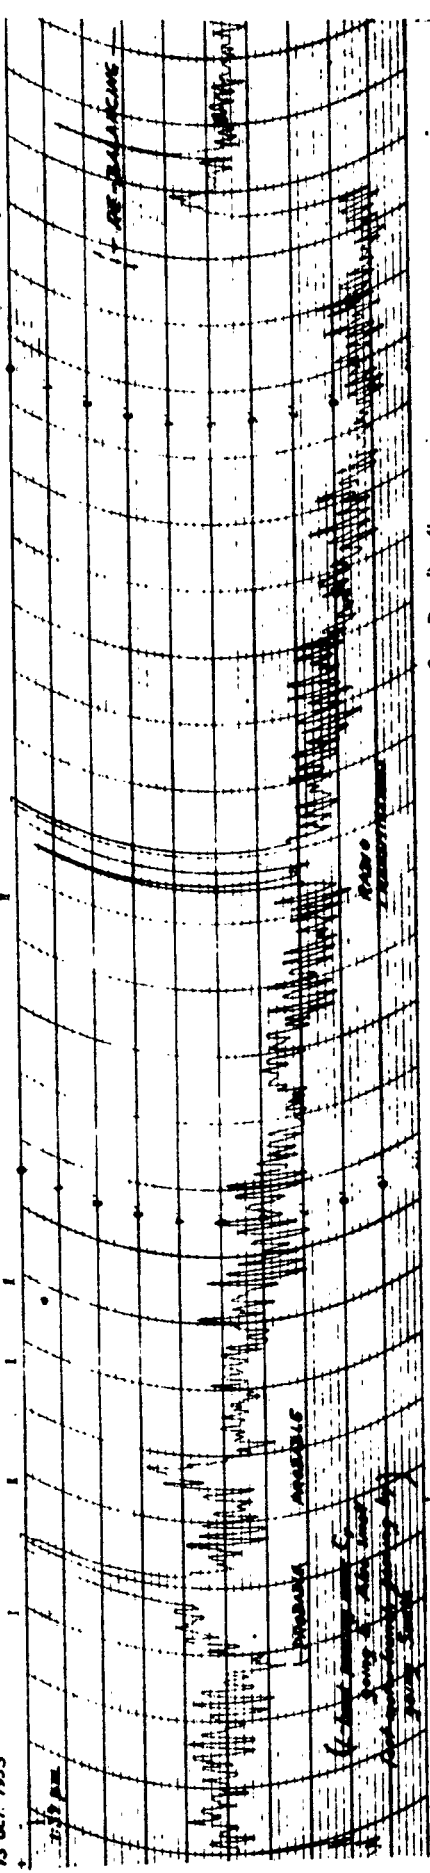
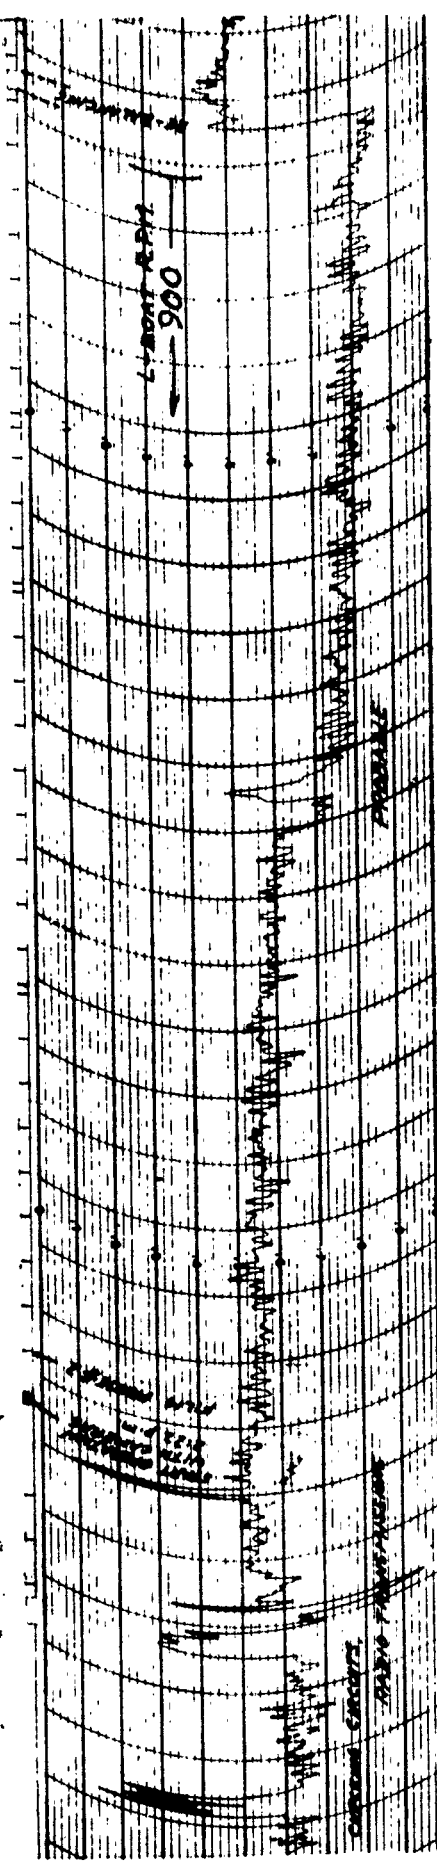
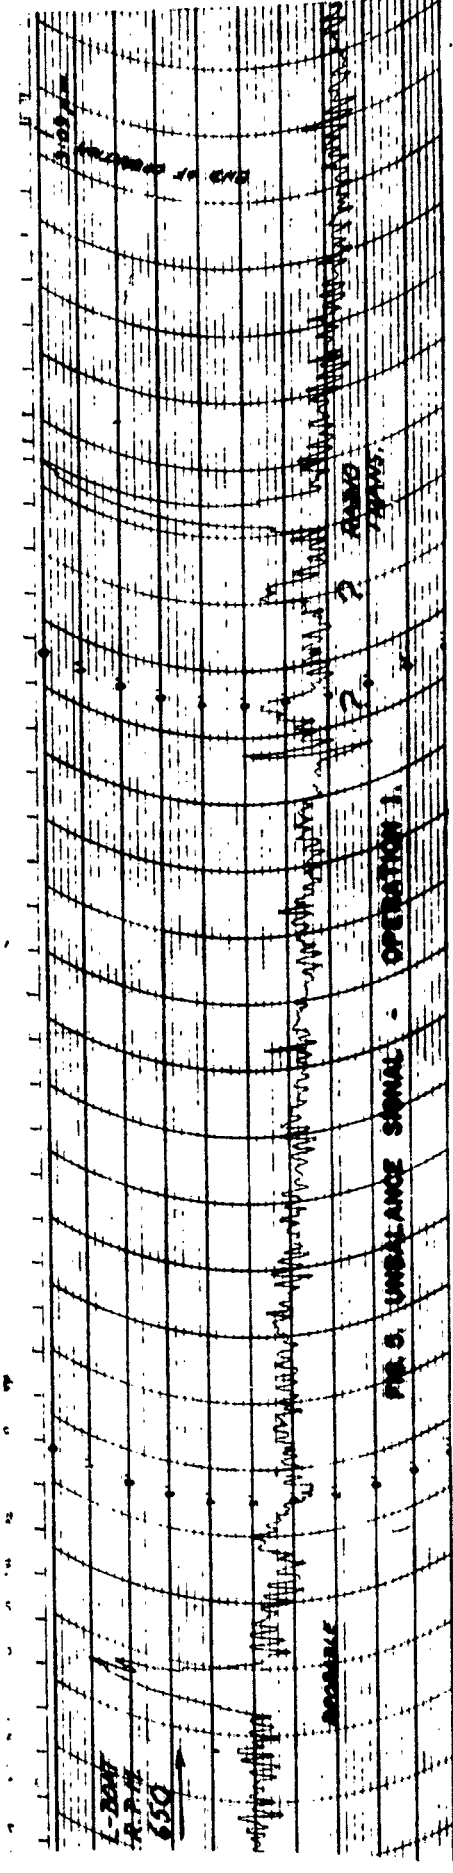
FIG. 5. UNBALANCE SIGNAL - OPERATION 1.

As it turned out, there was trouble with the shutter-triggering mechanism of the camera on Prospect Hill. By the time this was noticed and corrected, the camera at Fort Getty was almost out of film, so that only a small part of the boat's course was recorded. The record of the detection or unbalance signal is shown in Figure 5. Two or three probably significant deflections were obtained (marked "probable" on the chart, Figure 5) at times when the L-boat was ascertained by binoculars to be somewhere in the upper region of the system. The principal other signals to be noted are interference from VHF radio transmissions from a transmitter a few feet away from the detection apparatus. The L-boat was instructed to change its engine speed about half way through the operation to make sure that the signals picked up were not merely frequency components generated by the shaft and propeller rotation.

The Esterline-Angus charts are displayed upside down so that the time axis runs in the normal left-to-right direction. The circuits were so set up that, as displayed, an upward deflection corresponds to a decrease in amplitude of  $E_1$  (obtained from coil  $C_5$ ) or, of course, to an increase in amplitude of that component of  $E_2$  (obtained from coil  $C_4$ ) which is 180 degrees out of phase with  $E_1$  (the phase of  $E_1$  is the reference phase for the

phase-sensitive rectifier). A downward deflection corresponds to the converse of the above or to a shift in phase of either signal. The time scale is one minute per division on the Esterline-Angus Chart. The synchronizing marks occur every 40 seconds, being counted down from the camera pulses by a scale-of-four mechanism constructed from latching relays. Additional marks in the margin could be inserted by manual control to note the time of occurrence of other events such as re-adjustments of the balance controls.

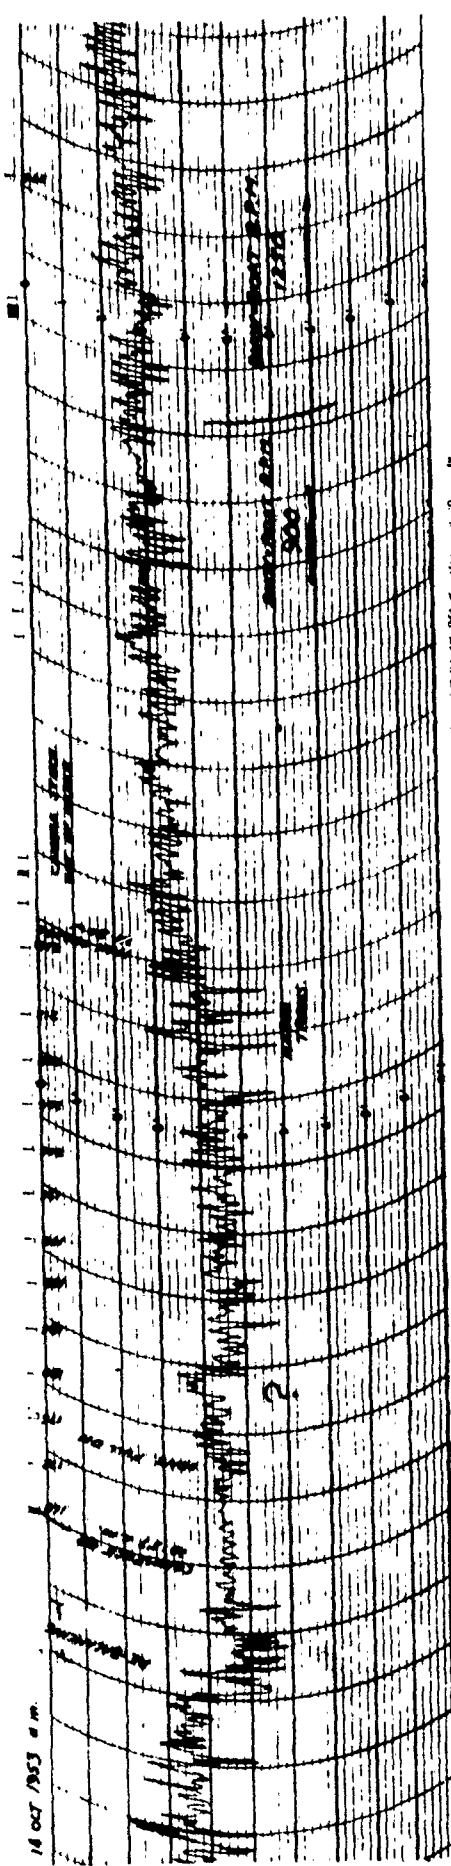
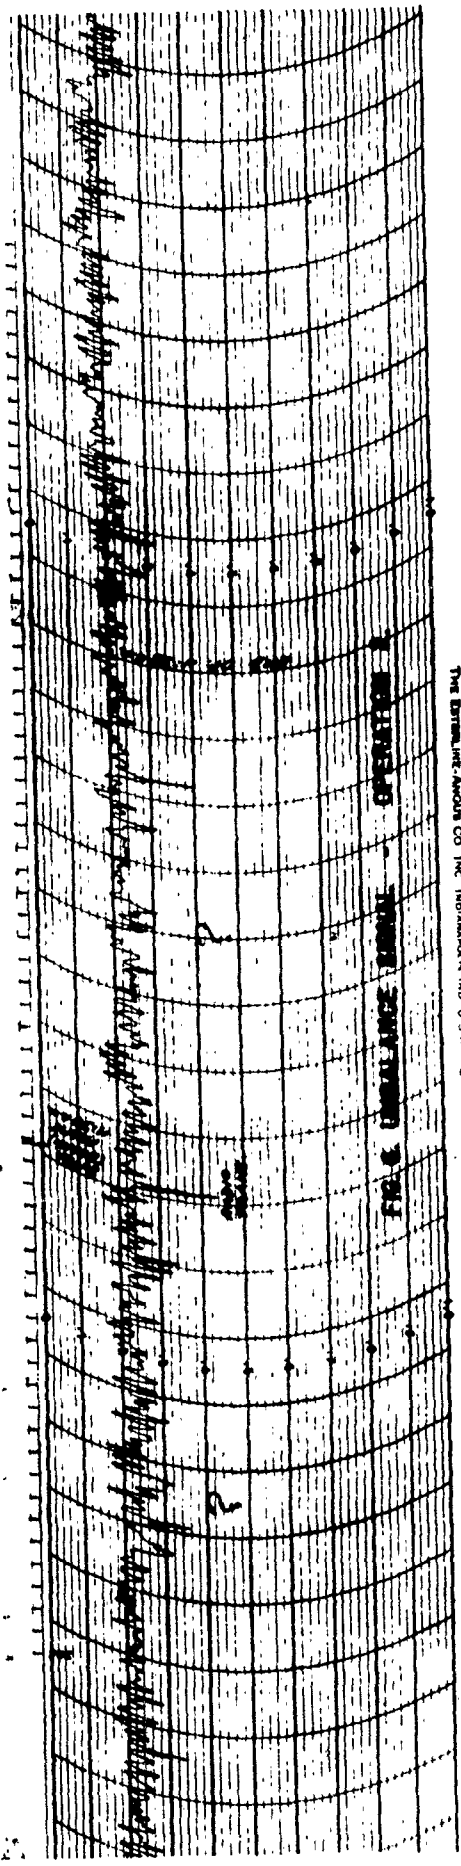
For comparison purposes a smaller boat was used, a buoy-boat 37 feet in length, with wooden hull, 11 foot beam, 8.7 tons displacement. Part way through the operation one of the wires carrying synchronizing signals was accidentally broken so that part of the camera record was lost. However, there are no obviously significant pen deflections on the chart (Figure 6). Those places marked on the chart with a question mark which were picked out as being possibly significant were found to correspond with points in the boat's course when it was well away from either detection coil. Hence it was not considered worth while to plot the remainder of the boat's course. The synchronizing marks for the first part of the record are 40 seconds apart, for the second part of the record they are 20 seconds apart.

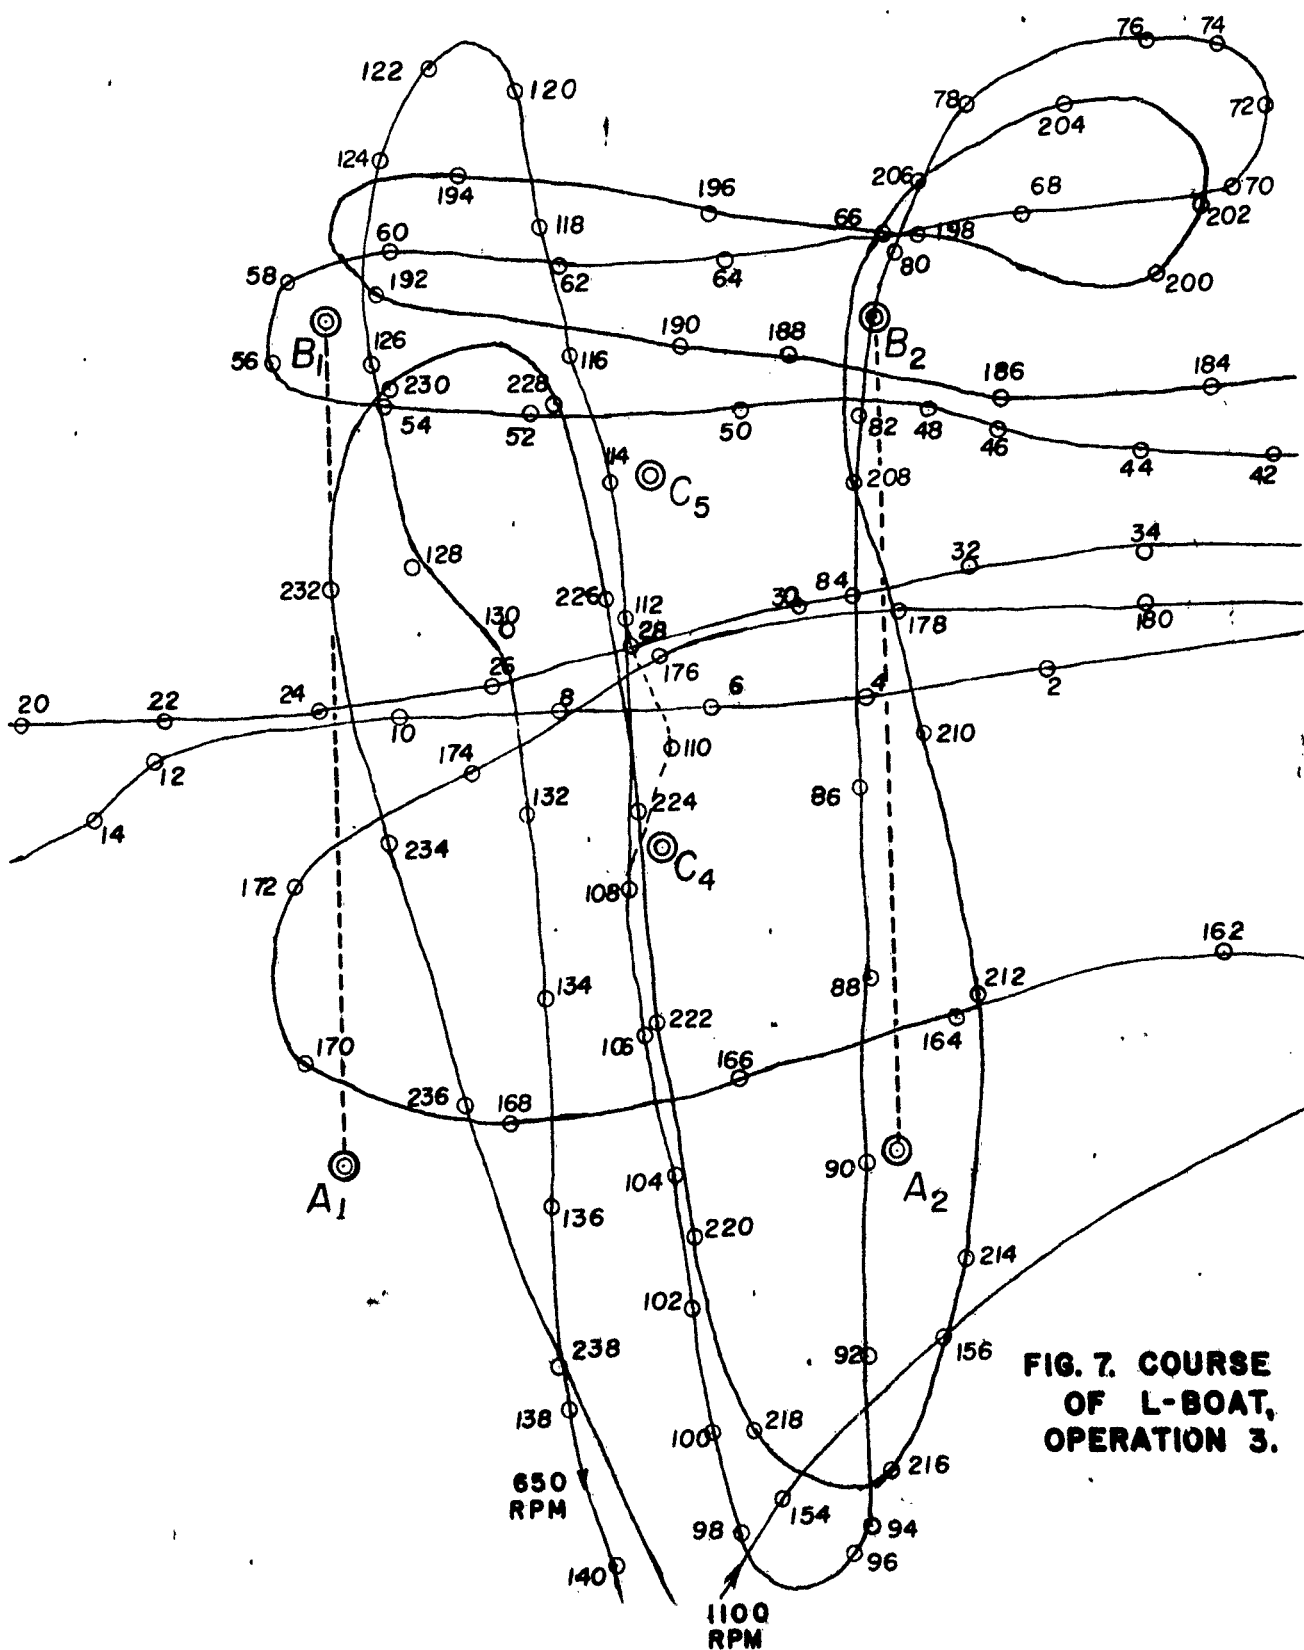
**FIG. 7. COURSE  
OF L-BOAT,  
OPERATION 3.**

is plotted in Figure 7. Only every other camera frame was used to plot the course. Point No. 110 is probably in error. The detection signal record is shown in Figure 8. There are six fairly close passes of the L-boat near the detecting coils, at which times deflections of the recording pen may be noted. The approximate distance of the boat from the coil is noted on the record, in meters, for each encounter, as well as the orientation of the boat's hull to the electrode system. The largest deflections, as might be expected, occur for the boat lying athwart the electrode system. A section of the record after the operation, when no boats were in the vicinity of the system, is included for comparison.

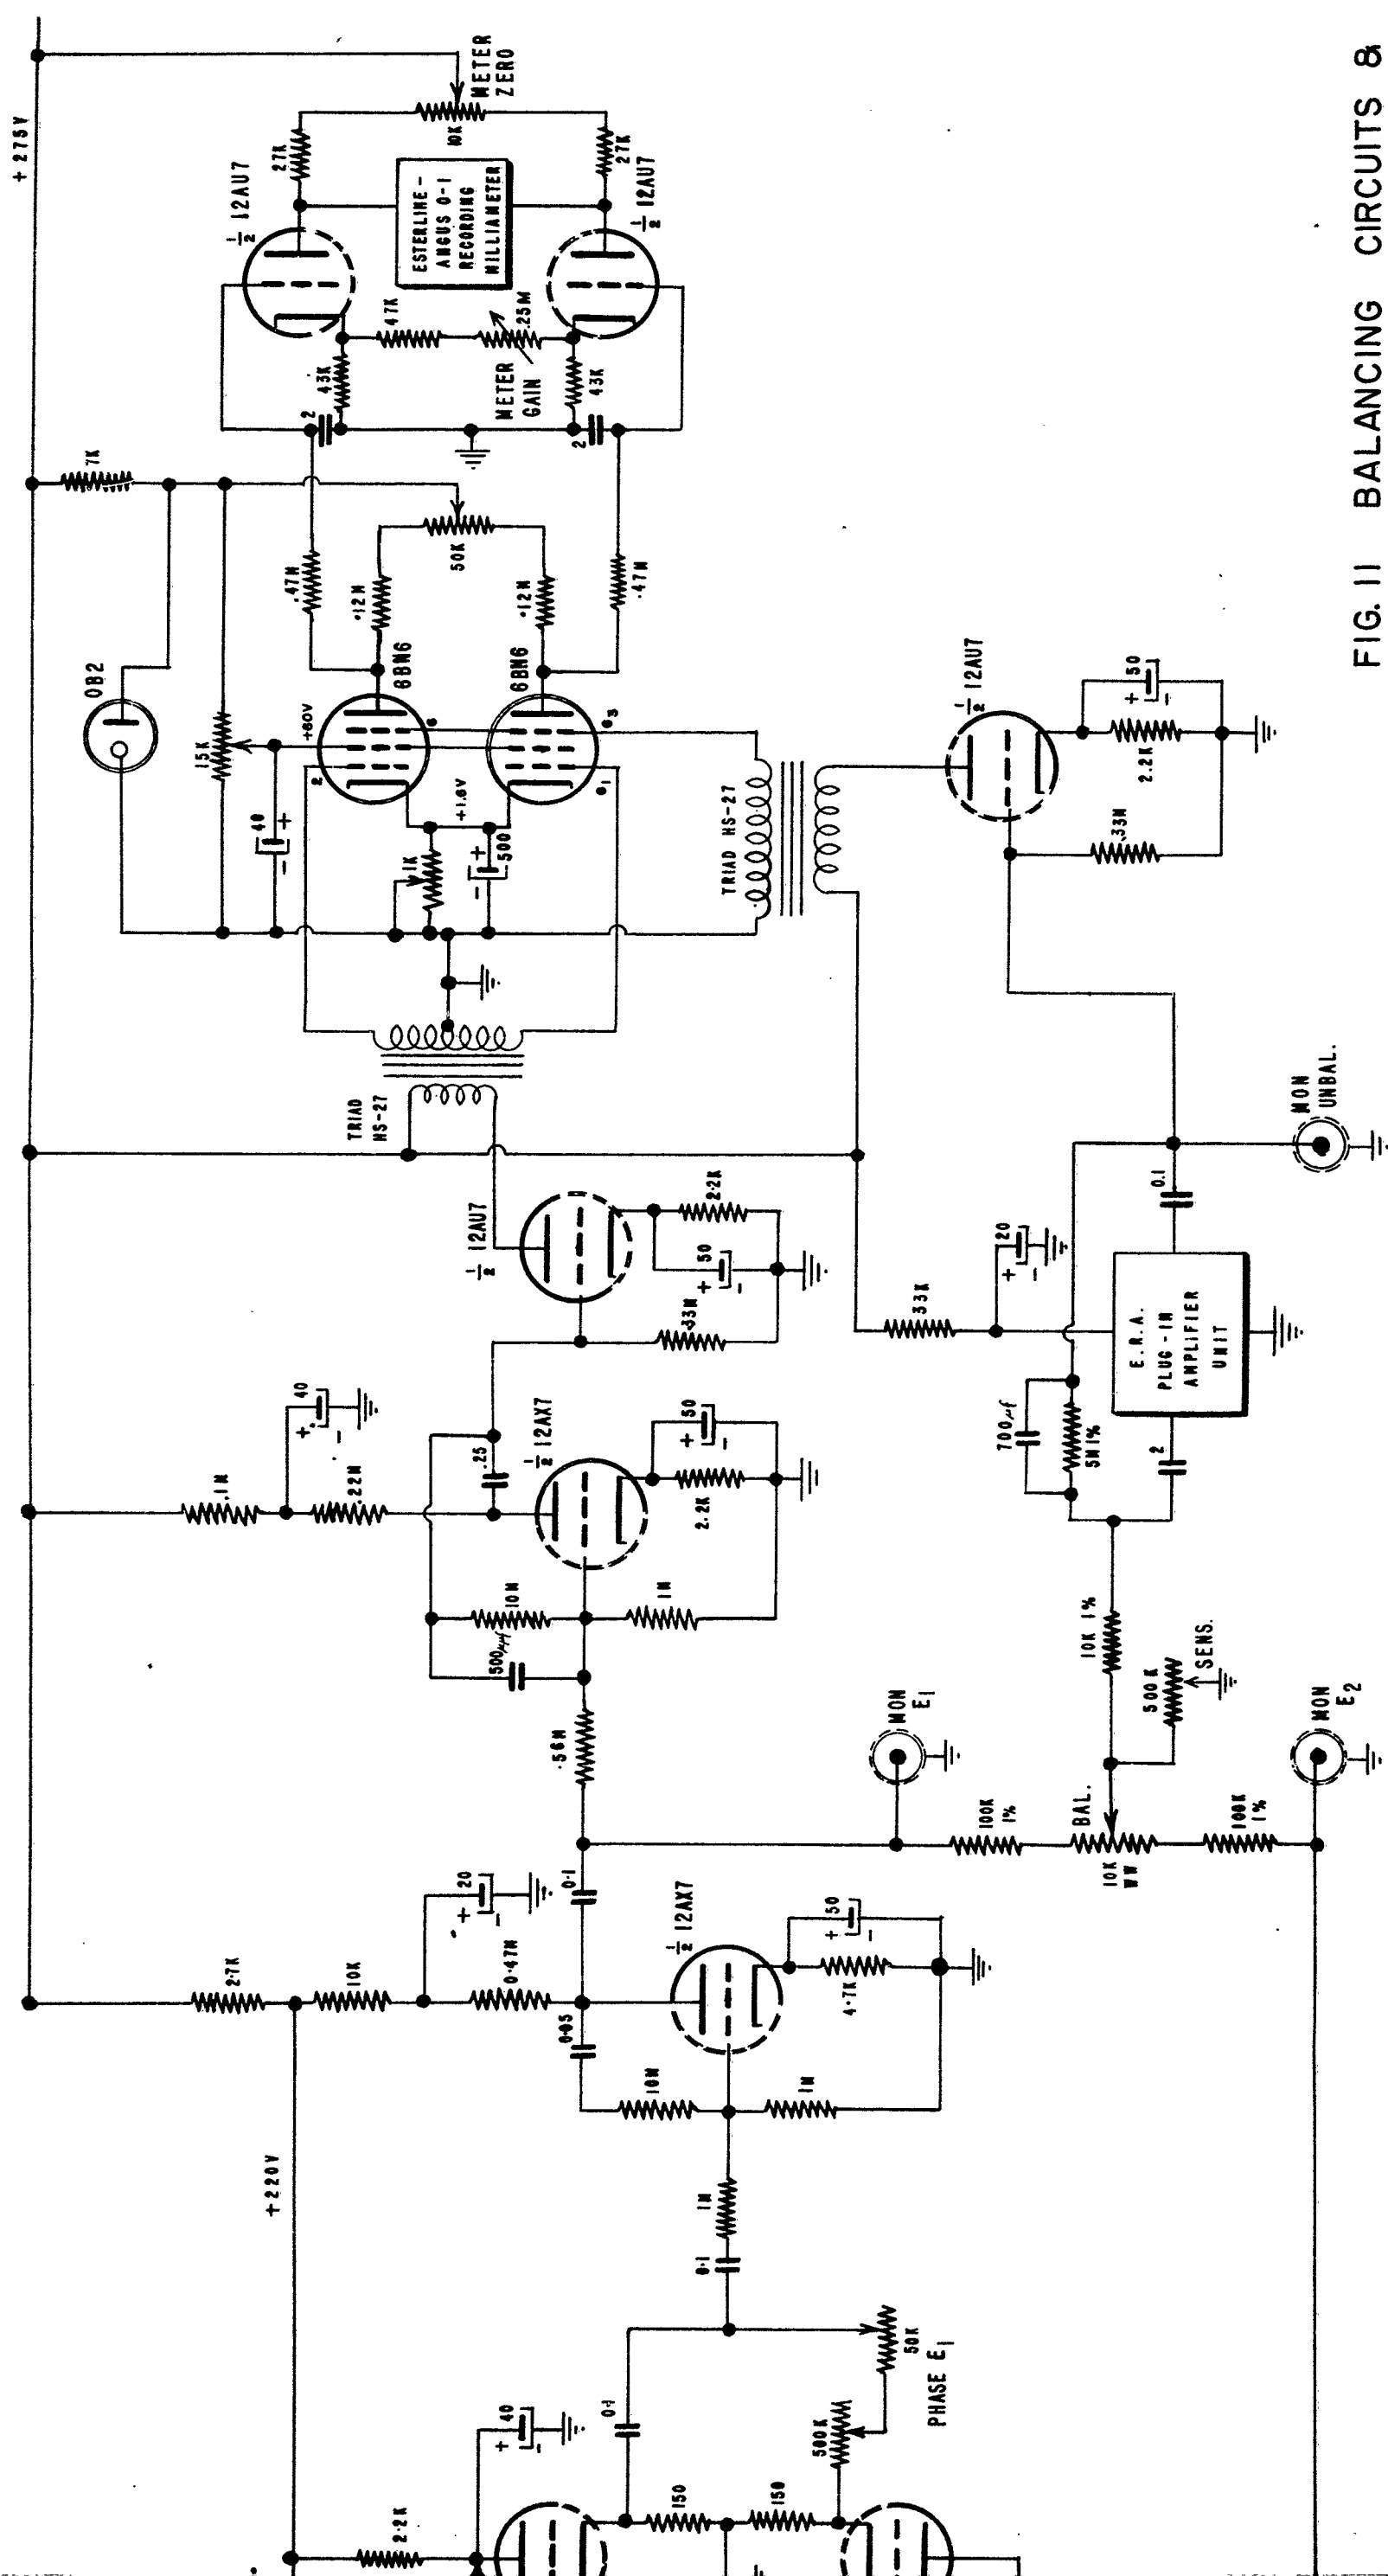
FIG. 11 BALANCING CIRCUITS &  
PHASE SENSITIVE RECTIFIER

The circuit diagram of the circuits for mixing the signals and recording the unbalance is given in Fig. 11.  $E_1$  is shifted in phase by a variable amount up to almost 180 degrees, then balanced against  $E_2$  in a resistive network. The voltage level of  $E_1$  and  $E_2$  at the mixing stage is about 0.2 volts rms. The

phase difference between the inputs from the two coils was about 45 degrees.  $E_1$  is also further amplified by about 40 times and applied in push-pull to the first control grids of two 6BN6 "gated beam" pentodes. The unbalance or difference signal from the mixing network is amplified by a factor of about 2000 and applied to the second, or "quadrature", control grids of the 6BN6's in parallel. (The name "quadrature" refers to the usual application of the tube as an F-M detector, and has nothing to do with the phase relationships in the present application.) The characteristics of the 6BN6 are such that the first, or reference, signal, as long as it is large enough, "saturates" and functions as a square gate, with the output voltage of the tubes virtually independent of its amplitude. The level at which the first grid saturates, however, is still controlled by the quadrature grid. The quadrature grids are operated in the linear region so that the output voltage of each tube during its "on" period is proportional to the voltage on its quadrature grid. Consideration of the phase relationships of the grid driving voltages will show that the integrated output of the stage is a balanced voltage the polarity of which is dependent on the phase of the quadrature grid signal with respect to the reference signal.

The plates of the 6BN6's are direct-coupled, via integrating networks of time constant 1 sec., to the control grids of the output amplifier stage which, in turn, drives an Esterline-Angus 0-1 recording milliammeter. The filaments of the phase-shifting
