Technical Note No. Mech. Eng. 155

ROYAL AIRCRAFT ESTABLISHMENT, FARNBOROUGH

Interim Note on an Investigation of the Liability to  
"Shatter" of High-Strength Light-Alloy Sheet  
when subject to Gunfire

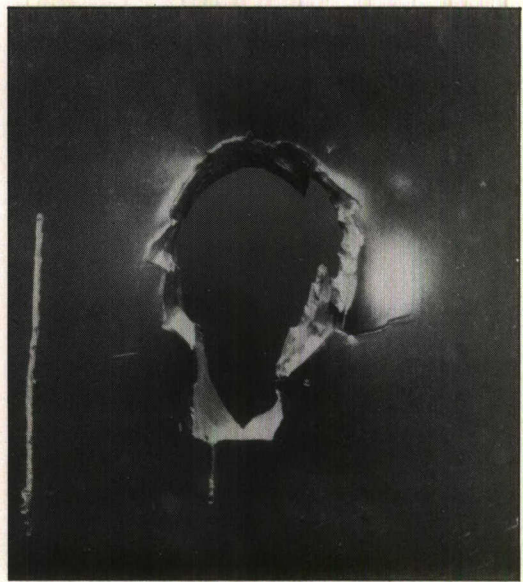
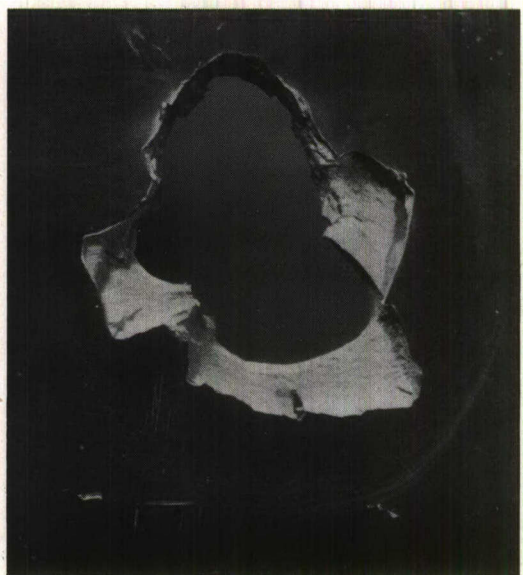
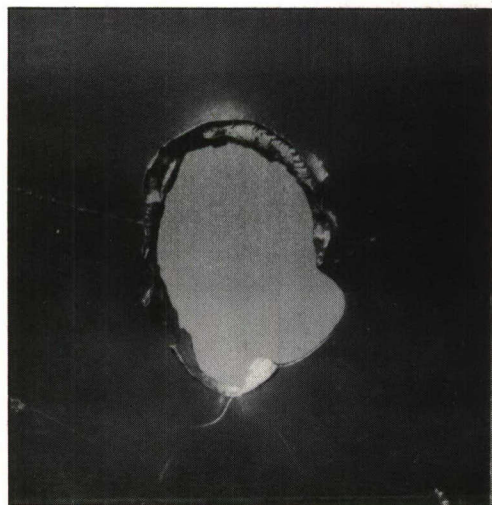
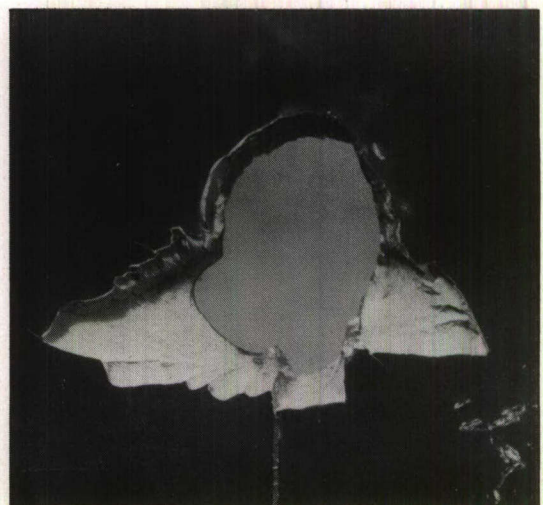
FIG.1. Unstressed Plates of D.T.D.687 Attacked with 20 mm. Solid Shot at 60° to the Normal.  
 Plate Thickness - 3/16 in.  
 Manufacturer- British Aluminium Co. Ltd.

47 plates were attacked in this manner (see Table I). There was no evidence of shatter. Typical damage is illustrated in Figs.1 to 5.

It was observed during the trials that some plates, particularly in the thicker gauges, had a tendency to flake on the exit side, when attacked in an unstressed state with 20 mm solid shot. The extent of flaking appeared to be greatest with the materials which, in other tests, appeared most susceptible to failure by "shatter" or "splitting" (see Figs. 1 to 5).

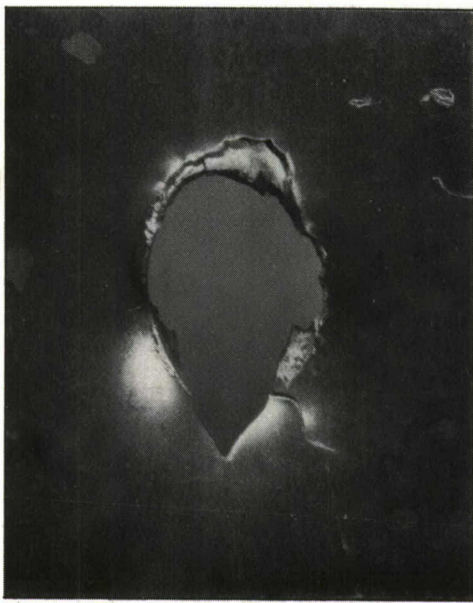
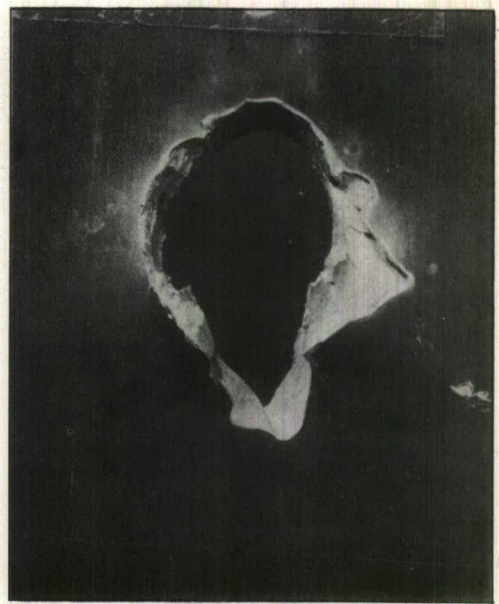
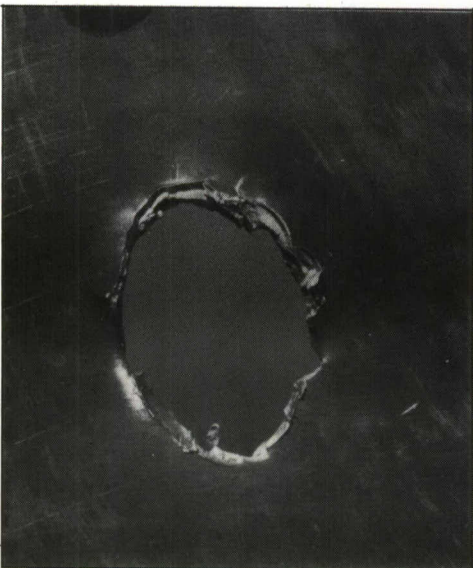
**FIG.2.** Unstressed Plates of 75 ST Attacked with 20 mm Solid Shot at 60° to the Normal.  
 Plate Thickness - 3/16 in.  
 Manufacturer - British Aluminium Co. Ltd.

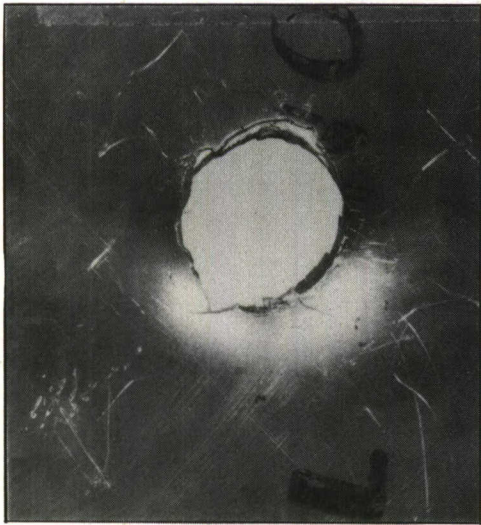
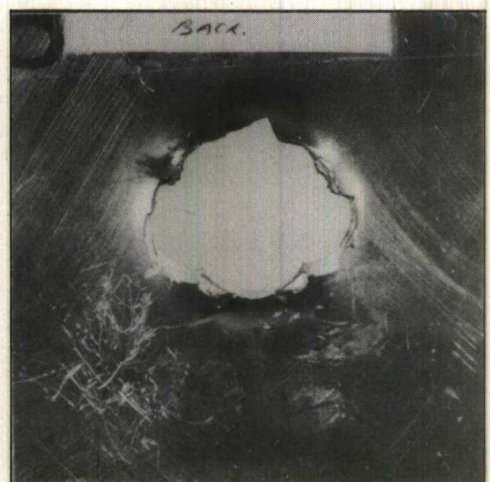
**a** Plate Thickness - .128 in. (10 S.W.G.)

**b** Plate Thickness - .064 in. (16 S.W.G.)

**FIG.5.** Unstressed Plates of D.T.D.687 Attacked with 20 mm Solid Shot at 45° to Normal.  
Plate Manufacturer - Northern Aluminium Co. Ltd.

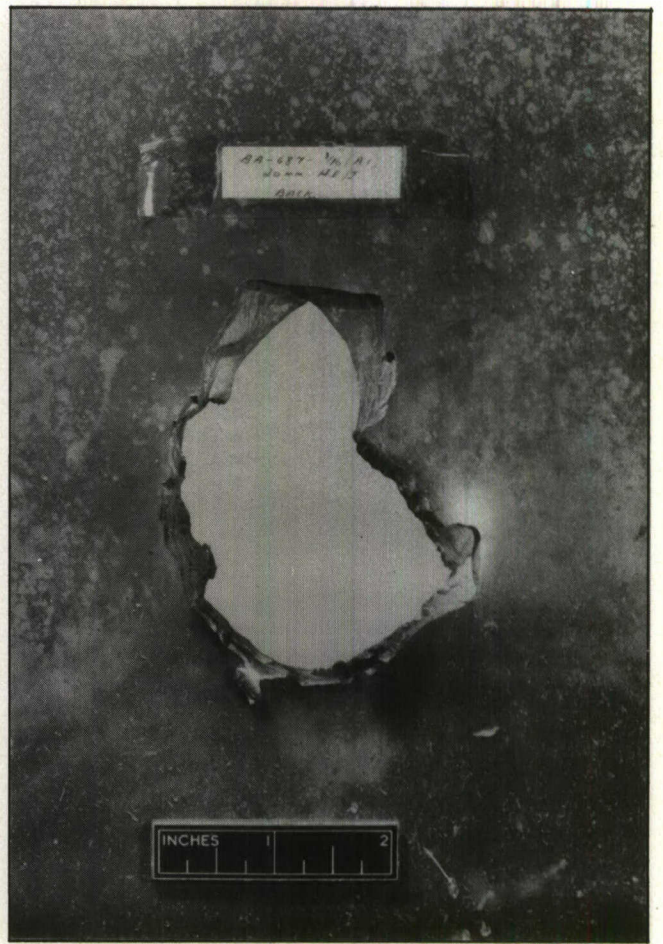
**FIG.6.** Unstressed Plates of D.T.D.687 Attacked Directly with 20 mm Explosive Shell at  $45^\circ$  to Normal. Plate Thickness -  $3/16$  in. Manufacturer - British Aluminium Co. Ltd.

Detailed results are recorded in Table II, and selected photographs reproduced in Figs.6 to 8.

In the 16 firings made, there was no evidence of shatter, but severe cracking occurred at the wound in one instance.

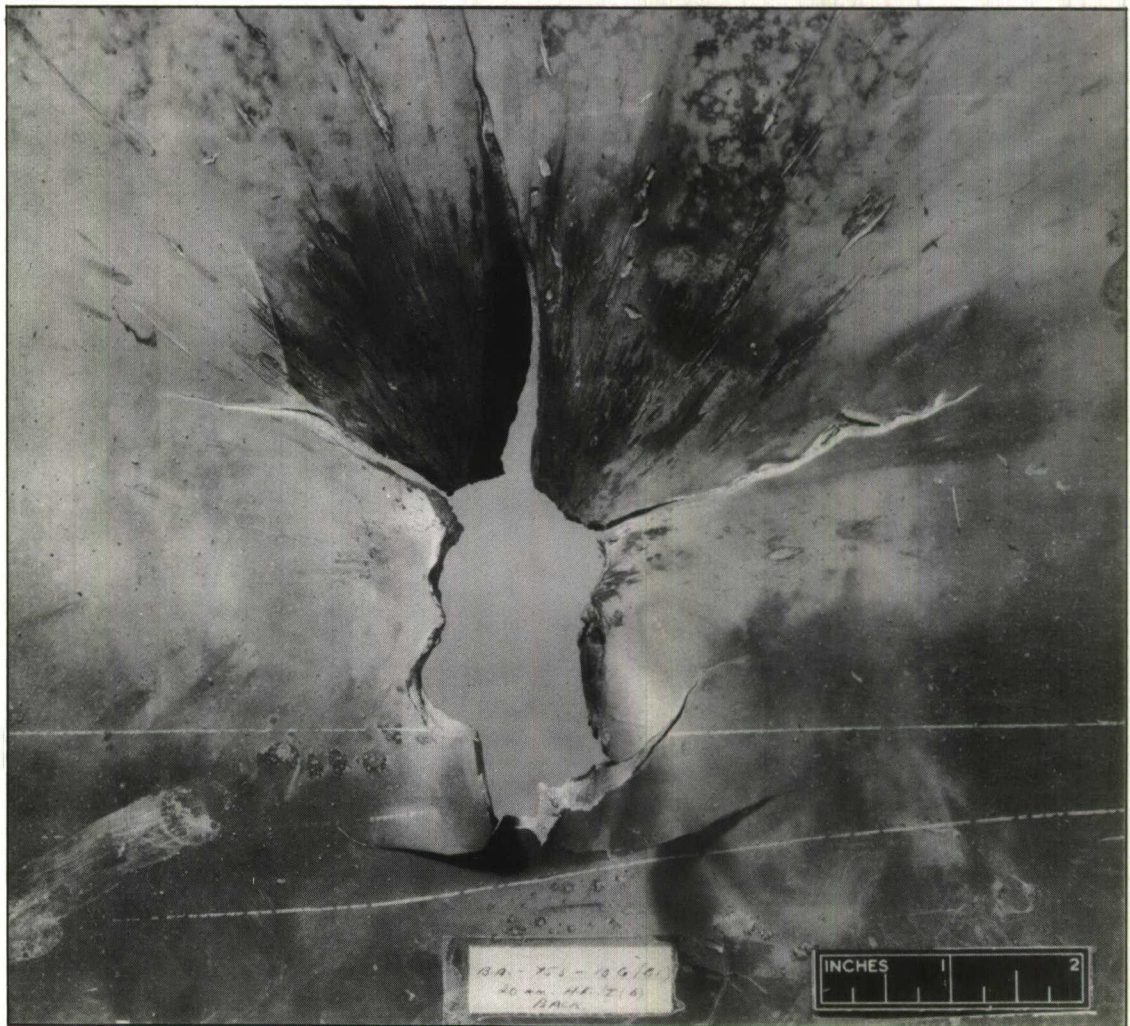
**a.** Firing 1. Exit Side.  
Detonation when Shell is Through Plate.

**b.** Firing 2. Exit Side.  
Detonation when Shell is in Plane of Plate.

**FIG.8.** Unstressed Plates of 75 ST (Analysis B1) Attacked Directly  
with 20 mm Explosive Shell at  $45^\circ$  to Normal.  
Plate Thickness - 10 S.W.G.  
Manufacturer - British Aluminium Co. Ltd.

In contrast, when 20 mm H.E./I shell were fired to detonate directly on unstressed plates, the resulting damage was usually confined to a hole 2 to 3 in. in diameter. In these tests it is probable that the hole was produced entirely by blast effect, and the fragments, being projected forward, did not strike the target plate.

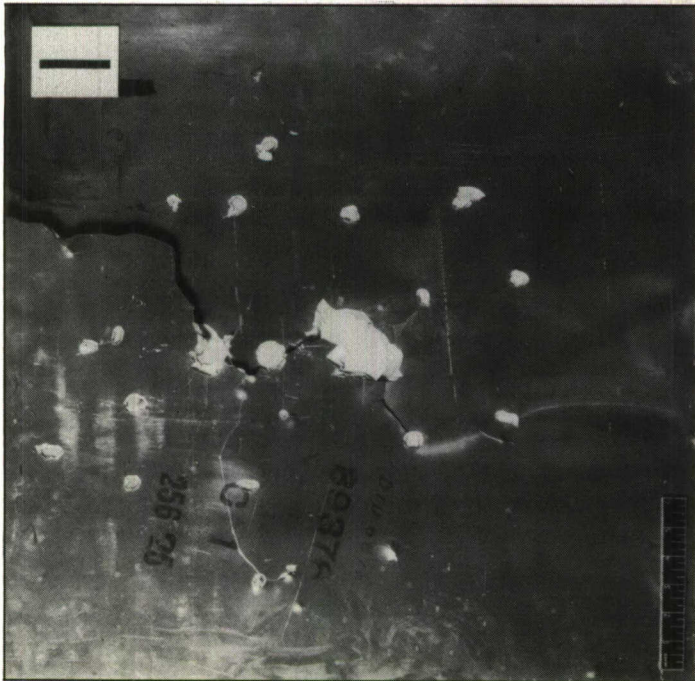
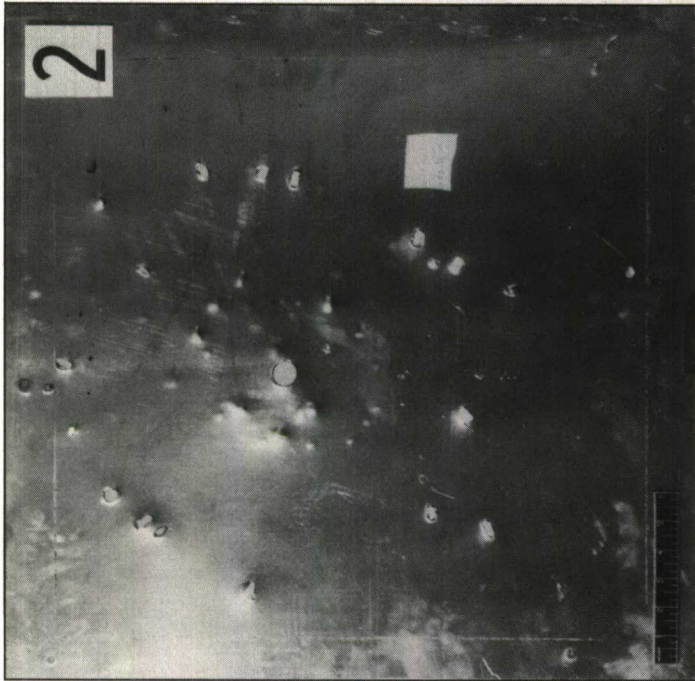
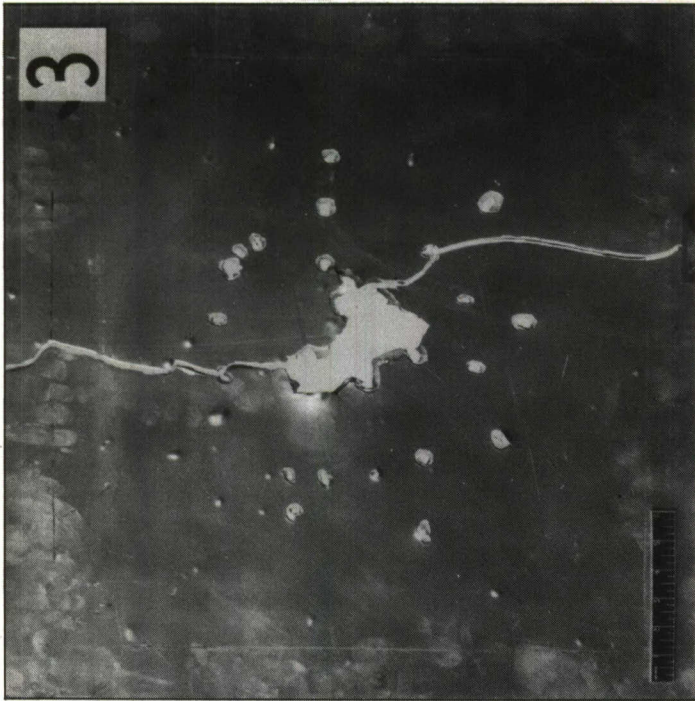
**a** Manufactured by British Aluminium Co. Ltd. to Spec. D.T.D.687 (Analysis C1) - 3/16 in. Thickness. "Burster" to Test Plate - 17 in.

**b** Manufactured by British Aluminium Co. Ltd. to Spec. D.T.D.687 (Analysis A2) - 3/16 in. Thickness. "Burster" to Test Plate - 19 in.

**c** Manufactured by Northern Aluminium Co. Ltd. to Spec. D.T.D.687 - 3/16 in. Thickness. "Burster" to Test Plate - 13 in.

**FIG.13.** UNSTRESSED PLATES DAMAGED BY REMOTELY DETONATED 20 MM EXPLOSIVE SHELL.

The results of the firings are recorded in Table VII and photographs of damaged plates are reproduced in Figs.13 to 16.

"Split": Failure by a single split across the plate, or  
Fragment wounds plus a simple split across the specimen (ref. Fig.13c).

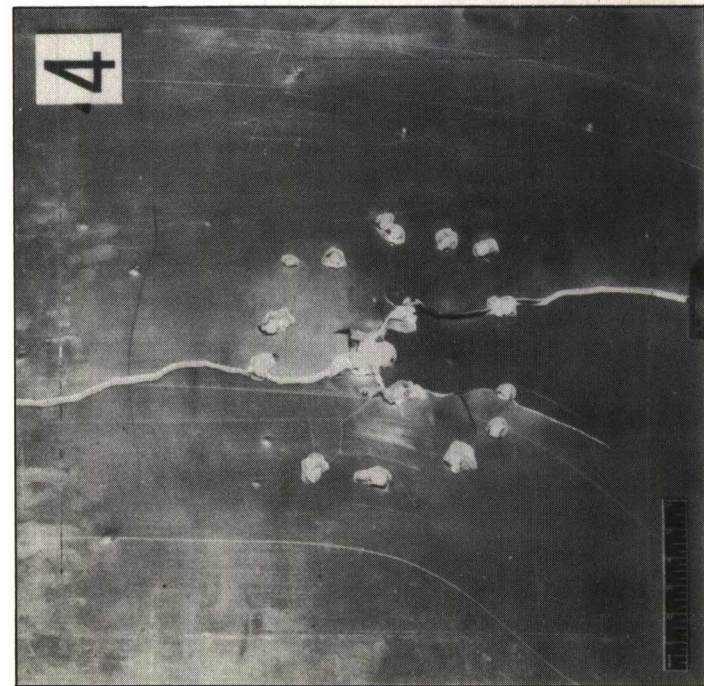
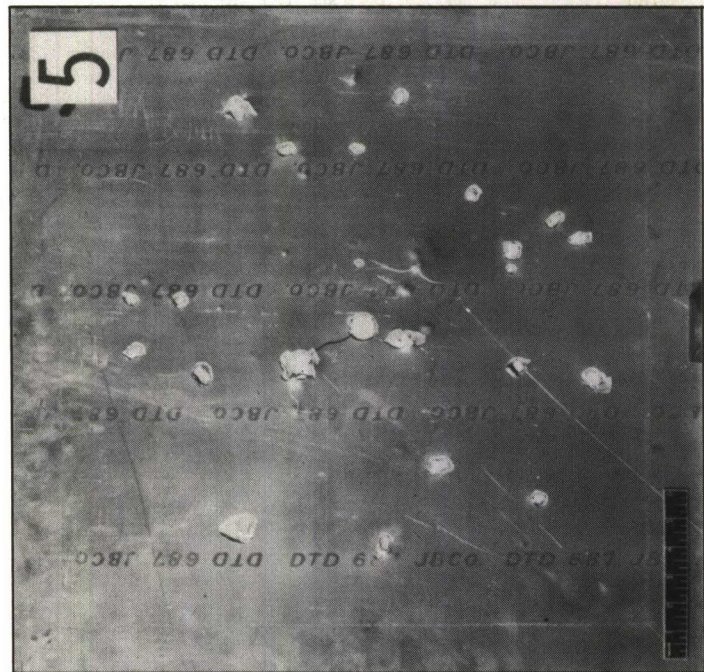
**a** Manufactured by Messrs. James Booth and Co. Ltd. to Spec. D.T.D.687 - 3/16 in. Thickness. "Burster" to Test Plate - 13 in.

**b** Manufactured by Messrs. James Booth and Co. Ltd. to Spec. D.T.D.687 - 3/16 in. Thickness. "Burster" to Test Plate - 19 in.

**c** Manufactured by Northern Aluminium Co. Ltd. to Spec. D.T.D.687 - .128 in. Thickness (10 S.W.G.) "Burster" to Test Plate - 19 in.

**FIG.14.** UNSTRESSED PLATES DAMAGED BY REMOTELY DETONATED 20 MM EXPLOSIVE SHELL.

"Shatter": Disintegration of the specimen, or  
Damage causing the plate to split into three or more large pieces, or  
Damage by fragment wounds plus multiple and widespread cracking (ref. Fig.15b), or  
Fragment wounds plus a full-width split and minor cracking (ref. Fig.14a).

"Holed": A single wound with not more than minor edge-cracks, or  
Fragment wounds, including - in some instances - small cracks joining pairs of wounds (ref. Fig.14b).

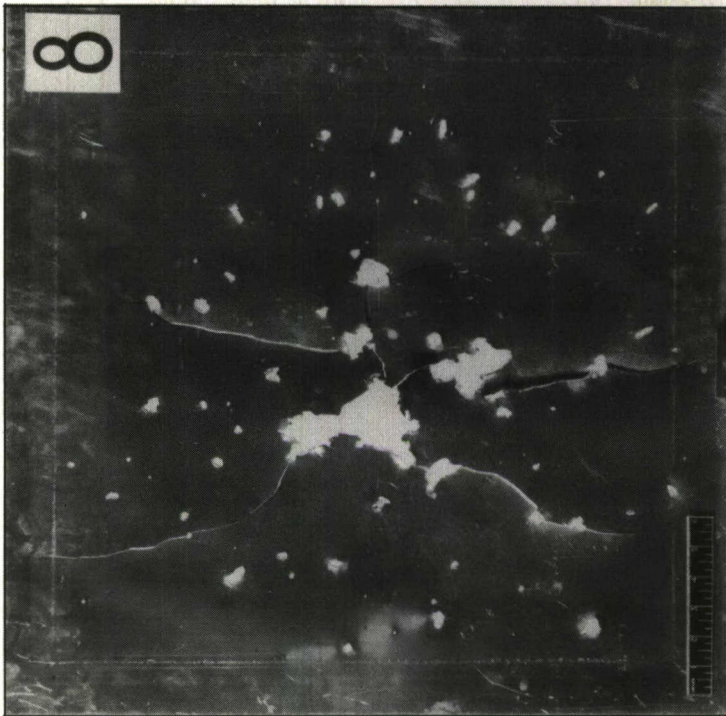
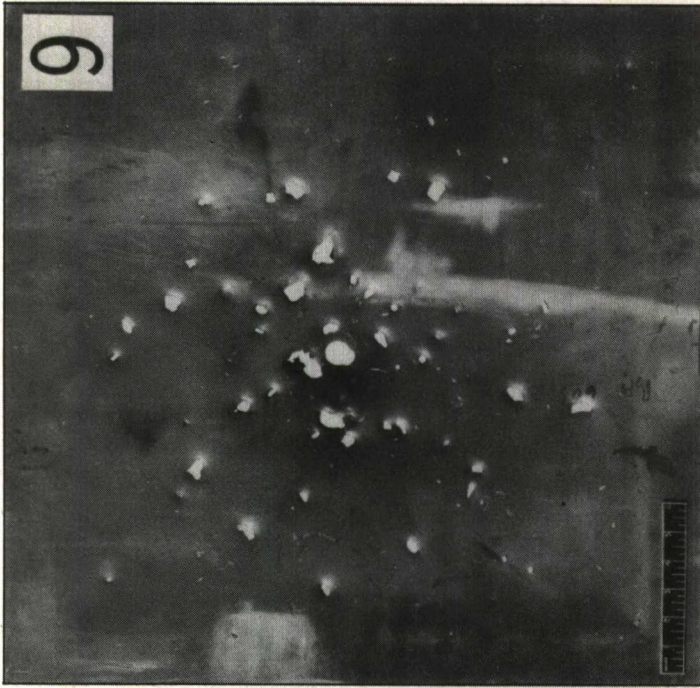
**a** Manufactured by Messrs. James Booth and Co. Ltd. to Spec. D.T.D.687 - .128 in. Thickness (10 S.W.G.) "Burster" to Test Plate - 19 in.

**b** Manufactured by British Aluminium Co. Ltd. to Spec. D.T.D.687 (Analysis C2) - .064 in. Thickness (16 S.W.G.) "Burster" to Test Plate - 19 in.

**c** Manufactured by British Aluminium Co. Ltd. to Spec. D.T.D.603 - .064 in. Thickness (16 S.W.G.) "Burster" to Test Plate - 19 in.

**FIG.15.** UNSTRESSED PLATES DAMAGED BY REMOTELY DETONATED 20 MM EXPLOSIVE SHELL.

Firing No.	Distance of Burster Plate to Specimen Under Test	Sheet Under Test			Analysis (see App. II)	Result
		Manu- facturer	Material	Thickness		
1	17 in.	The British Al. Co. Ltd.	D.T.D.687	3/16 in.	C1	"Shatter"* (see Fig.13(a))
2	19 in.	The British Al. Co. Ltd.	D.T.D.687	3/16 in.	A2	Fragment Damage Only (see Fig.13(b))
3	13 in.	The Northern Al. Co. Ltd.	D.T.D.687	3/16 in.	-	Split (see Fig.13(c))
4	13 in.	Messrs. James Booth & Co. Ltd.	D.T.D.687	3/16 in.	-	"Shatter" (see Fig.14(a))
5	19 in.	Messrs. James Booth & Co. Ltd.	D.T.D.687	3/16 in.	-	Fragment Damage Only (See Fig.14(b))
6	19 in.	The Northern Al. Co. Ltd.	D.T.D.687	10 S.W.G.	-	Fragment Damage Only (See Fig.14(c))
7	19 in.	Messrs. James Booth & Co. Ltd.	D.T.D.687	10 S.W.G.	-	"Shatter" (see Fig.15(a))

Firing No.	Distance of Burster Plate to Specimen Under Test	Sheet Under Test			Analysis (see App. II)	Result
		Manu- facturer	Material	Thickness		
8	19 in.	The British Al. Co. Ltd.	D.T.D. 687	16 S.W.G.	C2	"Shatter" (see Fig. 15(b))
9	19 in.	The British Al. Co. Ltd.	D.T.D. 603 <sup>xx</sup>	16 S.W.G.	-	Fragment Damage Only (see Fig. 15(c))
10	16 in.	The Northern Al. Co. Ltd.	D.T.D. 687	10 S.W.G.	-	Fragment Damage Only (see Fig. 16(a))
11	13 in.	The British Al. Co. Ltd.	D.T.D. 603 <sup>xx</sup>	10 S.W.G.	-	Fragment Damage Only (see Fig. 16(b))
12	13 in.	The British Al. Co. Ltd.	D.T.D. 687	10 S.W.G.	A1	Fragment Damage Only (See Fig. 16(c))
13	13 in.	Messrs. James Booth & Co. Ltd.	D.T.D. 687	10 S.W.G.	-	Fragment Damage Only
