WADC TECHNICAL REPORT 54-492

# **OXIDATION-RESISTANT COATINGS FOR MOLYBDENUM**

*CLIMAX MOLYBDENUM COMPANY OF MICHIGAN*

*DECEMBER 1954*

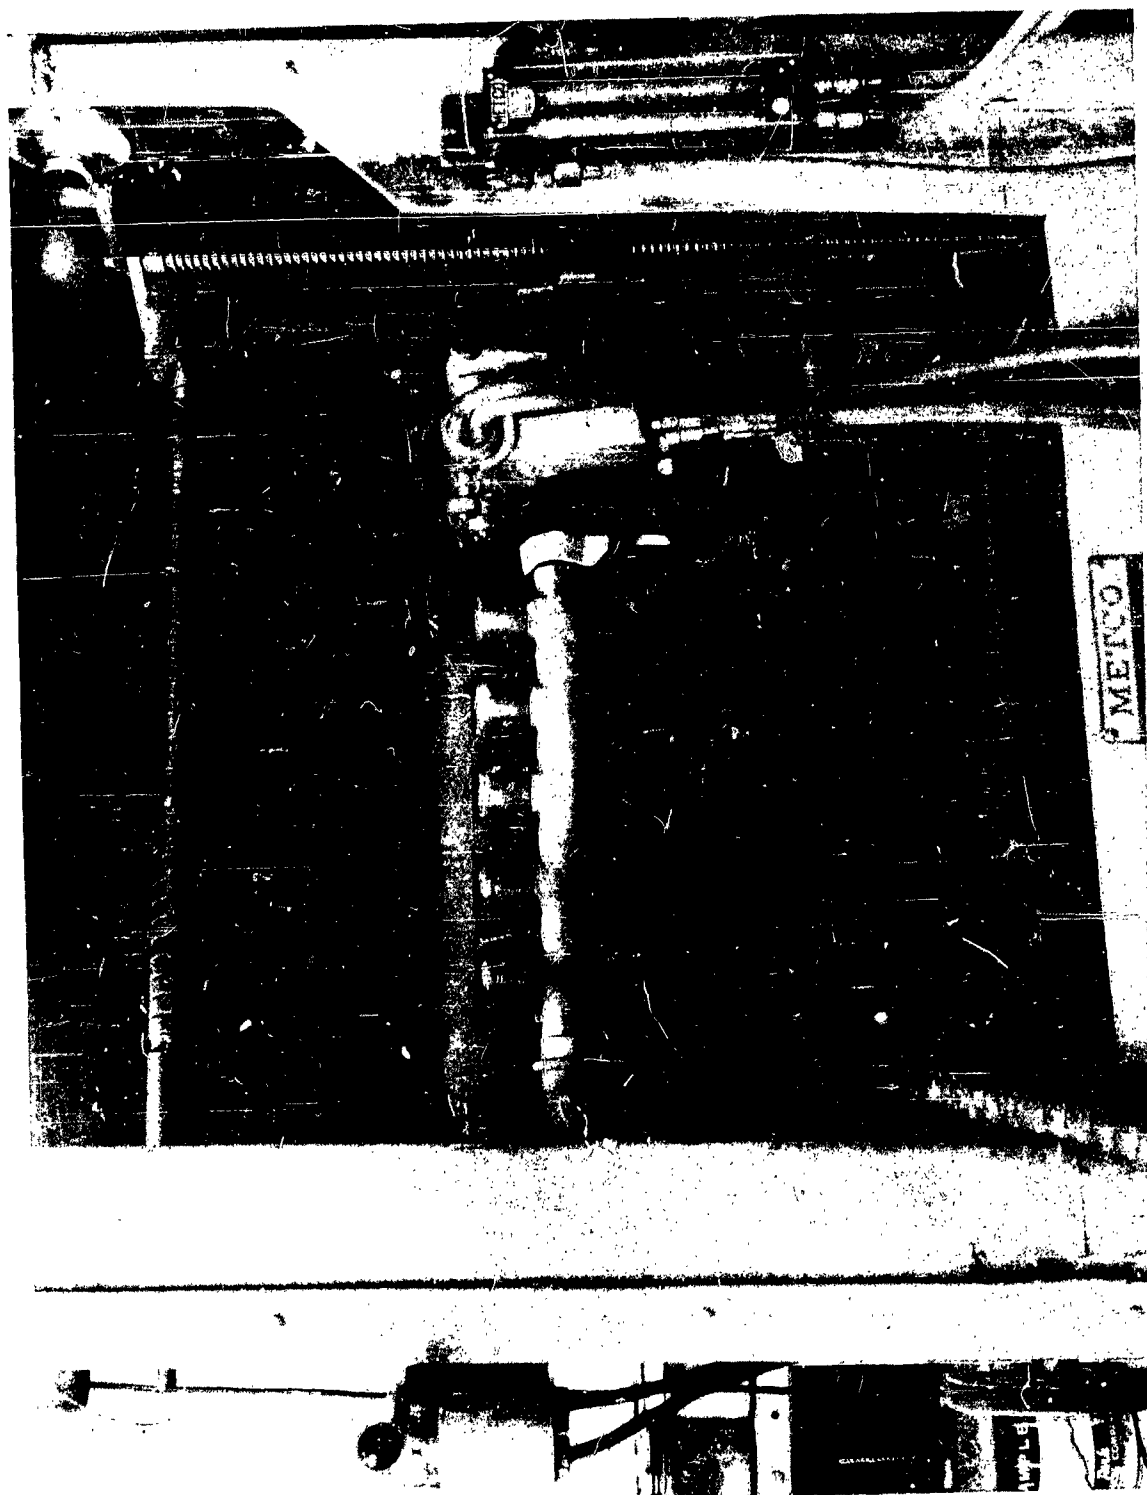
FIG 2 (P11144) - EQUIPMENT IN POSITION FOR SPRAY COATING EDGES OF PANELS

The edges of the panels are coated as follows: two edges, the edge facing the gun and an adjacent edge, are sprayed with the panels in a horizontal plane as shown in Figure 2. By turning the manifold 180 degrees on its longitudinal axis, the panels can be held in a second horizontal plane, below the axis of the manifold, and the remaining two edges of each panel are sprayed. Although the panels are now below the opening of the sleeve, the vacuum cleaner maintains a pressure differential sufficient to support the weight of a panel and to prevent it from moving during the spraying operation.

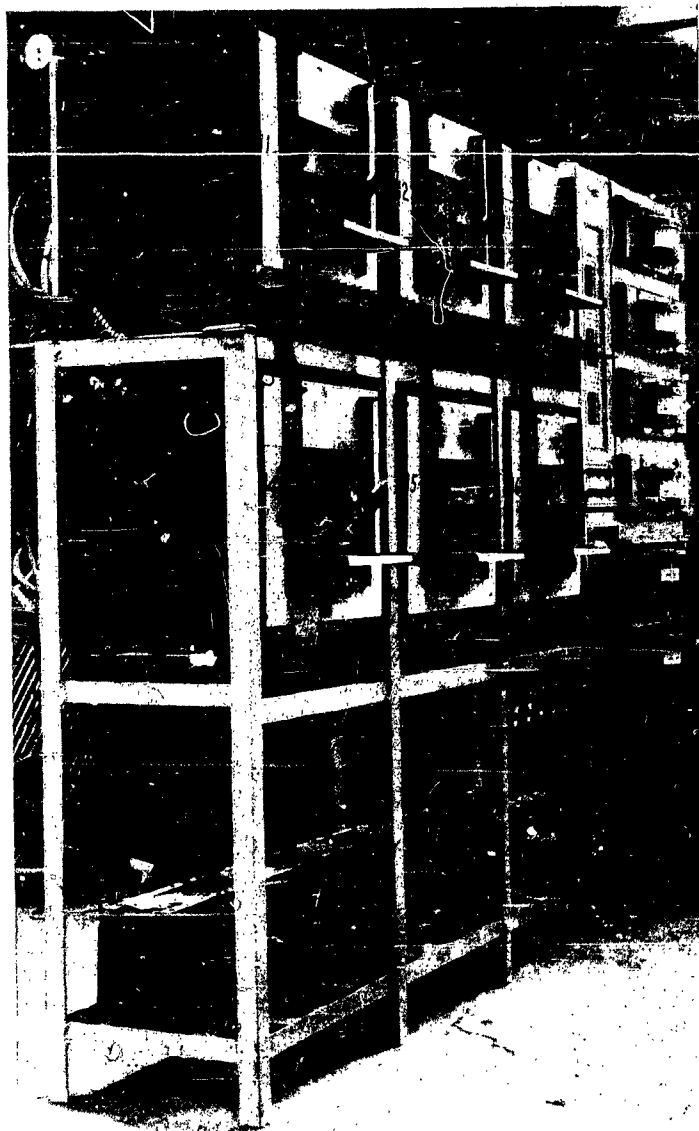
FIG 4 (P1142) - FRONT VIEW OF SIX FURNACES FOR  
CONDUCTING OXIDATION TESTS IN  
AIR AT 1800°F

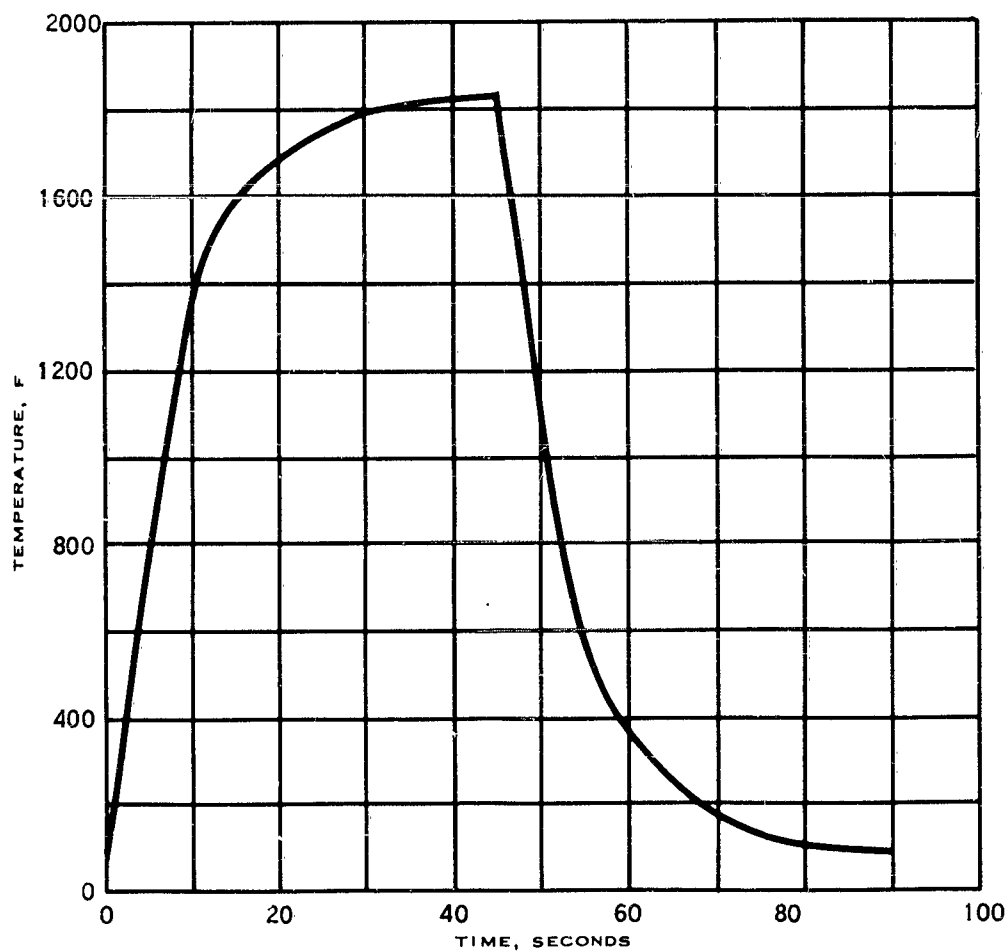
FIGURE 9 — HEATING AND COOLING CURVE OF SPECIMEN  
IN CYCLIC THERMAL SHOCK TEST

SPRAY COATED MOLYBDENUM SPECIMEN  
4 IN. BY 1 IN. BY 0.055 IN.

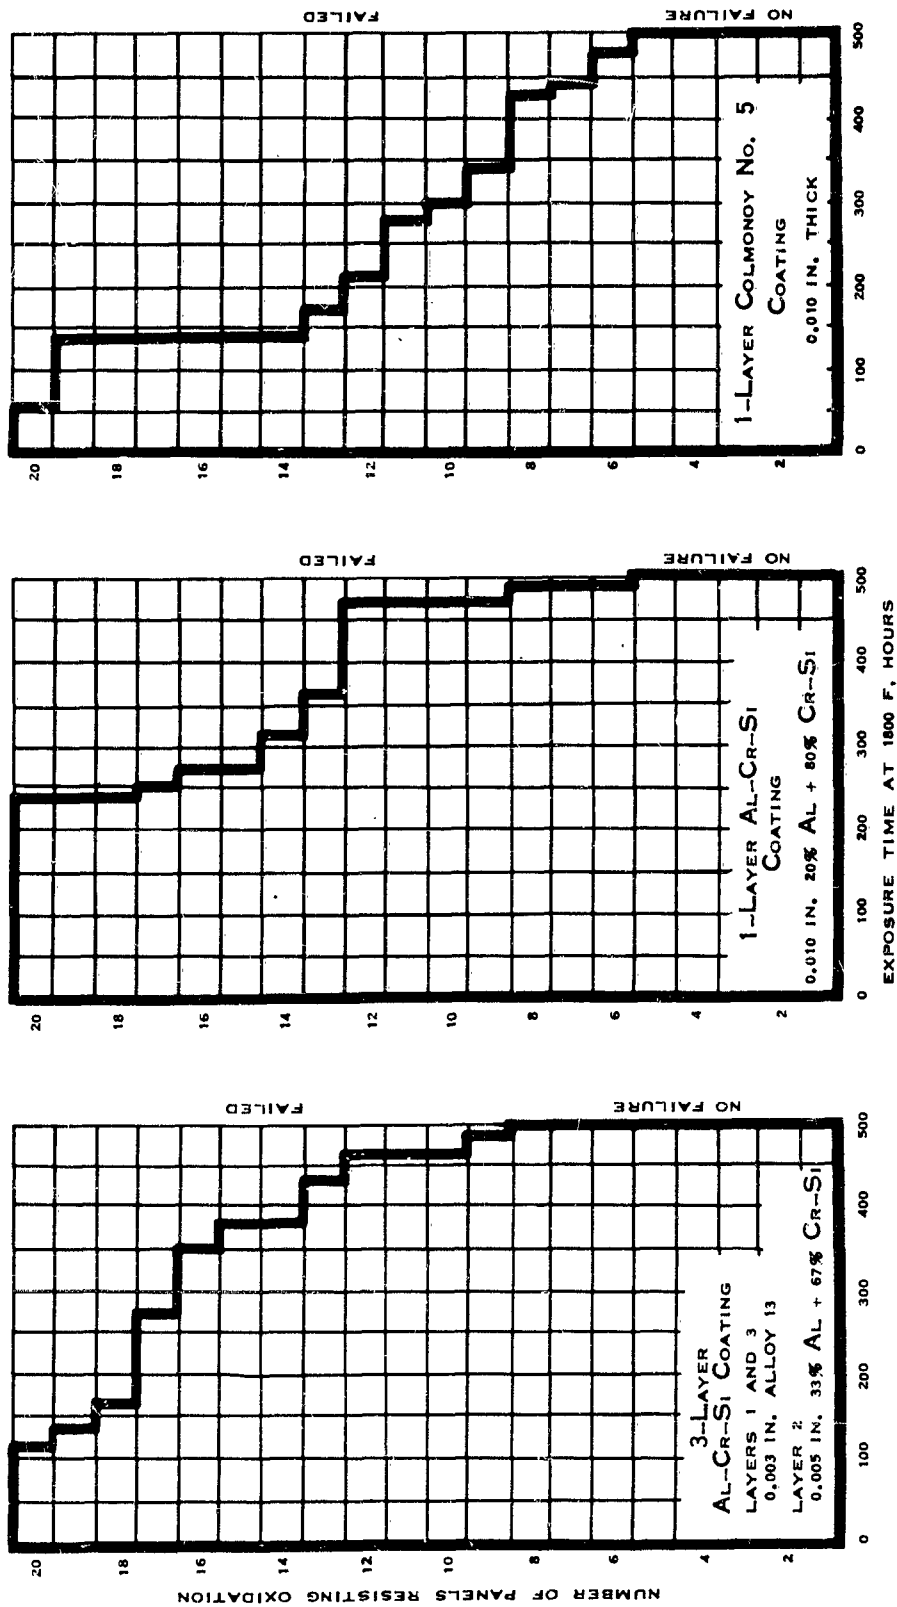
FIGURE 12 — FAILURE DISTRIBUTION CURVES FOR OXIDATION TESTS WITH THREE COATING COMPOSITIONS  
PANELS WERE GRIT-BLASTED WITH ALUMINA AND MANUALLY SPRAYED

The results of the oxidation tests at 1800°F, given in Figure 12, show that more than 50% of the panels failed in less than 500 hours of testing, exhibiting very poor reproducibility of results. The cause of the numerous failures that occurred before the end of the 500-hour period was attributed to variables in the spray coating process. These were investigated; the results of the investigation are reported in the next section.

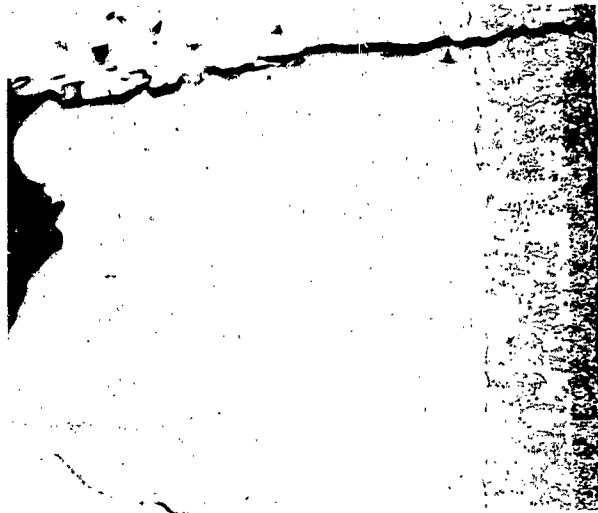
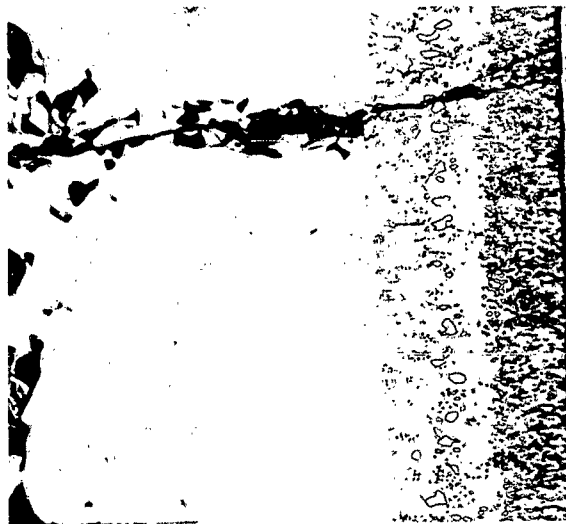
A. Diffusion Treated Two Hours in  
Purified Hydrogen at 2000°F

FIG 13 - MICROSTRUCTURES OF Al-Cr-Si COATINGS ON MOLYBDENUM  
AFTER DIFFUSION TREATING AND AFTER OXIDATION  
TESTING IN AIR FOR 25 HOURS AT 1800°F

Coating cracks were purposely included in each of the photomicrographs of Figures 13-15 to show that within the 500-hour period of testing at 1800°F the molybdenum was not oxidized at the base of the cracks. Evidently the coating expands sufficiently upon heating to 1800°F that the cracks are closed, and thus air is prevented from gaining access to the molybdenum at 1800°F.

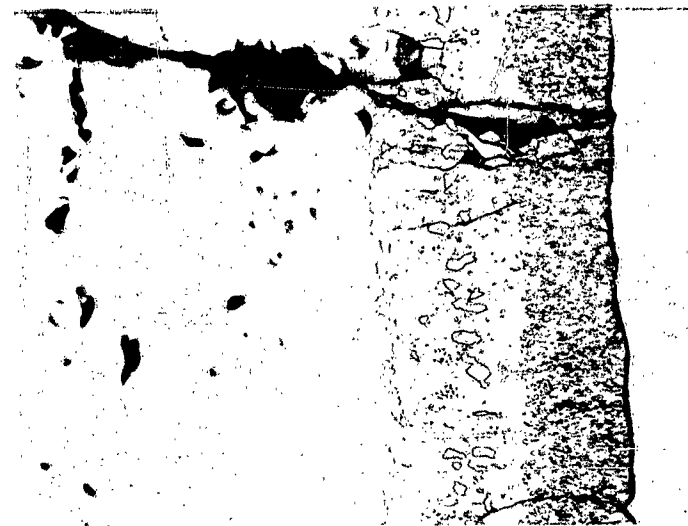
A. Oxidation Tested 50 Hours in  
Air at 1800°F

FIG 14 - MICROSTRUCTURES OF Al-Cr-Si COATINGS ON MOLYBDENUM  
AFTER OXIDATION TESTING IN AIR FOR 50 AND  
100 HOURS AT 1800°F

The irregularity of the interface at the base of the crack in Figure 14B was caused by the presence of a small molybdenum carbide which interfered with the interdiffusion of the coating and molybdenum. This effect is illustrated more clearly with another specimen in Figure 16.

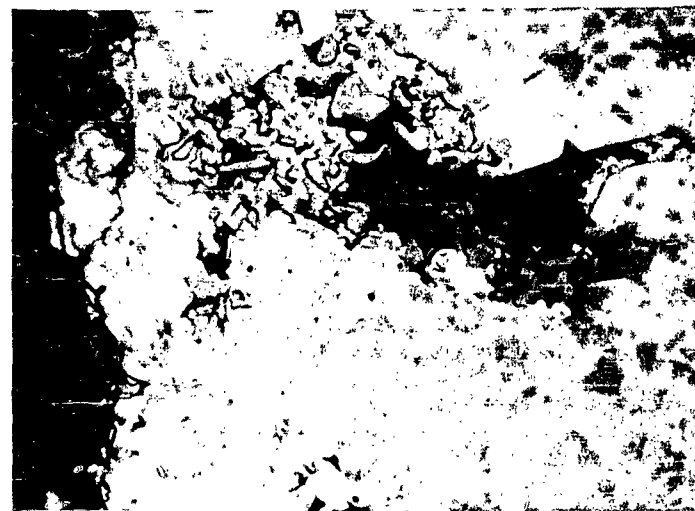
FIG 17 - THREE-LAYER Al-Cr-Si COATING DIFFUSION TREATED  
FOR TWO HOURS IN PURIFIED HYDROGEN AT 2000°F  
Structure of coating showing location of filed  
surface with respect to molybdenum substrate

The results showed that the coating was essentially metallic. The microstructures of the coated specimens after the filings were removed are shown in Figures 17 and 18 to illustrate the structure present immediately adjacent to the layer that was analyzed.

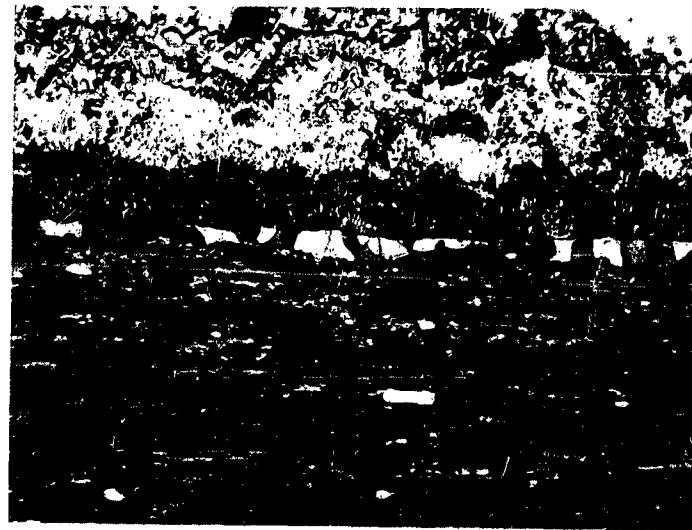
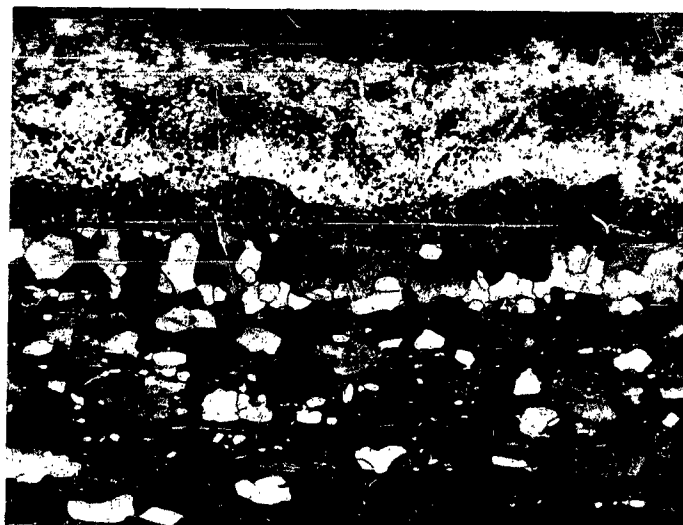
A. Diffusion Treated Two Hours in  
Purified Hydrogen at 2000°F

B. Stressed for 27 Hours in Air  
at 1800°F

FIG 19 - MICROSTRUCTURES AT GAGE SECTIONS OF COATED DUCTILITY  
TEST SPECIMENS AS DIFFUSION TREATED AND AFTER  
STRESSING FOR 27 HOURS IN AIR AT 1800°F

It was observed that the stress required to produce an elongation in the range 2-5% in 100 hours at 1800°F with coated 0.75% vanadium alloy was less for the specimens coated with the Colmonoy alloys than for the specimens coated with aluminum-chromium-silicon composition (see Table 2). Metallographic examination of specimens, before and after testing, revealed a phenomenon which may explain this observation. The Colmonoy-coated specimens exhibited complete recrystallization of the 0.75% vanadium-molybdenum alloy in a narrow zone adjacent to the coating. This is shown in Figures 19 and 20 with specimens as-diffusion treated, and after testing under stress for 27 and 136 hours, respectively, at 1800°F. The photomicrographs show that, as-diffusion treated, the specimen had a narrow recrystallized zone, and that the width of the recrystallized zone increased with increase in exposure time at 1800°F.

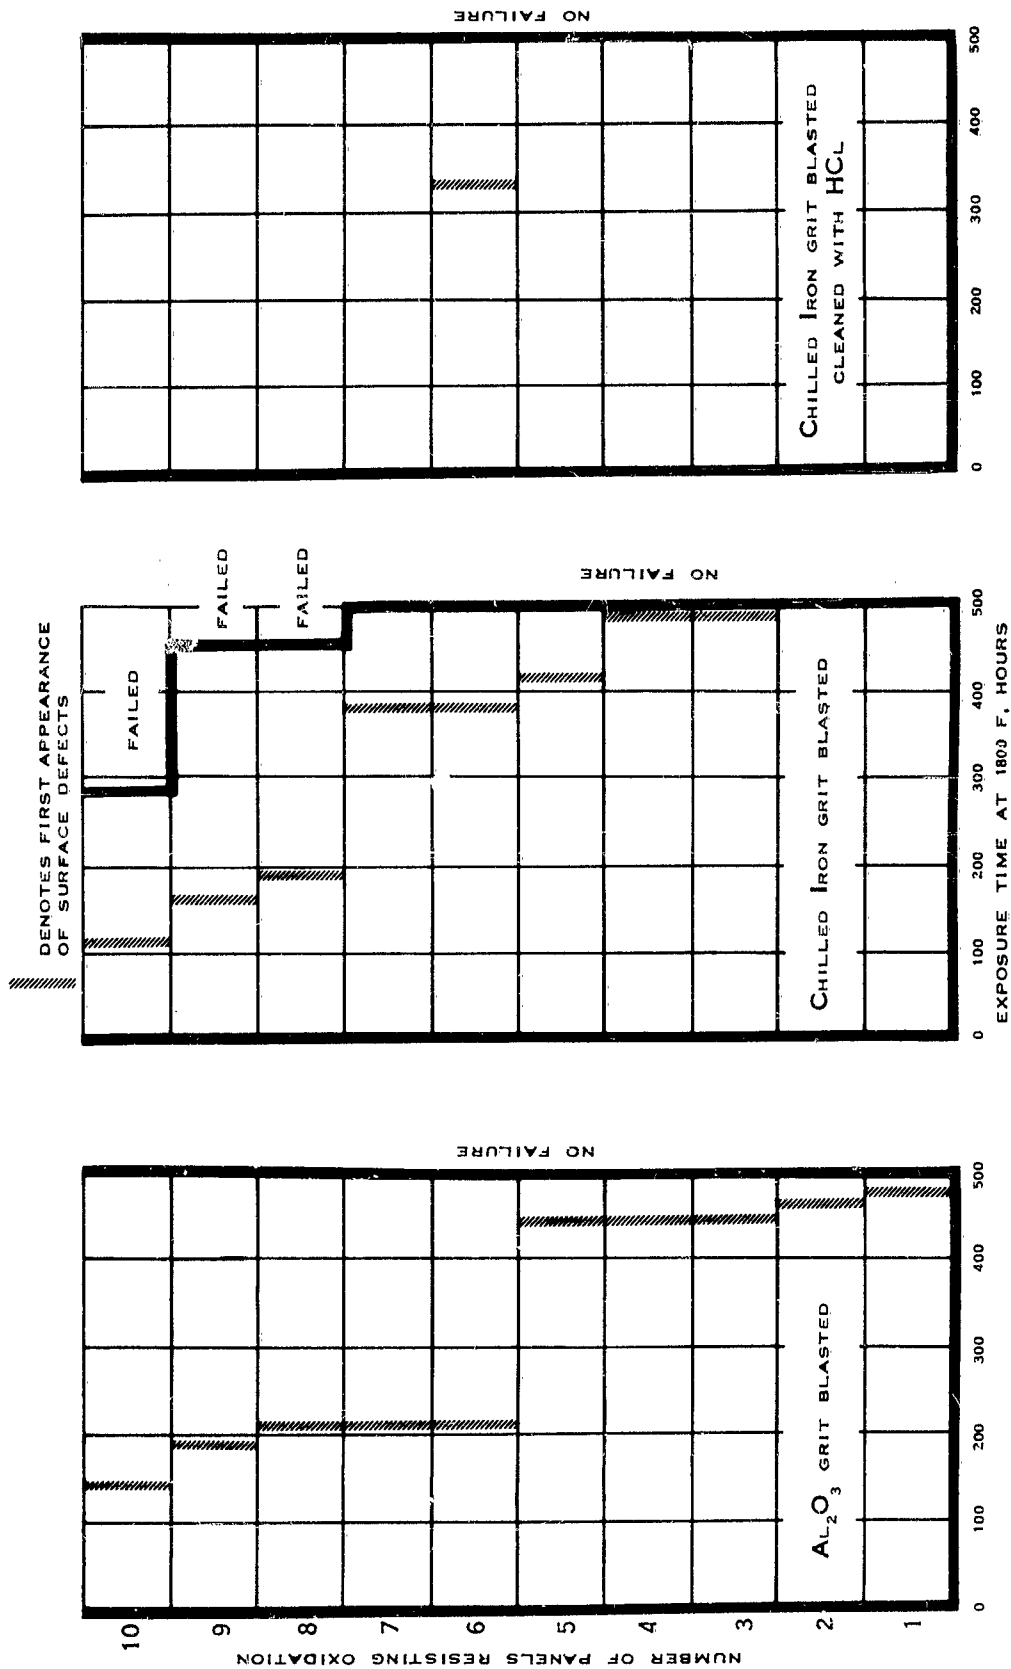
FIGURE 21 - EFFECT OF SURFACE PREPARATION UPON RESISTANCE TO OXIDATION AT 1800 F  
ONE LAYER 0.010" AL-CR-SI SPRAY COATING

Originally the molybdenum test panels were blasted with aluminum-oxide grit to prepare the surfaces for coating. Occasionally SAE Grade G-25 iron grit was employed. Both types of grit were found to produce satisfactory roughening of the surfaces to facilitate mechanical bonding. Meticulous metallographic examination of coatings which had been subjected to oxidation testing led to the discovery that particles of aluminum-oxide grit often became embedded in the surface of the molybdenum panels and were subsequently covered over by the sprayed metals. The presence of the aluminum oxide interfered with the formation of the diffusion zone between the coating metals and the molybdenum substrate. Since there was some evidence that the diffusion zone was important to the effectiveness of the coating, it was suggested that the grit particles could be a cause of coating failures. Metallographic observations of as-sprayed panels revealed that the iron grit also became embedded in the molybdenum, but no iron grit could be found in coated panels that had been diffusion treated. Failure to find the particles in panels after the diffusion treatment and/or the oxidation tests did not remove the suspicion that they were a cause of coating failure. By experiment, however, it was found that embedded iron grit particles could be removed by treating the grit blasted panel with concentrated hydrochloric acid. No satisfactory method of removing embedded aluminum oxide grit was developed.
