NAVORD REPORT 4040

RESULTS OF A TELEMETERING INVESTIGATION OF PARACHUTE OPENING  
ALTITUDE OF THE UNIVERSAL PARACHUTE PACK ON THE MINE CASE MK 36

22 AUGUST 1955

**U. S. NAVAL ORDNANCE LABORATORY**  
**WHITE OAK, MARYLAND**

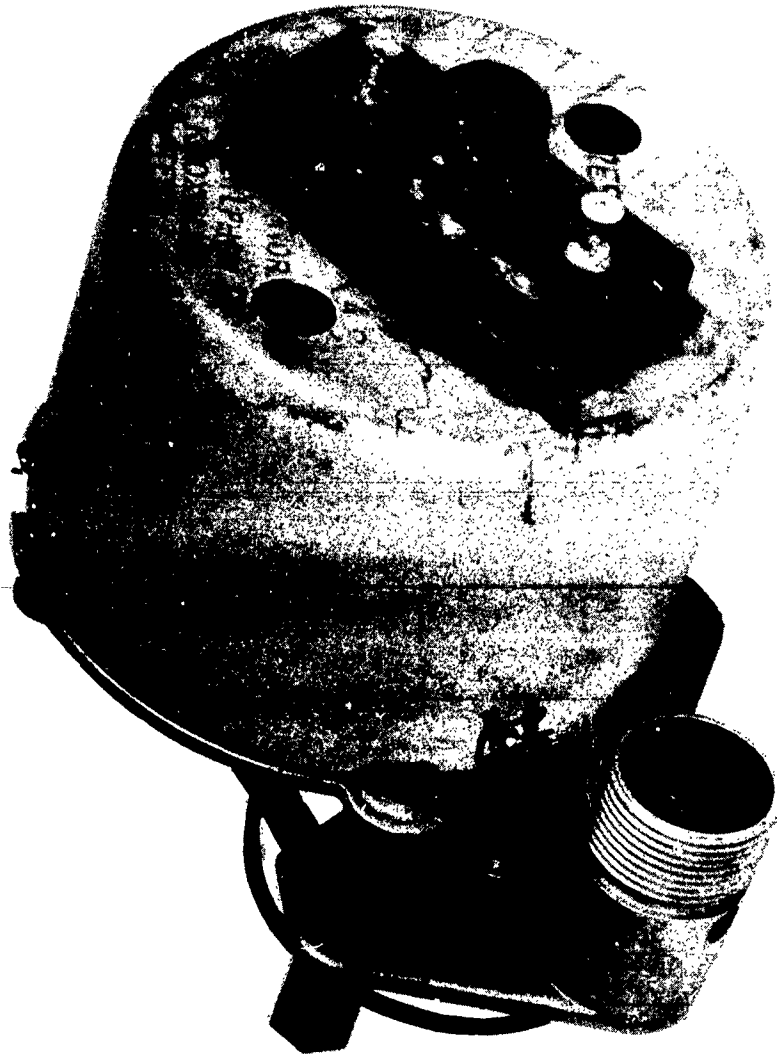
25. A vibration gage was attached to the pressure switch as shown in Figure 6. This gage consisted of a Meissner type 25009 adjustable RF coil. The iron slug of this coil was cemented to the top of the bellows and the coil portion was mounted on the cover of the pressure switch. Any motion of the bellows would change the relative position of the slug in the coil and thus change the coil inductance. The coil was incorporated into an oscillator at 70 KC. This formed a fourth channel of the system. No temperature gages were included in these mines.

FIG. 6 PRESSURE SWITCH WITH VIBRATION GAGE ATTACHED
