WADC TECHNICAL REPORT 55-18  
PART I

**DESIGN PROPERTIES OF HIGH-STRENGTH STEELS IN THE  
PRESENCE OF STRESS-CONCENTRATIONS AND  
HYDROGEN EMBRITTLEMENT**

**Part I. Effects of Hydrogen Embrittlement on Static Properties  
of High-Strength Steels**

*SYRACUSE UNIVERSITY*

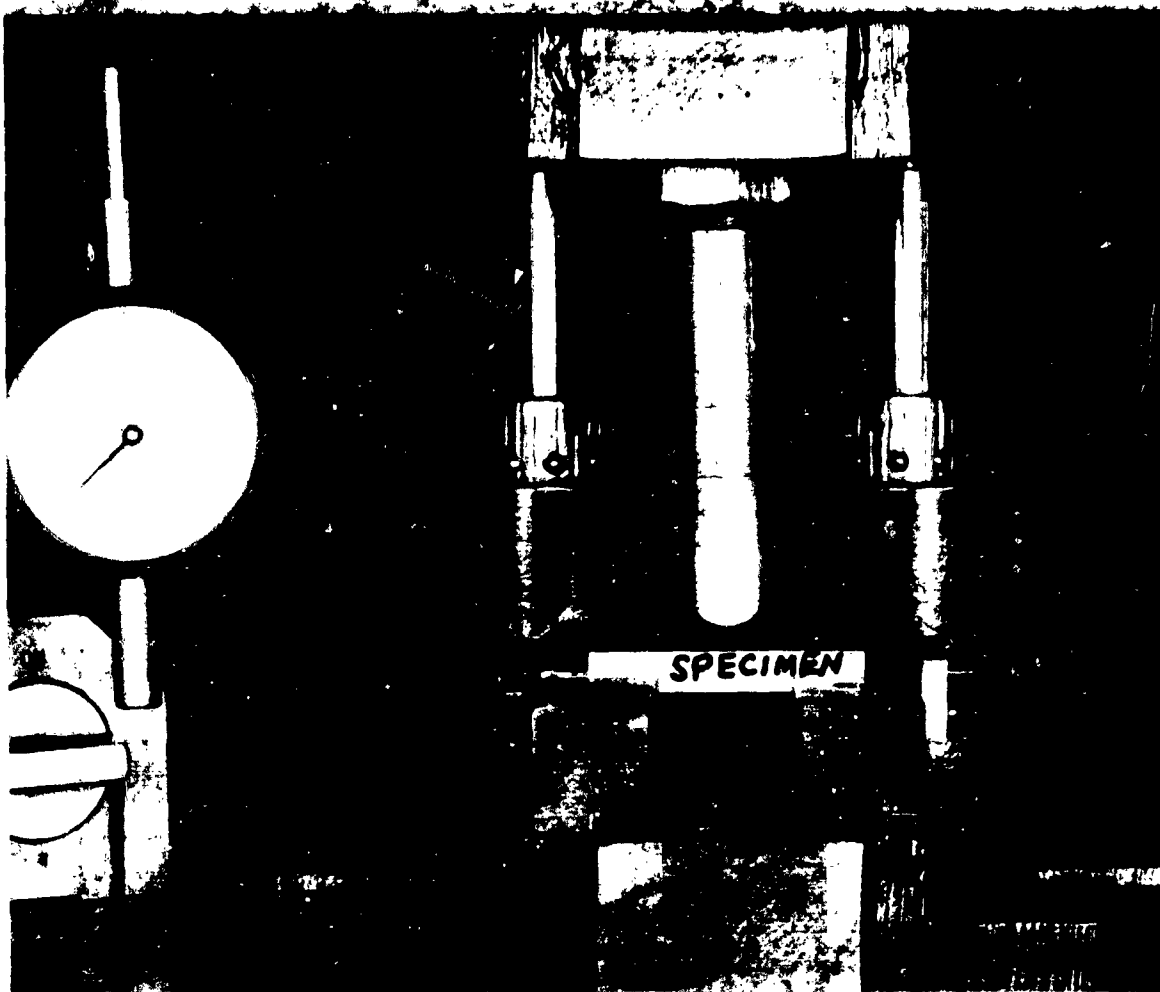
FIG. 4      FIXTURE USED FOR BEND TESTS.
