Project NY 113 001-6  
Technical Memorandum M-106

DEVELOPMENT OF AN IMPROVED PONTOON SYSTEM

3 August 1955

U. S. Naval Civil Engineering Research and Evaluation Laboratory  
Port Hueneme, California

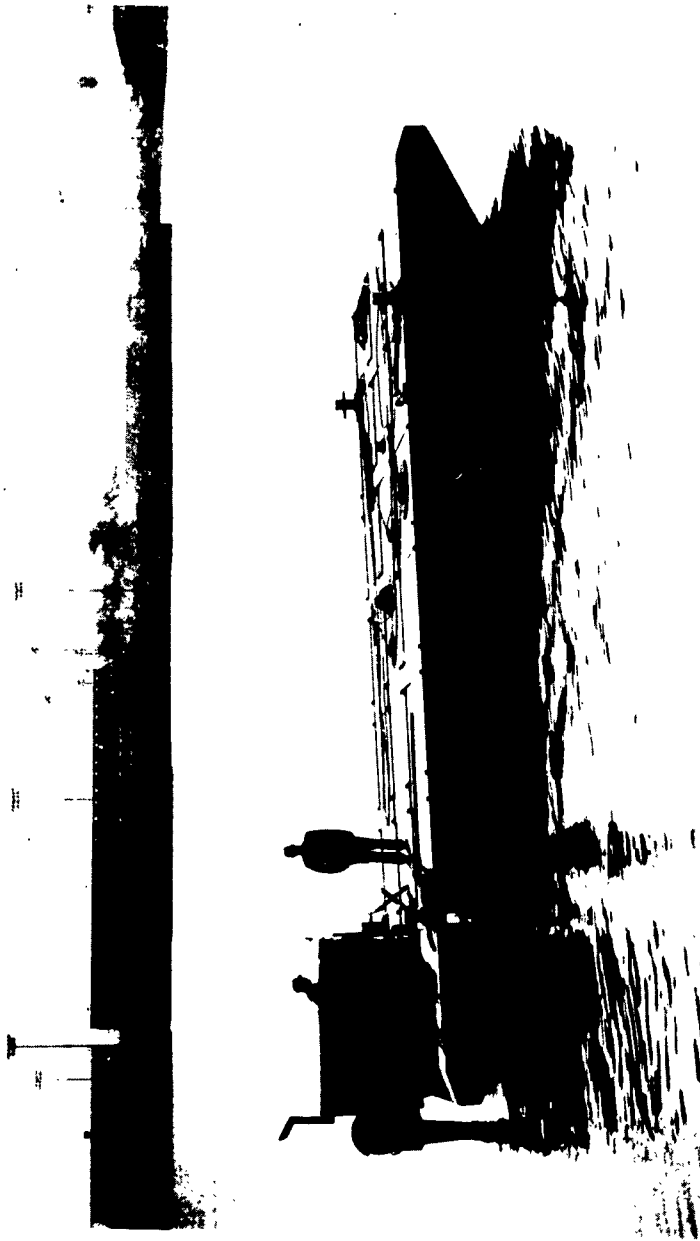
Figure 1. One 3 x 7 barge of the P-1, P-2 new pontoon gear design.

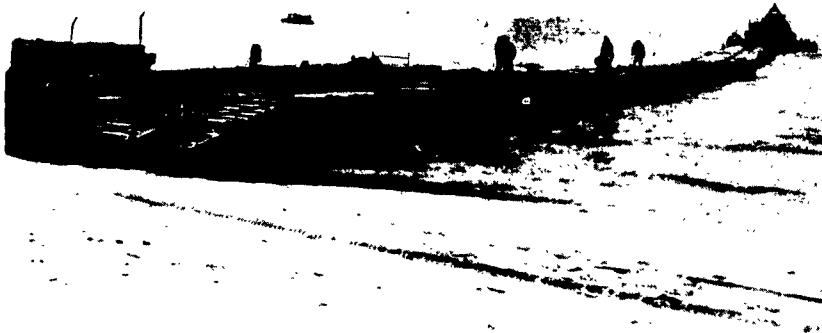
Figure 5. T8 and T11 pontoons forming slope from T6B pontoon to beach.

An investigation of the T8 and T11 pontoon designs shown in Figure 5 revealed that a ramp from the deck of a barge or causeway to the beach was found necessary in the early part of World War II. Initially, a T7A was inverted, and a long wooden ramp was used from part way down the pontoon slope to the beach (see Figure 6).

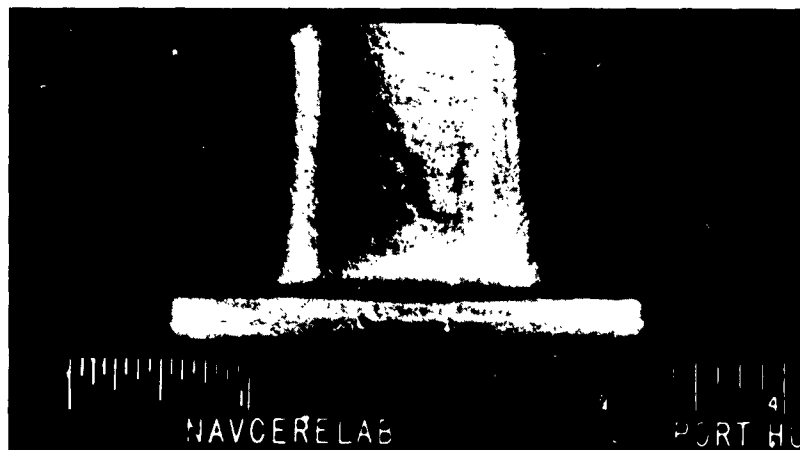
Figure 13. Preliminary design of loose flanged nut.

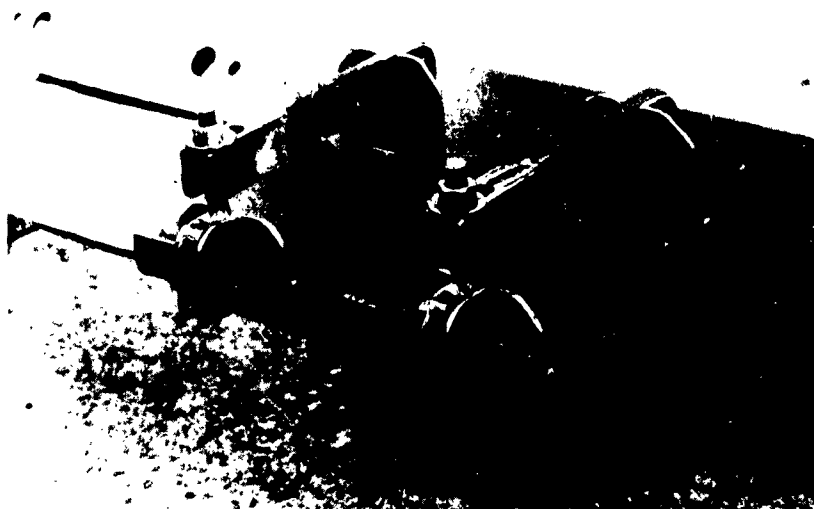
Figure 34. Clamp used to position new angles while welding.

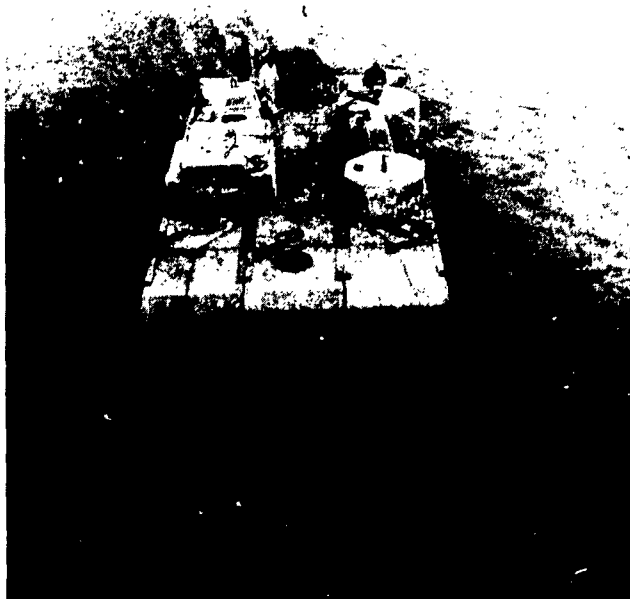
Figure 39. One 3 x 7 barge, new pontoons, during bollard tests. Barge in reverse position.

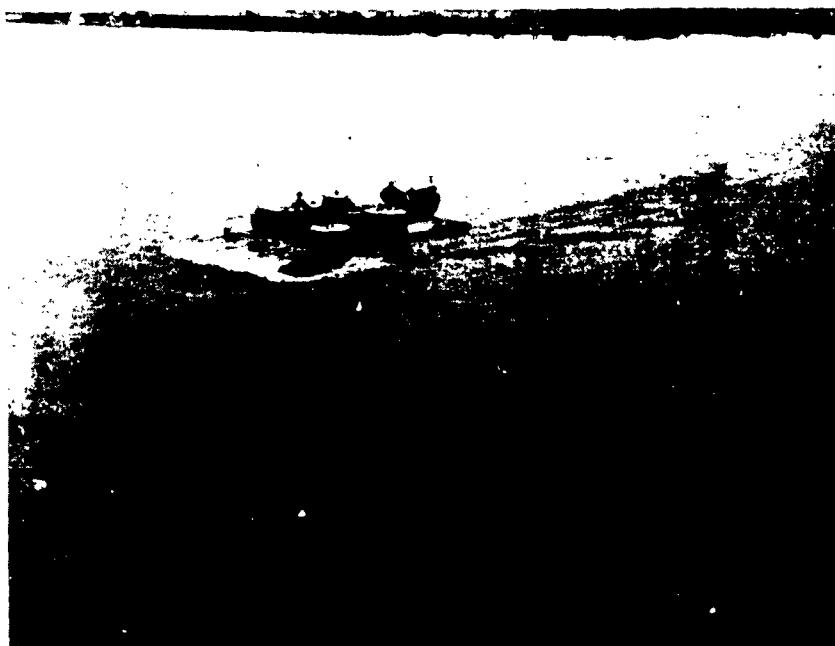
Figure 42. One 3 x 7 barge, new pontoons and angles, with 50-ton load during tests.

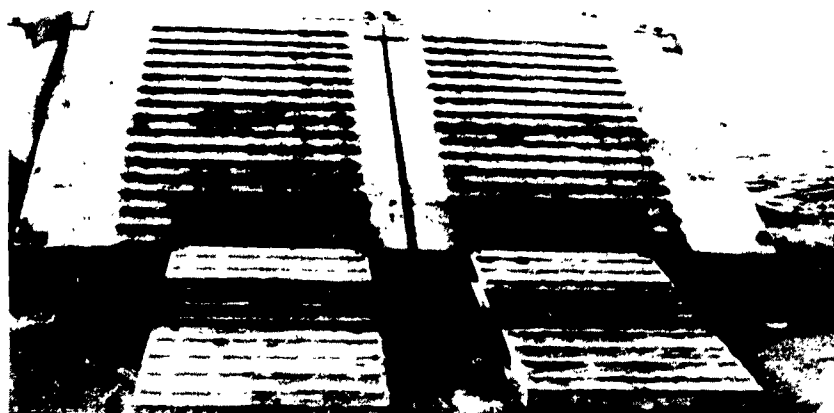
Figure 46. Hinged ramp for P-2 pontoon.

In order to evaluate the P-2 pontoon for use as a ramp and the 3 x 12 barge for LST side-launchings, a 3 x 12 ramp barge was assembled. A new type of hinged ramp (see Figure 46), fabricated from steel WF beams and plate, was used from the front end of the P-2 pontoon to the beach. This ramp weighed 400 lb or approximately two-thirds of the weight of the present type of wooden ramp.

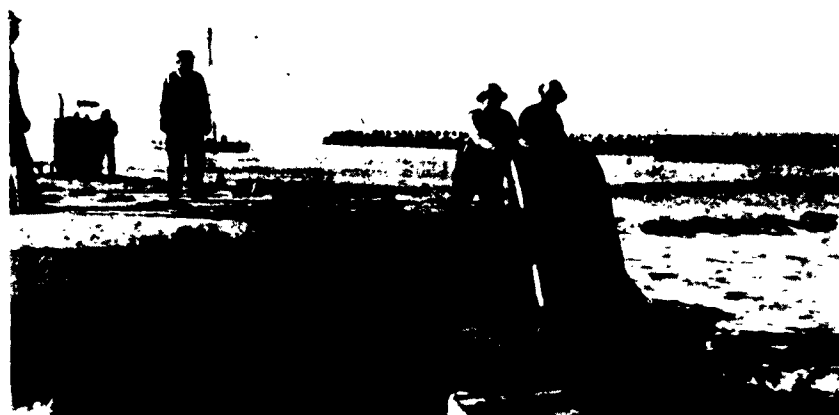
Figure 47. Hinged ramp with adapter slope for P-2 pontoon.

In the test as a ramp, it was found that the slope of the P-2 could be satisfactorily negotiated by all available vehicles except the extra-long-wheel-base vehicles such as the flat-bed truck, 4-ton 6 x 6, 4 DT, 172-in. -wheel-base, cab-protected and winch-rear-mounted, which is now obsolete. The hand-brake band on the drive shaft just touched the top edge of the angles as the truck went up the ramp. It was decided that an adapter slope (see Figure 47) could be put on the P-2 pontoon to make the slope entirely satisfactory for all types of vehicles (see Figures 48 and 49). This slope attachment is much less expensive than an extra or longer pontoon. Attachment is to be made by welding in position at the same time that the hinge and the cleats are welded on the ramp P-2 pontoons.

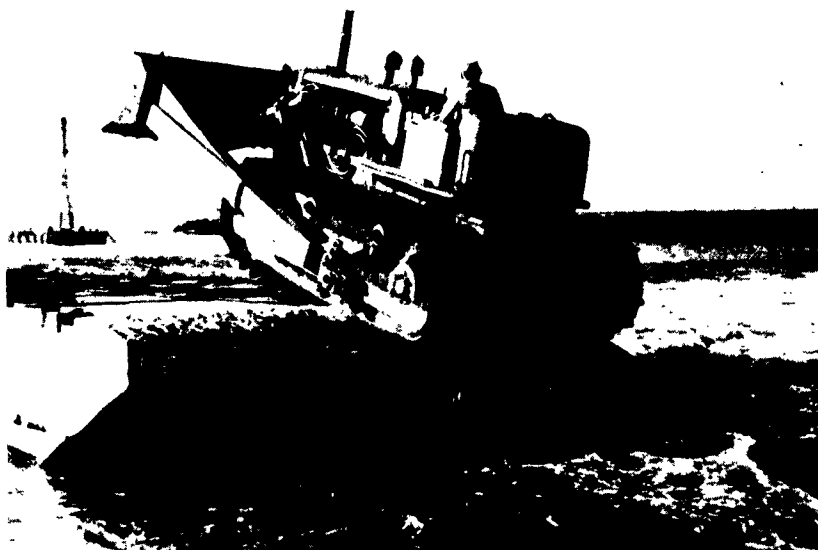
Figure 48. HD19 tractor boarding new design landing barge.

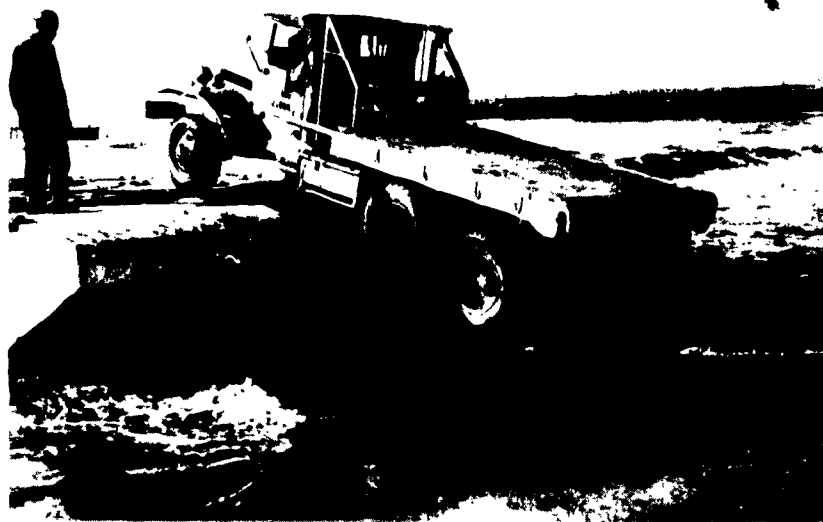
Figure 49. Four-ton, 6 x 6 truck with 172-in. wheel base loading on the new ramp and ramp adapter.
