U. S. ARMY ENGINEER RESEARCH AND DEVELOPMENT LABORATORIES  
CORPS OF ENGINEERS

Technical Report 1514-TR

THE VULNERABILITY OF ENGINEER VANS TO CHEMICAL,  
BIOLOGICAL, AND RADIOLOGICAL WARFARE (U)

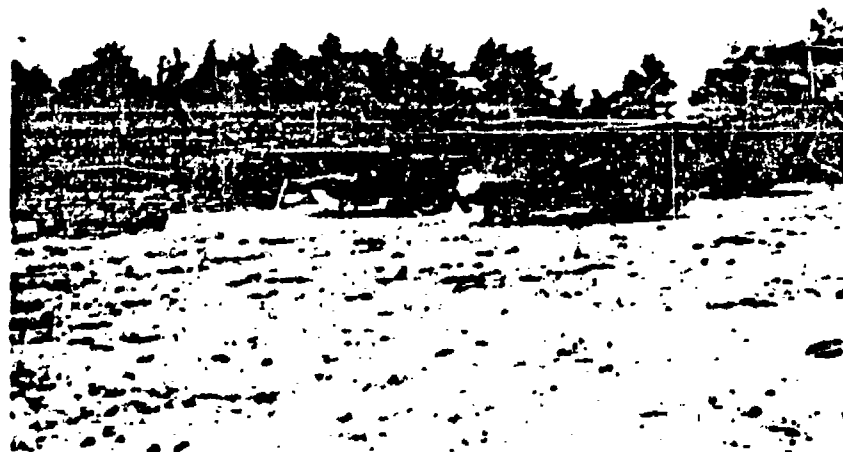
Fig. 2. (l to r) Water purification van, expanded engineer expensible van, shop van trailer, map reproduction van, and expanded camera van in position.

b. Vans and Equipment. Used in the tests were prototype Corps of Engineers vans of the following types (Fig. 2):

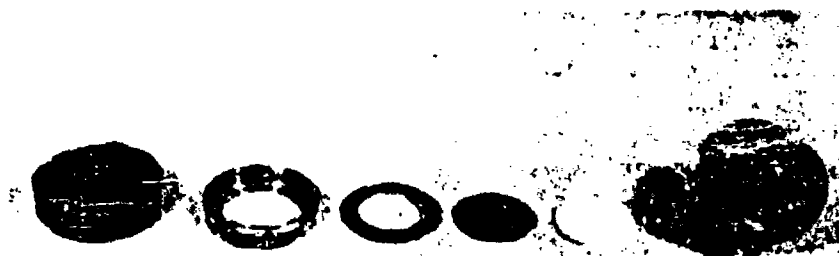
Fig. 6. Filter holder dismantled. (1 to r) Rubber cover, screw-down lid, hold-down ring, filter, nutrient pad support, and filter holder body.

Sampling equipment included filter holders with critical orifices, which regulated air flow to within 10% of the calibrated volume, machined by Millipore Corporation, rubber covers, Millipore AA Black Plain one-inch filters and pads (Figs. 6 and 7), 1/6-hp Cast Vacuum Pumps, Fischer Scientific Co. laboratory clamps, and 6-foot-high ring stands. Samples were collected by placing the Millipore filters on nutrient pad supports in the filter holders. The filter holders were then attached to the vacuum pumps by means of  $\frac{1}{4}$ -inch rubber hose (Fig. 8). As air was drawn through the filters, all FP particles were impinged on the filters. Fluorescent-particle-counting equipment included two model FBV-8 Bausch and Lomb microscopes. This model is equipped with a mechanical stage which

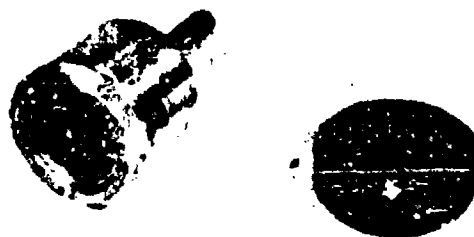
Fig. 7. Filter holder assembled.
