TECHNICAL REPORT  
EP-108

DESERT FLOOD CONDITIONS IN THE WHITE MOUNTAINS  
OF CALIFORNIA AND NEVADA

QUARTERMASTER RESEARCH & ENGINEERING CENTER  
ENVIRONMENTAL PROTECTION RESEARCH DIVISION

APRIL 1959

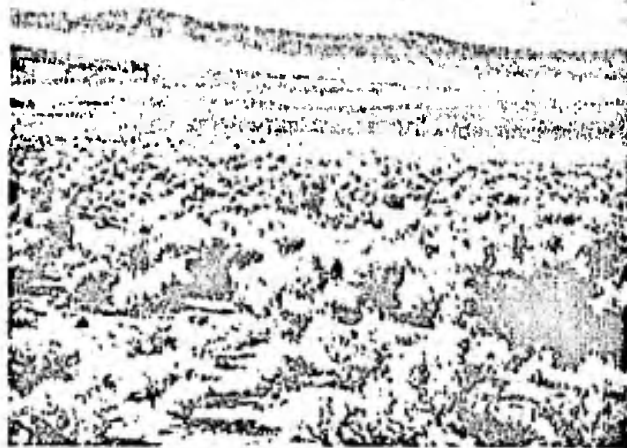
Figure 10. Valley Shrub vegetation on alluvial fan of Marble Creek. Most of the bushes are Great Basin sagebrush, recognizable by its light color. The few darker plants in the fore- and middle-ground are bitterbrush. The density shown is typical for Valley Shrubs. The height of the largest bushes is about 4 to 5 feet.

Covering all of the valley floors and alluvial fans and extending into the mountains themselves for a short distance is an association of Valley Shrubs. The total number of species is great, but the dominant plants make up a comparatively brief list. In the northern lowlands of the area, Great Basin sagebrush (Artemisia tridentata) is the predominant plant, with minor amounts of other shrubs, notably joint firs (Eohedra spp.), bitterbrush (Purshia tridentata), and various buckwheats (Eriogonum spp.). Farther south in the valleys, at lower elevations, sagebrush all but disappears; here, a rather extensive mixture of shrubs replaces it: rabbit brush (Chrysothamnus sp.), salt bush (Atriplex spp.), greasewood (Sarcobatus vermiculatus), hop sage (Grayia spinosa), dalca (Parosela sp.), cotton thorn (Tetradymia spinosa), and other lowland plants. This vegetal association blankets valley flats and alluvial fans and gives the impression of a rather continuous cover (Fig. 10). However, this impression is misleading. There is no development of a turf or sod, and bare ground between plants greatly exceeds the portion of surface actually covered or protected by vegetation.

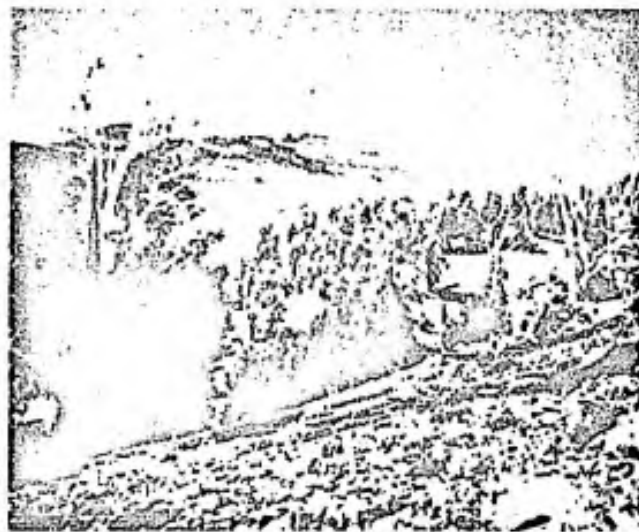
Figure 11. Bristlecone pine on crest of White Mountains. Elevation here is about 10,500 feet. The trees have a height of 35 to 40 feet. Bedrock is dolomite, which the High-Altitude Pines seem to prefer.

Extending from about 9,000 feet to the upper timber line at 10,500 to 12,000 feet is the zone of High-Altitude Pines (Fig. 11). Bristlecone pine (*Pinus aristata*) is the dominant species, but here and there occur groves or individual specimens of limber pine (*Pinus flexilis*). Stunted sagebrush and other smaller plants survive at these higher elevations, but the ground cover generally is sparse. Soil is all but lacking here, although shallow patches of finer debris locally support areas of relatively thick lesser vegetation.

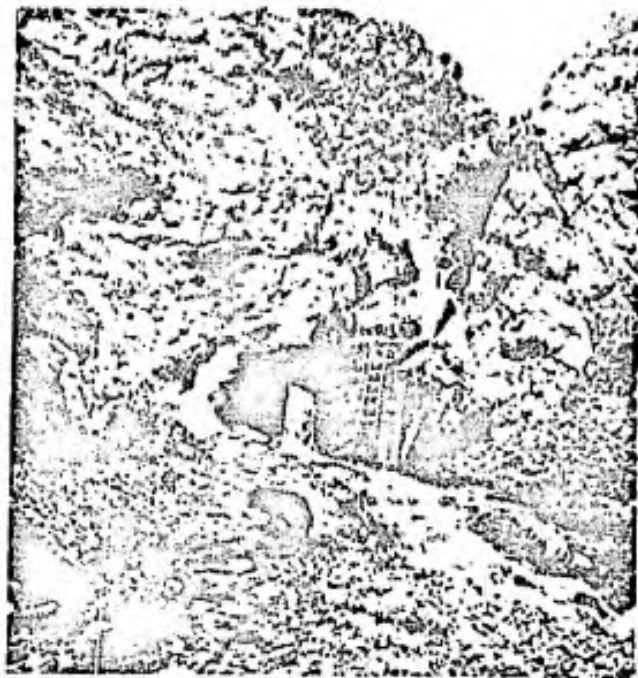
Figure 19. Milner Creek bedrock narrows and dam at foot of lower falls. Men on dam give scale.

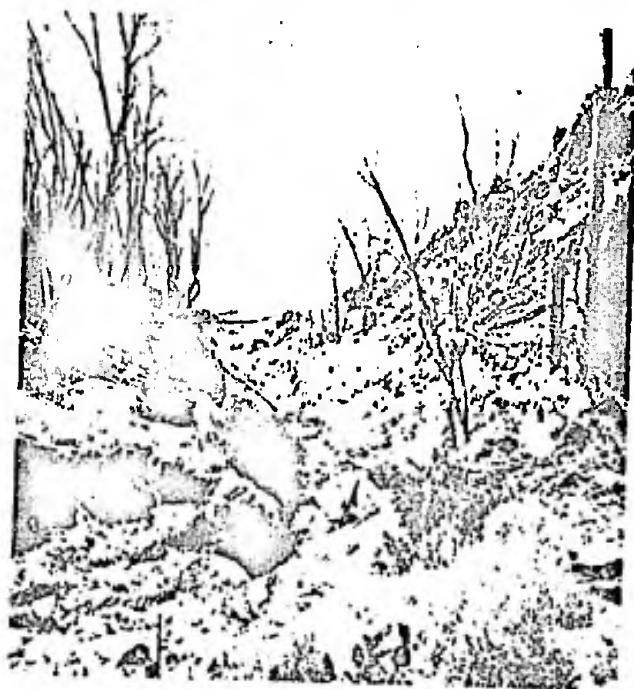
Figure 20. View looking downstream just above mouth of Cottonwood Canyon showing dead trees on terrace formed by 1952 flood. Depth of cut at this point is about 15 feet.

There is excellent evidence of the removal of debris from the floor of the lower canyon of one of the drainage systems, Cottonwood Canyon. Today, a stand of dead cottonwood trees occupies matched narrow terraces of alluvial fill about 15 to 20 feet above the creek bottom in the lower half-mile of canyon (Fig. 20). Prior to 1952, these trees were green and were growing on a flat extending completely across the lower canyon; the creek then occupied a shallow channel in the approximate center of the flat (Springer, R., Personal Communication, 1957). During the flood of 1952, a body of material roughly 20 to 30 feet wide, 20 feet deep, and about 1,500 to 2,000 feet long was removed and added to that brought down from higher in the basin. The lowering of the

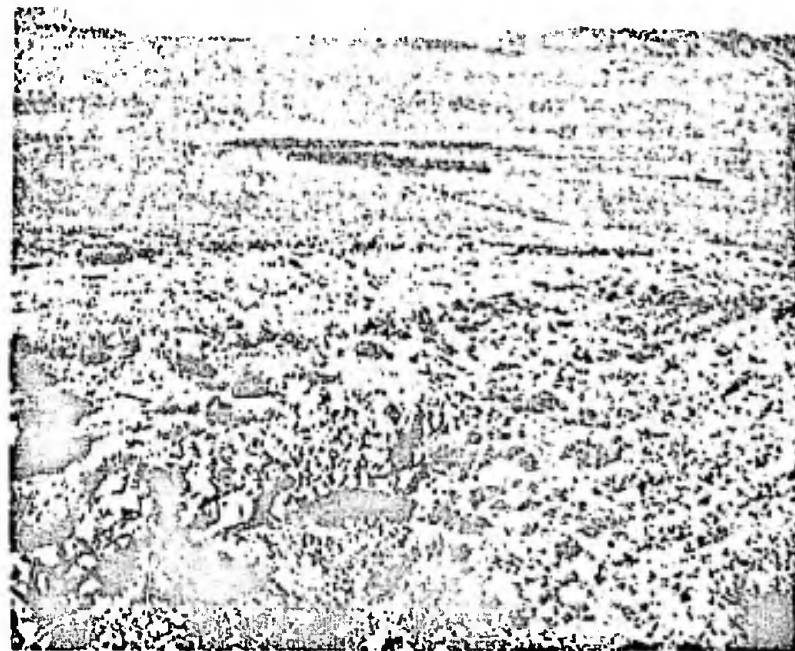
Figure 24. Lateral ridges along edge of 1952 debris flow near apex of Cottonwood Canyon fan. One ridge extends diagonally across picture from lower left corner and is about 3 feet high and 5 feet wide at the base. A second ridge can be seen on opposite side of fresh deposits. Cultivated fields in background are Symons ranch, near which the lower end of the debris flow is visible.

The appearance of the debris flows today, several years after the event, is quite distinctive. In cross section they are concave upward, with well-defined lateral ridges 3 to 6 feet wide and 2 to 4 feet high along parts of their margins (Fig. 24). Evidently the central part of these debris flows had greater fluidity than the margins, and material gradually was left stranded along the edges. Subsequent water runoff followed the centers of the flows and removed a certain amount of material, tending to accentuate the ridge-like characteristics of the margins.

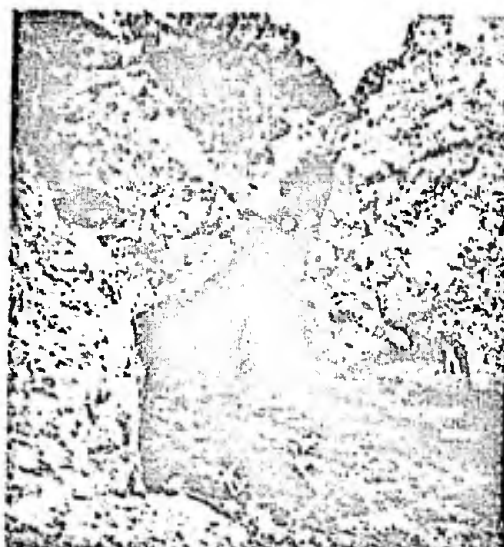
Figure 31. Flow over Milner Creek intake box during the period of snowmelt flooding of June 1957. Compare with Figure 19.

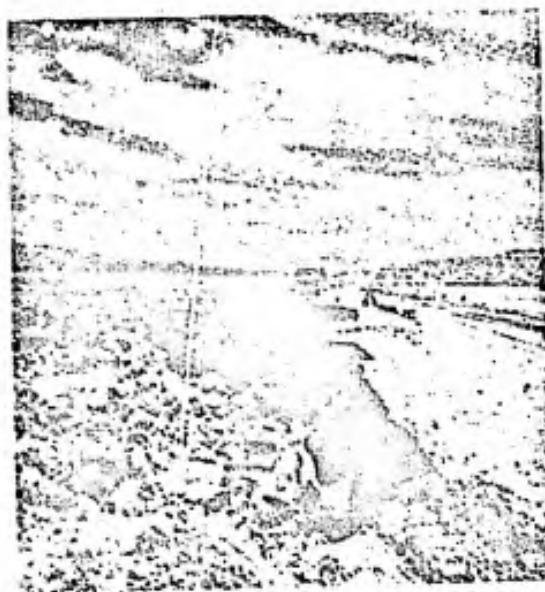
Figure 38. Damage to U.S. 6 at west end of Columbus Salt Marsh, Nevada. This was caused by the cloudburst flooding of 21 August 1957. The amount of uncovered culvert, about 15 feet, indicates the width of road and shoulder removed by the overflow.

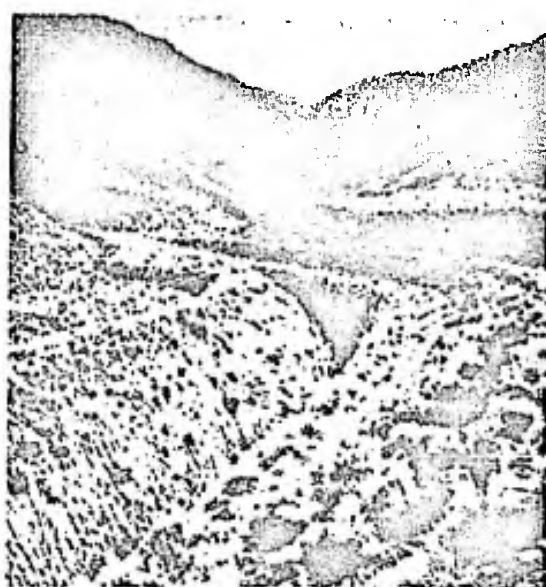
Figure 40. Lateral ridges along active channel in lower Straight Canyon deposited by flood of 1918. The channel is about 10 feet deep and 20 feet wide. Despite its artificial appearance, it is a natural feature. One lateral debris ridge appears in the right foreground near the right edge of the photograph and can be followed upstream beyond the prominent terrace in the middle distance. The lateral ridge in the left half of the picture is on the upper edge of the channel and appears especially clearly at the first upstream bend. The lateral ridges are about three to four feet high and four to eight feet wide at their bases.
