TREC TECHNICAL REPORT 61-34

VTOL DOWNWASH IMPINGEMENT STUDY  
DUCT ADAPTER TEST PROGRAM

HILLER AIRCRAFT CORP  
Palo Alto, California

Hiller Engineering Report No. 60-88

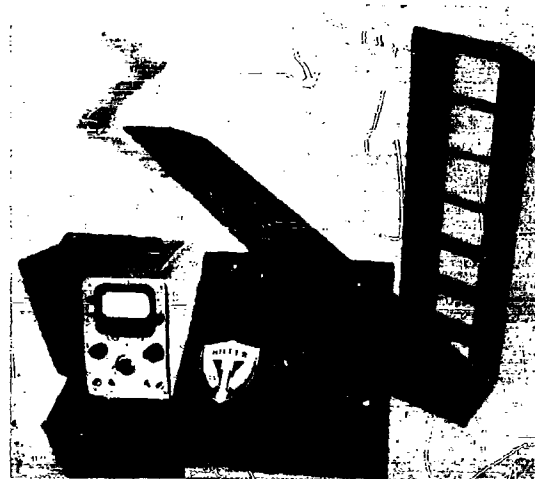
Fig. 3. Instrument Panel, Tachometer  
and Particle Trap

A Hewlett-Packard Model 500C electronic tachometer was used to determine accurately the propeller rpm. The tachometer uses a photo cell to sense intermittent reflected light from the propeller drive shaft.

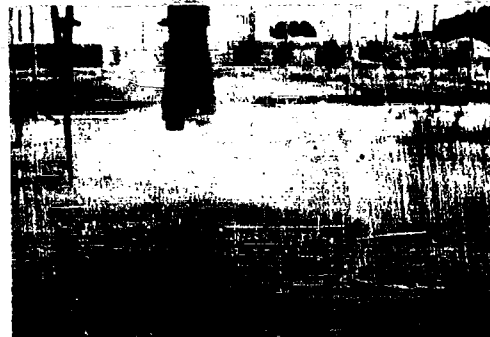
Fig. 35  
 Comparison of V A Tests With  
 Side by Side Ducts, Variable  $Z/D$  and  $w$

The spray height increases with increasing disk loading at constant  $Z/D$ , and at constant disk loading the spray height increases with  $Z/D$  (Figure 35 - see next three pages). It can be seen from these that at times the photographs were taken before the waves had propagated across the pond. The wave rod traces, however, were always made after conditions were stabilized. The data obtained from the wave rods has been reduced and profile plots of surface displacement versus radius ratio were constructed for:  $Z/D = .5$  (Figure 73),  $Z/D = 1.5$  (Figure 74), and  $Z/D = 3$  (Figure 75). The primary wave amplitude (Figure 76) and wave frequency (Figure 77) were plotted versus disk loading for each of the five wave rods located as shown in Figure 40.

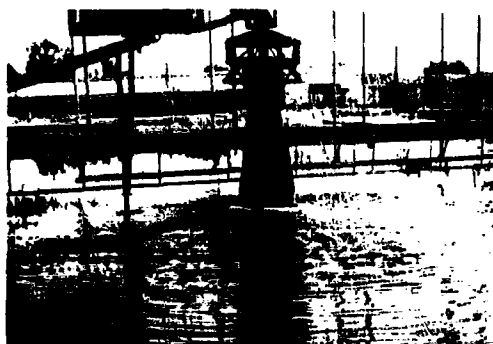
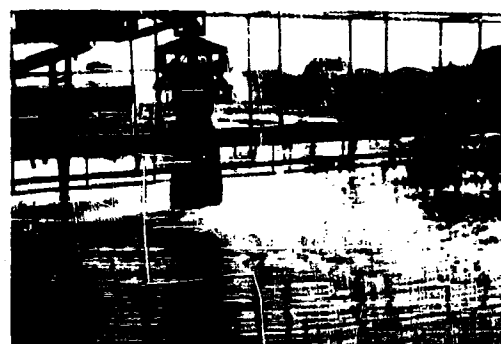
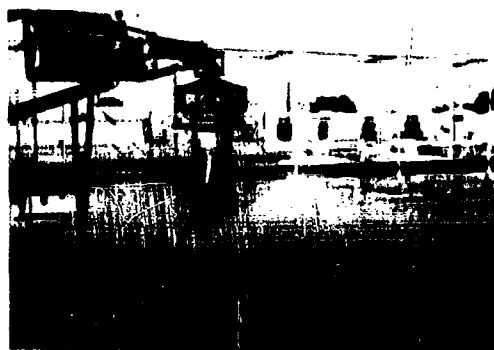
While the plenum chamber was in operation it was possible to observe the water surface in the plenum area. The water surface in this area was below the mean water level, but its surface was quite smooth with waves beginning in the area of the change in surface elevation and propagating outward. At the highest disk loading tested the spray, although quite dense, stayed near the surface. The set of photographs (Figures 36a, b and c) shows the plenum chamber in operation at the disk loadings tested ( $w = 4.36, 8.40$  and  $31.25$ ) over the water. The

Fig. 36a. Test V A 7 Plenum Chamber  $w = 4.36$

Fig. 36b. Test V A 6 Plenum Chamber  $w = 8.40$

Fig. 36c. Test V A 4 Plenum Chamber  $w = 31.25$

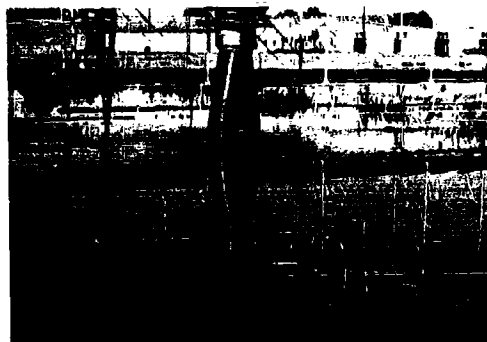
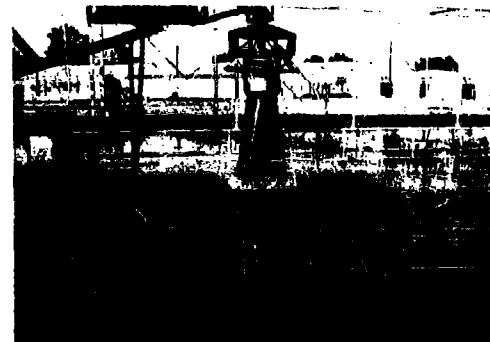
The annular nozzle projected the spray almost vertically, even at the very low disk loading of 2.31 pounds per square foot. Large drops were lifted four to six inches above the water surface (Figures 37a, b and c). The water under the base plate appeared to be much rougher

Fig. 37a. Test V A 3 Annular  
Nozzle  $w = 2.31$

Fig. 37b. Test V A 2 Annular  
Nozzle  $w = 9.64$
