## A REPORT ON INSTALLATION AND TESTING OF VISUAL GLIDE PATH INDICATORS

NATIONAL AVIATION FACILITIES EXPERIMENTAL CENTER  
ATLANTIC CITY, NEW JERSEY

FINAL REPORT

INSTALLATION AND TESTING OF  
VISUAL GLIDE PATH INDICATORS

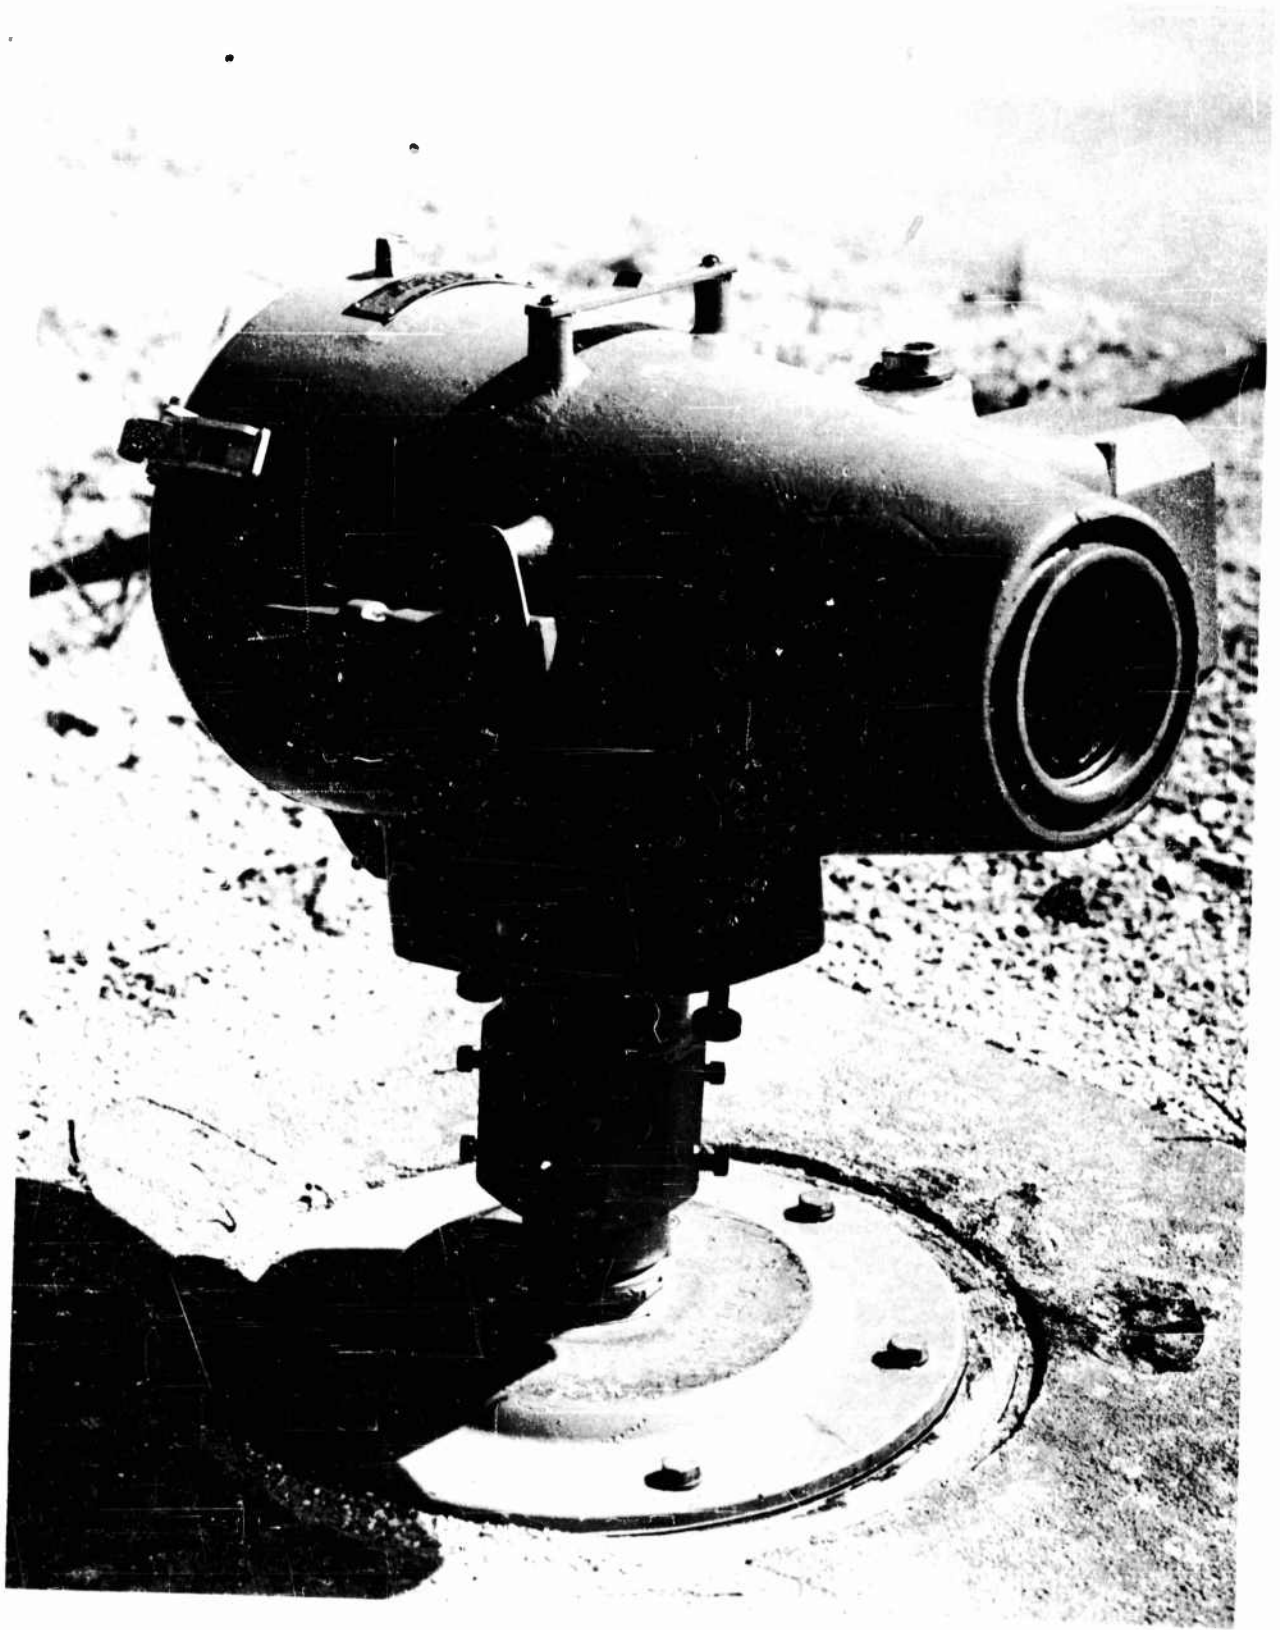
FIG. 4 WESTINGHOUSE TRI-COLOR UNIT

c. An entirely different principle is used in the Westinghouse Tri-Color indicator (see Fig. 4). A complete system consists of two projectors, one mounted on each side of the runway opposite the 1,000-foot point. Each projector emits a single beam, split into yellow, green, and red sectors by a filter. The unit is aimed up the glide path at the proper angle so the pilot sees yellow light if high, green light when on the glide path, and red light if low. The horizontal beam spread is  $15^{\circ}$ . The vertical spread of the yellow sector is  $7^{\circ}$ , the green is  $2^{\circ}$ , and the red is  $6^{\circ}$ , for a total of  $15^{\circ}$ . In order to distinguish the light from other steady-burning lights, the beam is interrupted about 40 times per minute by a shutter actuated by a small electric motor. The lines separating the colors are very sharp. This has caused the manufacturer to recommend that the unit on the left side of the runway be aimed  $1/2^{\circ}$  higher than the

one on the right, which is set to the desired glide angle. This will warn the pilot of an impending descent below the glide path, since he will intercept the red beam of the left-hand unit before leaving the green beam of the right-hand unit. Conversely, a deviation toward the high side will cause the yellow beam of the right-hand unit to become visible first.

The Westinghouse Tri-Color system was effective at night in clear weather. It has been seen at the outer marker (4.3 nautical miles) under those conditions, and the guidance received was good. In daylight, however, the units were seldom seen by pilots until the aircraft was practically over the threshold. Several pilots called to verify that the units were not turned on, although they were operating properly. Also, color definition deteriorated when precipitation was present or when moisture collected on the lens. This latter condition was noted after particles of snow had blown against the lens and melted there. Some pilots expressed confusion about the  $1/2^\circ$  difference between the glide paths of the two units, even after they had been briefed.

Fail-safe capabilities of the systems vary. The tri-color units are flashed by means of a motor driven cam-operated shutter. On

one occasion, power failed in the motor circuit and the motor stopped. No light was emitted, even though the lamp was energized. This was apparently due to the shutter stopping in such a position as to block the beam. Since they are used in pairs, there is still a unit operable in case of failure of one. The Mirror system can provide guidance in case of individual lamp failures, and no problems of failing unsafe occurred. The Cumming-Lane system was successfully flown on only one-half a complete system, with all components on the left hand side of the runway out of commission. During times when individual amber lamps were either down or badly out of adjustment, guidance was available. Comments relative to the Mirror system also apply to the USAF Interim system. The RAE system might be said to be the least vulnerable to failure which could cause an unsafe condition. Since the complete array contains 36 lamps (three in each unit), failure of a single lamp is hardly perceptible. A failure of a unit, a complete half bar, or all units on one side of a runway will not decommission the system, because the color relationship between the remaining units will still provide glide slope information, since alignment is not a feature of the system. Finally, the most severe type of breakdown might be considered the complete failure of all units in either the upwind or downwind bars on both sides of the runway. In this event, a pilot could still avoid undershooting by remaining above the red signal of the operative lamps. In this test, it was found possible to fly the pink sector of a bar of light. Thus, a safe approach could be flown using this technique.

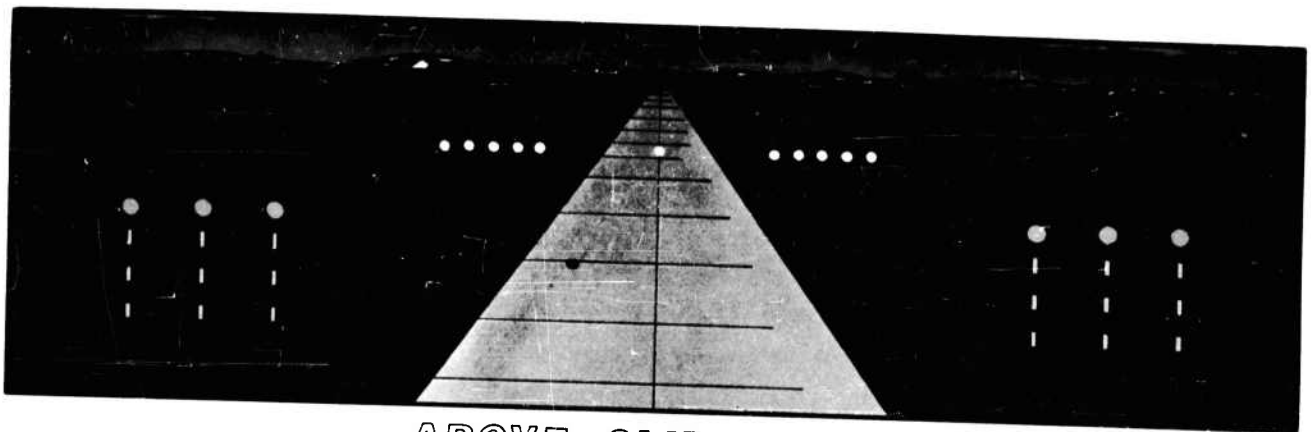
FIG. 8 COCKPIT VIEW OF CUMMING-LANE SYSTEM

# DOUBLE BAR SYSTEM

ABOVE GLIDE PATH

ON GLIDE PATH

BELOW GLIDE PATH

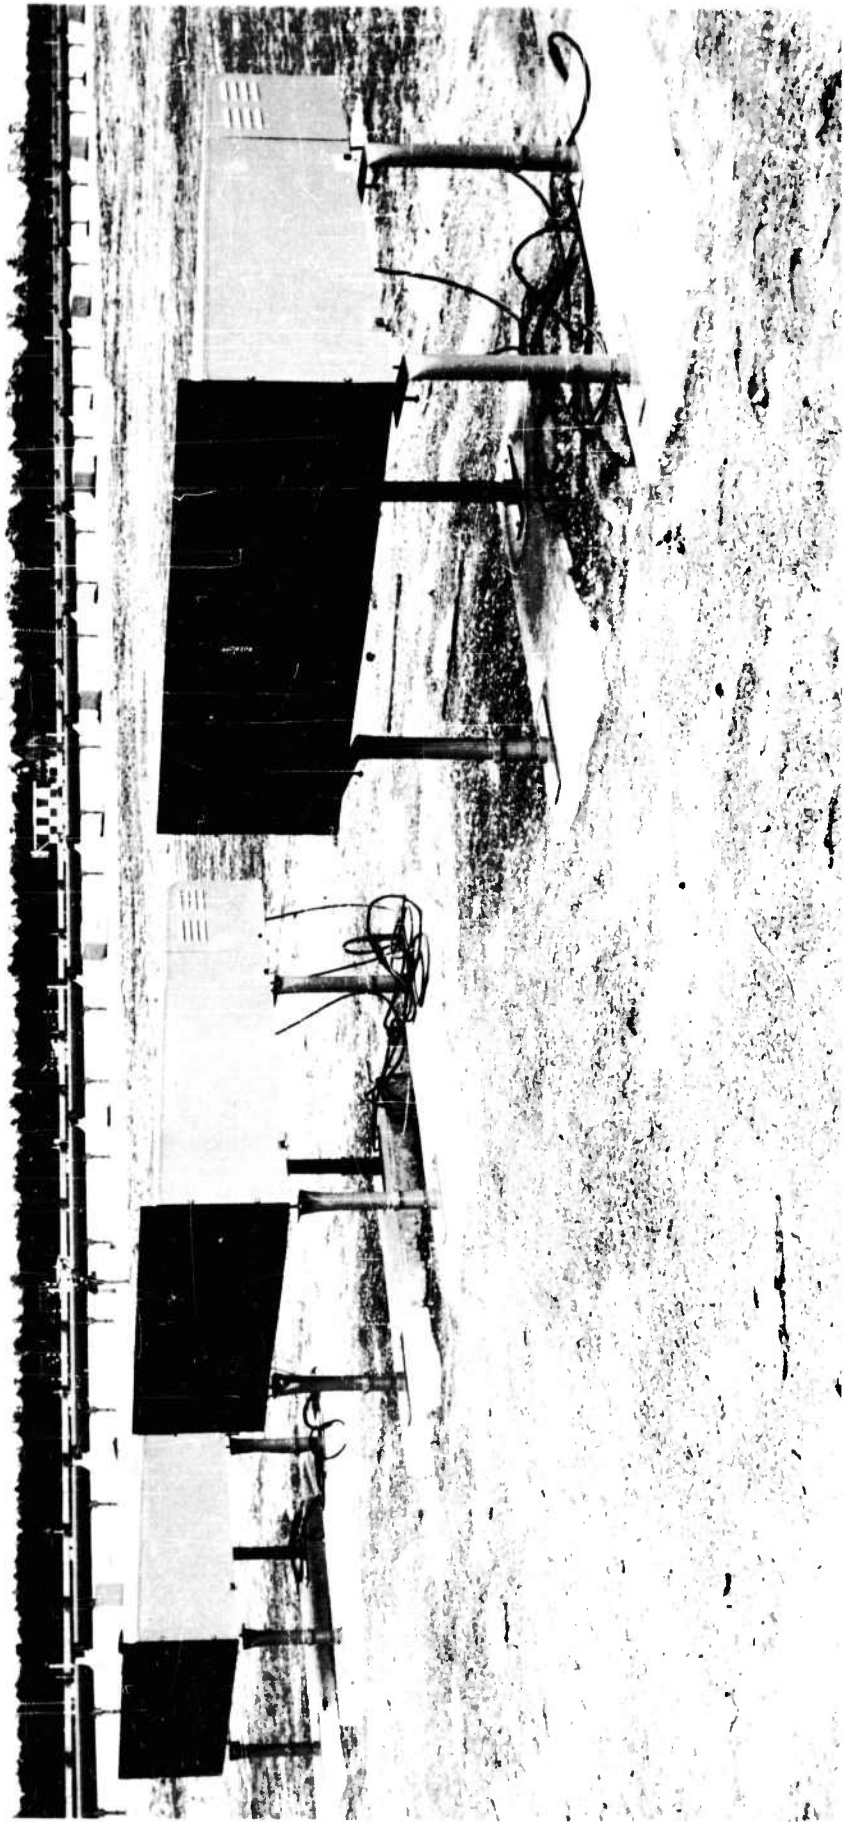
· FIG. 9 R. A. E. UNITS

e. The system developed at the Royal Aircraft Establishment, and known as the RAE Angle of Approach Indicator (AAI), uses still another principle. The complete system consists of 12 light source units arranged in bars, with three units placed on each side of the runway, opposite the 750-foot mark (from threshold) and three on each side of the runway at the 1,250 foot mark. Each unit is about 4 feet 6 inches square, and contains three high-intensity sealed-beamed lamps and three filters, the upper half of which is red and the lower half clear, mounted immediately in front of the lamps. A horizontal slit across the front of the box, about 2 inches wide, is at the focus of the lamp. The effect, then, is somewhat like a pinhole camera, so that an observer viewing the slit from a high angle sees white light. As his viewpoint is

lowered, the light changes in color through pink to red. By adjusting the tilt of the box so that the bottom of the white beam is at the desired glide slope angle, the arrangement of all the units then will define a safe glide path corridor. When on the proper glide path, the pilot is in effect overshooting the bars nearer the threshold, and undershooting the bars farther down. Thus, he will see the nearer bars as white and the farther bars as red. A position below the glide path will cause both rows of light to be red, and a high position will cause both bars to be white. Impending departure from the glide path is indicated to the pilot by a transition in color from red through pink to white or vice versa. A movement to the high side will cause the farther bars to change from red through pink to white. A descent below the glide path will change the nearer bars from white through pink to red. The RAE system is shown in Figs. 9 through 12.

RAE System: The RAE system, as a whole, was almost completely trouble-free. One lamp failed early in the test, and was sent to the National Bureau of Standards for examination. It is suspected that the lamp may have been damaged in shipment or in installation. In the units made by Thorn Electrical Industries, Ltd., the British manufacturer, it has been noted that the red filtering material has split on a number of the filters and separated from the glass. This has had no apparent effect on the signal, but the Sylvania Electric Products Co. (the company authorized to produce the units in the United States) proposes to incorporate the red color in the glass itself, to eliminate this problem. A deficiency in the design of the lamp holder was evident in the large number of small bolts (12) required to hold the assembly together. This minor deficiency was more than offset by the ease with which a complete lamp assembly could be replaced in case of failure. The sealed-beam lamp was secured in a prefocused position in the holder, which is attached to the optical bench framework by 4 Dzus fasteners shaped like wing nuts. Positioning lugs on the frame fit into holes on the lamp assembly so that it can be installed in only the correct position.

A defective lamp can be removed and replaced in about one minute. The faulty assembly can then be removed to the shop, the sealed beam unit replaced and focused, and reassembled for future use. The buffeting effect of the winds during the test period, coupled with some shifting of the concrete bases, under the units, caused some of the units to get out of adjustment. This situation is quickly and easily corrected by using a bubble sextant to sight on the edge of the white beam and measuring its angle of elevation. A sample series of sextant sightings is included in Appendix IV. After the sightings have determined the degree of correction required, the adjusting screw is turned in the proper direction, using the click stop feature to measure the correction applied. This is an ingenious feature which provides a noticeable "click" as the screw is turned through each minute of arc. Each revolution will cover five minutes of arc. This feature may also be used in the initial adjustment of the units, after first leveling the optical benches with an ordinary spirit level.

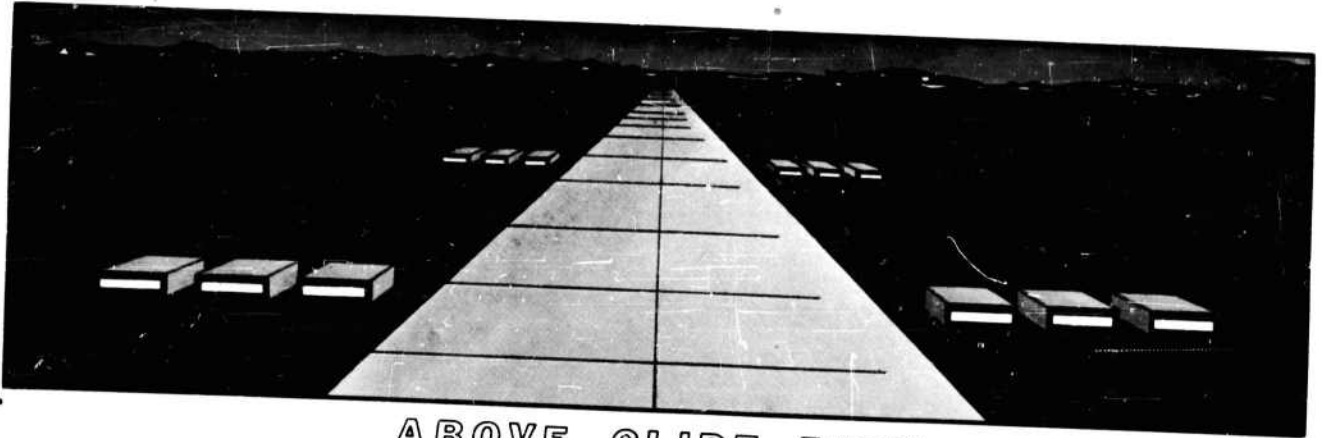
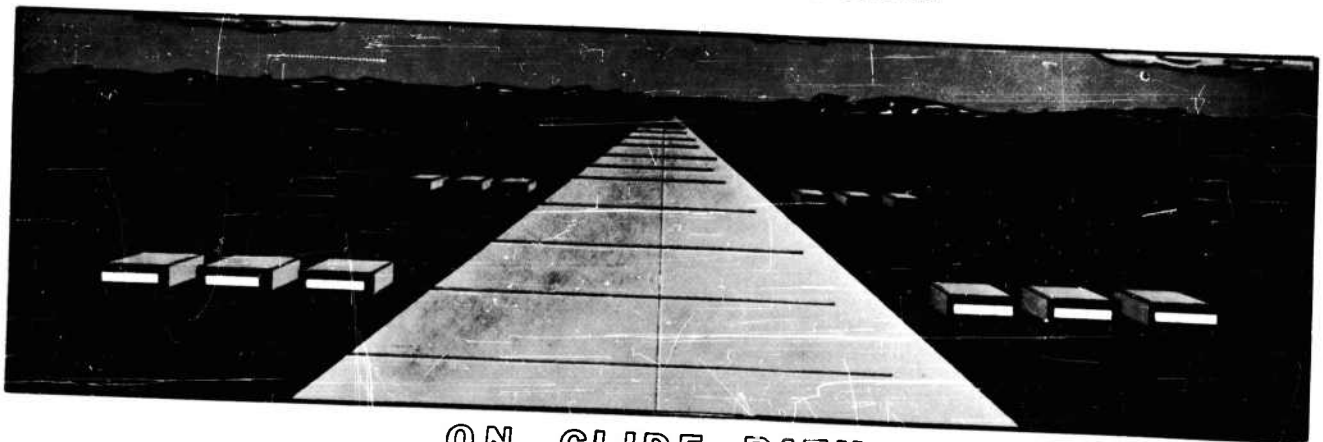
FIG. 12 COCKPIT VIEW OF RAE SYSTEM

# RED - WHITE SYSTEM

ABOVE GLIDE PATH

ON GLIDE PATH

BELOW GLIDE PATH
