Contract No. DA-11-022-ORD-905  
OCO, R & D Branch Project No. TB5-2  
Department of Army Project No. 593-21-060

DEVELOPMENT OF QUALIFICATION TEST METHODS

FOR GEAR LUBRICANTS

Final Summary Report

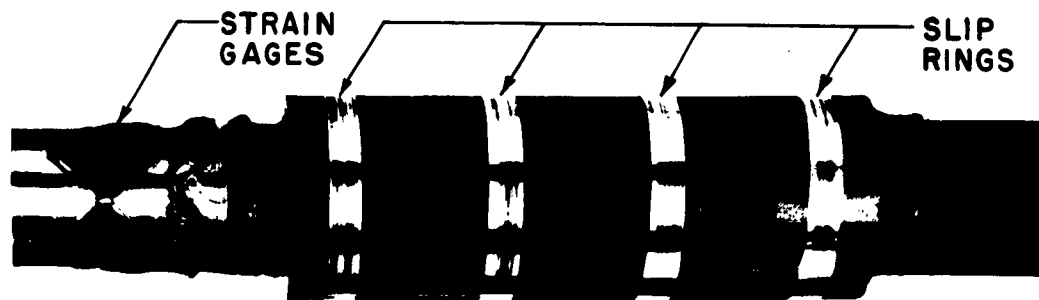
The determination of dynamic torque loading of rear axle gears in standard gear lubricant tests was accomplished by recording axle torque, sensed by electric resistance strain gages, on a high speed light beam type oscilloscope. Since all of the work was carried out on a 1949 Chevrolet automobile drive assembly, it was possible to use two methods of strain gage application to measure the drive system torque. One method involved the application of the electric resistance strain gages in a bridge network fastened to the axle shaft of the automobile drive system as shown in Fig. 13. The signal was obtained from the strain gage bridge through a slip ring assembly. By mounting the gages with their centerlines perpendicular to the two adjacent gages the effect of bending in the axle shaft was eliminated. The use of four active gages in the bridge produced four times

FIG. 13 — STRAIN GAGES AND SLIP RING ASSEMBLY  
ON AUTOMOBILE AXLE SHAFT
