**MARINE CORPS  
LANDING FORCE DEVELOPMENT CENTER  
MARINE CORPS SCHOOLS  
QUANTICO, VIRGINIA**

One Man Rotorcycle;  
Final Report

PROJECT NO. 52-58-03

**MARINE CORPS EQUIPMENT BOARD**

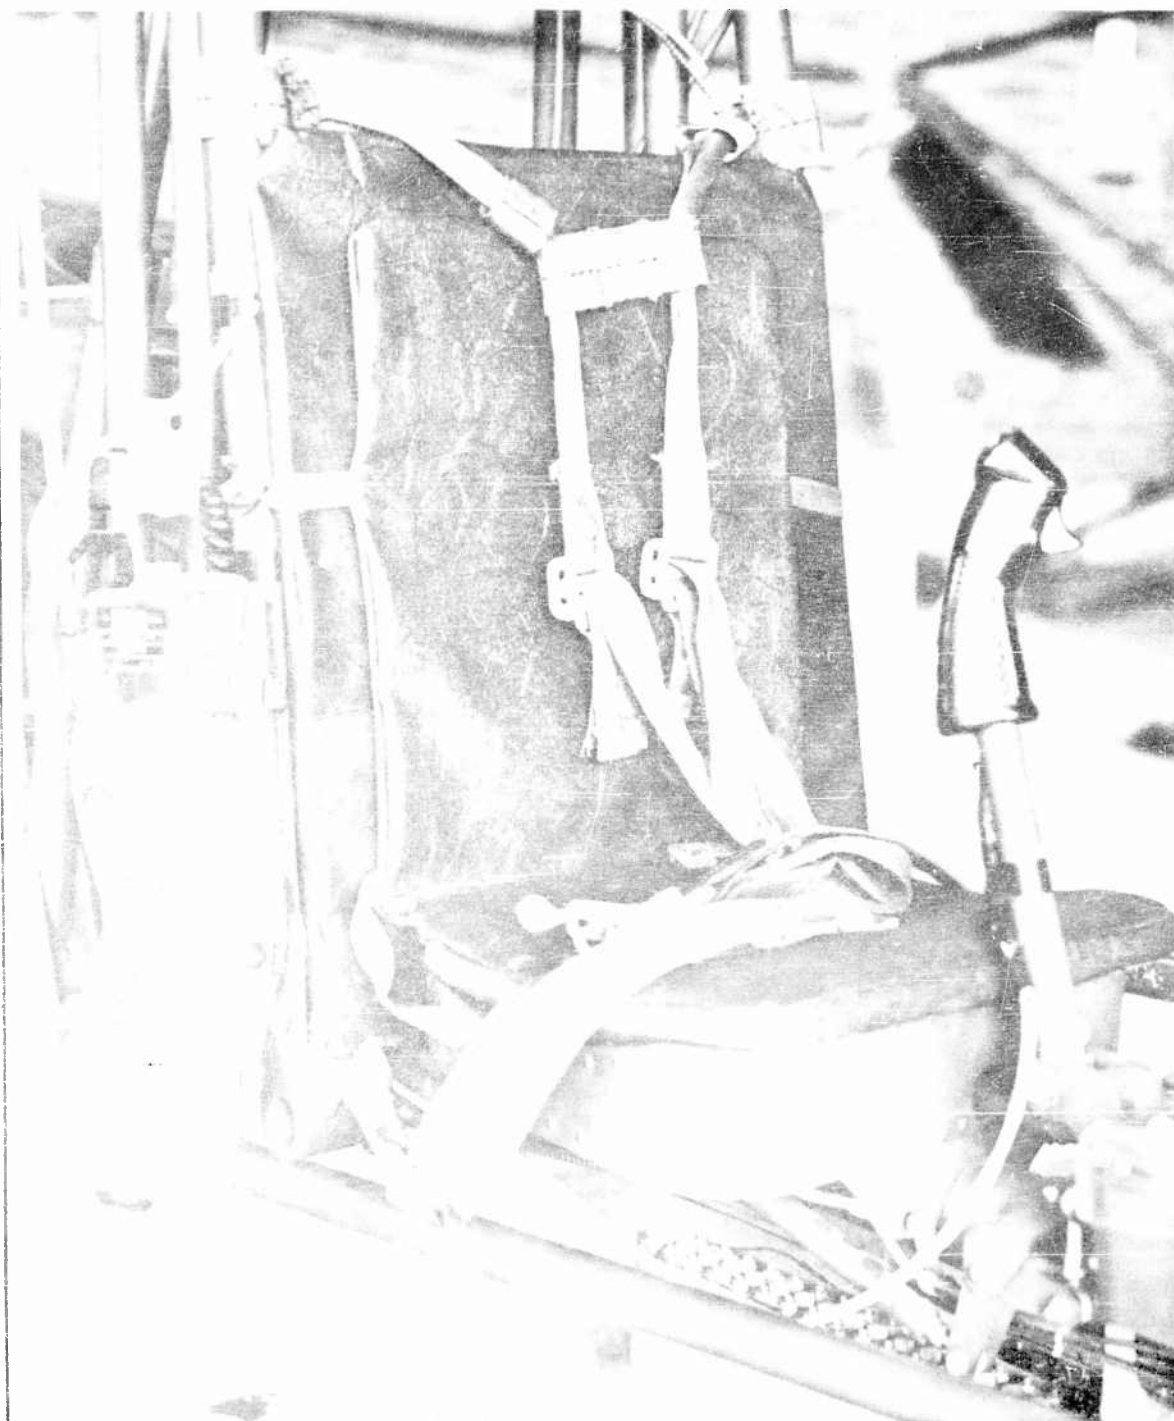
FIG. 8

View of cyclic control stick modified  
with standard aircraft stick grip

1. The cyclic stick on the three YRON-1 rotorcycles delivered to Quantico was considered to be excessively long. Accordingly, the stick was shortened approximately 6 inches and a standard aircraft stick grip added (see figure 8, Annex D). The shortened stick provided better control, permitted the pilot to rest his arm on his leg during flight, and with the addition of a radio, would have permitted the pilot to use the control button on the stick grip to transmit.

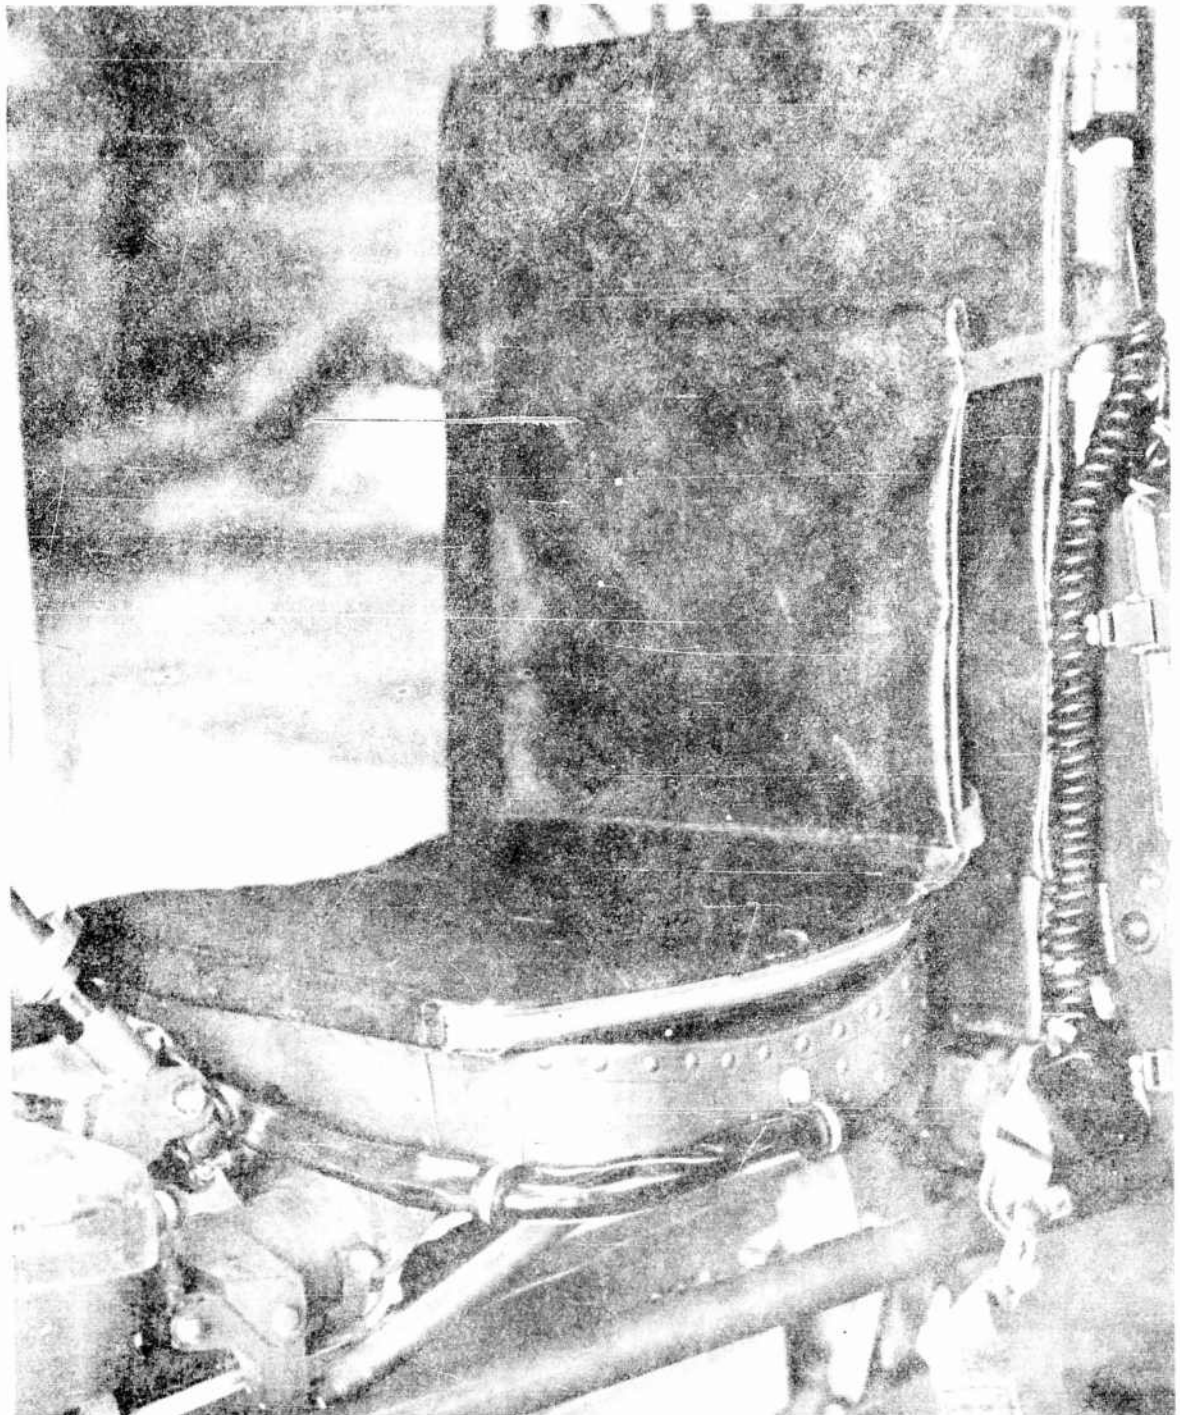
FIG. 9

25 Mar 1960  
 Seat cushions and back pads fabricated  
 by HMX-1

2. Back pads and seat cushions were added after the YRON-1s were delivered to Quantico (see figure 9, Annex D). The addition of these two items provided a more comfortable seat for the operator. In cold weather the metal seat allowed the cold to penetrate even heavy winter flight clothing. The added weight of four pounds is not considered excessive for the comfort gained by the operator.
