AFFTC-TR-61-15
August 1961

T-38A CATEGORY II STABILITY AND CONTROL TESTS

WILLIAM A. LUSBY, Jr
Captain, USAF
Project Engineer

NORRIS J. HANKS
Captain, USAF
Project Pilot

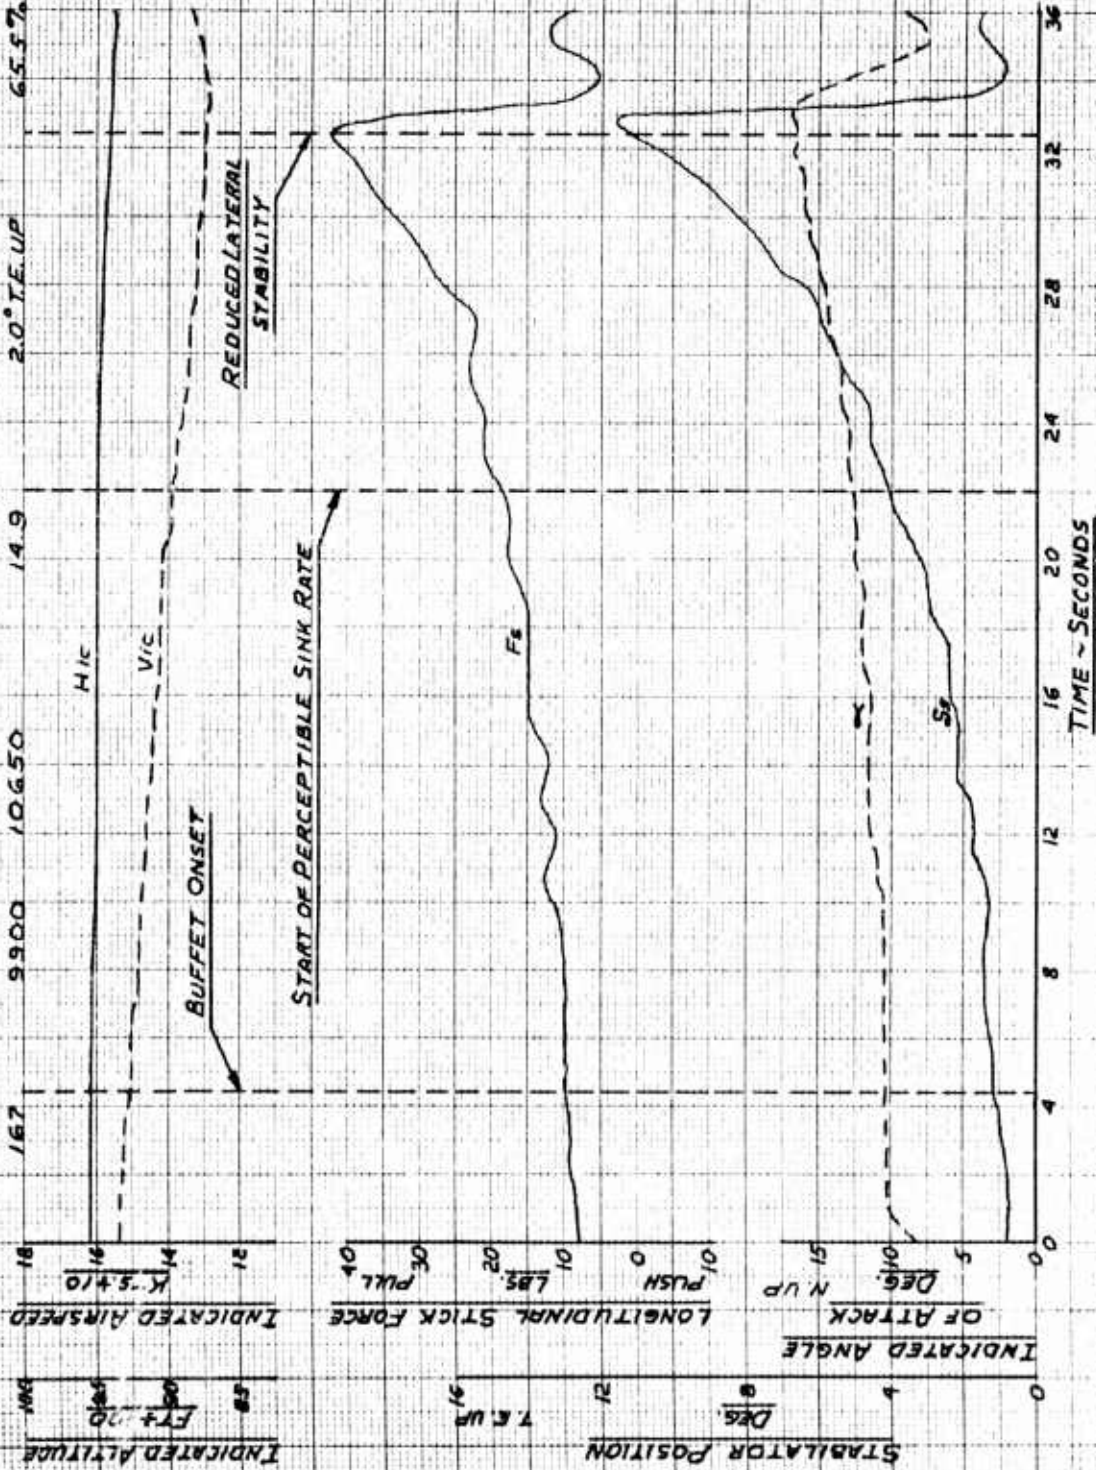
FIG. NO. 64

TRIM V_c ~ KTS. 167 HP ~ FT. 9900 GROSS WT ~ LBS. 10650 HIC V_{IC} S_{STAB} ~ DEG. 2.0° T.E. UP POWER ~ % R.P.M. 65.5%

C.G. ~ % M.A.C. 14.9

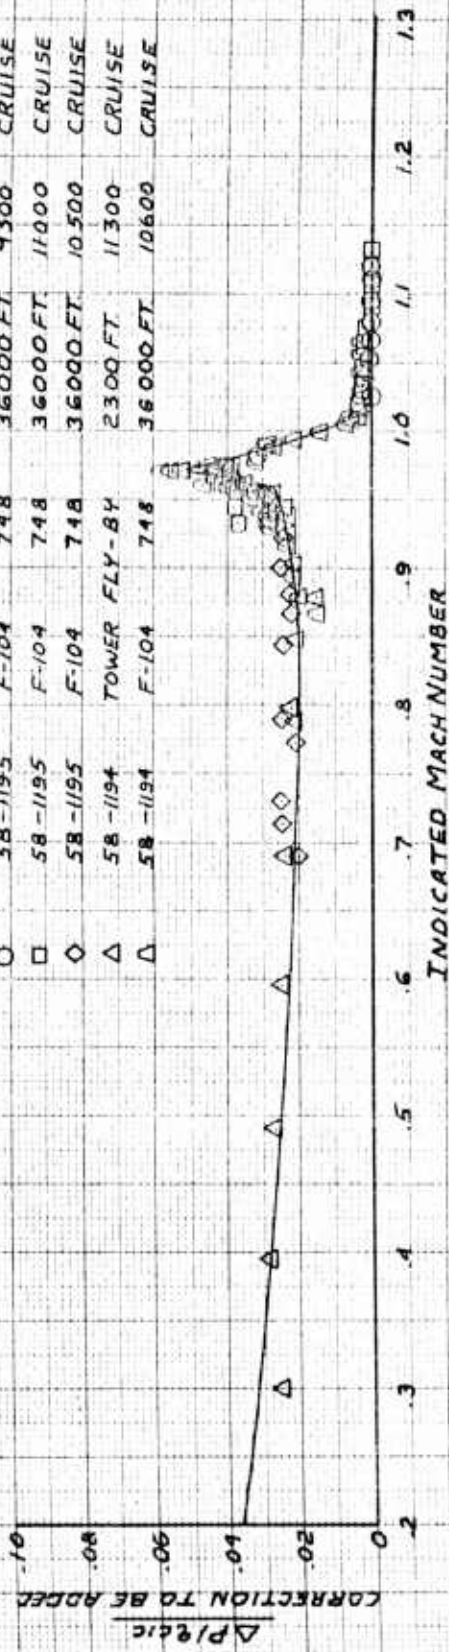
FIG. NO. 74

T-38A SN58-1194, 58-1195 YJ85-5 ENGINES

SYMBOL	AIRPLANE NO.	PACER	PACER NO.	ALTITUDE	GROSS WT.	CONFIG.
○	58-1195	F-104	748	36000 FT.	9300	CRUISE
□	58-1195	F-104	748	36000 FT.	11000	CRUISE
◇	58-1195	F-104	748	36000 FT.	10500	CRUISE
△	58-1194	TOWER FLY-BY		2300 FT.	11300	CRUISE
△	58-1194	F-104	748	36000 FT.	10600	CRUISE

The test nose boom system was calibrated by the tower fly-by, pacer, and smoke trail acceleration methods (see Fig. 74, Appendix I). The production airspeed system has been modified as recommended in the Category I report, AFFTC-TR-59-42, and will include a short nose boom. Development testing of the production airspeed system is presently being conducted by the contractor. The final production airspeed system will be calibrated on the Category II performance test aircraft.
