KELLETT
1929
Aircraft
CORPORATION

AN INVESTIGATION OF
VTOL OPERATIONAL PROBLEMS

DUE TO DOWNWASH EFFECTS
Released to ~~ASTIC~~ by
Bureau of **NAVAL WEAPONS**
without restriction.

DATE 12 June 1961 REPORT NO. 179T80-2

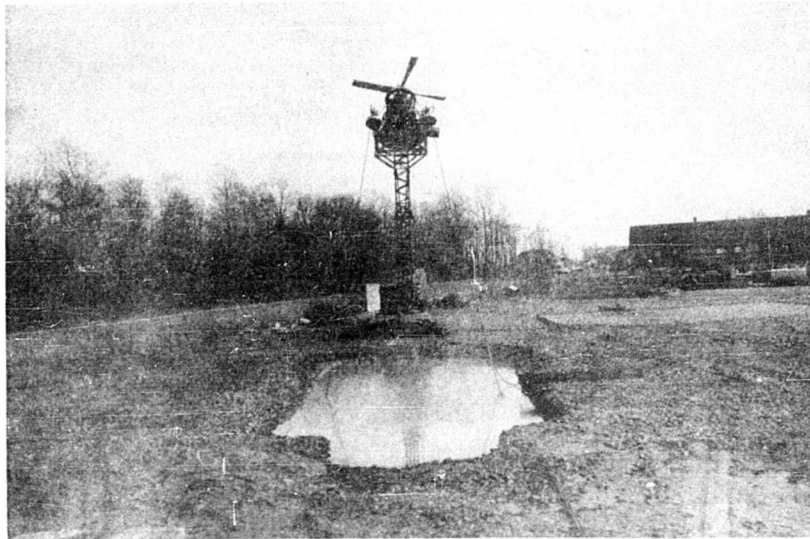
Figure 8: TEST SET-UP FOR OPERATIONS OVER
WATER TEST POOL

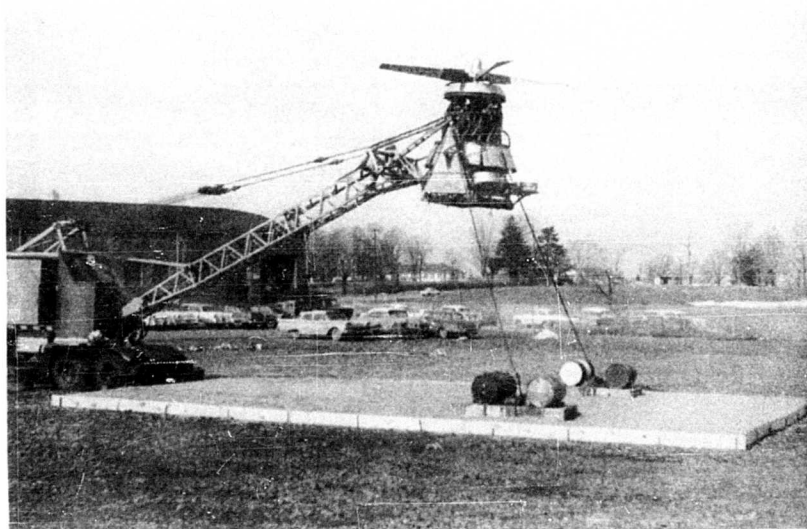
Figure 9: TEST SET-UP FOR OPERATIONS OVER
SAND TERRAIN

A test bed was prepared to simulate operation over sandy terrain. The test bed was 30 feet wide by 50 feet in length with an average sand depth of 10 inches. A photograph of the test set up for testing over sand is presented as Figure 9. The average moisture content of the sand was 4 percent and the average density of the wet sand was 85 pounds per cubic foot. The particle size graduation from a standard sieve analysis of the sand is shown in Figure 10.

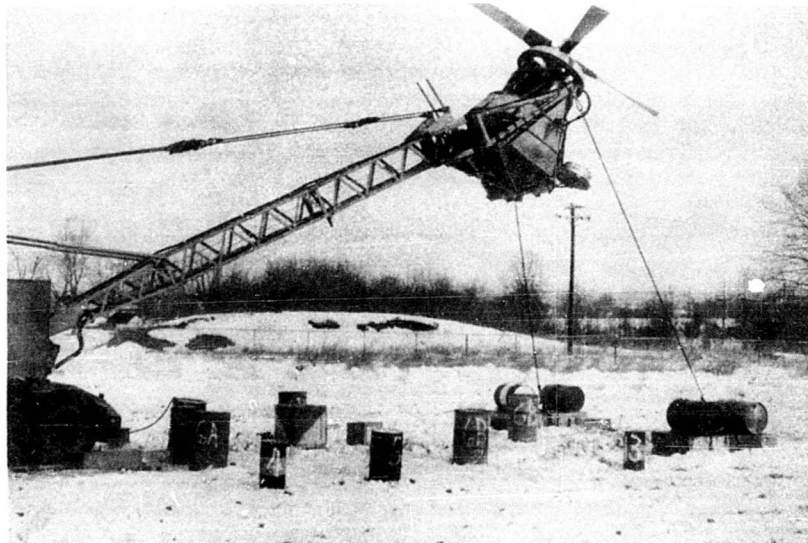
Figure 12: TEST SET-UP TEST OBJECTS ON
SNOW COVERED SURFACE

The test objects described previously and as listed in Table 1 were arranged in a predescribed manner on a macadam or a packed snow covered surface. A photograph of the test set up for operation with the propeller at 25 foot height and with a 30 degree thrust axis inclination is shown in Figure 12. Various patterns of test objects were utilized to best suit the test condition.
