THE DOW METAL PRODUCTS COMPANY  
DIVISION OF THE DOW CHEMICAL COMPANY  
TECHNICAL SERVICE & DEVELOPMENT LABORATORY  
MIDLAND, MICHIGAN

PROTECTIVE COATINGS ON MAGNESIUM ALLOYS  
INTENDED FOR USE ON COMPONENTS OF AIRBORNE VEHICLES

Final Report (Detailed)  
June 1, 1960 to September 5, 1961  
Department of the Army  
Detroit Ordnance District  
Contract No. DA-20-018-ORD-19650

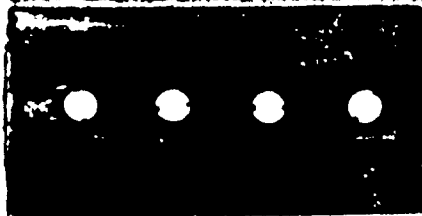
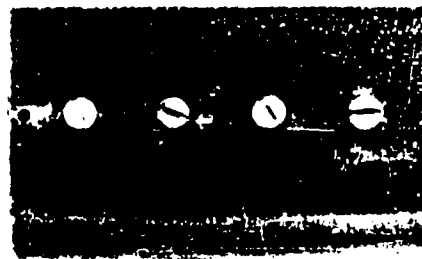
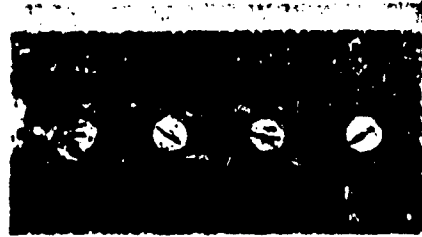
Figure 6

In general, the overall corrosion resistance was good and no significant attack was noticeable on the panel surfaces or at the galvanic couple area of unpainted panels. Tin plated fasteners on Dow #17 anodized unpainted panels showed a slight advantage over cadmium plate, while the magnesium-bare steel stannate treated assembly was best. Considerable spalling of the Dow #17 anodized coating was noted while the stannate coating appeared to be intact. (Figure 6).
