DC-TR: 5-61

PRODUCTION ENGINEERING  
OF  
METAL AND OTHER INERT PARTS  
FOR  
M30 ROCKET MOTOR  
FOR  
NIKE HERCULES MISSILE  
(FINAL ENGINEERING REPORT)

AMMUNITION GROUP  
PICATINNY ARSENAL, DOVER, NEW JERSEY

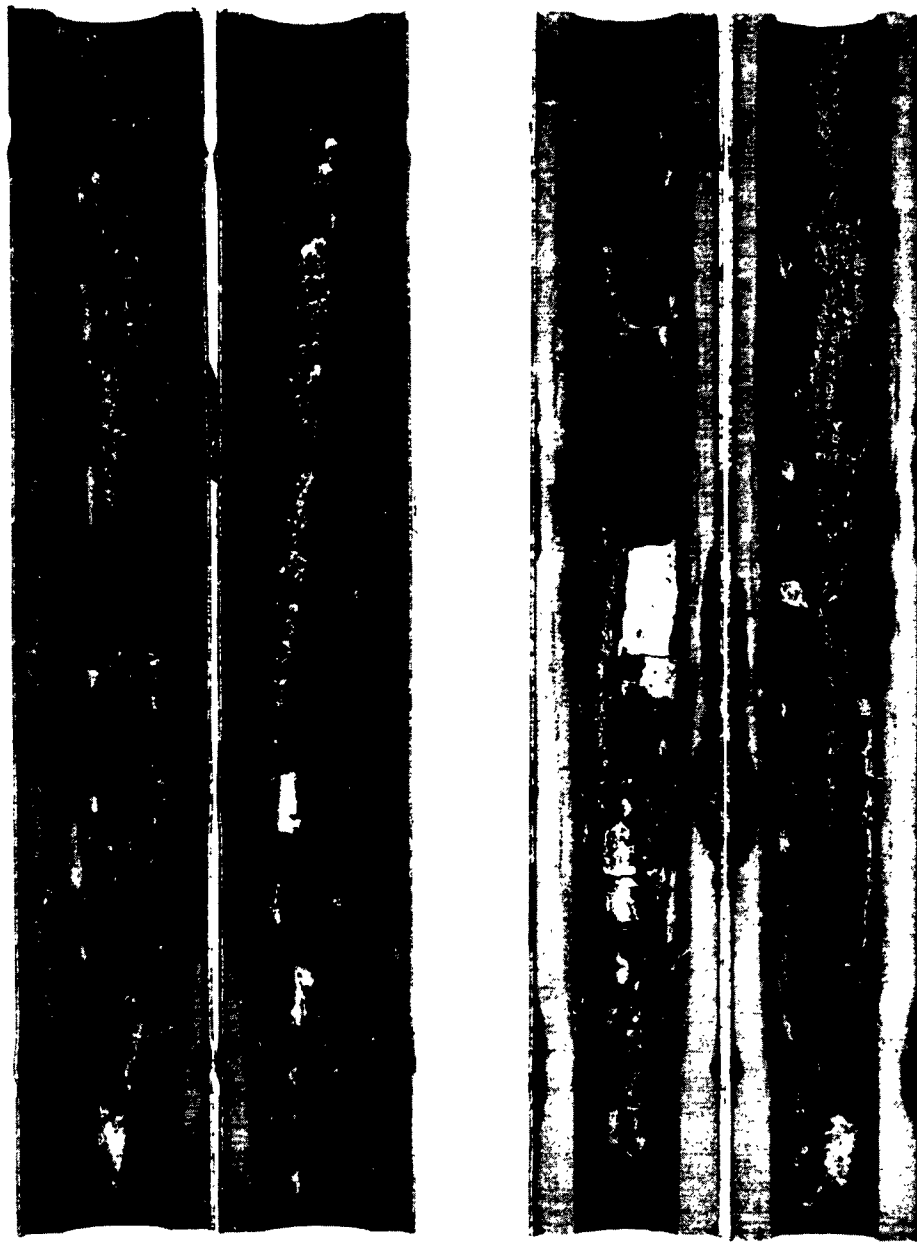
Figure 13. Haveg Rocketon

Haveg Rocketon - Both test samples withstood the test firing without failure, although the first sample might be considered ~~margin~~ marginal since the insulation along a portion of the sidewall eroded down to the metal casing. The second sample evidenced a symmetric pattern of char and erosion.

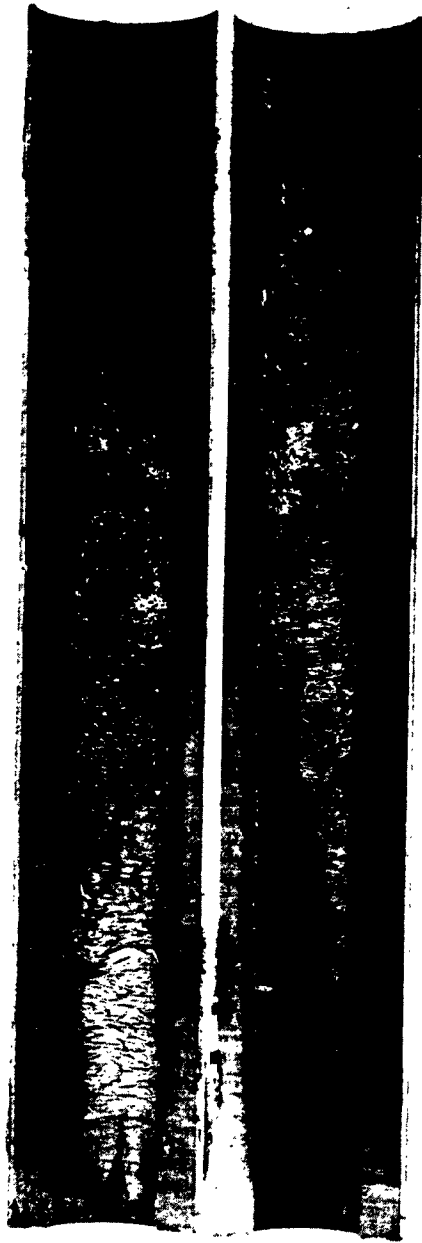
Figure 14. Raybestos - Manhattan 150 RPD

Raybestos-Manhattan 150-RPD - The sample withstood the test with no sign of structural failure. The heat transfer rate was high; other characteristics appeared excellent.

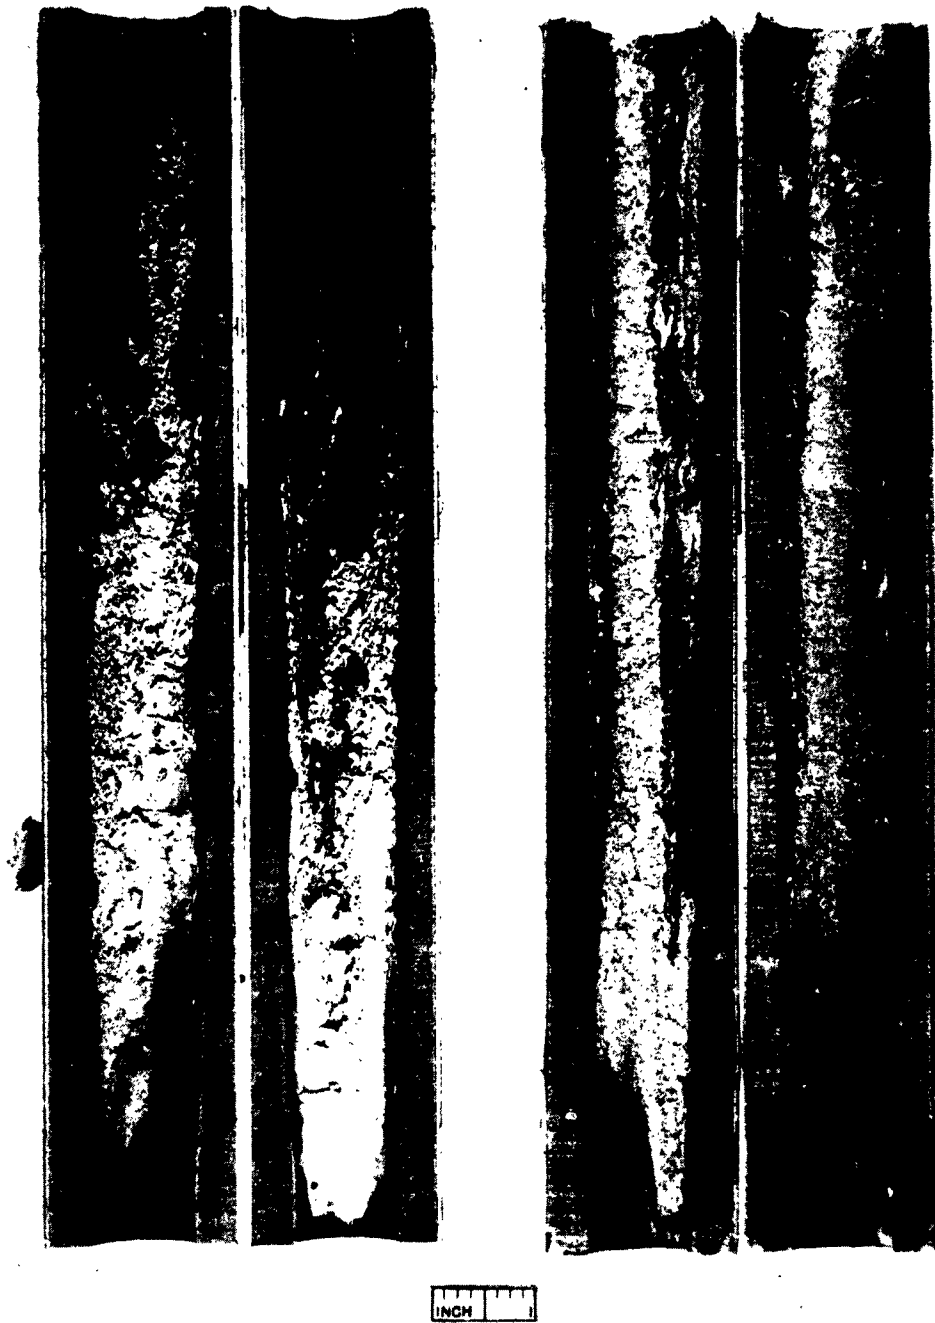
Figure 16. Raybestos - Manhattan 41 RPD

Raybestos-Manhattan 41-RPD - Both samples withstood test firing without failure. Patterns of erosion and char were symmetric.

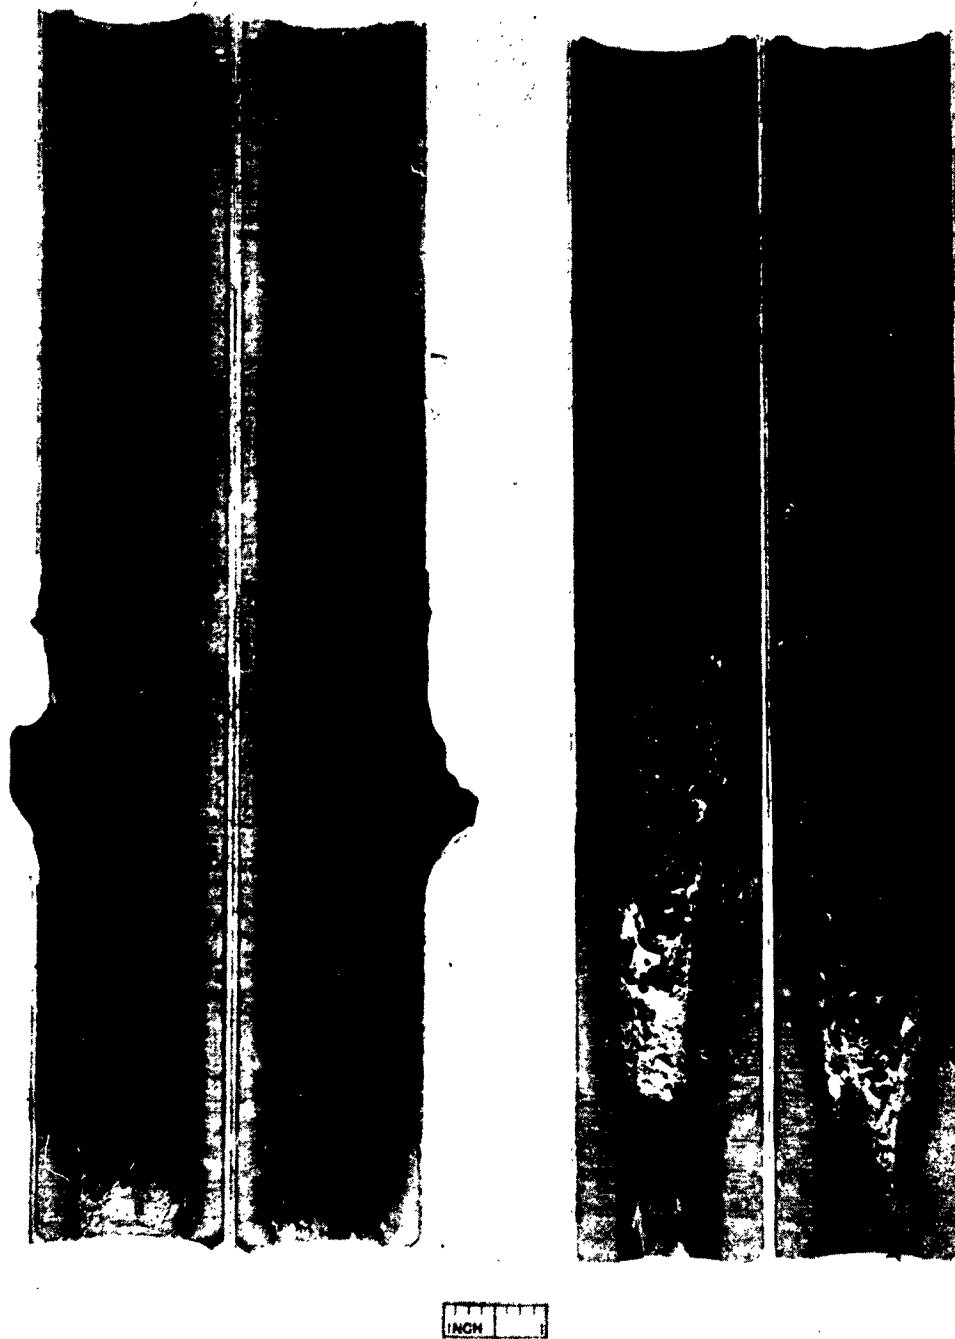
Figure 18. Plastic Age, Durez 16771

Plastic Age, Durez 16771 - Samples were fabricated in two sections. First sample burned through on the upstream side of the joint in 34 seconds. Loss of material was excessive in both samples.

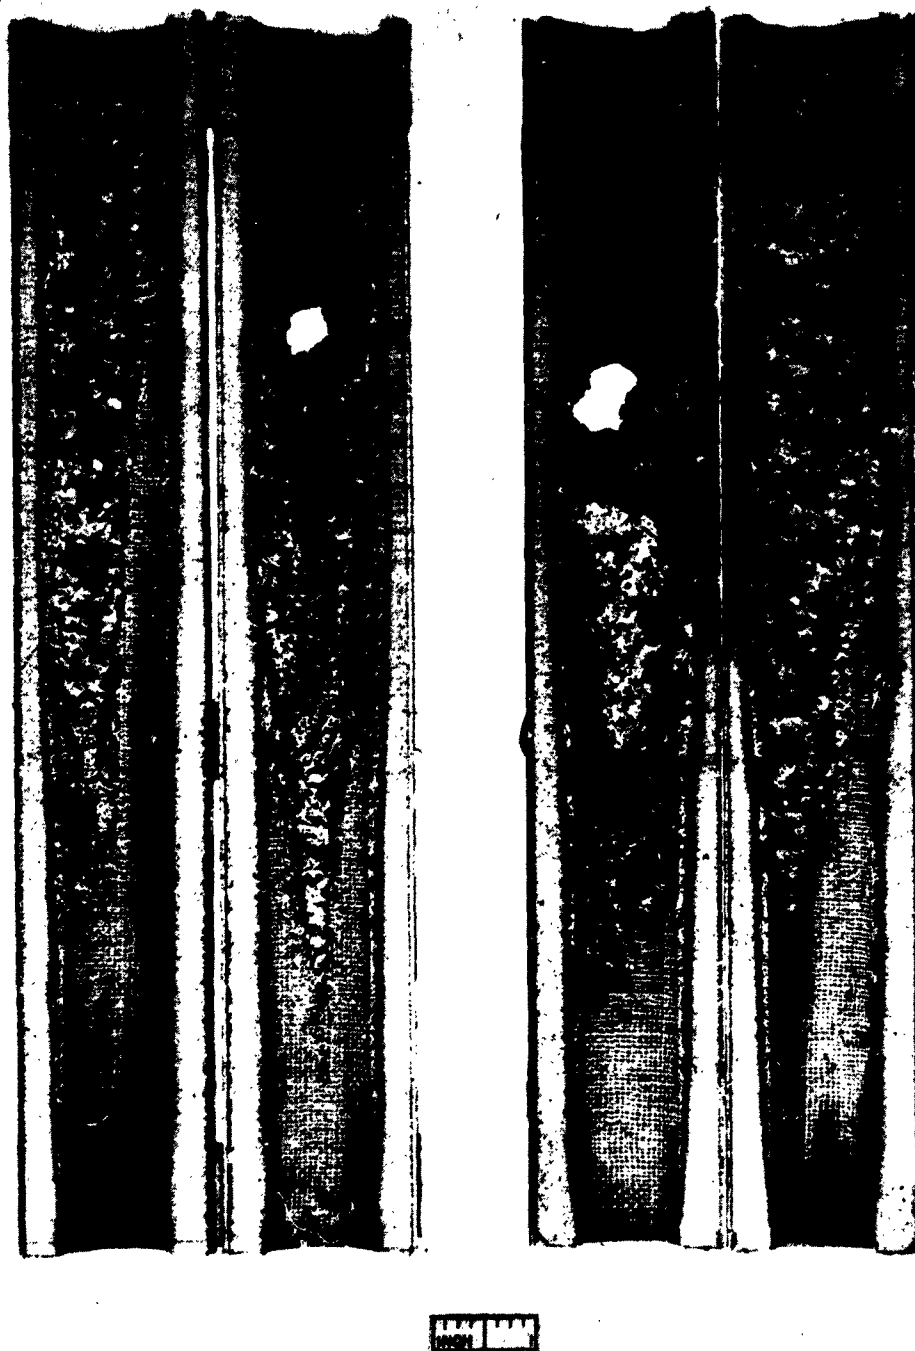
Figure 20. Synthane, Asbestos Cloth - Melamine

Synthane asbestos cloth, melamine - First sample burned through in 20 seconds. Second sample burned through in 24 seconds.
