ASD INTERIM REPORT 7-878 (II)  
March 1962

## SANDWICH ROCKET MOTOR CASE PROGRAM

North American Aviation, Inc.  
Space and Information Systems Division

A description is given of the fabrication studies and tests to determine the material allowables for, together with a description of, subscale and full-scale filament-wound sandwich rocket motor cases.

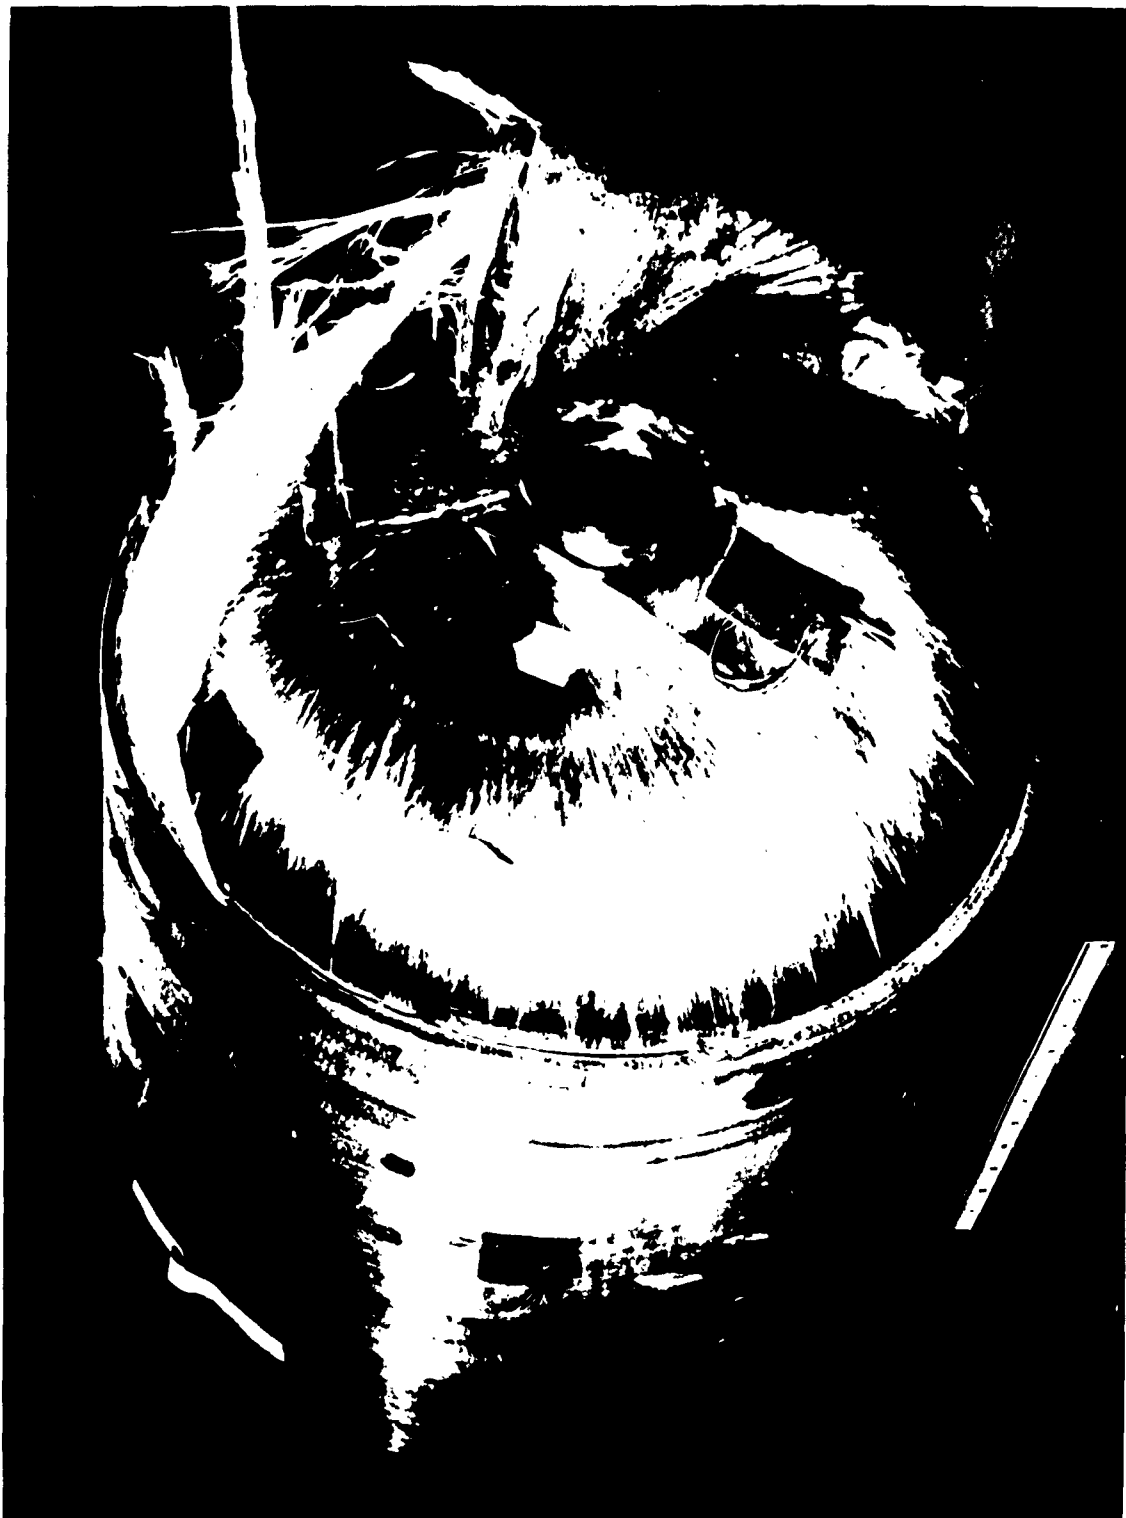
Figure 20. Subscale Case 1 after Failure

The photoelastic material which was applied to subscale case 1 can be seen in Figure 20. The dome failed in the area where the photoelastic film was applied but the failure was not attributable to the film or process of application.

Subscale Case 1 failed at an internal pressure of 490 psi. The failure is shown in Figure 20. The longitudinal fibers of the inner facing failed in tension at a point 3 inches below the tangency point of the dome and cylinder. (This is just below the point where the second layer of longitudinal wraps on the dome is cut off.) It is believed that the longitudinal load from the dome did not redistribute itself between the 2 facings of the sandwich. Part of the longitudinal load should be transferred by shear through the core of the sandwich into the outside facing. The relatively large step in the longitudinal windings—resulting from cutting the second longitudinal wrap—causes a stress concentration in the first wrap which also may have contributed to the premature failures. If it were assumed that none of the longitudinal load transferred to the outside facing, the tensile stress in the inside longitudinal wrap at the time of failure was approximately 140,000 psi.

Because of many difficulties encountered during fabrication, it was impossible to determine the exact cause of the premature failure. The bond between the core and the inside facing was found to be poor in the area of the failure, which may have been a reason for the poor shear transfer between facings. The specimen failed at the end of the case from which the skirt had been removed, and it is possible that the case had been damaged when attempts were made to remove the skirt tooling prior to removing the skirt.

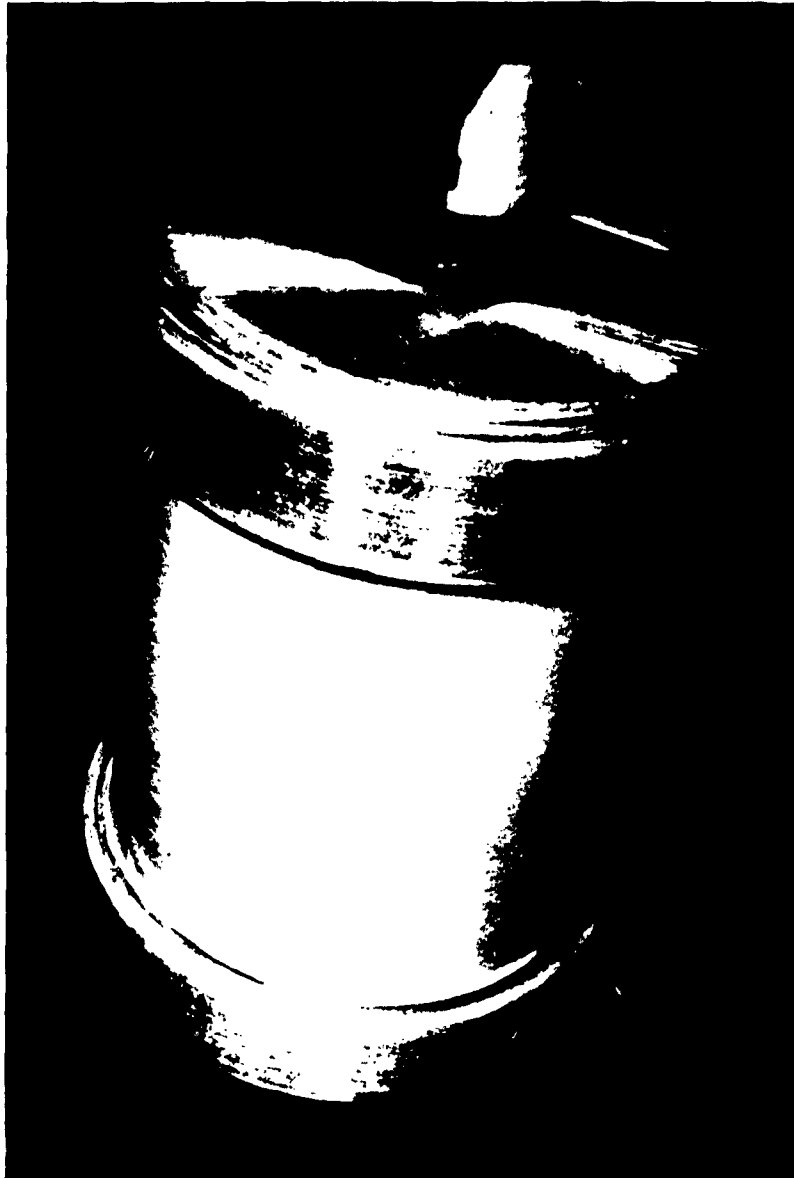
Figure 31. Sandwich-Wall Cylinder Prior to Application of Core

The end reinforcements and core-to-face adhesive were applied (see Figure 31) in the following manner:

1. At each end, strips of No. 143-style fiberglass cloth (impregnated with U.S. Polymeric E787 resin)—with the warp oriented in the longitudinal direction—and 0.008-inch circumferential windings were alternately applied (30 layers of No. 143 cloth and 29 circumferential wraps to form solid plastic inserts.
