P R A T T & W H I T N E Y A I R C R A F T  
D I V I S I O N O F U N I T E D A I R C R A F T C O R P O R A T I O N  
E A S T H A R T F O R D 8, C O N N E C T I C U T, U. S. A.

Sixth Quarterly Report on  
Research and Development of Titanium  
Rocket Motor Case

January 31, 1962  
Pratt & Whitney Aircraft Division  
United Aircraft Corporation  
East Hartford 8, Connecticut

TECHNICAL REPORT NO. WAL 766.2/1-5

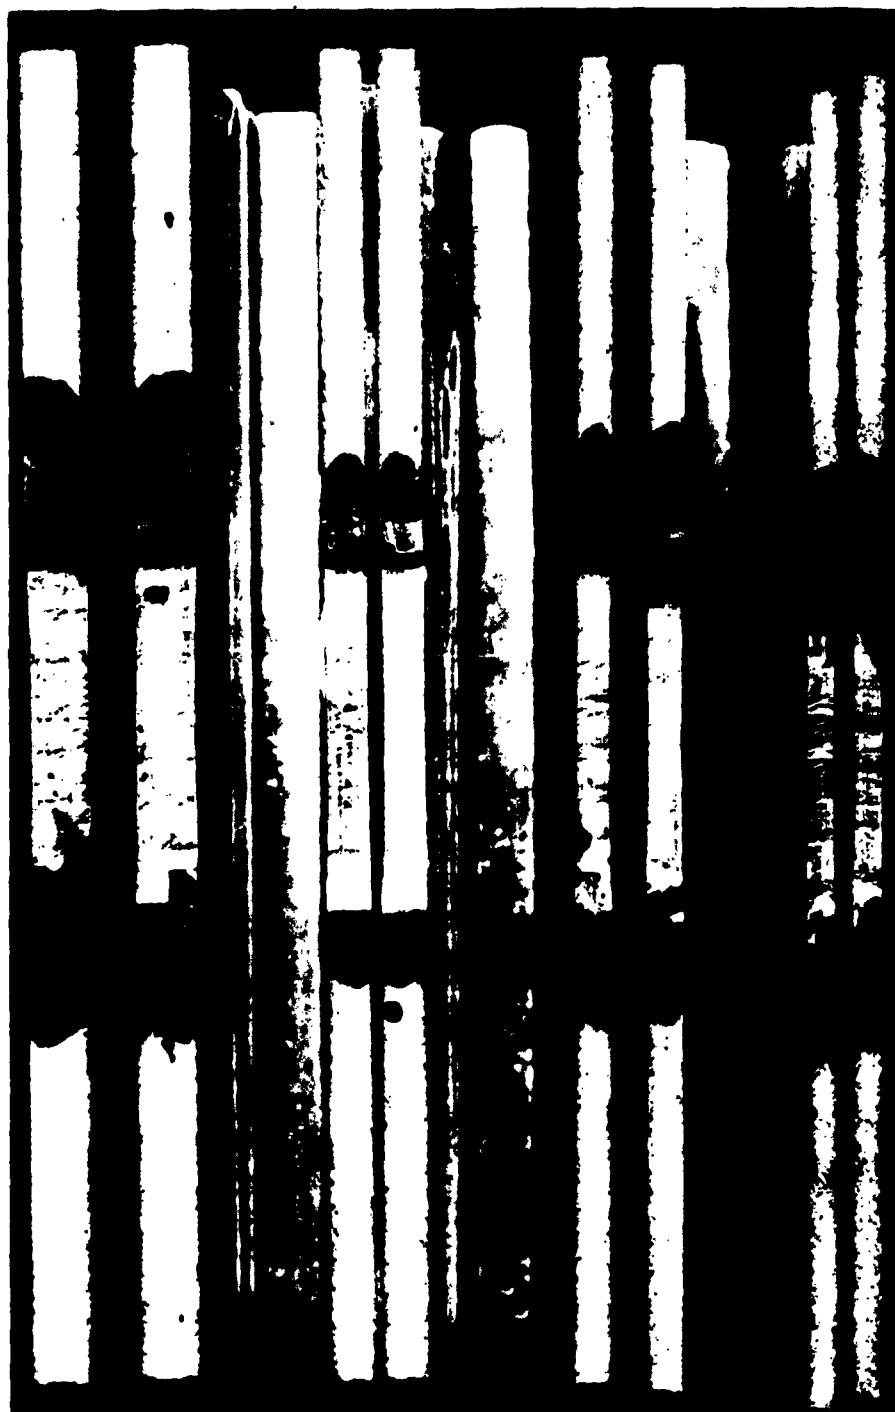
Figure 42

MAG: 2 3/4X  
 FRACTURE SURFACES OF TOUGHNESS (Gc) SPECIMENS FROM COLD-ROLLED  
 AND AGED SHEET STOCK OF VARIOUS THICKNESSES. NOTE EXTENT OF  
 SLOW CRACK PROPAGATION (INK STAINS)  
 H-24325

| <u>Number</u> | <u>Title</u> |
|---|---|
| 42 | Fracture Surfaces of Toughness ( $G_c$ ) Specimens from Cold-Rolled and Aged Sheet Stock of Various Thicknesses. Note extent of Slow Crack Propagation |

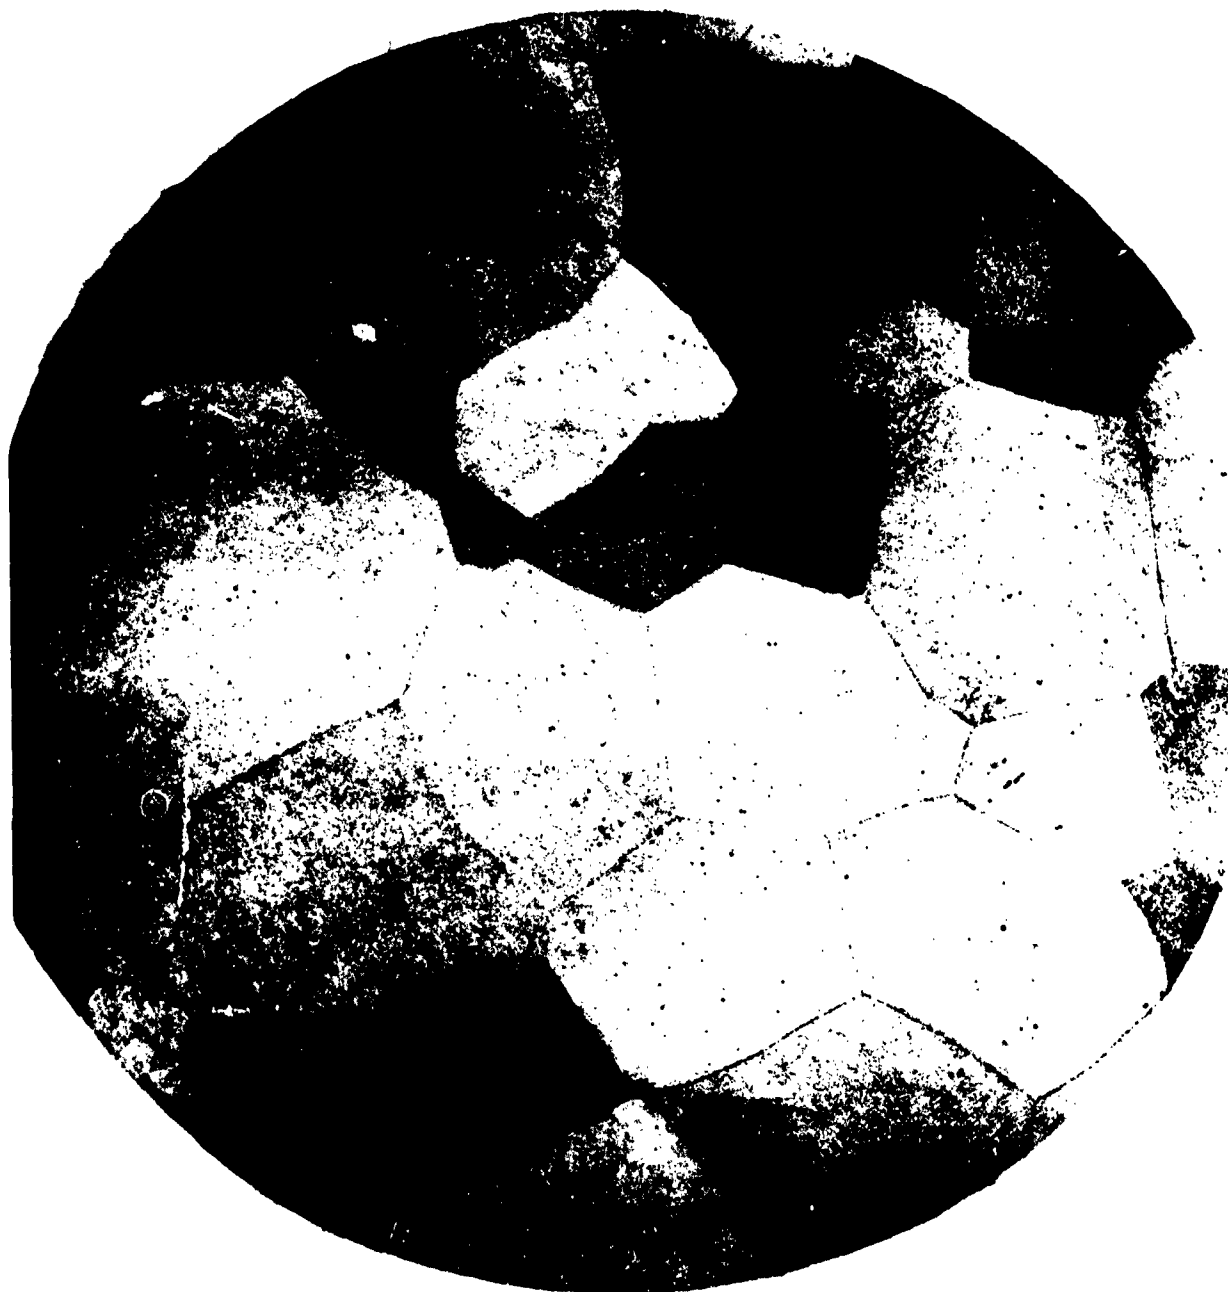
Figure 52

ETCHANT: 5% HF, 35% HNO<sub>3</sub> MAG: 100X  
TYPICAL MICROSTRUCTURE OF FULL SCALE FRONT DOME EJO-1  
PRESS-FORGED AT 1700F BY THE PANCAKE AND PREFORM METHOD  
AND RESTRUCK AT 1900F NOTE COARSE EQUI-AXED GRAIN SIZE  
AND NONUNIFORM AGING

| <u>Number</u> | <u>Title</u> |
|---|---|
| 52 | Typical Microstructure of Full-Scale Front Dome EJO-1 Press-Forged at 1700F by the Pancake and Preform Method and Restruck at 1900F. Note Coarse Equi-Axed Grain Size and Nonuniform Aging |
