THE BABCOCK & WILCOX CO.

BOILER DIVISION

FINAL SUMMARY REPORT
INVESTIGATION OF FABRICATION PROCEDURES
FOR 16Cr-8Ni-2Mo WROUGHT MATERIALS
NObs-72054 INDEX NO. NS-021-300
596-2007-45 757-047796
REPORT NO. 541
OCTOBER 3, 1961

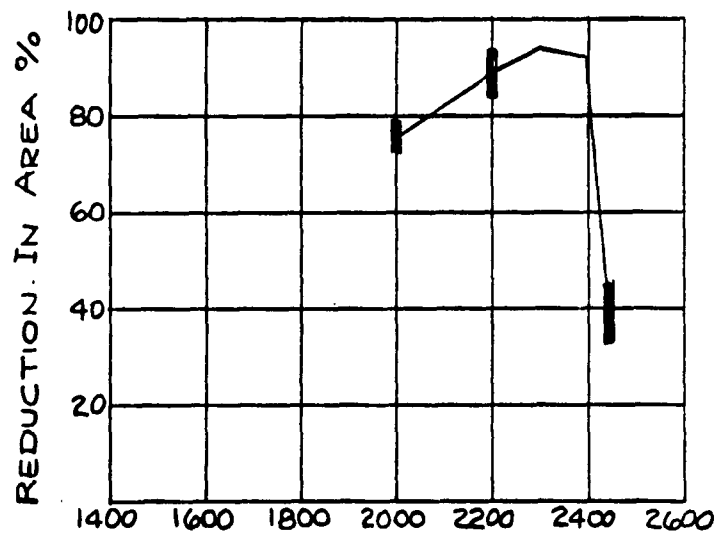
FIGURE - 7 R.P.I. HOT DUCTILITY TEST (NIPPES) RESULTS, PERCENT REDUCTION OF AREA, TESTED ON HEATING.

Figures 7, 8, 9, 10, 11, and 12 are plots of the various properties for a heat of TP-316, cur tests on Heat 1946, and for the Crucible heat of Croloy 16-8-2. In comparing Figures 7 and 8, which show reduction in area on heating and reduction in area on cooling from 2450 F, we see Croloy 16-8-2 exhibits excellent rapid recovery of ductility values after being subjected to simulated heat-affected zone temperatures. Other Figures show Croloy 16-8-2 to recover tensile properties very well, and also shows high ability to plastically deform prior to fracture.

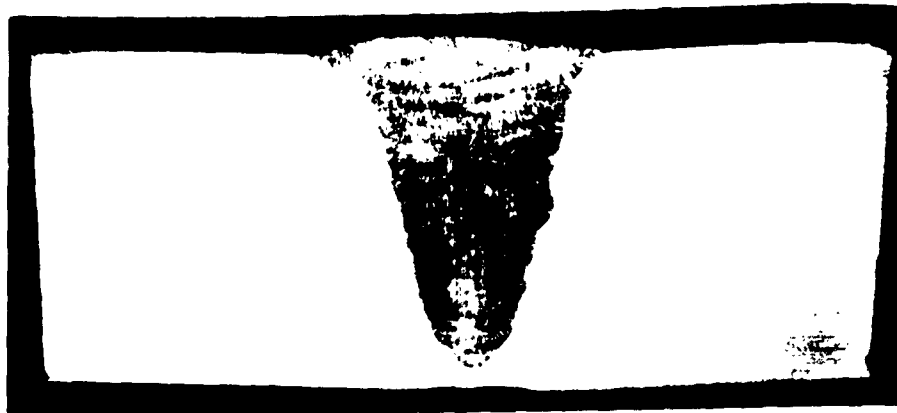
Macroetch of Code 6412 weld

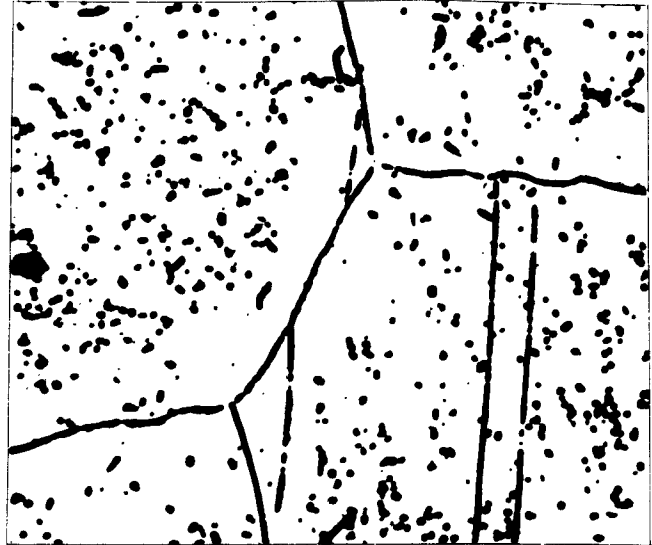
Fig. 38 - Microstructure of Heats 1946 and 2099 after aging of 5000 hours at 1200 F and 1350 F.

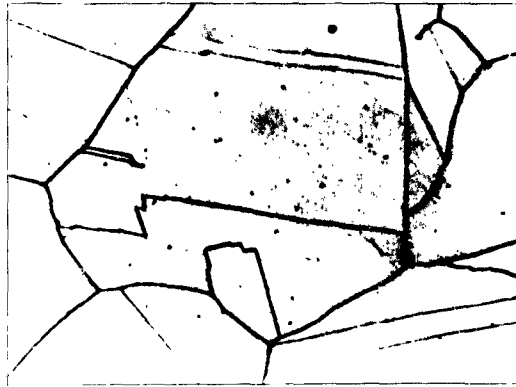
Figure 40
Microstructural Changes Occurring During Rupture Tests
Glyceria Etch - X500
